# **South Downs College, Waterlooville**

## **Flood Risk Assessment**

| Date | 31 <sup>st</sup> January 2025 |
| Revision | Revision D [Changes Highlighted] |

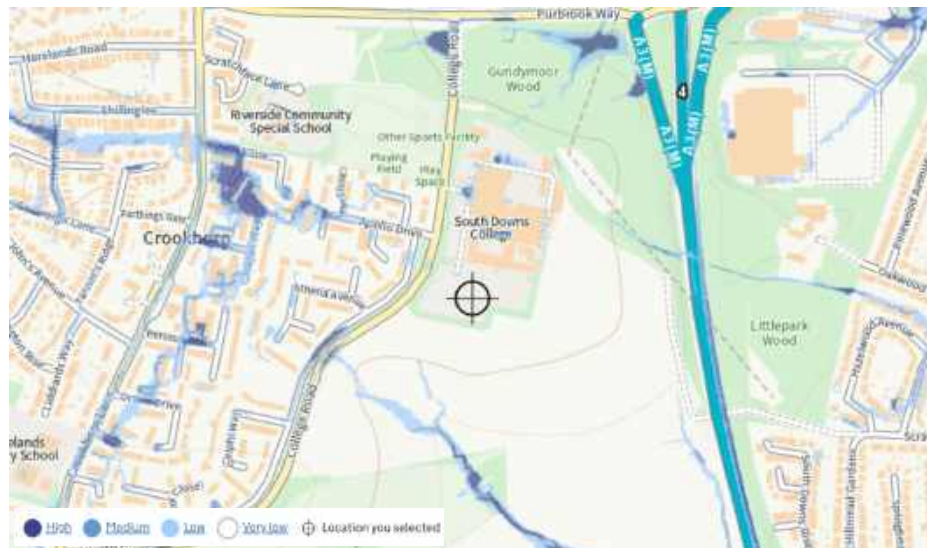
**Figure 2.3 – Flood Risk from Surface Water**

- 2.8 An extract of the 'Flood Risk from Surface Water' mapping has been reproduced as Figure 2.3 below. This mapping is based on LIDAR data and indicates the typical conveyance routes of surface water runoff. The mapping shows that the site is not at risk

of surface water flooding from off-site flows or from excessive ponding on site.

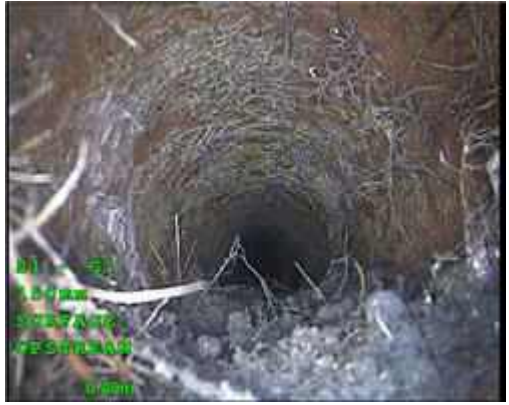
| Pos | Video Ref | Code | Description | Image |
|---|---|---|---|---|
| 00.40m | 0:00:00 | S1 DER | Settled deposits coarse 0.4m - 1.8m: 10% Cross sectional area loss - Severity 3 | Image Provided - Ref: 0_2<br> |

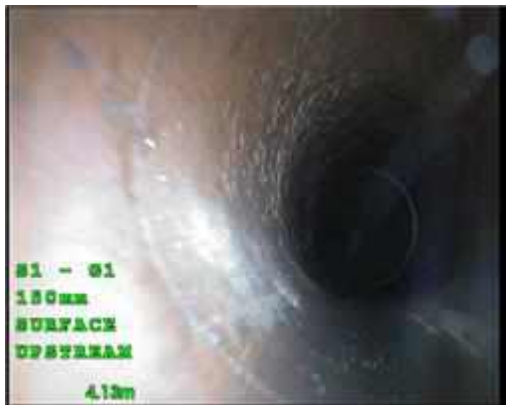
| Pos | Video Ref | Code | Description | Image |
|---|---|---|---|---|
| 04.10m | 0:00:39 | CC | Crack, circumferential from 06 o'clock to 06 o'clock - Severity 1 | Image Provided - Ref: 0_4<br> |

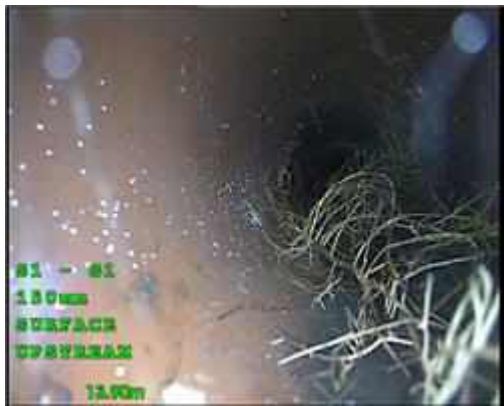
| Pos | Video Ref | Code | Description | Image |
|---|---|---|---|---|
| 13.90m | 0:02:09 | R | Roots - Severity 3<br>TAP ROOTS | Image Provided - Ref: 0_6<br> |

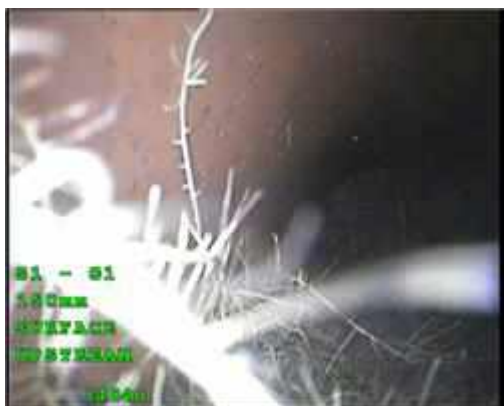
| Pos | Video Ref | Code | Description | Image |
|---|---|---|---|---|
| 14.80m | 0:02:28 | R | Roots - Severity 3<br>MASS ROOTS | Image Provided - Ref: 0_7<br> |

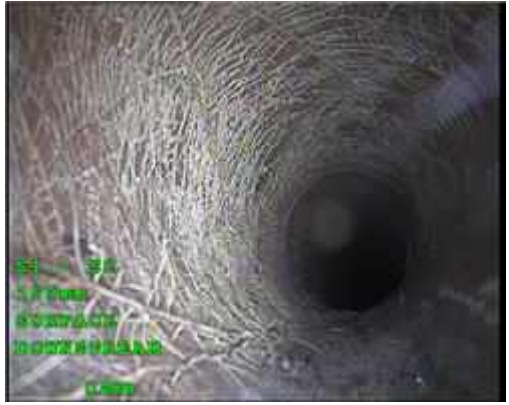
| Pos | Video Ref | Code | Description | Image |
|---|---|---|---|---|
| 00.40m | 0:00:00 | R | Roots - Severity 3<br>FINE ROOTS | Image Provided - Ref: 1_2<br> |

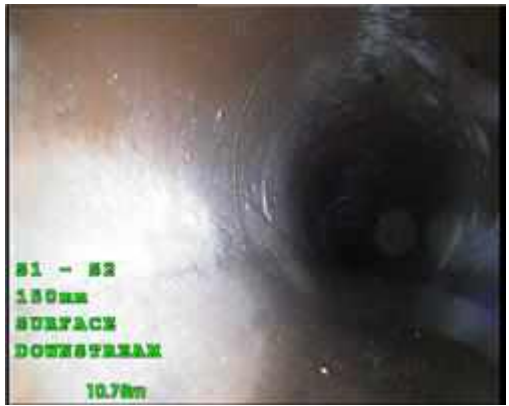
| Pos | Video Ref | Code | Description | Image |
|---|---|---|---|---|
| 10.78m | 0:01:32 | CC | Crack, circumferential from 06 o'clock to 02 o'clock - Severity 1 | Image Provided - Ref: 1_5<br> |

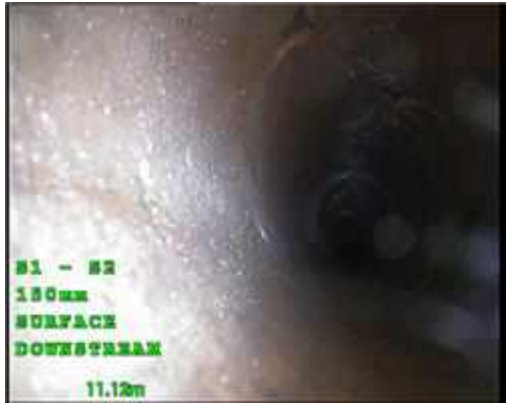
| Pos | Video Ref | Code | Description | Image |
|---|---|---|---|---|
| 11.12m | 0:01:35 | H | Hole in drain/sewer at 11 o'clock - Severity 4 | Image Provided - Ref: 1_7<br> |

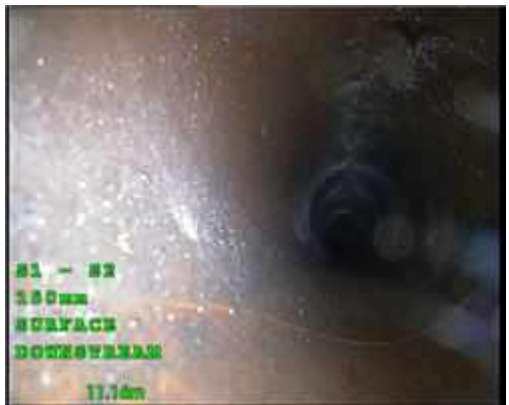
| Pos | Video Ref | Code | Description | Image |
|---|---|---|---|---|
| 11.15m | 0:01:36 | FC | Fracture circumferential from 12 o'clock to 07 o'clock - Severity 3 | Image Provided - Ref: 1_8<br> |

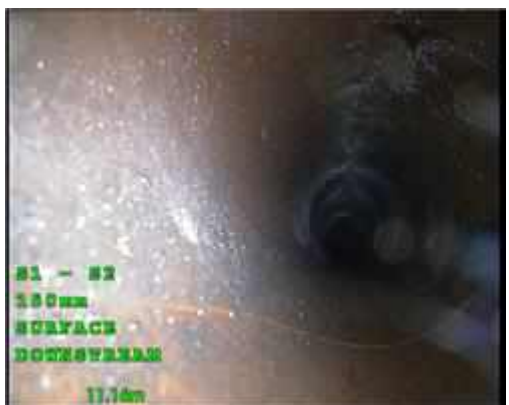
| Pos | Video Ref | Code | Description | Image |
|---|---|---|---|---|
| 11.16m | 0:01:36 | H | Hole in drain/sewer at 12 o'clock - Severity 4 | Image Provided - Ref: 1_9<br> |

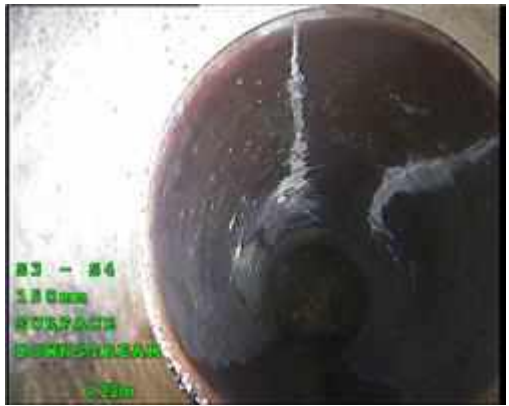
| Pos | Video Ref | Code | Description | Image |
|---|---|---|---|---|
| 09.22m | 0:01:31 | CL | Crack, longitudinal at 12 o'clock - Severity 1 | Image Provided - Ref: 3_3<br> |

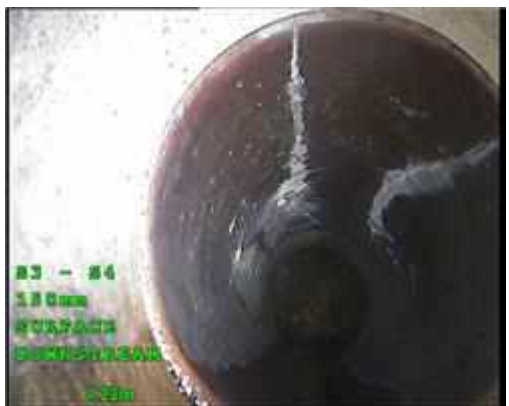
| Pos | Video Ref | Code | Description | Image |
|---|---|---|---|---|
| 09.22m | 0:01:31 | CL | Crack, longitudinal at 02 o'clock - Severity 1 | Image Provided - Ref: 3_4<br> |

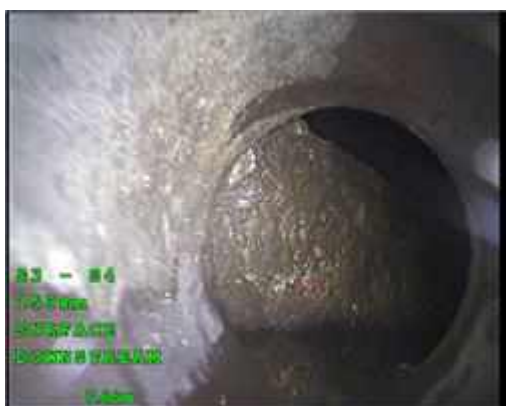
| Pos | Video Ref | Code | Description | Image |
|---|---|---|---|---|
| 09.50m | 0:01:37 | DEE | Attached deposits, encrustation from 08 o'clock to 12 o'clock: 5% Cross sectional area loss - Severity 3 | Image Provided - Ref: 3_5<br> |

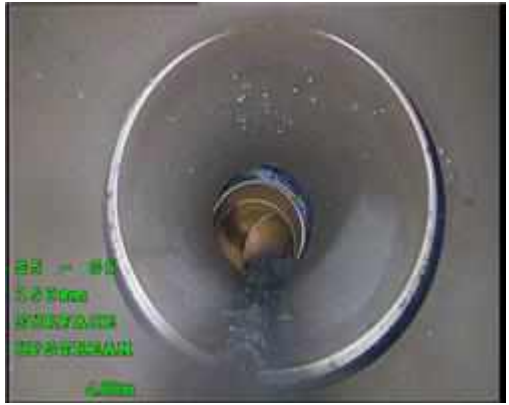
| Pos | Video Ref | Code | Description | Image |
|---|---|---|---|---|
| 04.00m | 0:00:40 | JDM | Joint displaced medium - Severity 3 | Image Provided - Ref: 9_4<br> |

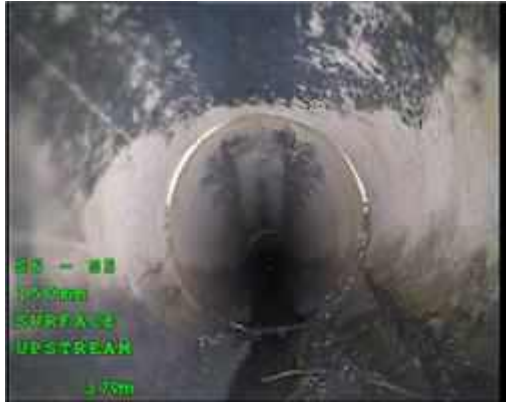
| Pos | Video Ref | Code | Description | Image |
|---|---|---|---|---|
| 03.79m | 0:00:36 | R | Roots - Severity 3 ROOTS | <p>Image Provided - Ref: 14_2</p> |

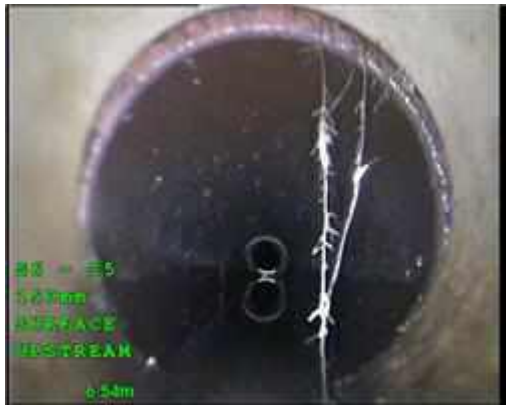
| Pos | Video Ref | Code | Description | Image |
|---|---|---|---|---|
| 06.50m | 0:01:29 | RJ | Roots at joint - Severity 3 FINE ROOTS AT JOINT | <p>Image Provided - Ref: 14_3</p> |

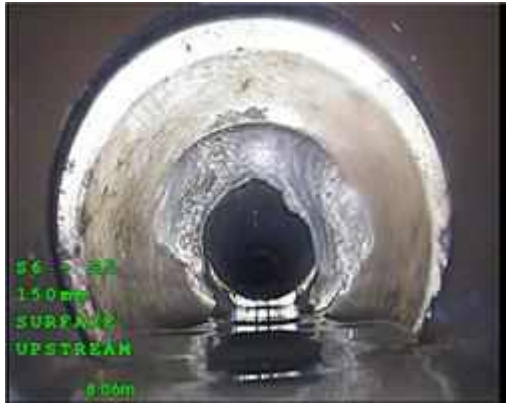
| Pos | Video Ref | Code | Description | Image |
|---|---|---|---|---|
| 08.00m | 0:01:40 | JDM | Joint displaced medium - Severity 3 | Image Provided - Ref: 14_6<br> |

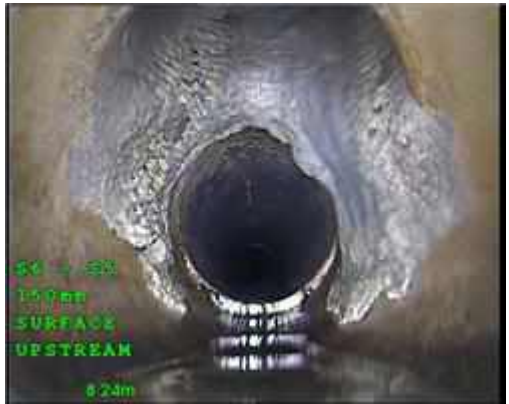
| Pos | Video Ref | Code | Description | Image |
|---|---|---|---|---|
| 08.24m | 0:01:44 | DEE | Attached deposits, encrustation from 09 o'clock to 03 o'clock: 10% Cross sectional area loss - Severity 3 | Image Provided - Ref: 14_8<br> |

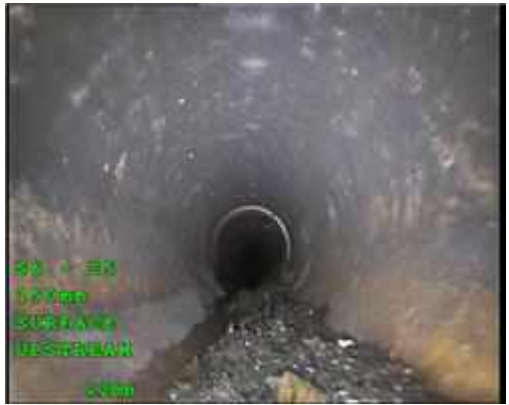
| Pos | Video Ref | Code | Description | Image |
|---|---|---|---|---|
| 09.20m | 0:01:58 | R | Roots - Severity 3<br>MASS ROOTS | Image Provided - Ref: 14_12<br> |

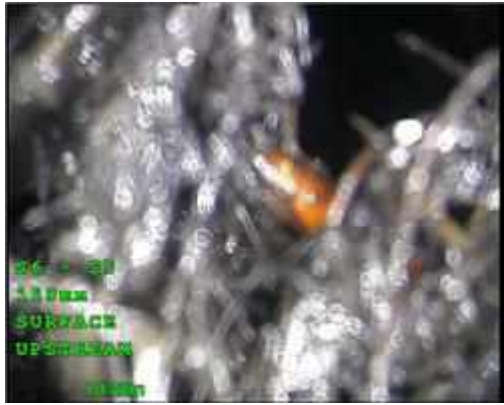
| Pos | Video Ref | Code | Description | Image |
|---|---|---|---|---|
| 10.20m | 0:03:06 | R | Roots - Severity 3<br>MASS ROOTS | <p>Image Provided - Ref: 14_13</p> |

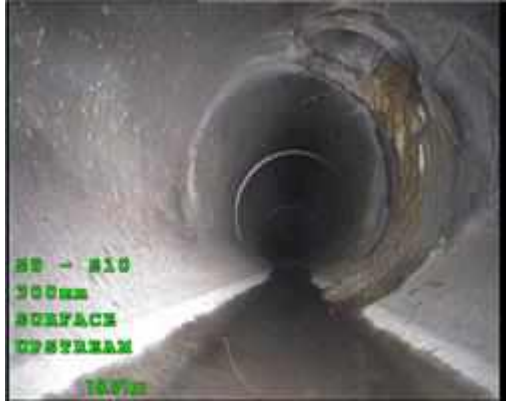
| Pos | Video Ref | Code | Description | Image |
|---|---|---|---|---|
| 18.90m | 0:02:47 | DEE | Attached deposits, encrustation from 01 o'clock to 06 o'clock: 5% Cross sectional area loss - Severity 3 | Image Provided - Ref: 18_7<br> |

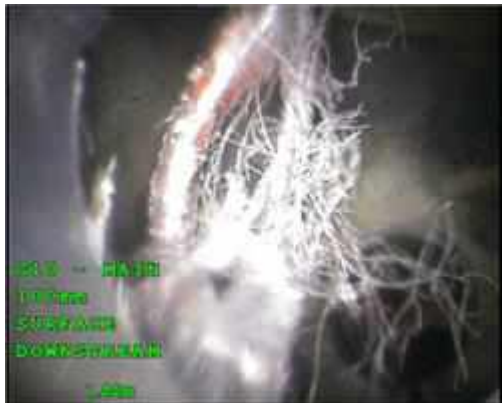
| Pos | Video Ref | Code | Description | Image |
|---|---|---|---|---|
| 01.40m | 0:00:16 | R | Roots - Severity 3<br>TAP ROOTS | <p>Image Provided - Ref: 21_2</p> |

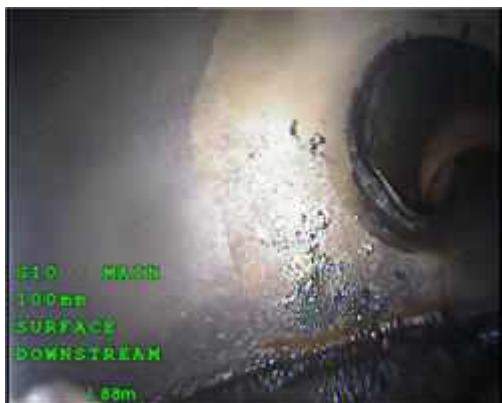
| Pos | Video Ref | Code | Description | Image |
|---|---|---|---|---|
| 01.50m | 0:00:23 | REM | General remark<br>POSSIBLE REDUNDANT<br>GULLY | <p>Image Provided - Ref: 21_3</p> |

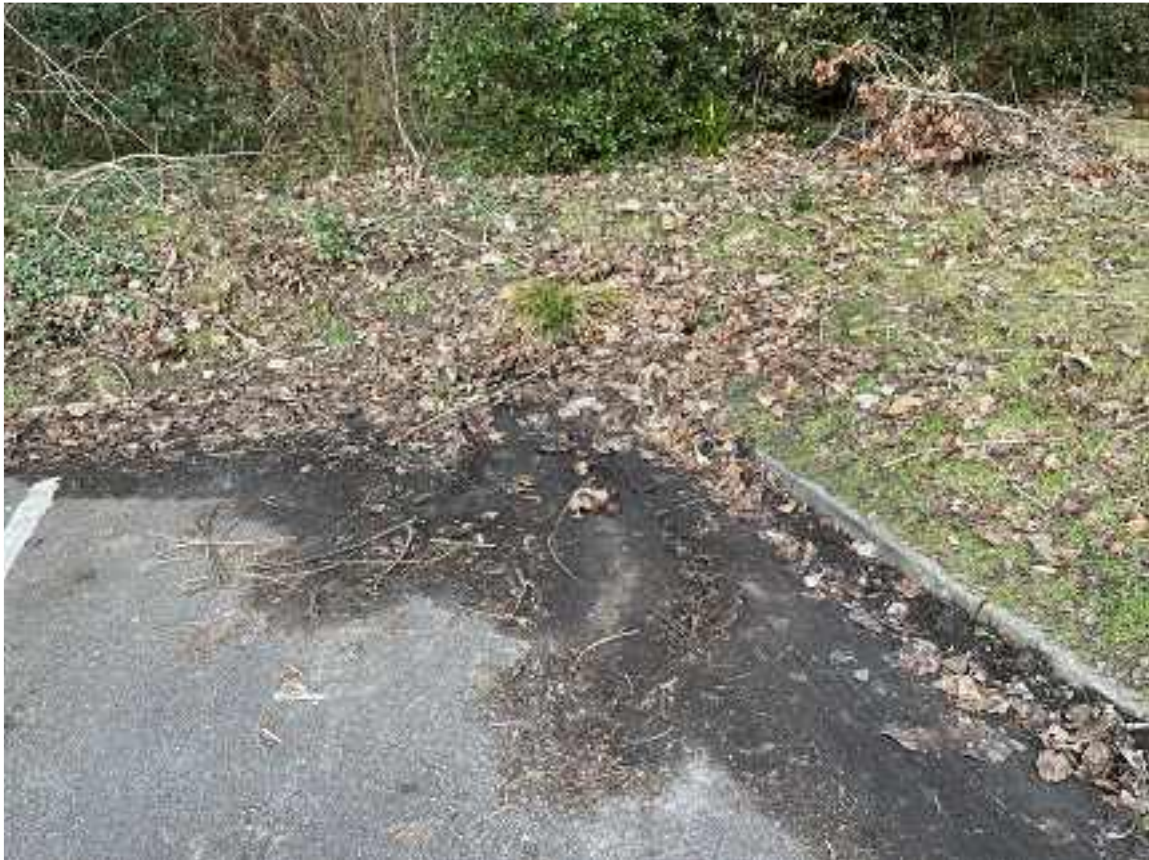
GULLY 01 (UNDER MUD AND LEAVES)

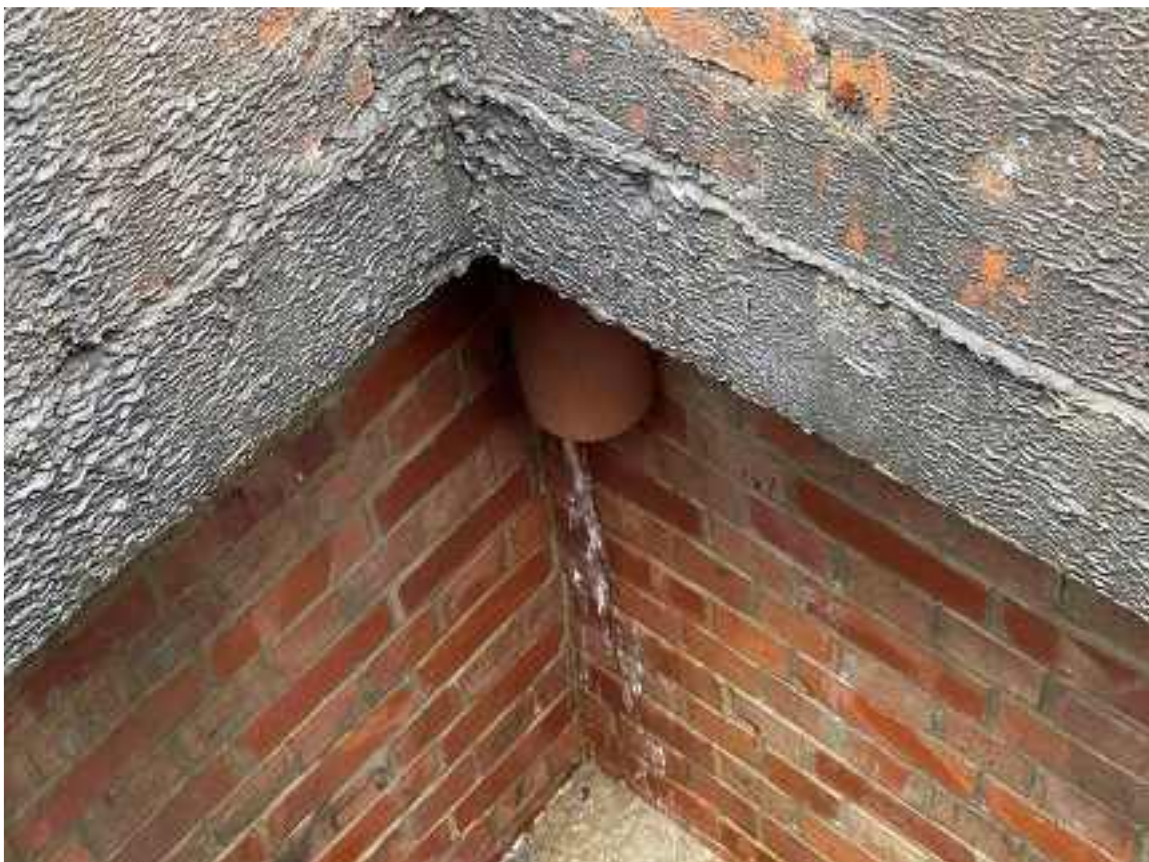
MH S8 (WATER CONTINUALLY RUNNING INTO MANHOLE)
