HCC Property Services,  
Three Ministers House,  
76 High Street, Winchester SO23 8UL  
tel: (01962) 847801  
**PROJECT NAME**  
Staunton Farm, Gothic Library

**SHEET NAME**  
GA Reflected Ceiling Plan  
Condition Survey  
And Scope of Works

**DRAWING No.**  
project code - originator - volume - level - type - role - number  
P13962-HCC-ZZ -113 HL PLAN L1 00

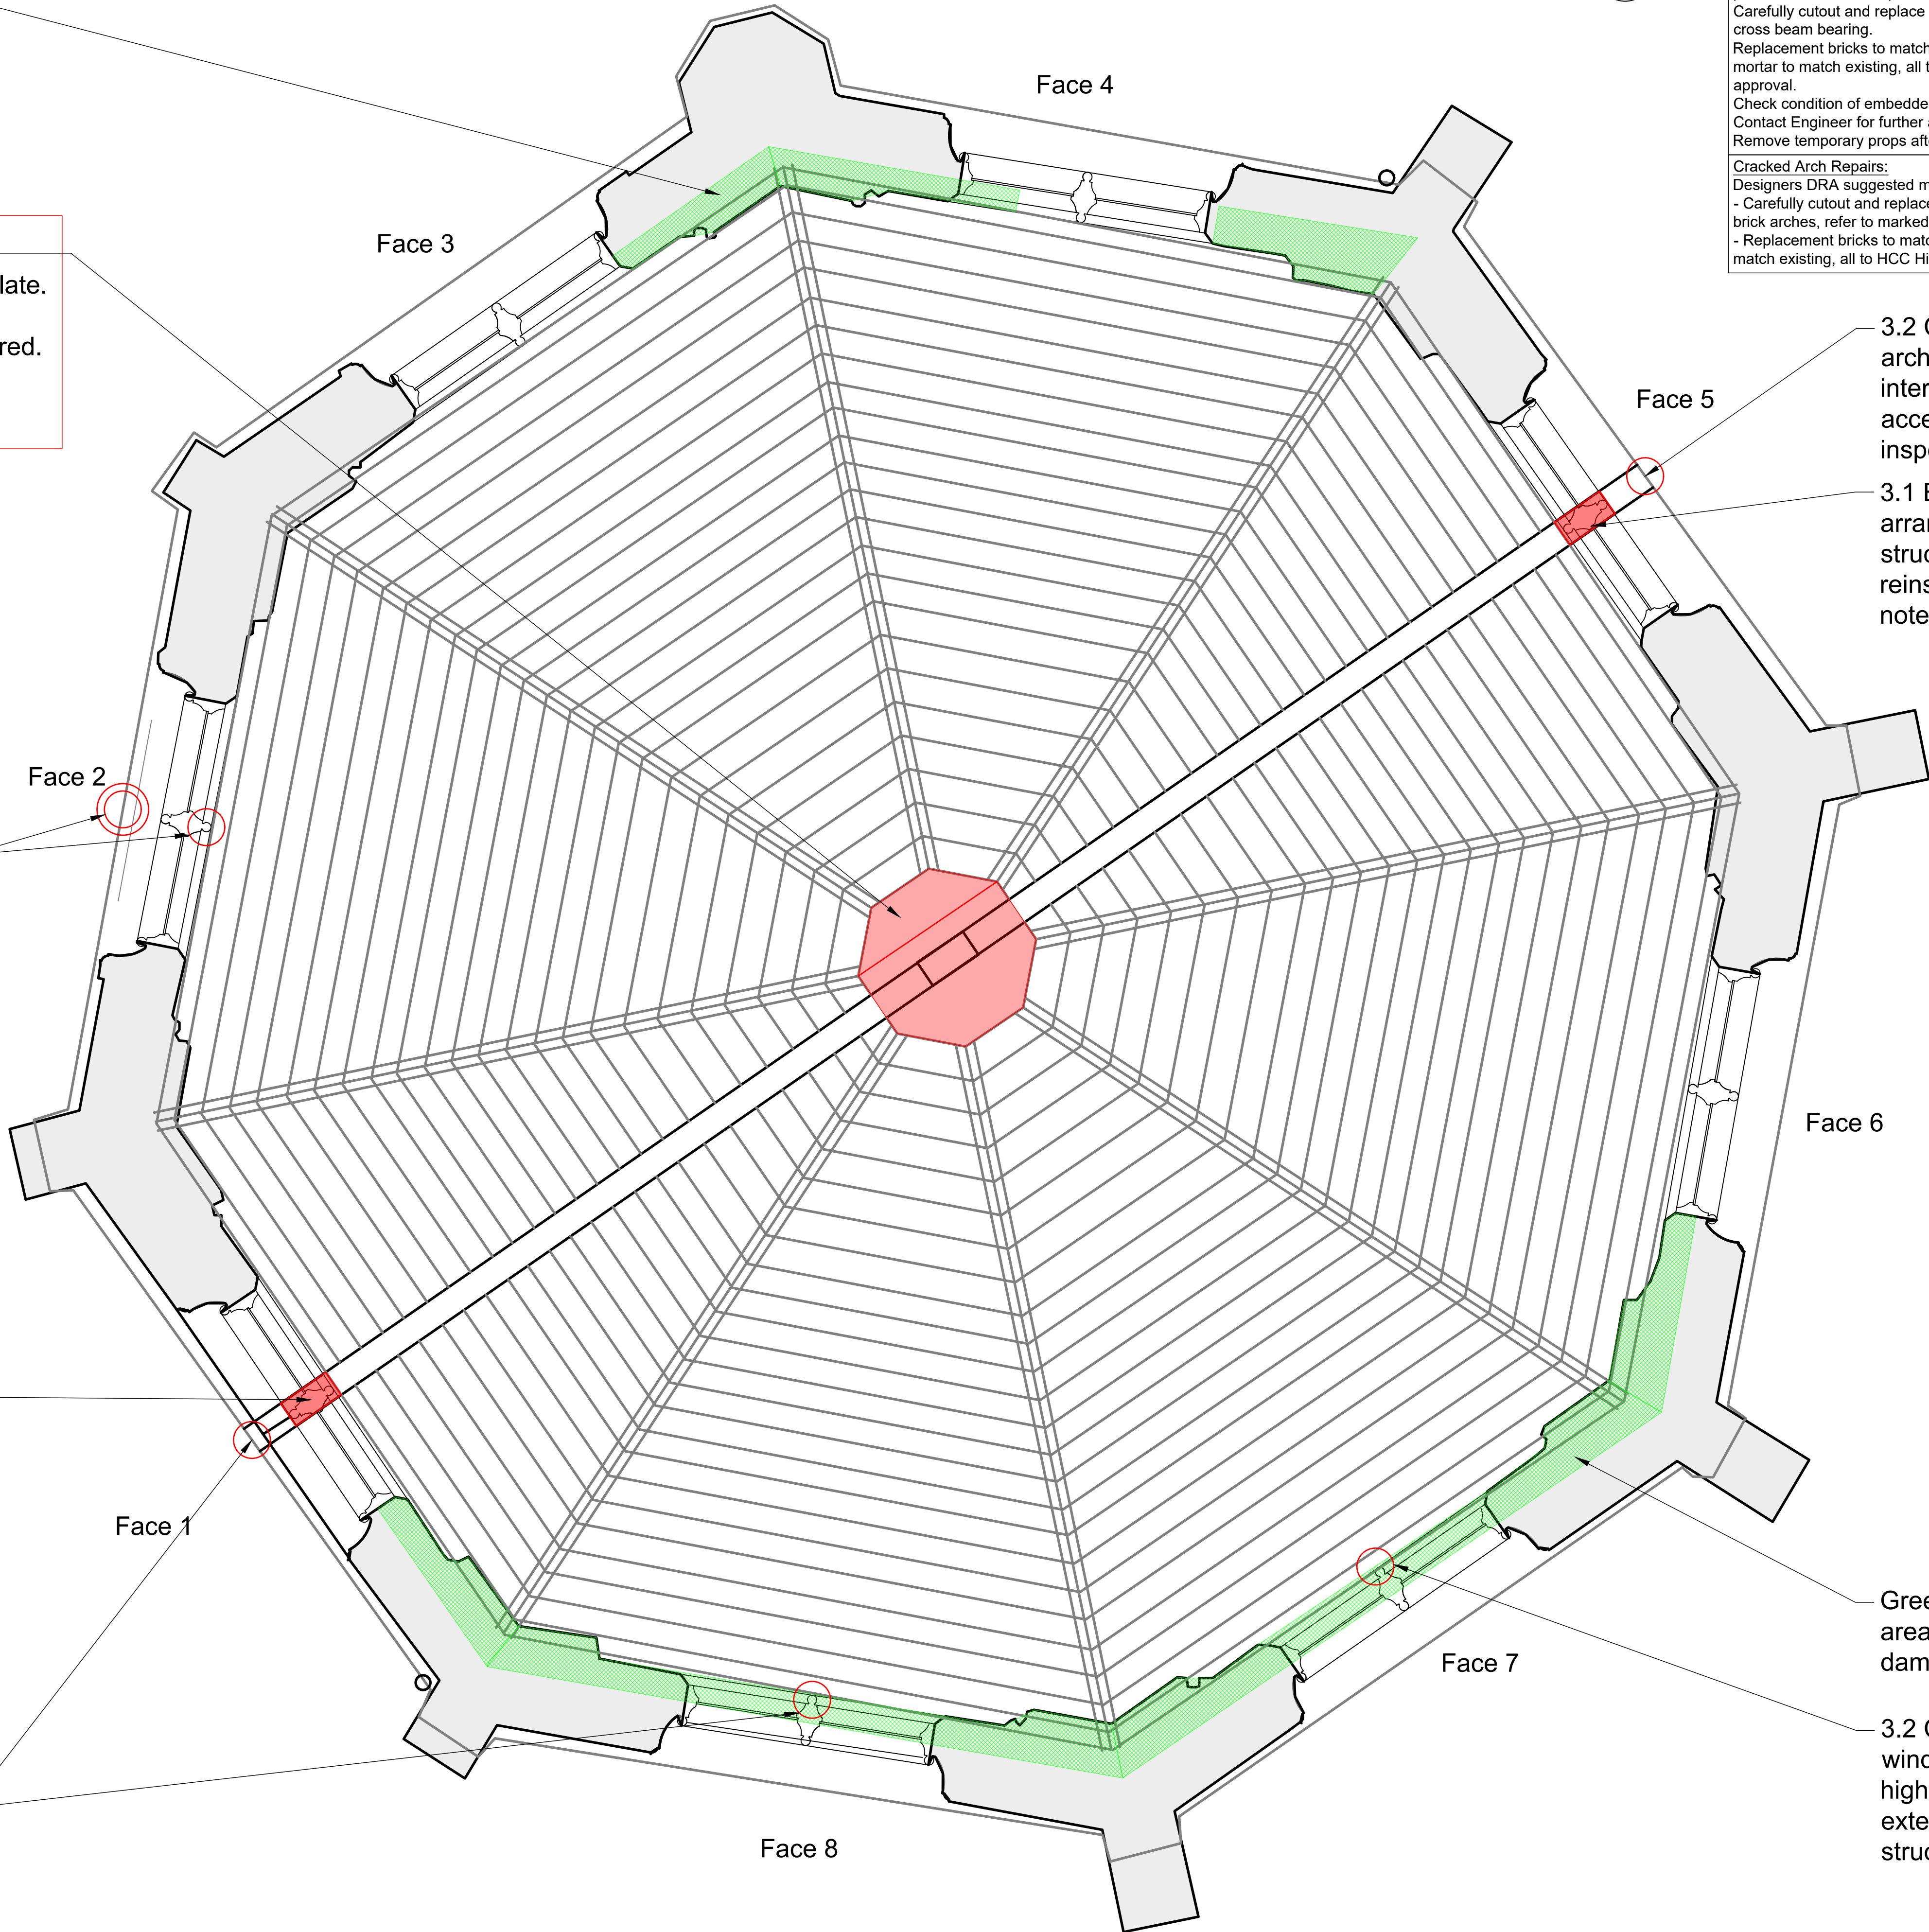
Green hatch indicates areas of high level damp masonry.

3.1 Structural inspection. Octagonal central timber plate. Significant split identified. New timber propping required. Refer to WSP sketch SK1 13/09/2024.

2.1 Cracks above window arch. Provide high level internal and external access for structural inspection.

3.2 Cracks above window arch. Provide high level internal and external access for structural inspection.

3.1 Expose beam ends, arrange inspection with structural engineer, reinstate and repair as per notes above.

**Cross Beam Bearing Repairs:**  
Designers DRA suggested method.  
Temporary prop existing timber crossbeam using RMD Superslim soldier props or similar equivalent. Provide plywood sheeting to protect the slabs and spread loads..  
Carefully cutout and replace eroded/cracked bricks to brick arch at cross beam bearing.  
Replacement bricks to match existing, NHL5 (tbc) lime based mortar to match existing, all to HCC Historic Team specification & approval.  
Check condition of embedded cross beam at bearings for decay.  
Contact Engineer for further advice if found to be decayed.  
Remove temporary props after mortar has set.

**Cracked Arch Repairs:**  
Designers DRA suggested methodology  
- Carefully cutout and replace eroded/cracked bricks to cracked brick arches, refer to marked up plan for locations.  
- Replacement bricks to match existing, NHL5 lime based mortar to match existing, all to HCC Historic Team specification & approval.
