28 November 2022

Jack Porter  
Estates Coordinator  
SGN  
St Lawrence House  
Station Approach  
Horley, RH6 9HJ

EMSWORTH ABANDONED RESIDENTIAL PROPERTY: STRUCTURAL BUILDING ASSESSMENT

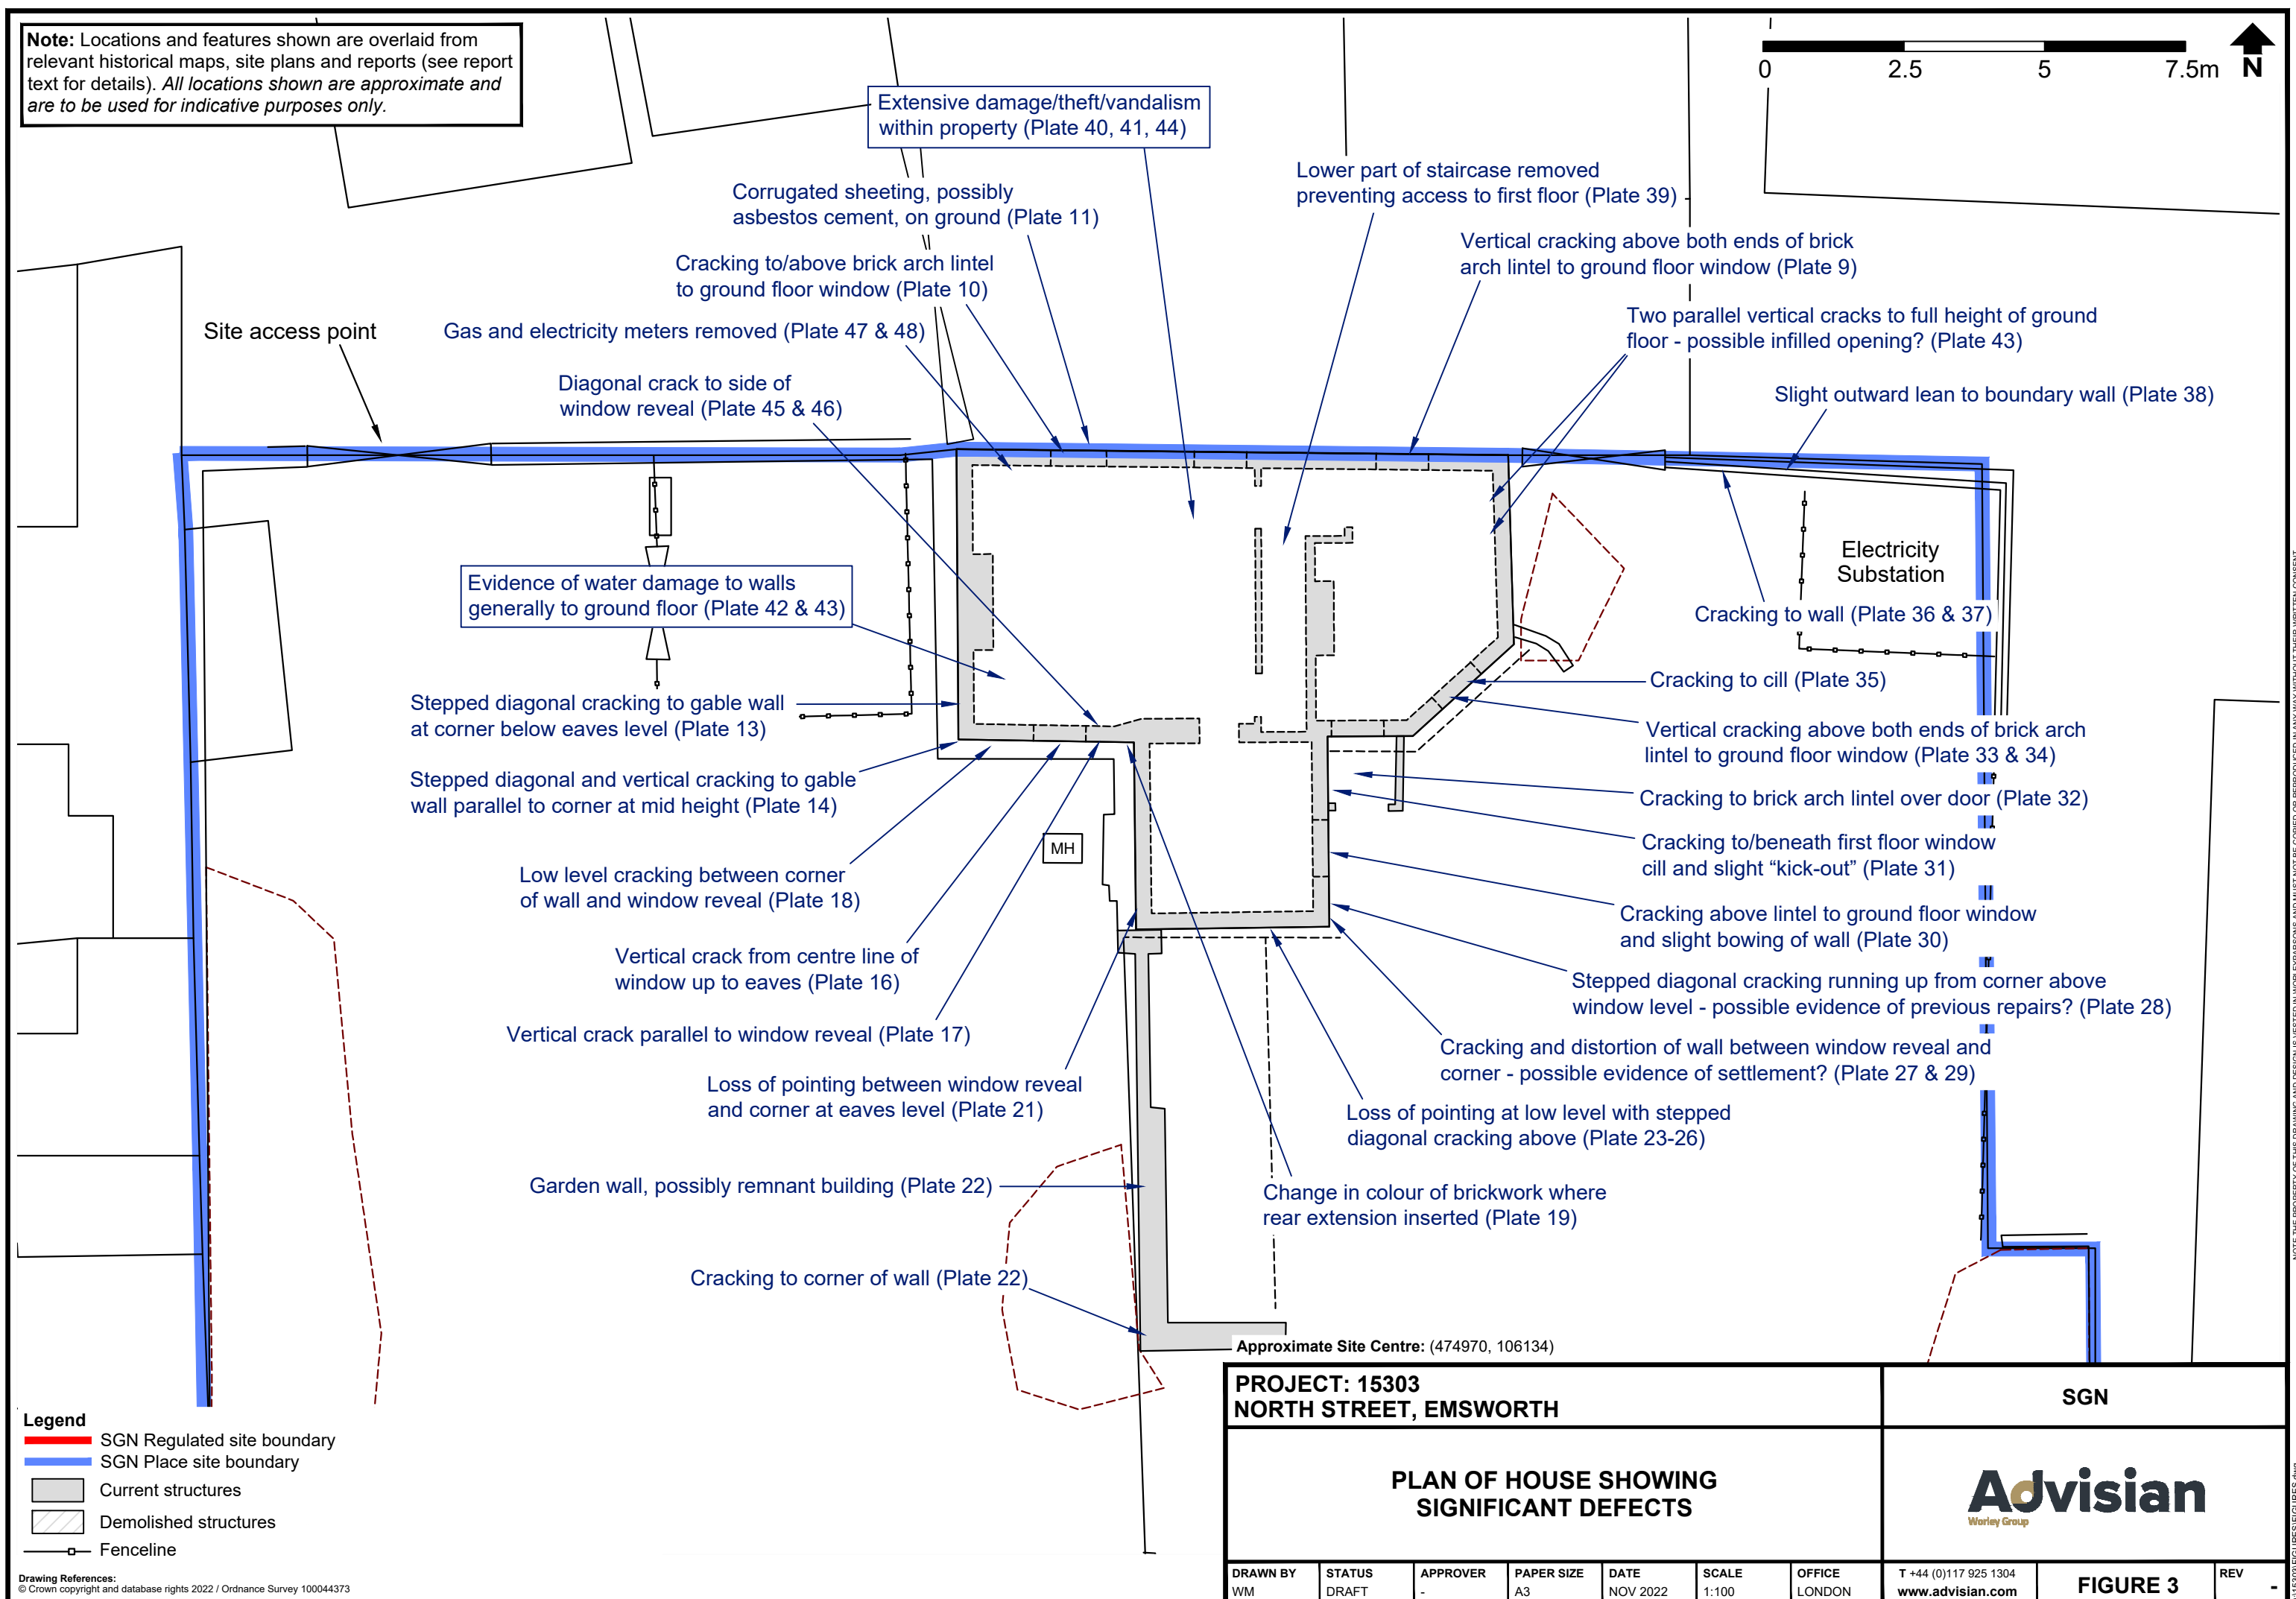
## PLAN OF HOUSE SHOWING SIGNIFICANT DEFECTS

A plan showing significant defects is included as Figure 3.

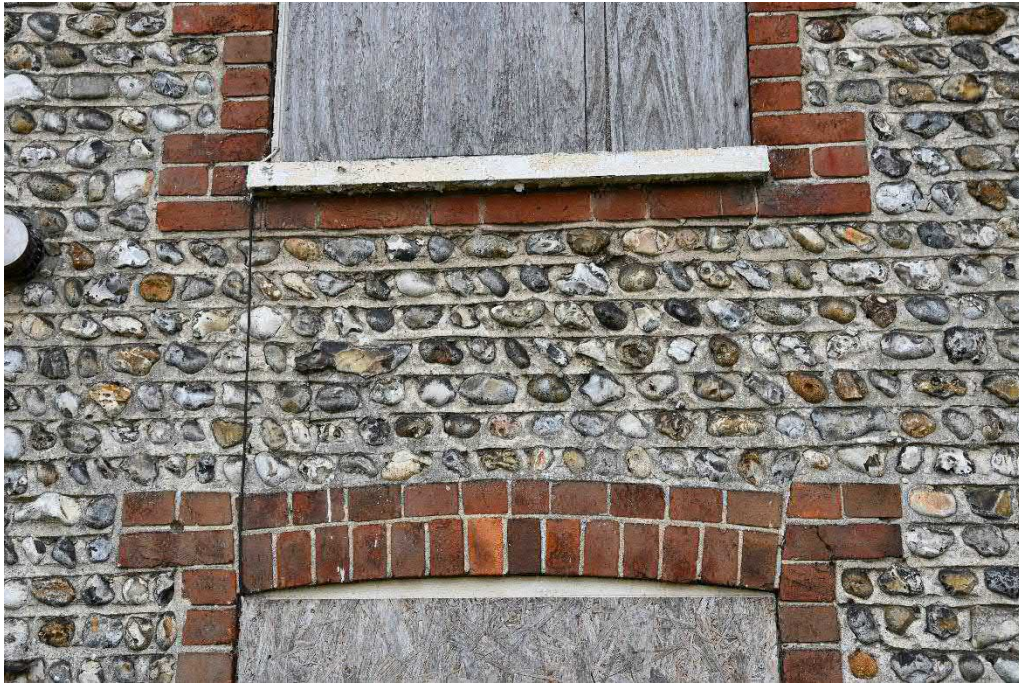
- 4.1.1. Vertical cracking above both ends of brick arch lintel to eastern ground floor window to north elevation (Plate 9).
- 4.1.2. Cracking observed to/above brick arch lintel to western ground floor window to north elevation (Plate 10).
- 4.1.3. Stepped diagonal cracking to western gable wall at south-west corner below eaves level (Plate 13).
- 4.1.4. Stepped diagonal and vertical cracking to western gable wall parallel to south-west corner at mid-height (Plate 14).
- 4.1.5. Vertical crack from centre line of western window to southern wall of main house up to eaves (Plate 16).

**PLATE 9:** Vertical cracking above both ends of brick arch lintel to eastern ground floor window in (8) above

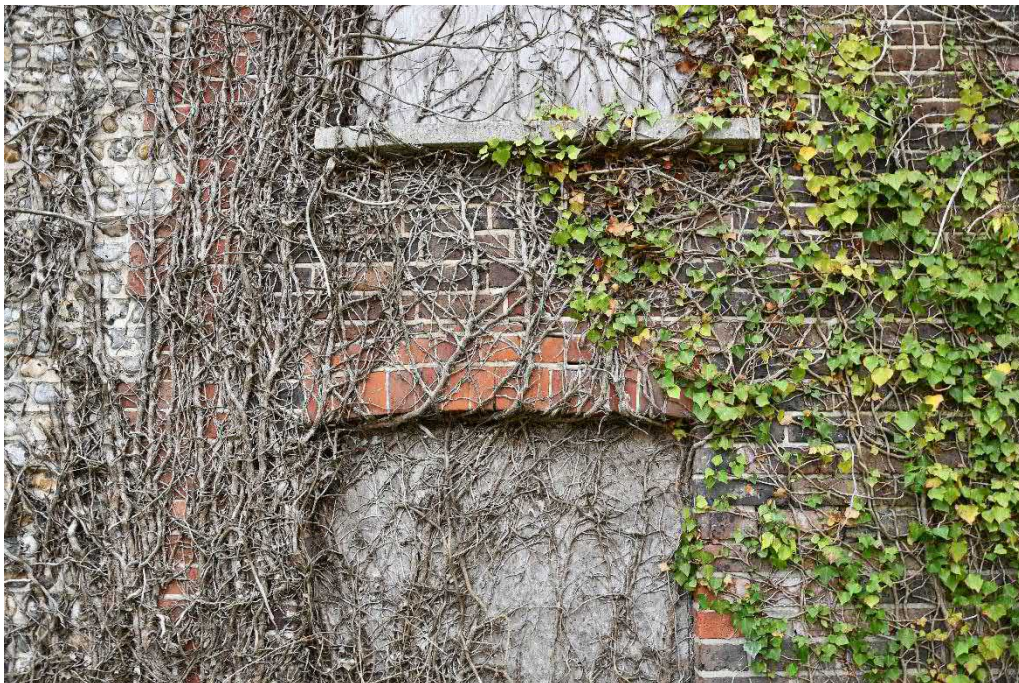
**PLATE 10:** Cracking to/above brick arch lintel to western ground floor window in (1) above

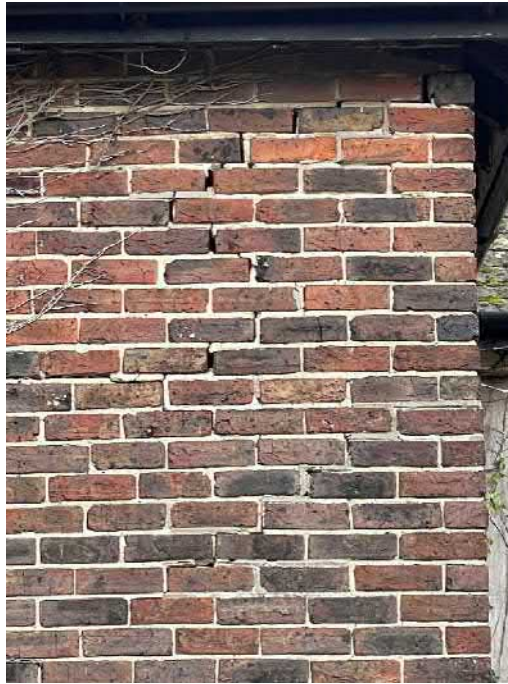
**PLATE 13:** Close-up on (12) above showing stepped diagonal cracking to gable wall at corner below eaves level

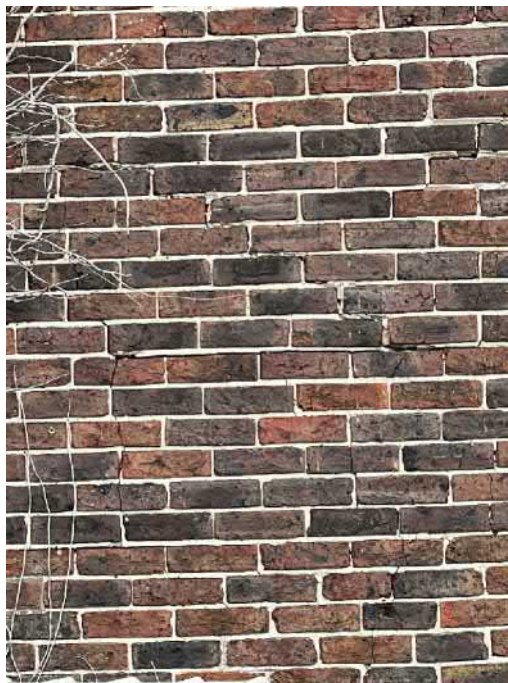
**PLATE 14:** Stepped diagonal and vertical cracking to gable wall parallel to corner at mid height immediately below view in (13) above

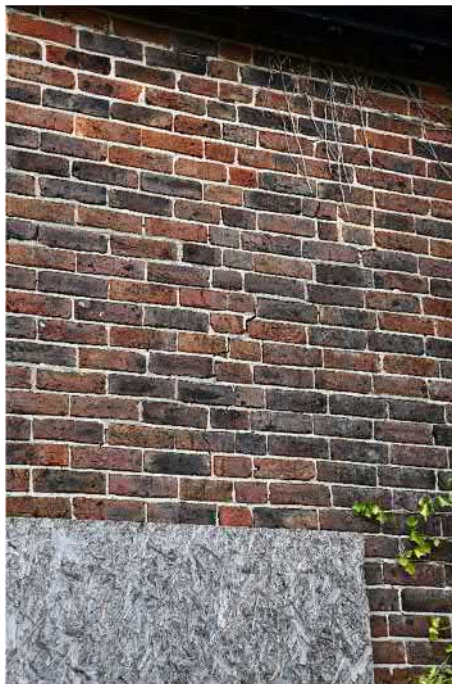
PLATE 16: Vertical crack from centre line of window up to eaves in (15) above

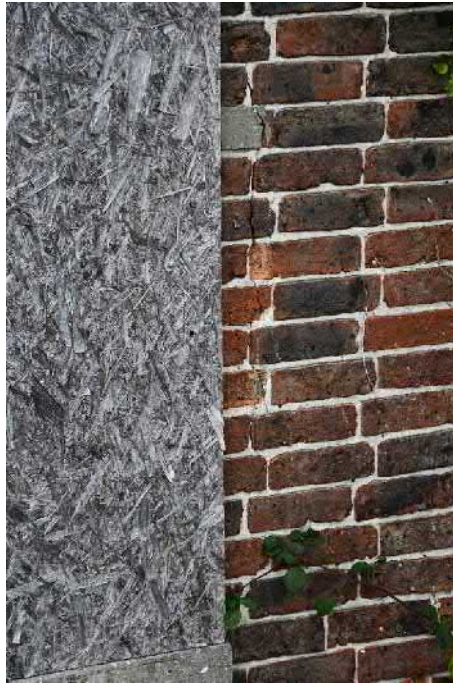
- 4.1.6. Vertical crack parallel to eastern reveal of western window to southern main wall of house (Plate 17).
- 4.1.7. Low level cracking between western corner of southern wall of main house and window reveal (Plate 18).

**PLATE 17:** Vertical crack parallel to window reveal in (15) above

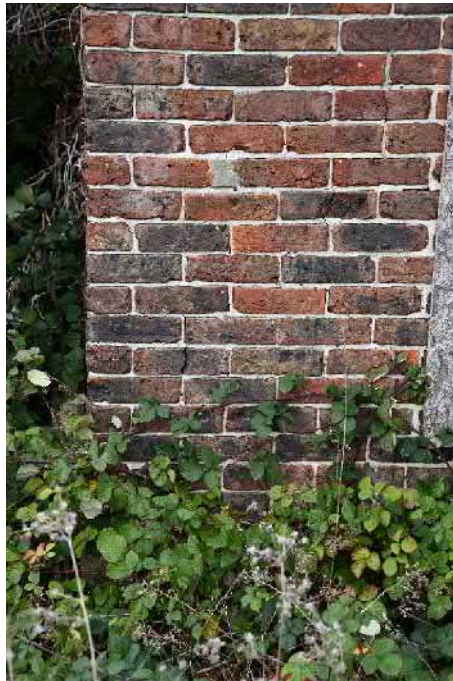
**PLATE 18:** Low level cracking between corner of wall and window reveal in (15) above

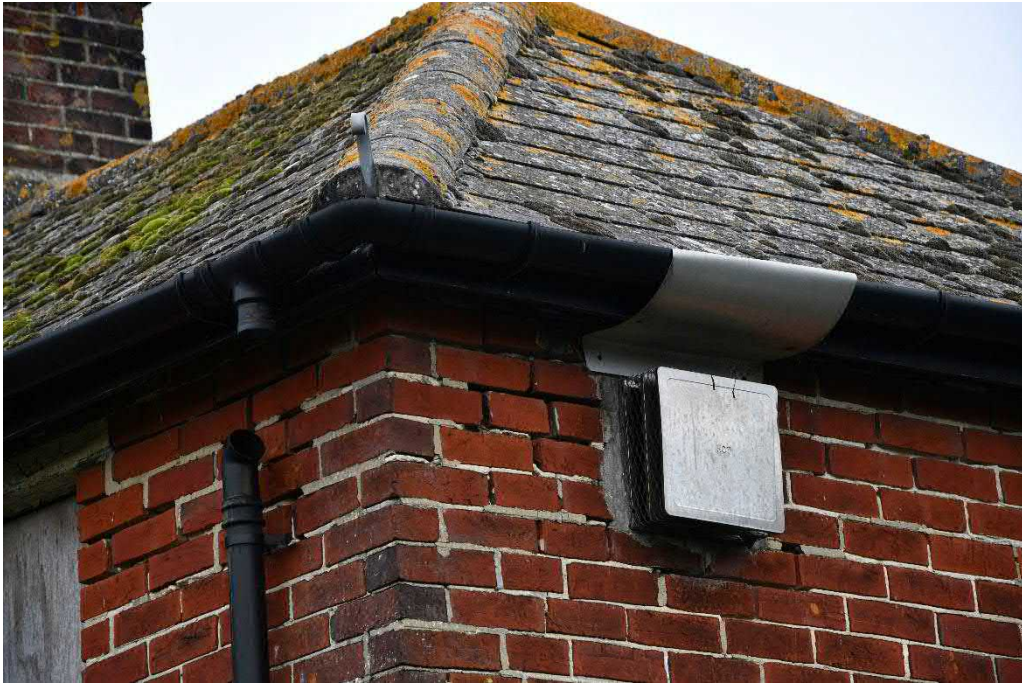
- 4.1.8. Loss of pointing between window reveal and south-west corner of rear “extension” at eaves level (Plate 21).
- 4.1.9. Cracking to corner of garden wall running south from rear “extension” (Plate 22).

**PLATE 21:** Close-up on (20) above showing loss of pointing between window reveal and corner at eaves level and around vent

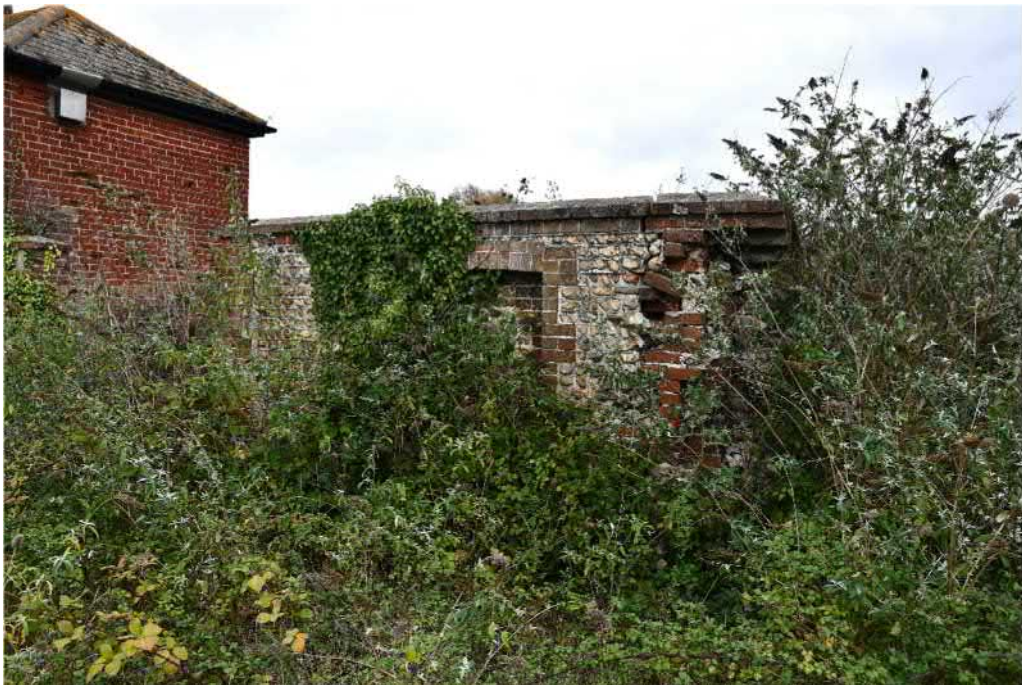
**PLATE 22:** Garden wall, possibly remnant building, running south from south-west corner of rear "extension – note cracking to corner of wall

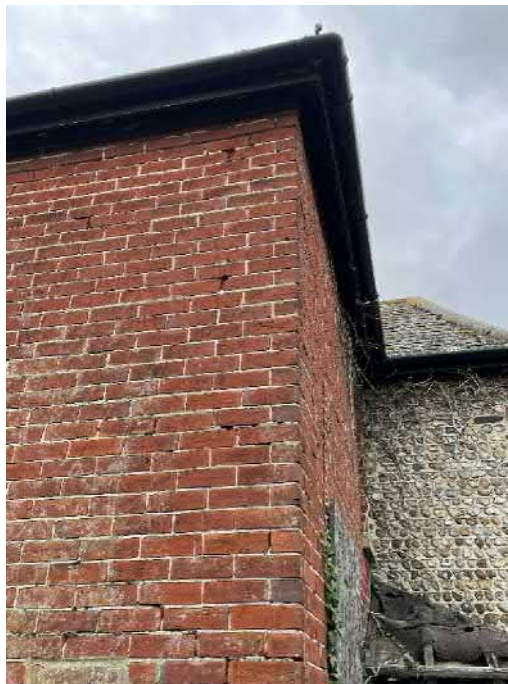
- 4.1.10. Loss of pointing at low level with stepped diagonal cracking above to south-east corner of rear “extension” (Plates 23-26).
- 4.1.11. Cracking and distortion of eastern wall to rear “extension” between window reveal and south-east corner (Plates 27 and 29).

**PLATE 24:** Close-up on (23) above showing stepped diagonal cracking between first floor and eaves level

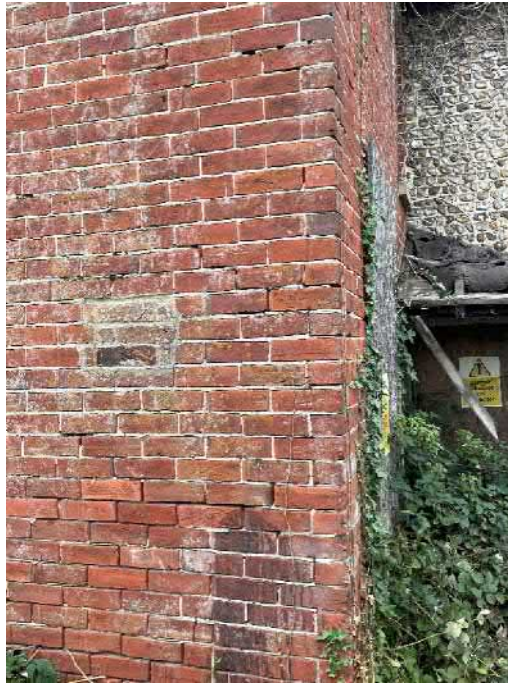
**PLATE 25:** Further view on (23) above showing loss of pointing at low level with stepped diagonal cracking above

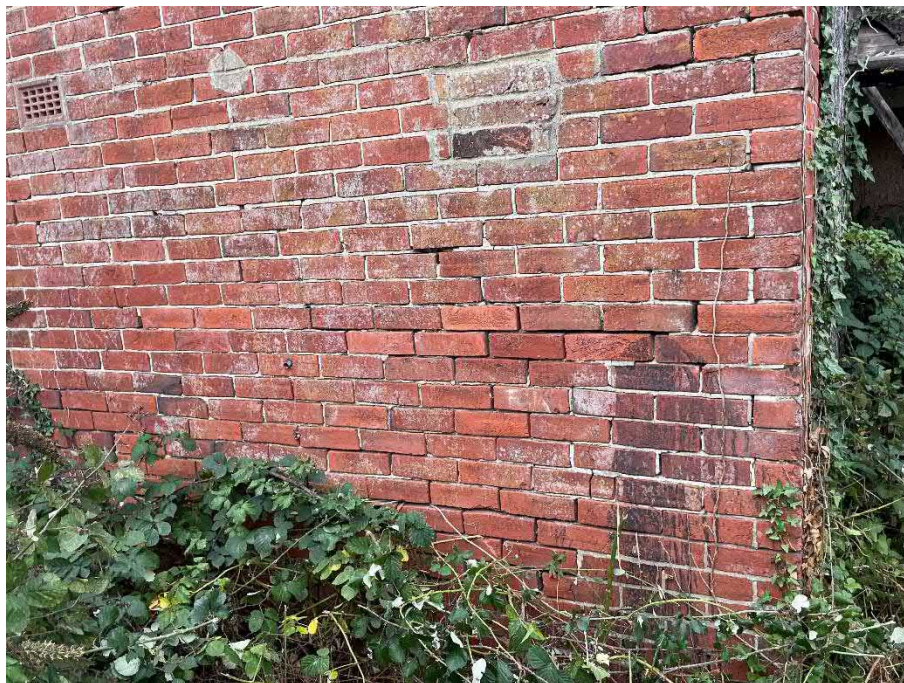
**PLATE 26:** Close-up on base of wall in (25) above showing extensive loss of pointing

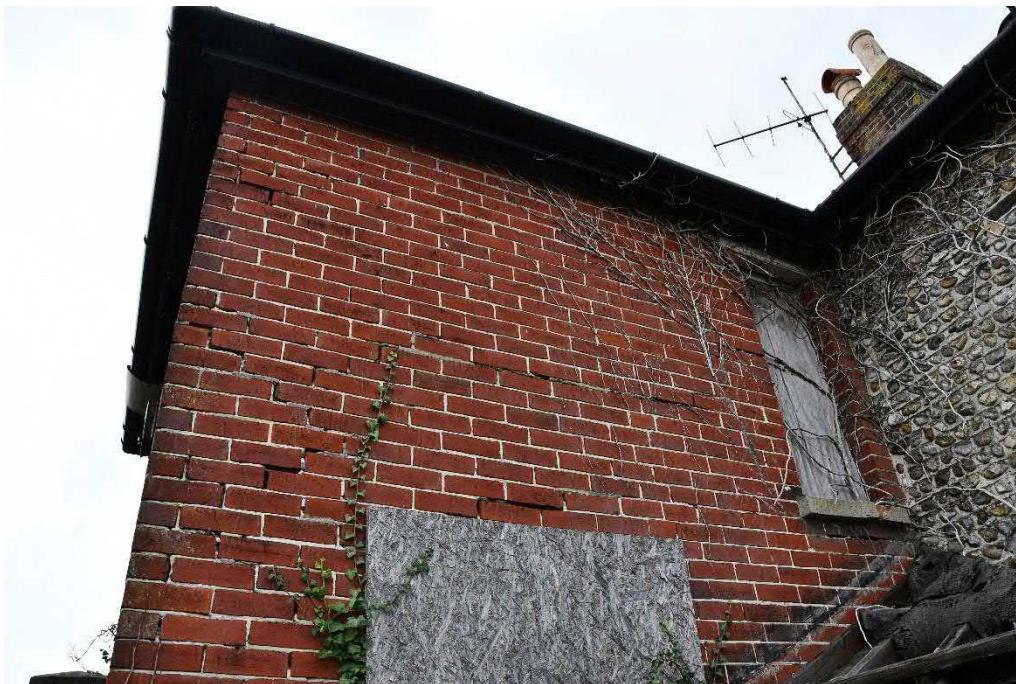
- 4.1.12. Stepped diagonal cracking running up from south-east corner of rear extension above window level to north (Plate 28).
- 4.1.13. Cracking above lintel to ground floor window to eastern wall of rear “extension” and slight bowing of wall (Plate 30).

PLATE 28: Close-up on (27) above showing stepped diagonal cracking running up from corner above window level – possible evidence of previous repairs?

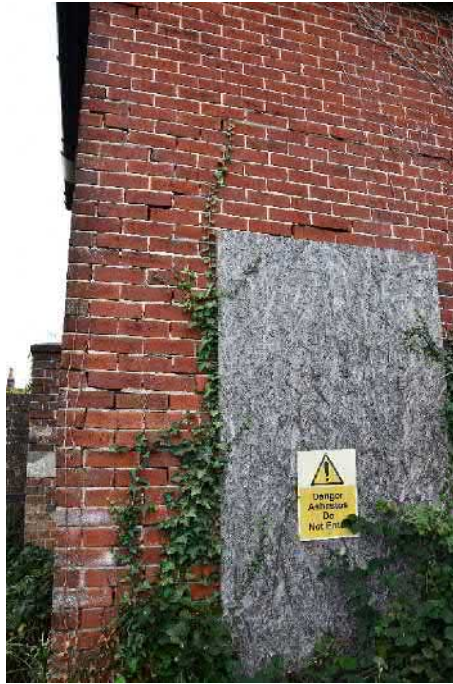
**PLATE 29:** Cracking and distortion of wall between window reveal and corner in (27) above – possible evidence of settlement?

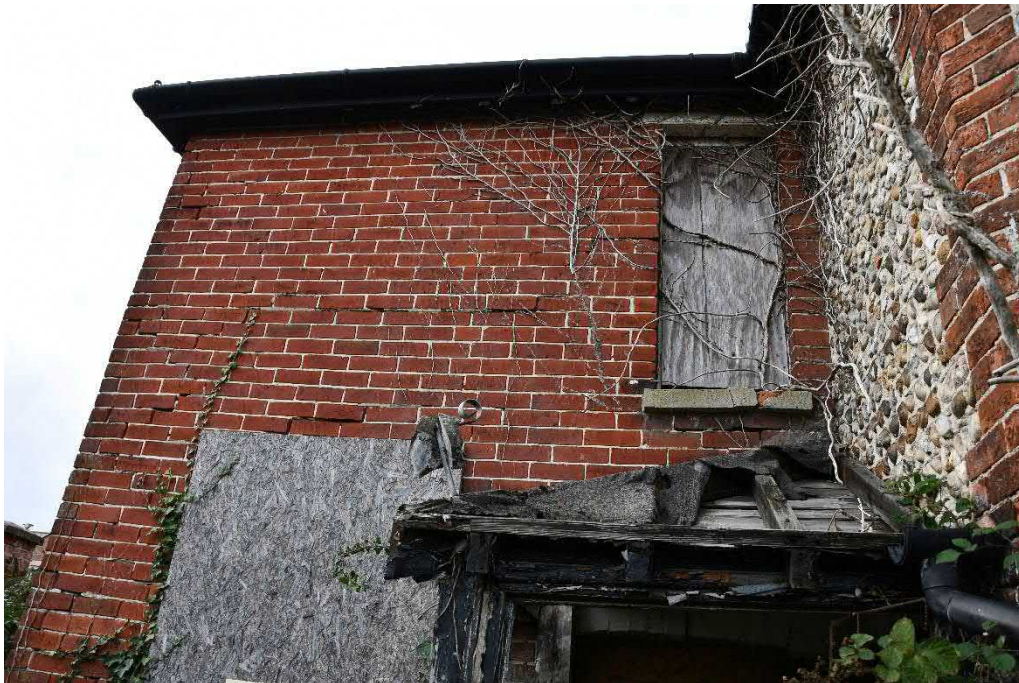
**PLATE 30:** Further view of (27) above - note cracking above lintel to ground floor window and slight bowing of wall

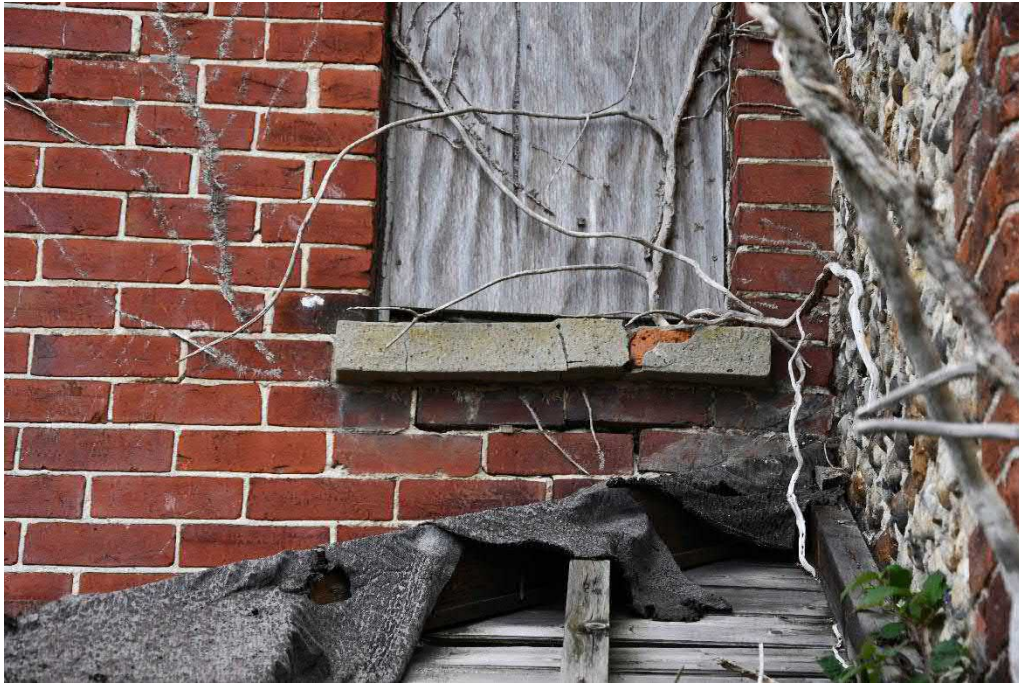
- 4.1.14. Cracking to/beneath first floor window cill and slight ‘kick-out’ to eastern wall of rear “extension” (Plate 31).
- 4.1.15. Cracking to brick arch lintel over door to east wall of rear “extension” (Plate 32).

**PLATE 31:** Cracking to/beneath first floor window cill and slight "kick-out" in (30) above

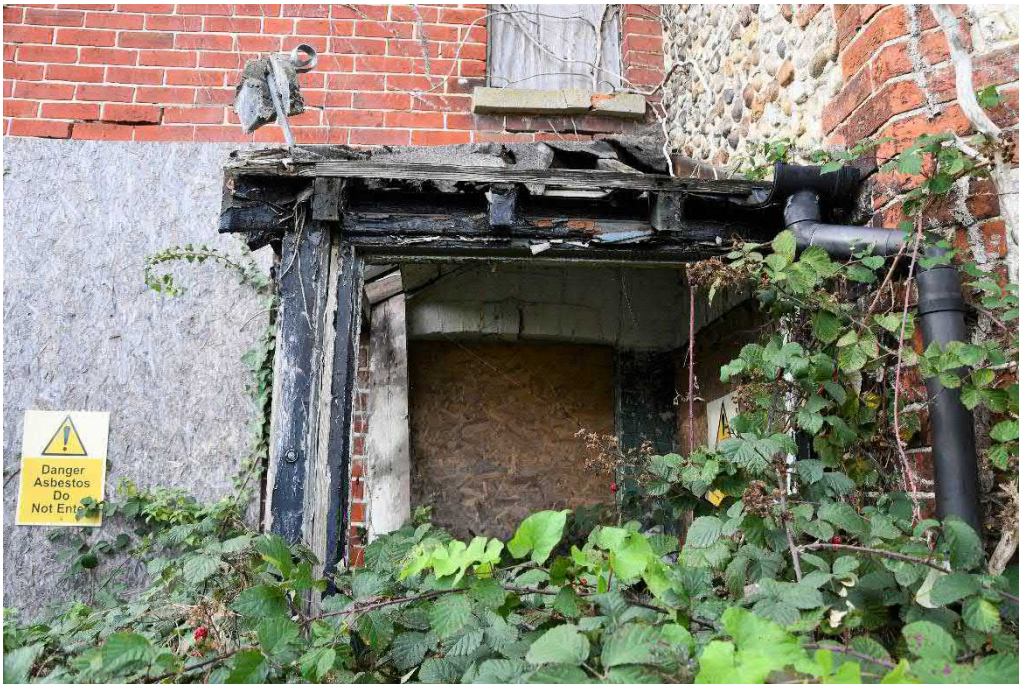
**PLATE 32:** Cracking to brick arch lintel over door in (30) above

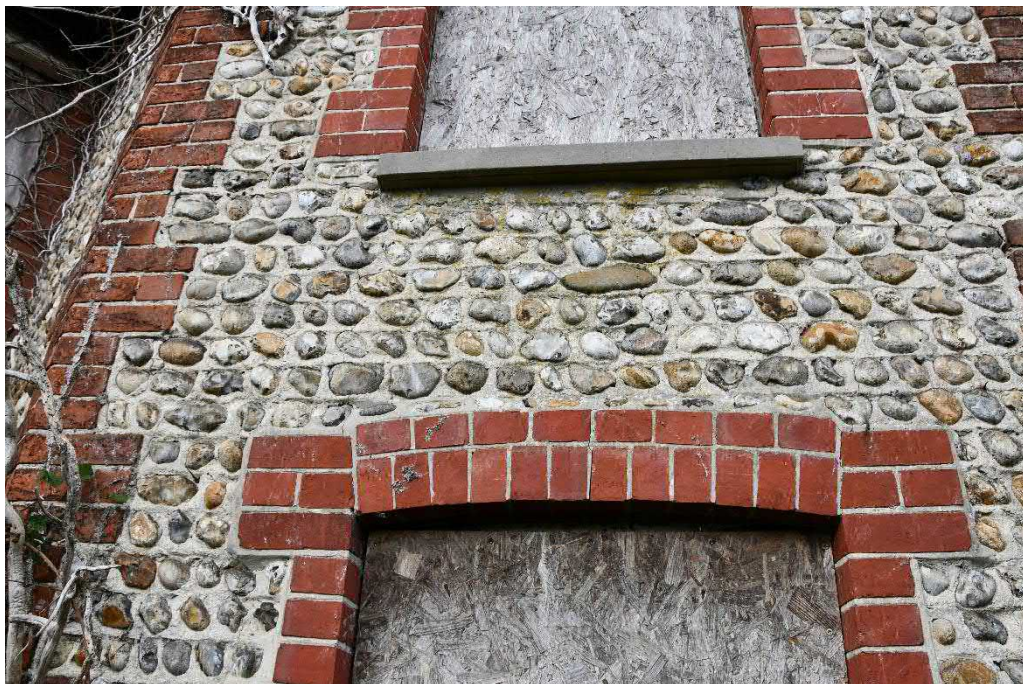
- 4.1.16. Vertical cracking above both ends of brick arch lintel to ground floor window to eastern end of main house (Plates 33 and 34).
- 4.1.17. Cracking to cill to ground floor window to eastern end of main house (Plate 35).

PLATE 34: Vertical cracking above both ends of brick arch lintel to eastern ground floor window in (33) above

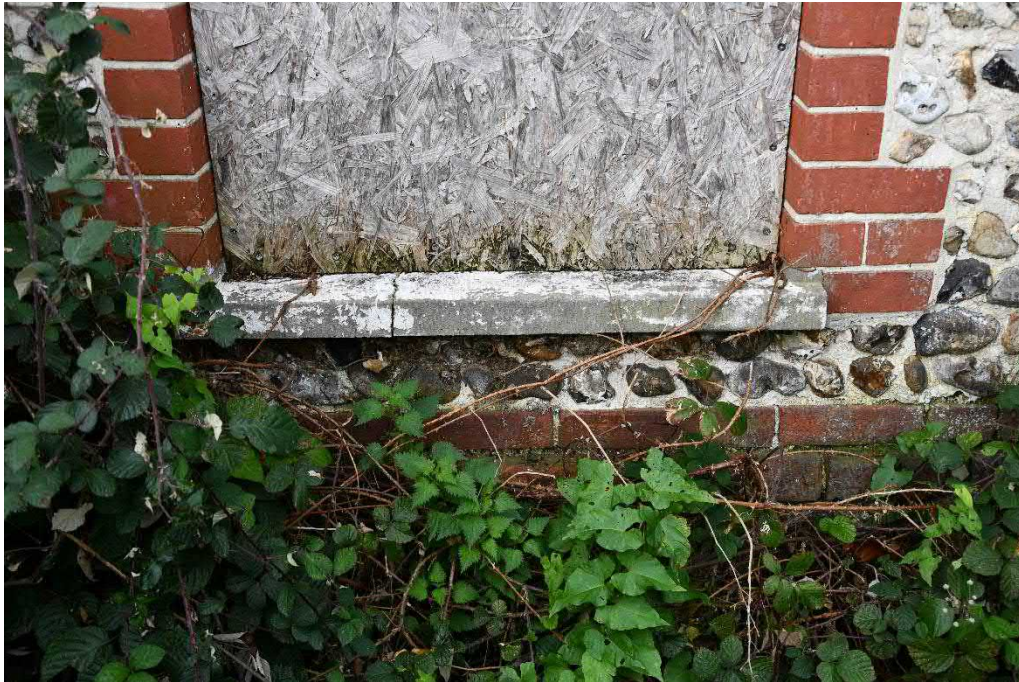
**PLATE 35:** Cracking to cill of ground floor window in (33) above

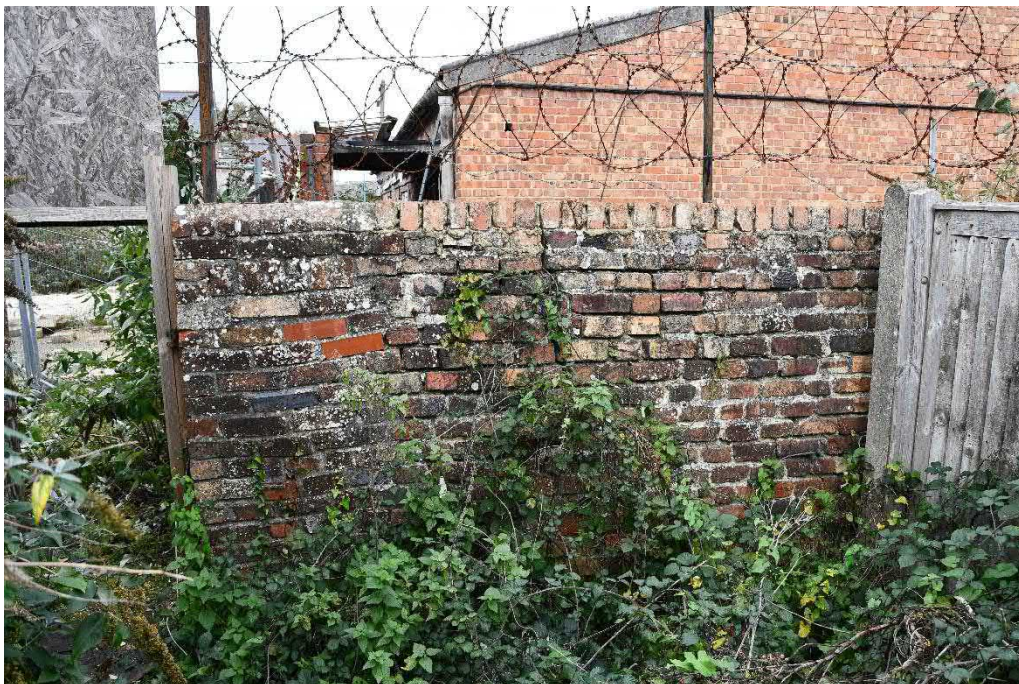
- 4.1.18. Cracking, loss of pointing and slight outward lean-to boundary wall to north side of site to east of property (Plates 36-38).

**PLATE 36:** Boundary wall on north side of site to east of house – note distortion to line of wall and loss of pointing

- The northern boundary will require resecuring with new fencing on completion of the demolition works. It may also be prudent to extend the demolition works to include the boundary wall to the north-east of the site.

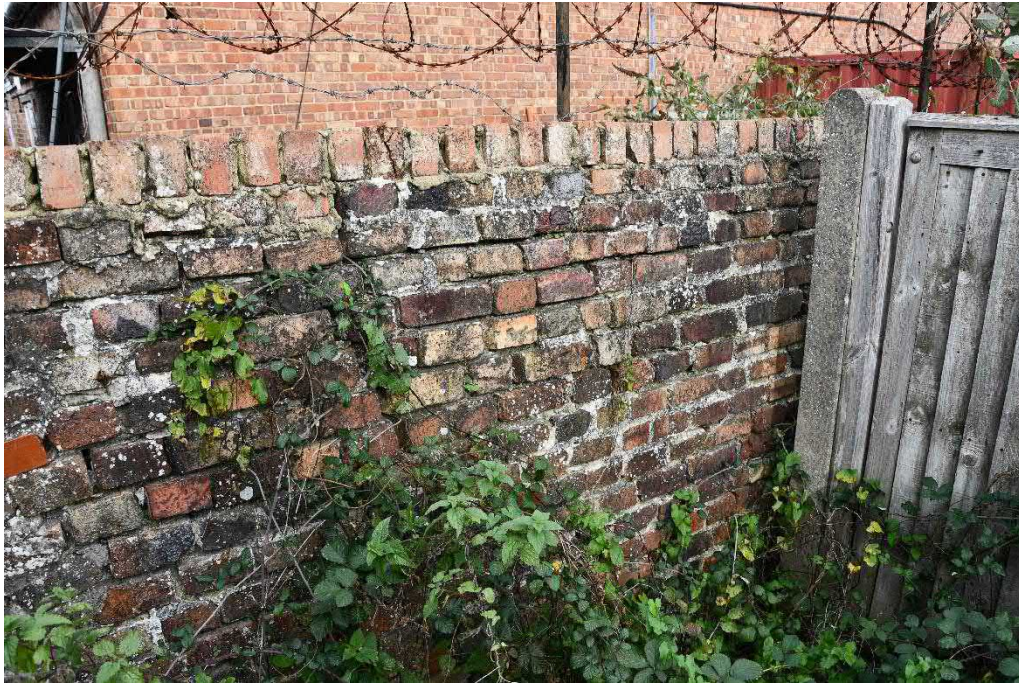
**PLATE 37:** Close-up on damage to wall in (36) above showing diagonal cracking to wall – note timber fence to substation to right of view

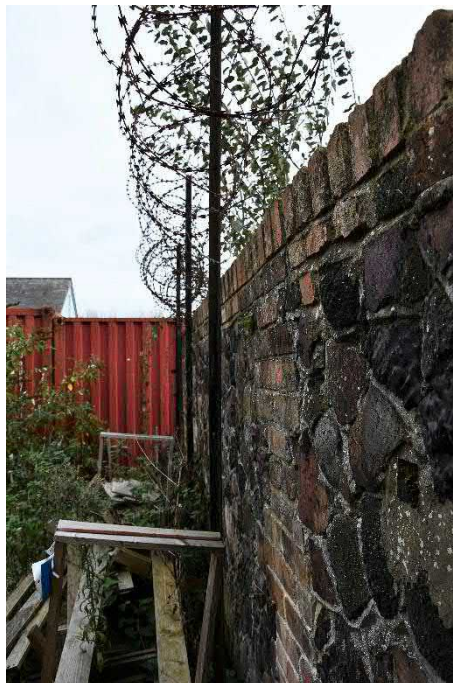
**PLATE 38:** View along north side of boundary wall in (36) above looking east – note slight outward lean to wall

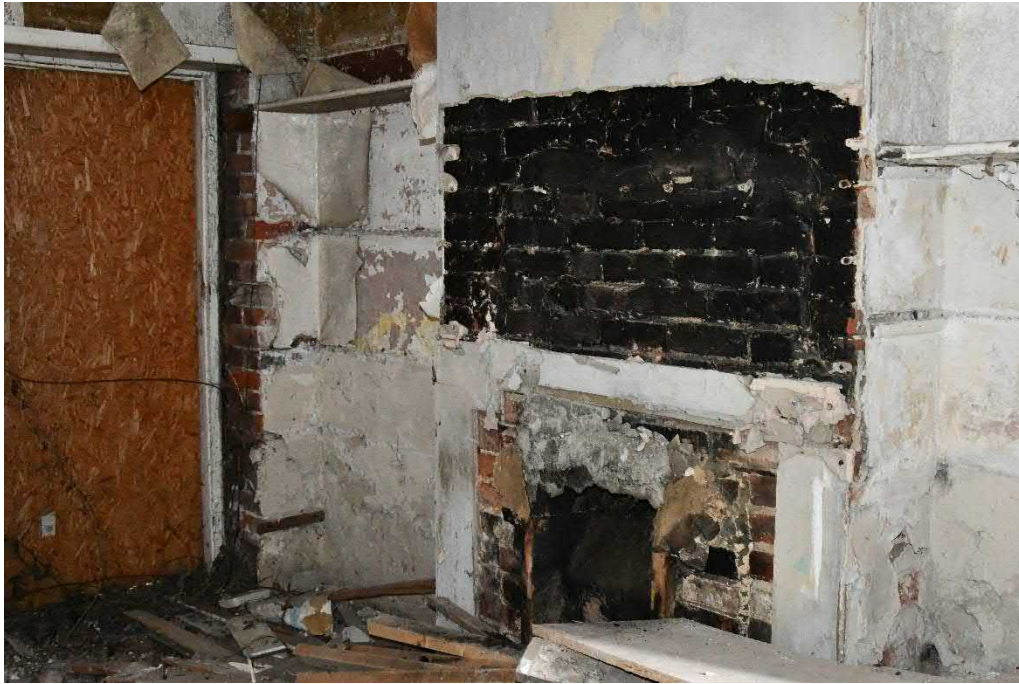
- 4.2.1. Extensive damage/theft/vandalism was noted within property (Plates 40, 41 and 44).
- 4.2.2. Two parallel full height vertical cracks to the eastern wall of the main house at ground floor level (Plate 43).
- 4.2.3. Evidence of water damage to walls generally to ground floor (Plates 42 and 43).
- 4.2.4. Diagonal cracking to the east side of the western ground floor window reveal to the rear wall of the main house in (Plates 45 and 46).

PLATE 41: Damage from removal (theft?) of fireplace

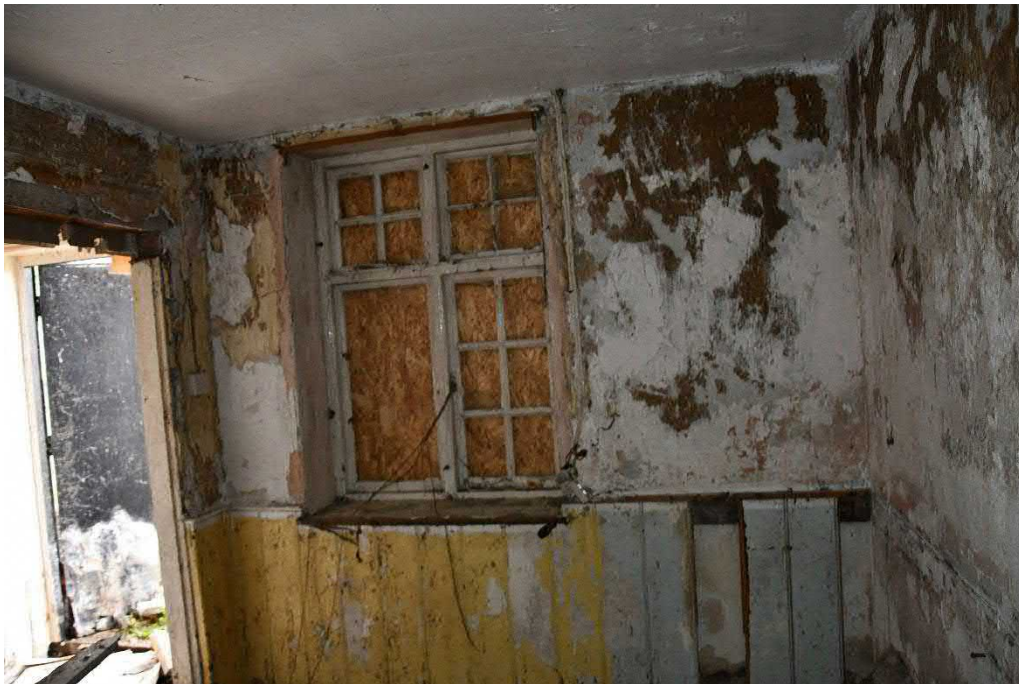
PLATE 42: Evidence of water damage to walls generally to ground floor

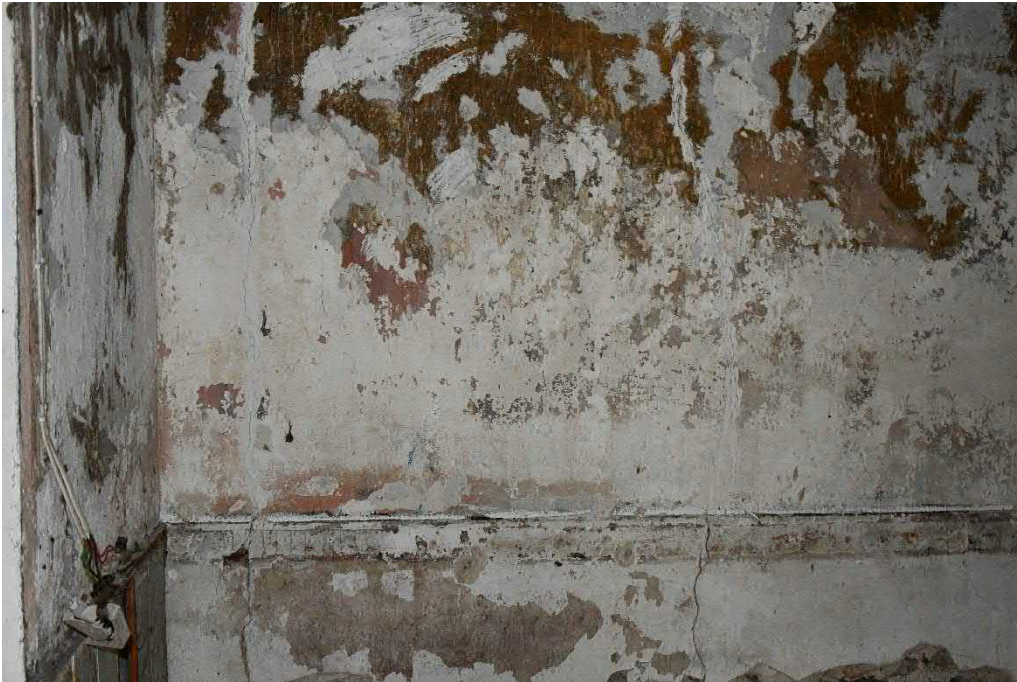
**PLATE 43:** View on eastern wall of house showing two parallel vertical cracks to full height of ground floor – possible infilled opening?

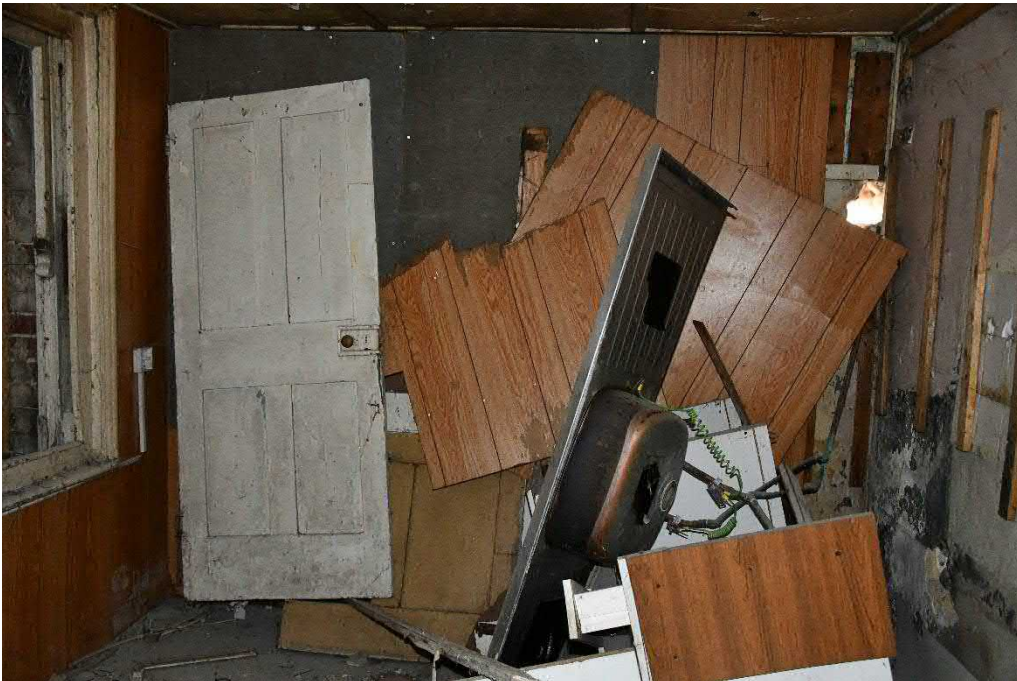
**PLATE 44:** Extensive damage/theft/vandalism within property

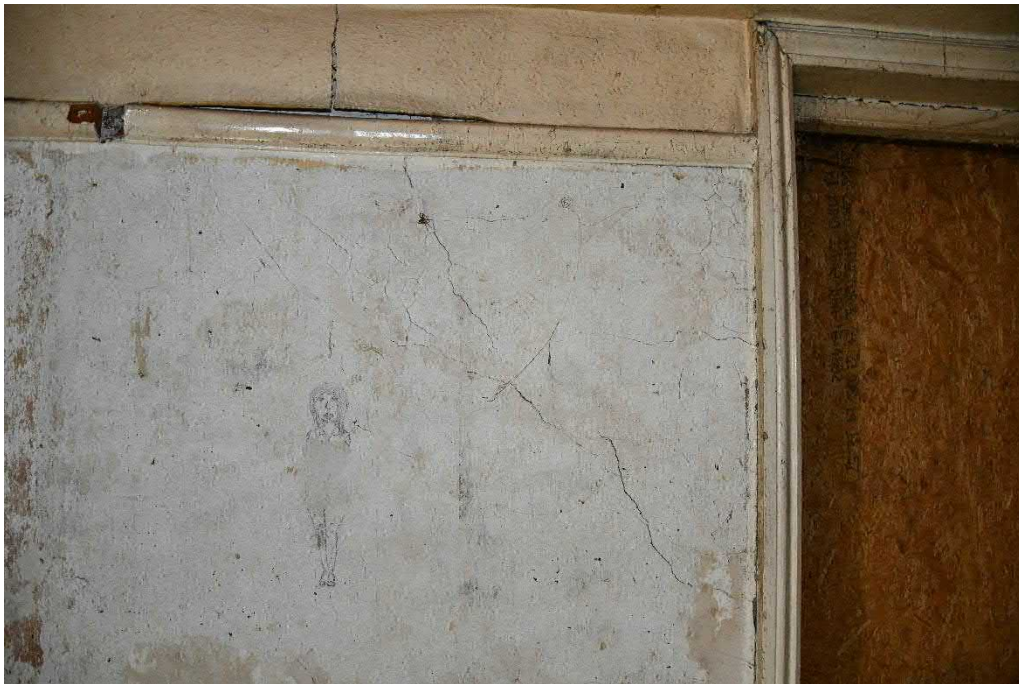
PLATE 46: Close-up on (45) above – note diagonal cracking to side of window reveal

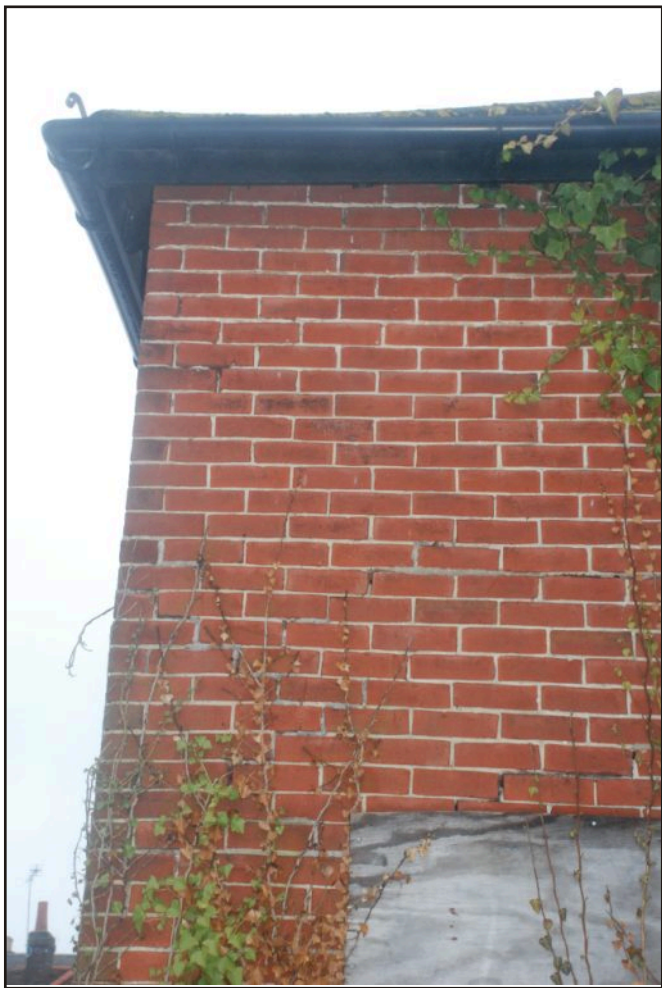
**Plate 8.**  
Close-up on (7) above showing cracking  
to rear corner.

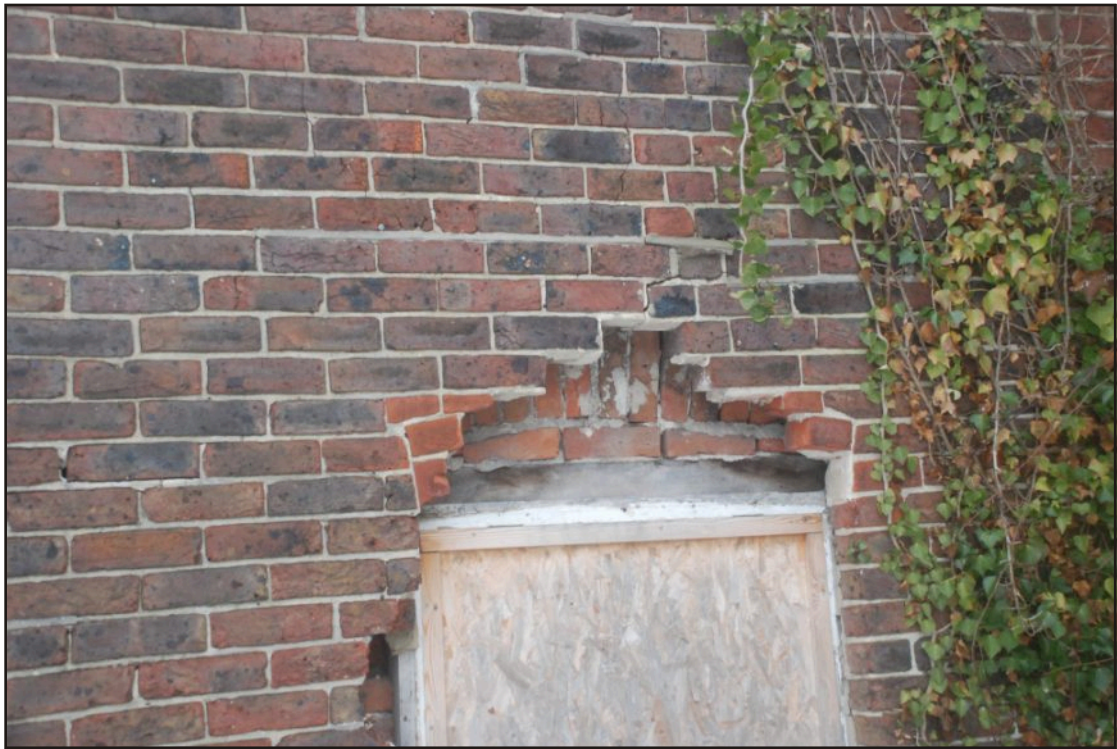
**Plate 11.** Close-up on (9) above showing failed lintel over ground floor window.

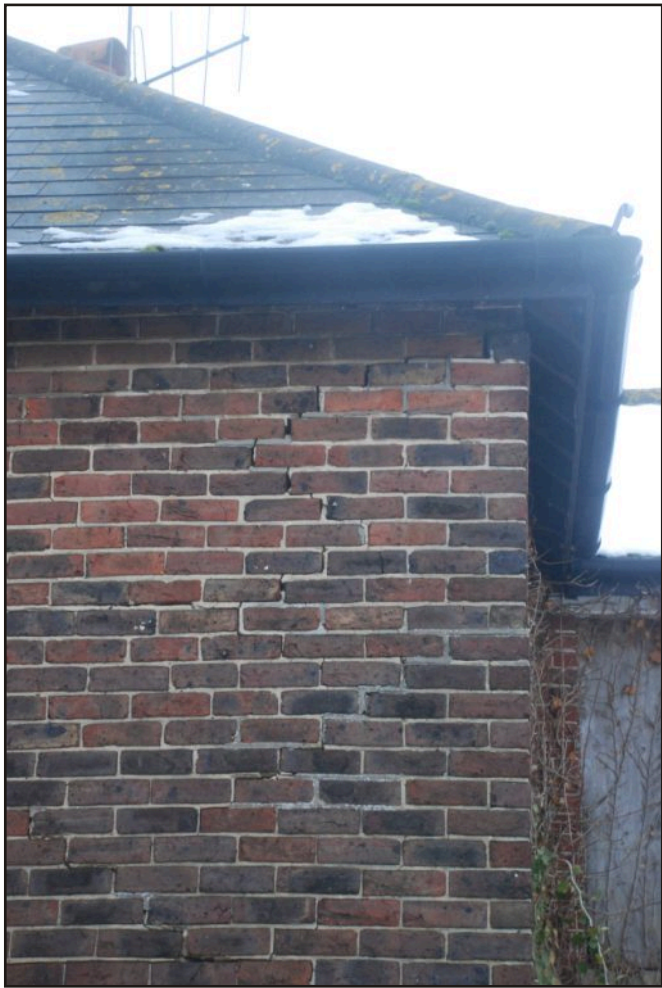
**Plate 13.**  
Close-up on south-west corner of house  
in (12) above showing cracking at  
eaves.
