28 November 2022

Jack Porter  
Estates Coordinator  
SGN  
St Lawrence House  
Station Approach  
Horley, RH6 9HJ

EMSWORTH ABANDONED RESIDENTIAL PROPERTY: STRUCTURAL BUILDING ASSESSMENT

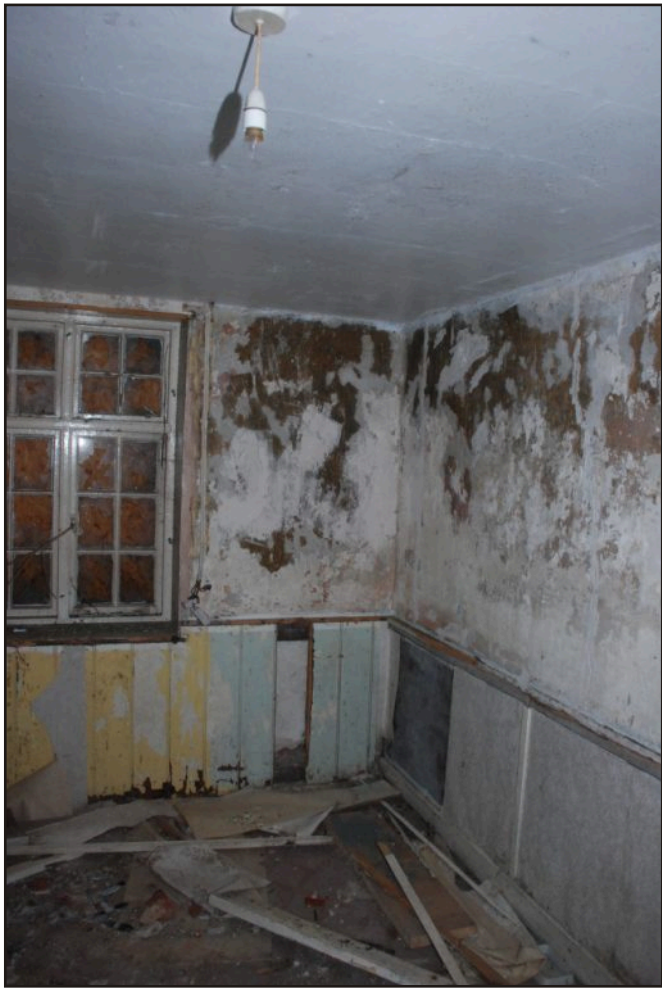
**Plate 23.**  
Room off rear door of house - note water damage to walls.

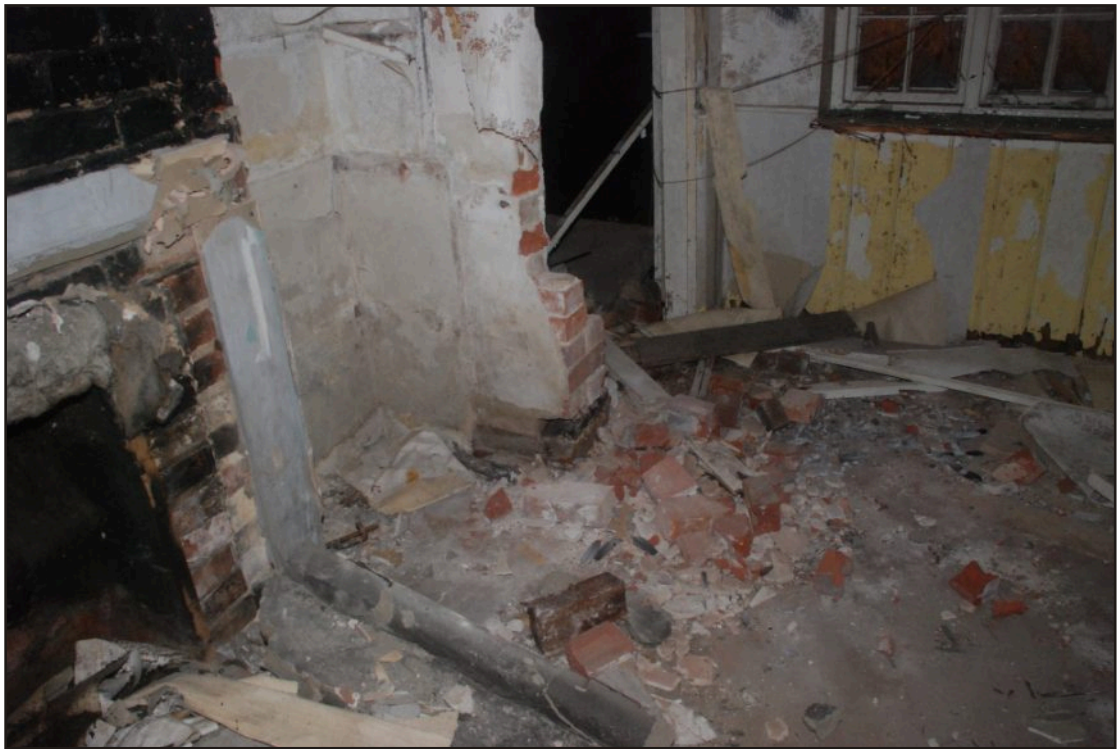
**Plate 24.** Further view on room in (23) above showing damage caused by removal of fireplace.

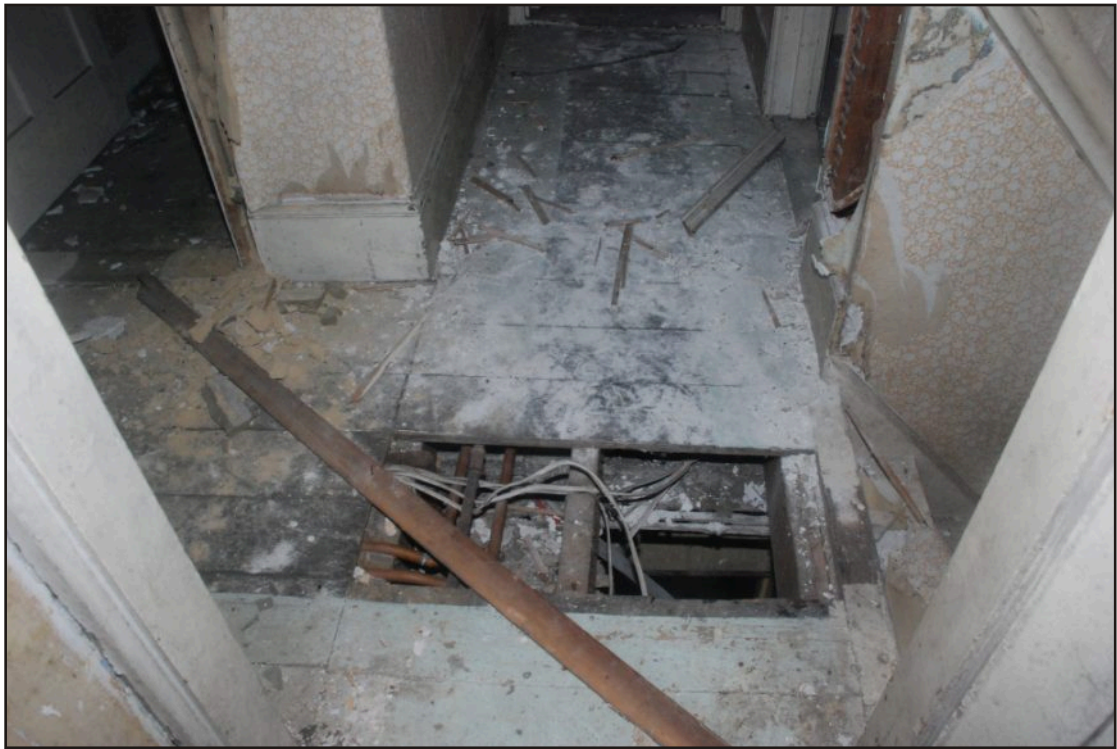
**Plate 27.** Missing floor boards at top of stairs to first floor.

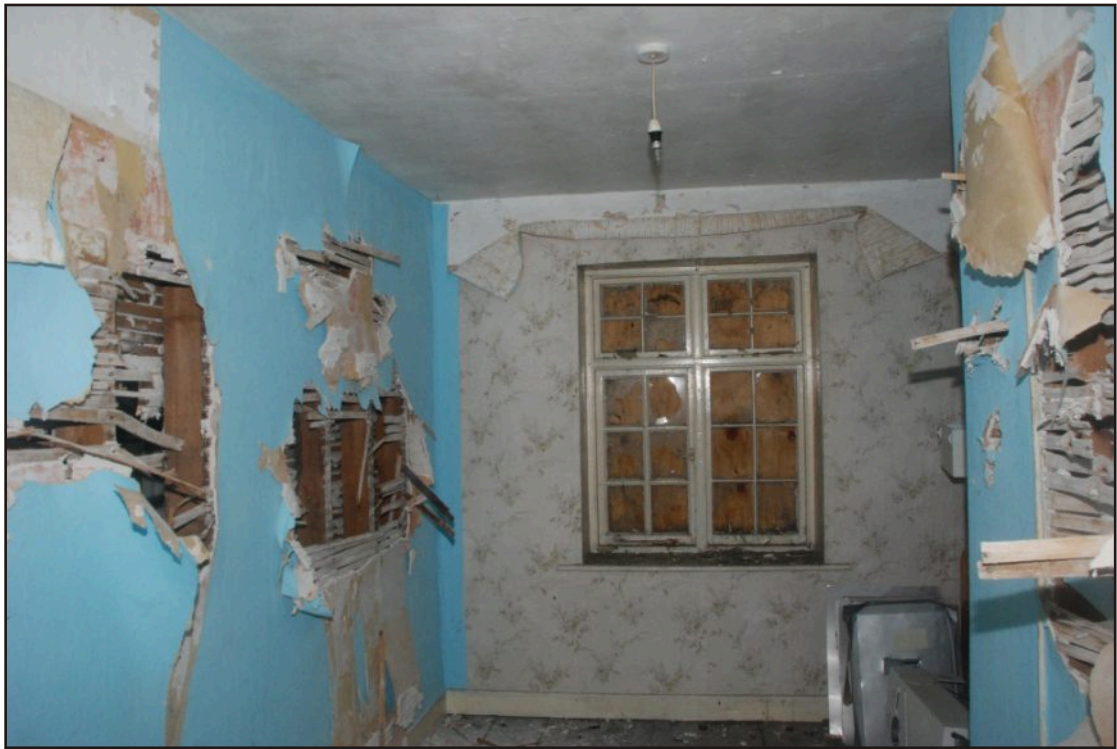
**Plate 29.** First floor room - note damage to lath and plaster internal walls.

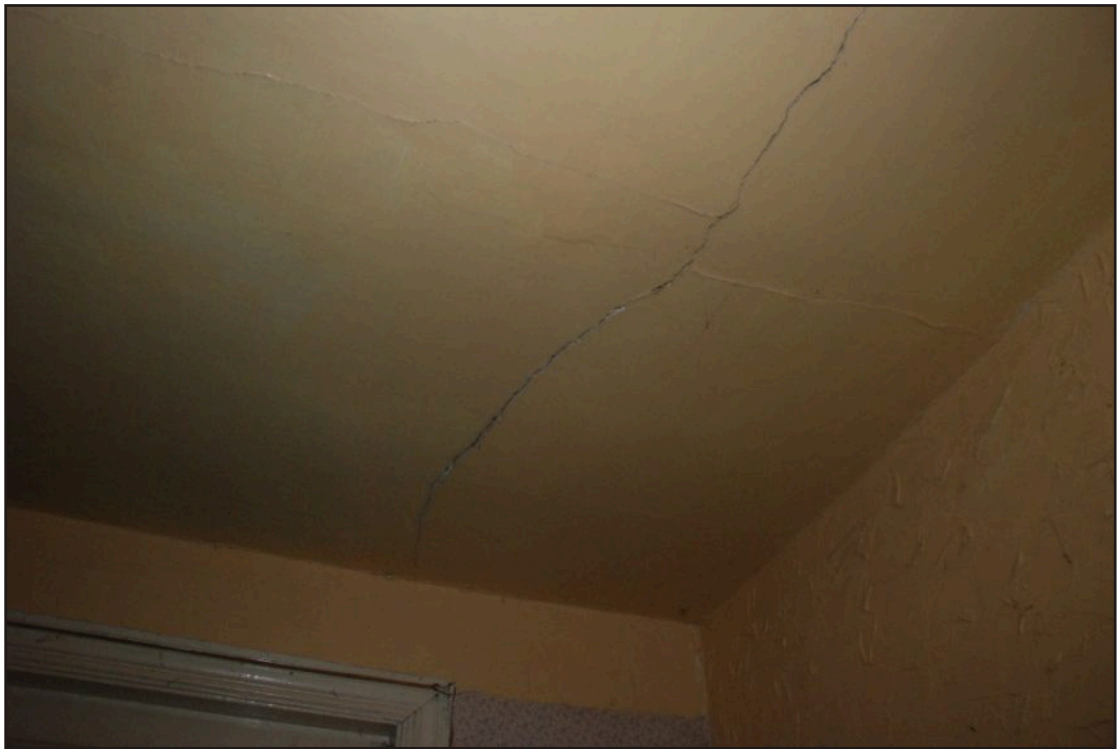
**Plate 32.** Ceiling cracking at first floor level.
