# Hutton + Rostron

### Southleigh Park House; Mansion House, Coach House and Stables: Preliminary condensation risk assessment

Site note A7 for 15 December 2020 and 05 January 2021 Job no.  
152.09

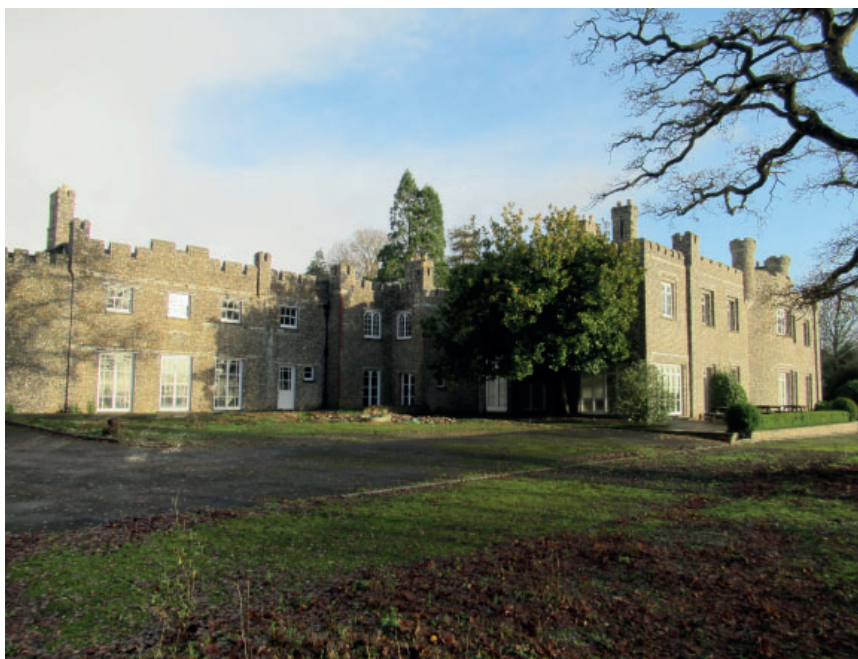
**Fig 1 :**

General view of façades. The exterior faces were found to be knapped flint bedded on a lime-based mortar

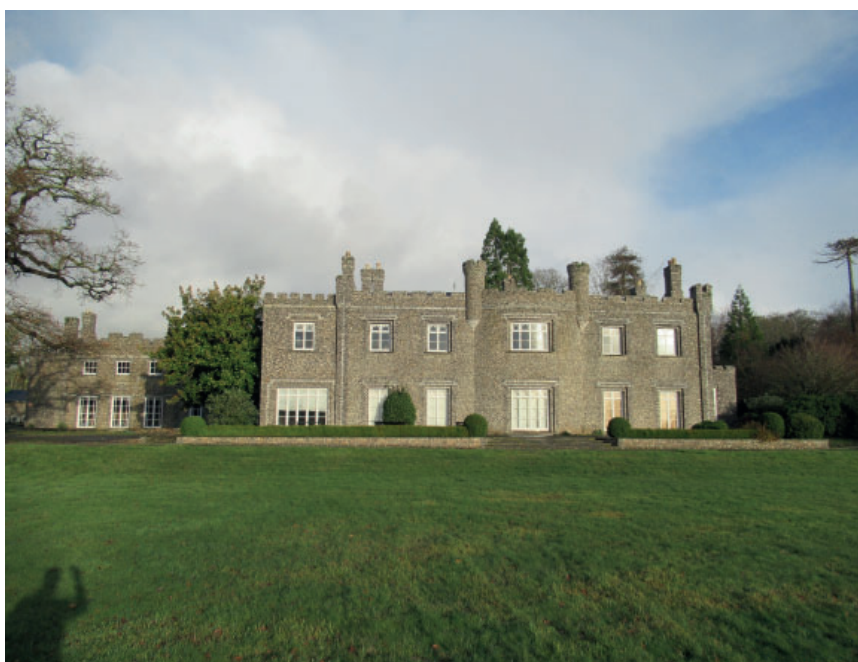
**Fig 2 :**

General view of façades. The exterior faces were found to be knapped flint bedded on a lime-based mortar

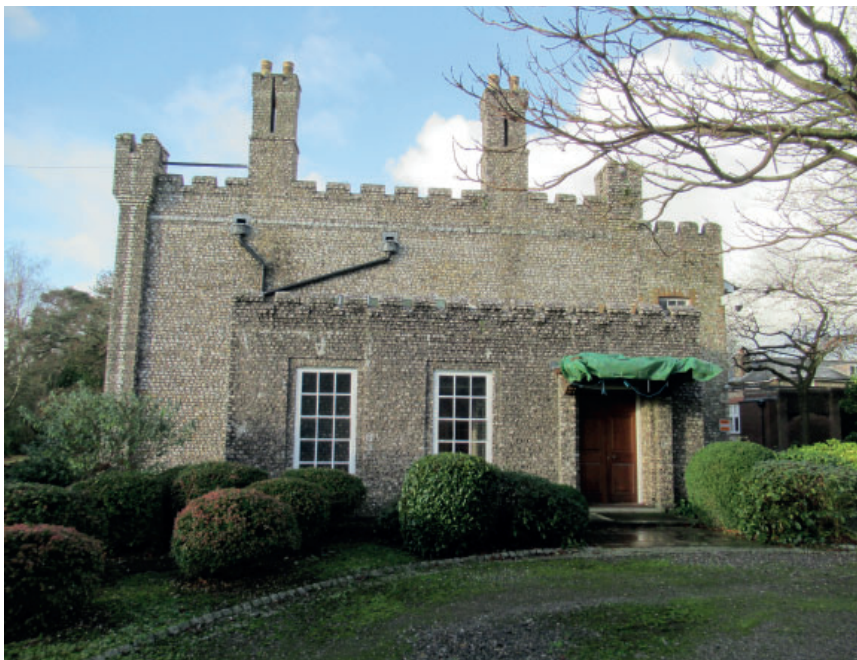
**Fig 5 :**

General view of façades. The exterior faces were found to be knapped flint bedded on a lime-based mortar

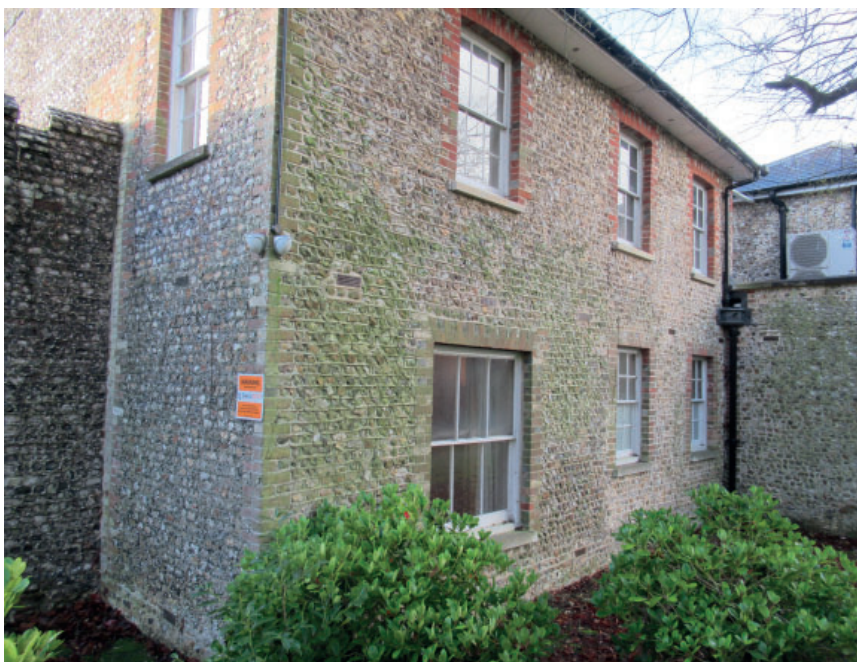
**Fig 6 :**

General view of façades. The exterior faces were found to be knapped flint bedded on a lime-based mortar

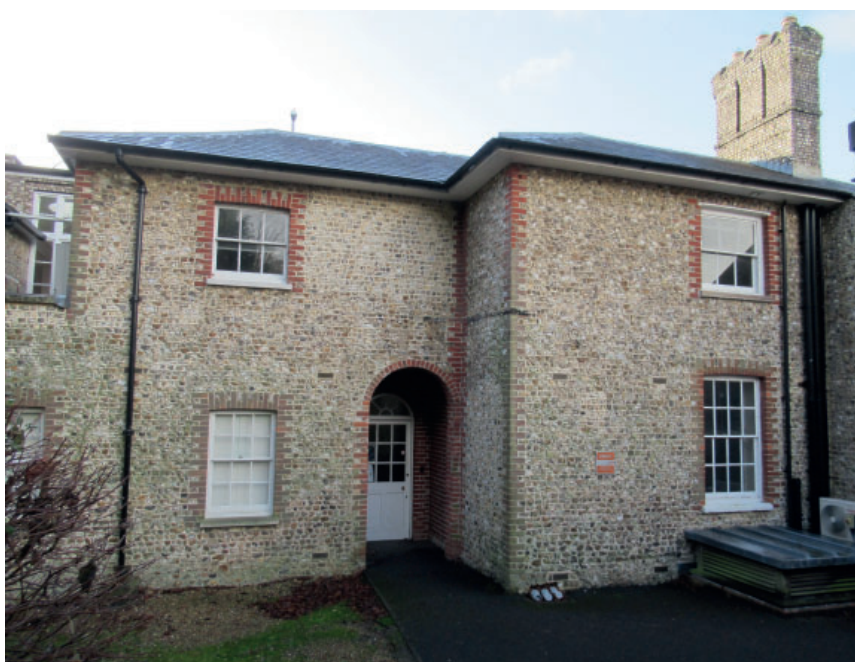
**Fig 8 :**

General view of façades. The exterior faces were found to be knapped flint bedded on a lime-based mortar

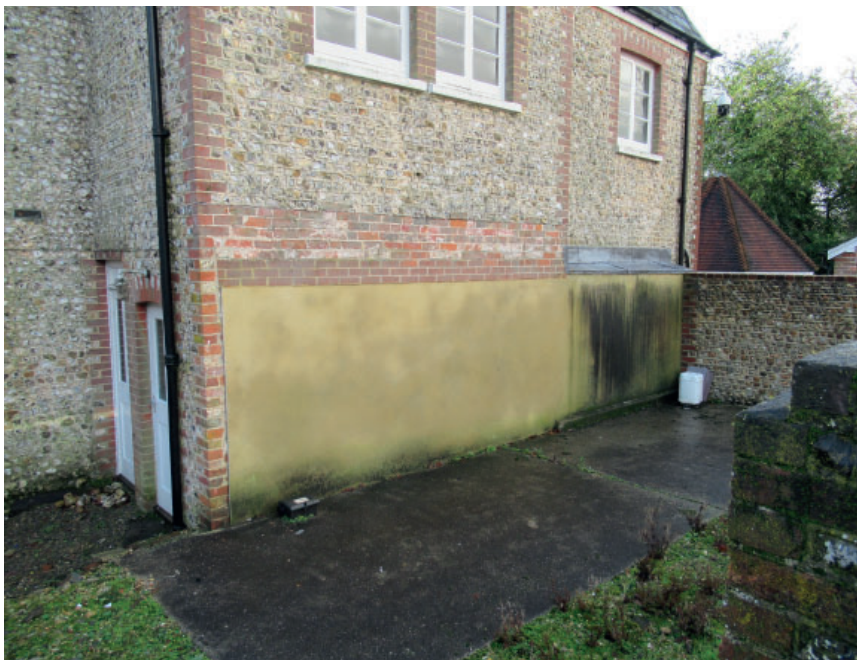
**Fig 9 :**

General view of façades. The exterior faces were found to be knapped flint bedded on a lime-based mortar. Note also the presence of a cementitious render at this location

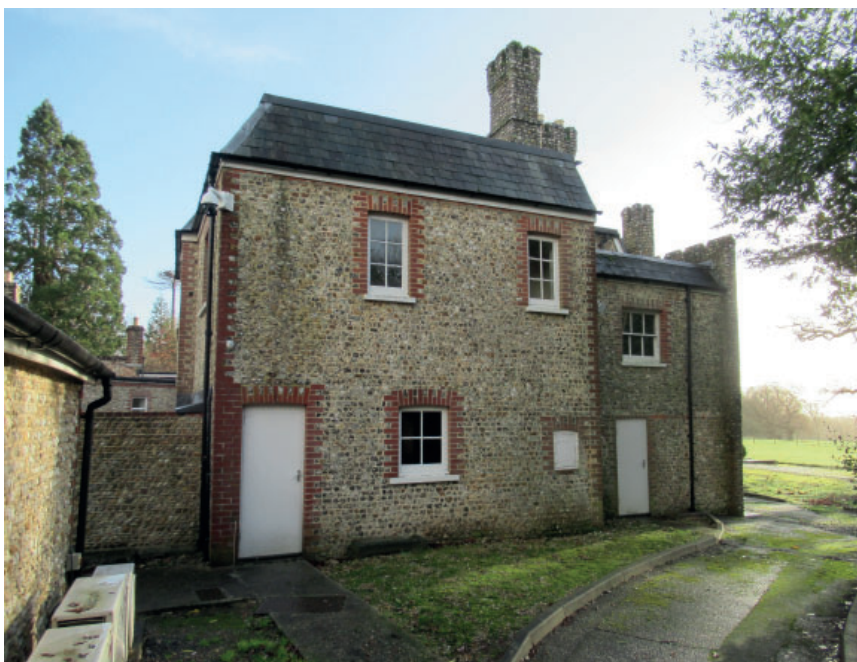
**Fig 10 :**

General view of façades. The exterior faces were found to be knapped flint bedded on a lime-based mortar

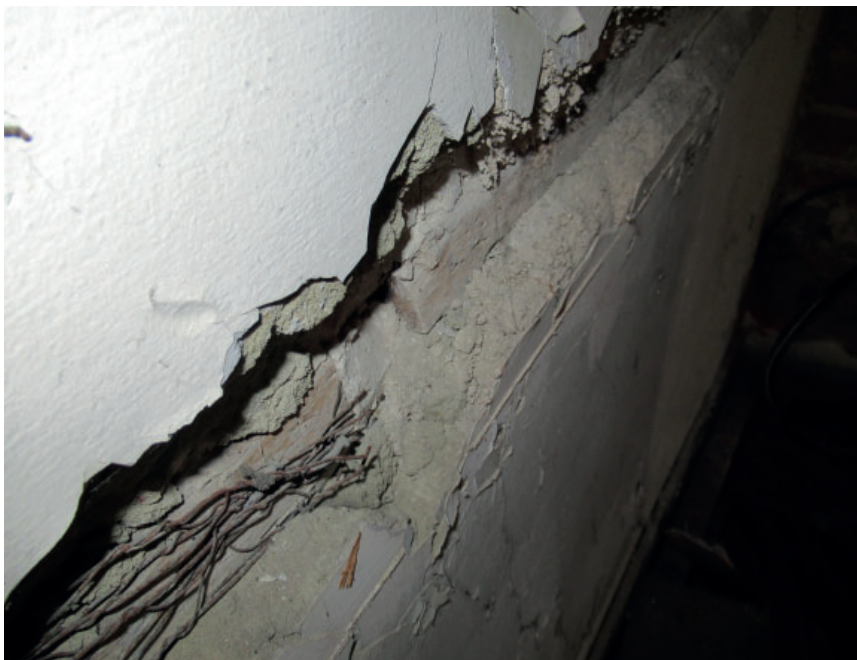
**Fig 17 :**

View of the render and brickwork

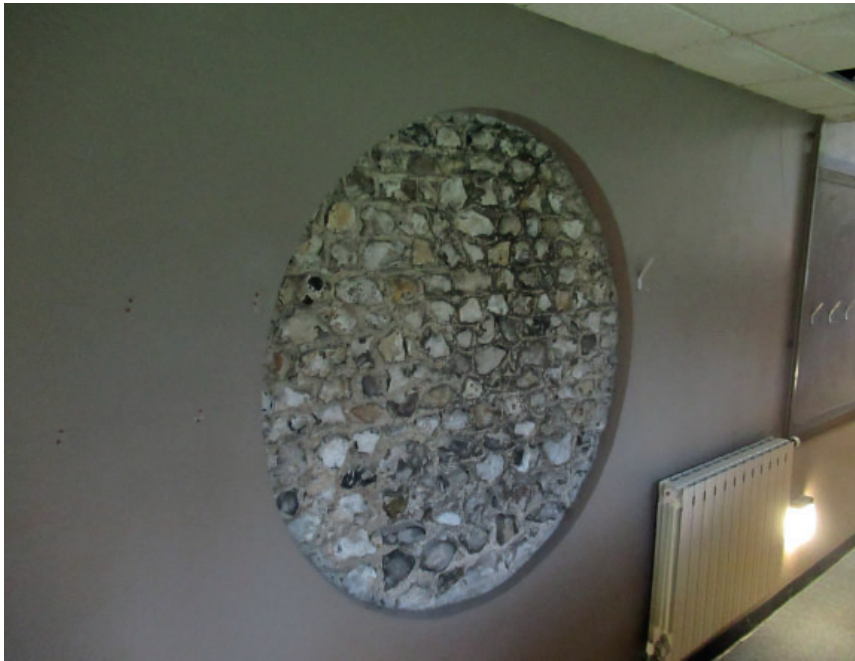
**Fig 41 :**

General view of façades. The exterior faces were found to be knapped flint bedded on a lime-based mortar. The previously external wall had been incorporated into the interior and rendered in this location

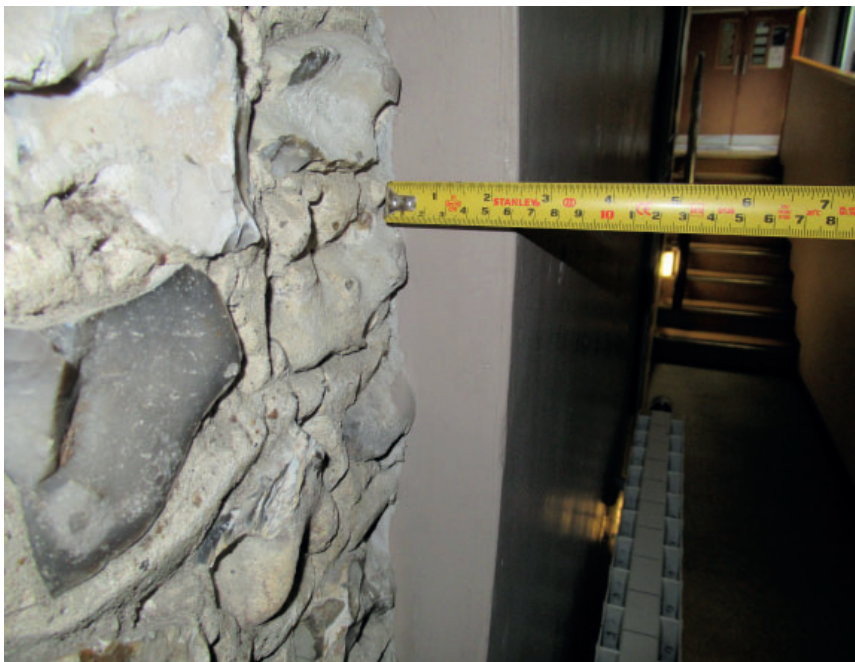
**Fig 42 :**

View of the plaster thickness
