# Hutton + Rostron Environmental Investigations Limited

## Southleigh Park House: Joinery condition investigation

Site note A3 for 26 January 2021, job no. 152.09

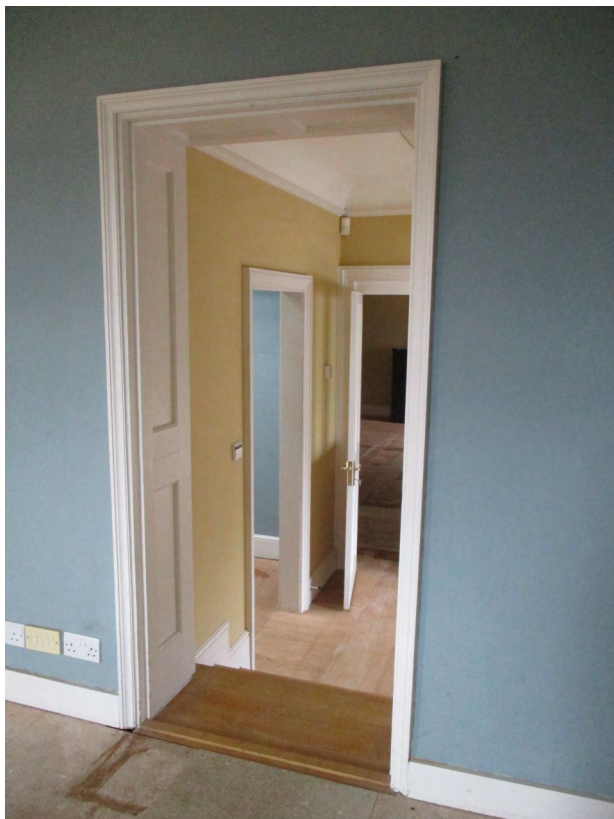
**Fig 2:**

| REFERENCE | ITEM | OBSERVATIONS | RECOMMENDATIONS | CLIENT COMMENTS |
|---|---|---|---|---|
| <b>SNA3.1.1</b><br>F.12 Main Office | Door frame and architrave df.19 | Softwood timber deep panelled door reveal and Ogee moulding to architraves. There were MDF 'wedges' to the base of the panelled reveal suggesting previously altered floor level<br><br>Localised cosmetic damage generally towards the base | -<br><br><i>Prepare and paint surface with a vapour permeable or microporous paint</i> | |

First floor, F.12 Main Office; showing df.19 softwood timber with only localised cosmetic damage

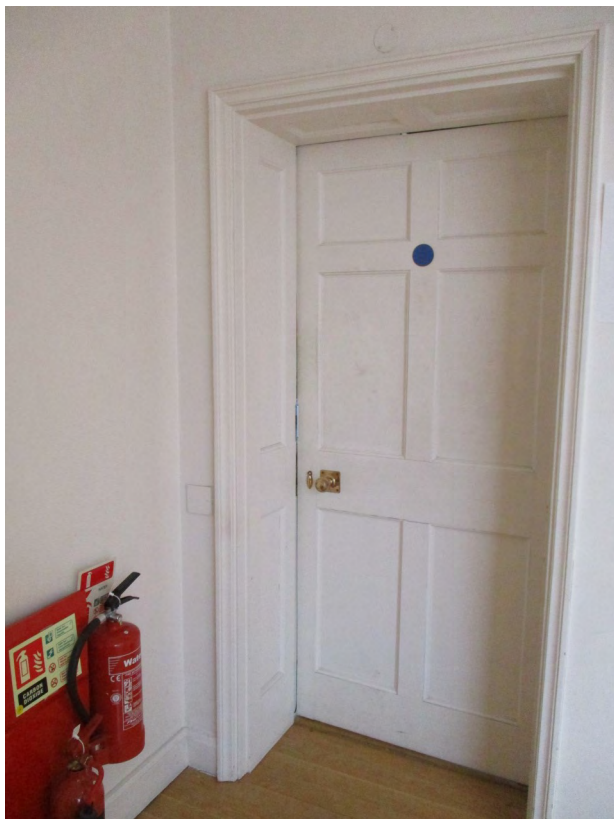
**Fig 4:**

| REFERENCE | ITEM | OBSERVATIONS | RECOMMENDATIONS | CLIENT COMMENTS |
|---|---|---|---|---|
| | Door, door frame and architrave df.01 | Softwood timber panelled fire door with deep panelled door reveal and Ogee moulding to architraves. There were MDF 'wedges' to the base of the panelled reveal suggesting previously altered floor level. Door furniture appeared to be brass<br><br>There was wear to the door furniture from general use<br><br>There was also slight opening up of joints causing cracking to the paint surface. Localised cosmetic damage generally towards the base of the architrave | -<br><br><i>No action required</i><br><br><i>Prepare and paint surface with a vapour permeable or microporous paint</i> | |

First floor, F.12 Main Office; showing df.01 softwood timber with only localised cosmetic damage

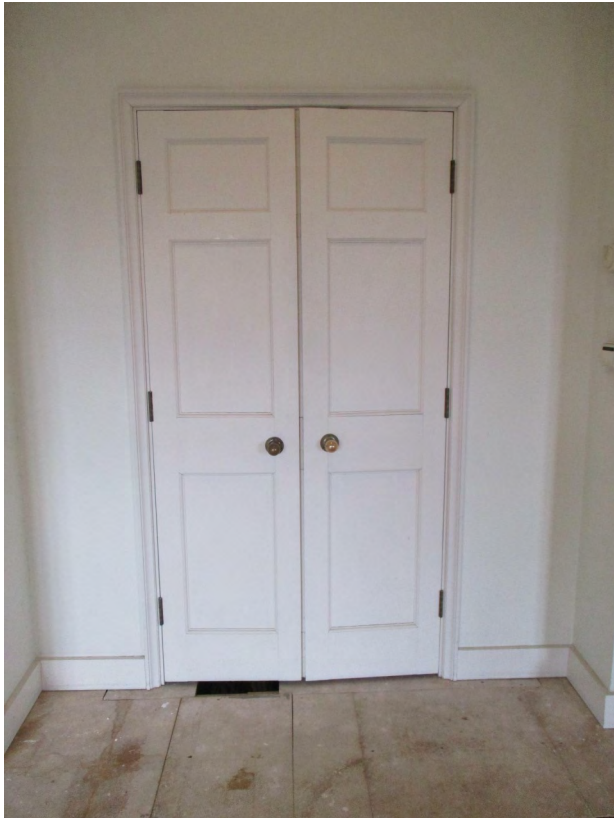
**Fig 5:**

| REFERENCE | ITEM | OBSERVATIONS | RECOMMENDATIONS | CLIENT COMMENTS |
|---|---|---|---|---|
| | Doors, door frame and architrave df.02 | Softwood timber panelled double cupboard doors and simplified Ogee moulding to architraves. Door furniture appeared to be brass<br><br>Localised cosmetic damage generally towards the base of the architrave | -<br><br><i>Prepare and paint surface with a vapour permeable or microporous paint</i> | |

First floor, F.12 Main Office; showing df.02 softwood timber with only localised cosmetic damage

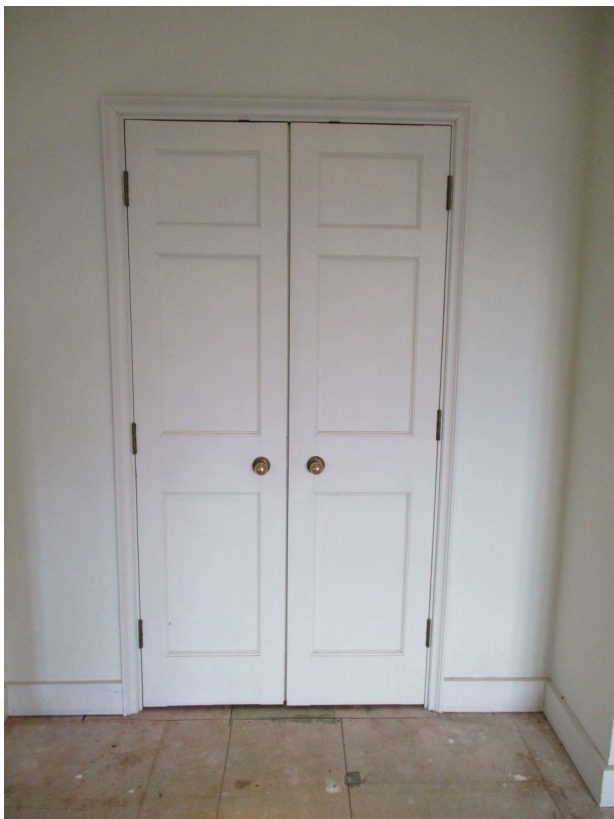
**Fig 6:**

| REFERENCE | ITEM | OBSERVATIONS | RECOMMENDATIONS | CLIENT COMMENTS |
|---|---|---|---|---|
| | Doors, door frame and architrave df.03 | Softwood timber panelled double cupboard doors and simplified Ogee moulding to architraves. Door furniture appeared to be brass<br><br>Localised cosmetic damage generally towards the base of the architrave | -<br><br><i>Prepare and paint surface with a vapour permeable or microporous paint</i> | |

First floor, F.12 Main Office; showing df.03 softwood timber with only localised cosmetic damage

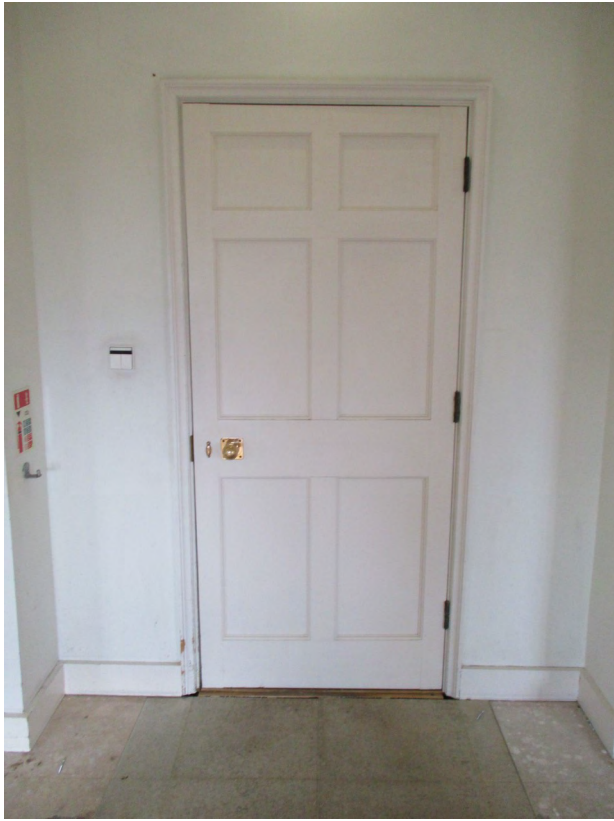
**Fig 7:**

| REFERENCE | ITEM | OBSERVATIONS | RECOMMENDATIONS | CLIENT COMMENTS |
|---|---|---|---|---|
| | Door, door frame and architrave df.04 | Softwood timber panelled door with deep panelled door reveal and simple moulding to architraves. There were MDF 'wedges' to the base of the panelled reveal suggesting previously altered floor level. Door furniture appeared to be brass<br><br>There was wear to the door furniture from general use<br><br>Localised cosmetic damage generally towards the base of the architrave | -<br><br><i>No action required</i><br><br><i>Prepare and paint surface with a vapour permeable or microporous paint</i> | |

First floor, F.12 Main Office; showing df.04 softwood timber with generally localised cosmetic damage

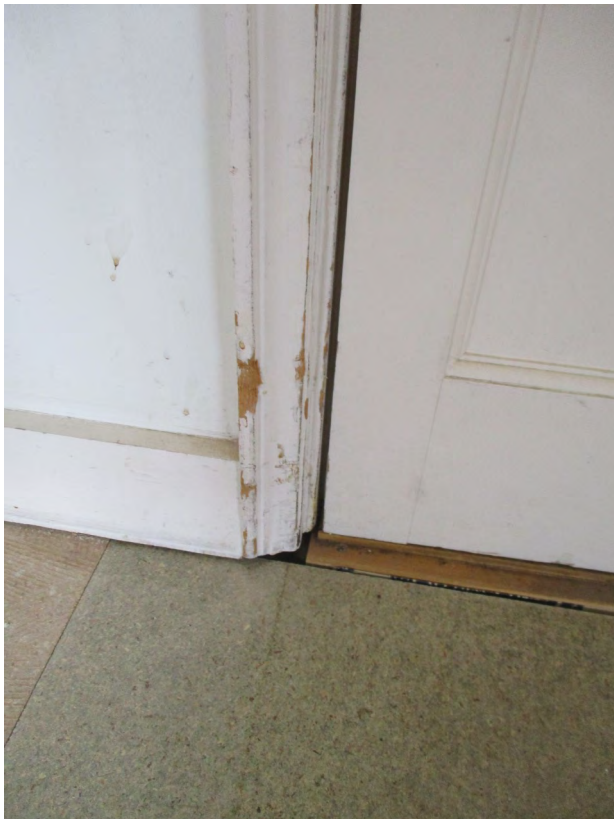
**Fig 8:**

First floor, F.12 Main Office; showing df.04 softwood timber architrave showing more extensive localised cosmetic damage

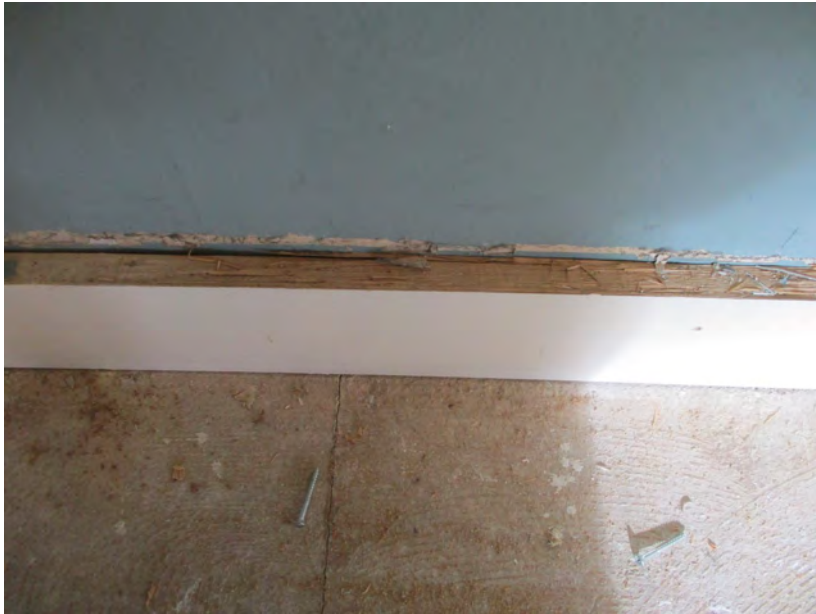
**Fig 9:**

| REFERENCE | ITEM | OBSERVATIONS | RECOMMENDATIONS | CLIENT COMMENTS |
|---|---|---|---|---|
| | Skirting | Softwood timber no moulding with localised wear/tear from use<br><br>General wear/tear from use and localised damage toward north-west corner | -<br><br><i>Prepare and paint surface with a vapour permeable or microporous paint</i> | |

First floor, F.12 Main Office; showing softwood timber skirting with only localised cosmetic damage

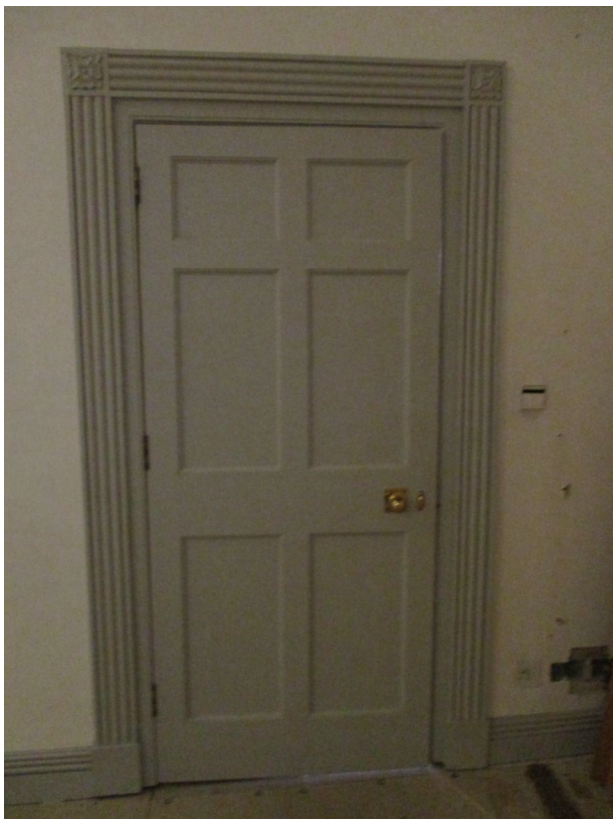
**Fig 12:**

| REFERENCE | ITEM | OBSERVATIONS | RECOMMENDATIONS | CLIENT COMMENTS |
|---|---|---|---|---|
| | Door, door frame and architrave df.05 | Softwood timber panelled door and reeded architrave with corner and plinth blocks. Door furniture appeared to be brass<br><br>There was wear to the door furniture from general use<br><br>Localised cosmetic damage generally towards the base of the architrave and door | -<br><br><i>No action required</i><br><br><i>Prepare and paint surface with a vapour permeable or microporous paint</i> | |

First floor, F.14 R & D Office; showing df.05 softwood timber with only localised cosmetic damage

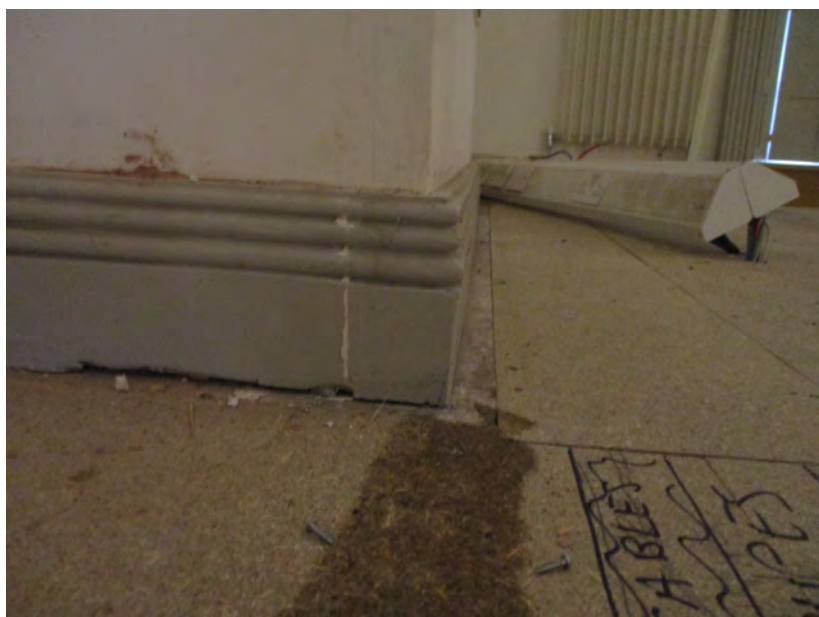
**Fig 14:**

| REFERENCE | ITEM | OBSERVATIONS | RECOMMENDATIONS | CLIENT COMMENTS |
|---|---|---|---|---|
| | Skirting | Softwood timber three reeded skirting increasing in size towards the floor<br><br>General wear/tear from use and localised damage in several places around the room | -<br><br><i>Remove paint from around surface of break and repair with new timber. Wood filler may be used to fill any gaps to create smooth surface for repainting. Prepare and paint surface with a vapour permeable or microporous paint</i> | |

First floor, F.14 R & D Office; showing  
softwood timber skirting with localised  
damage

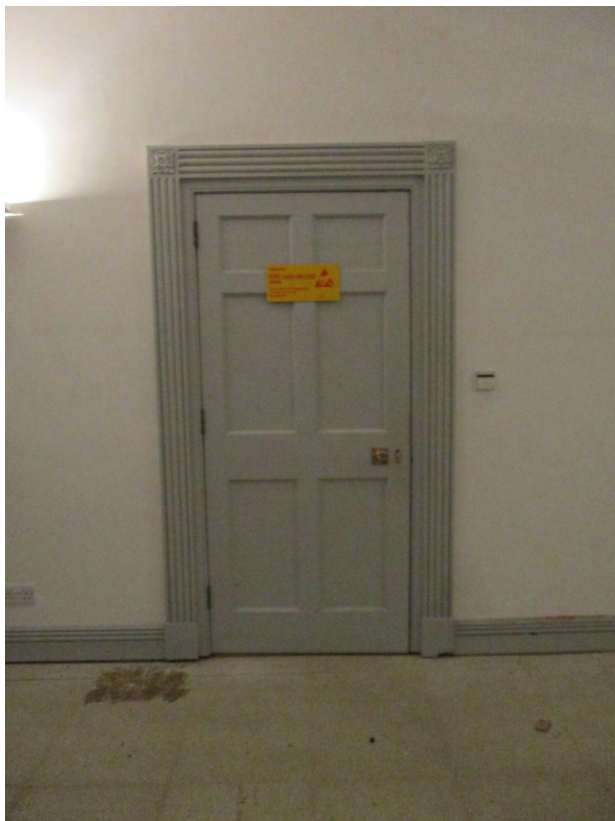
**Fig 15:**

| REFERENCE | ITEM | OBSERVATIONS | RECOMMENDATIONS | CLIENT COMMENTS |
|---|---|---|---|---|
| <b>SNA3.1.4</b><br>F.15/F.16 R & D<br>Lab 3 | Door, door frame and architrave df.06 | Softwood timber panelled door and reeded architrave with corner and plinth blocks. Door furniture appeared to be brass<br><br>Loss of material to the bottom left corner block<br><br>There was wear to the door furniture from general use | -<br><br><i>Remove paint from around surface of break and repair with new timber. Wood filler may be used to fill any gaps to create smooth surface for repainting</i><br><br><i>No action required</i> | |

First floor, F.14 R & D Office; showing df.06 softwood timber with generally localised cosmetic damage

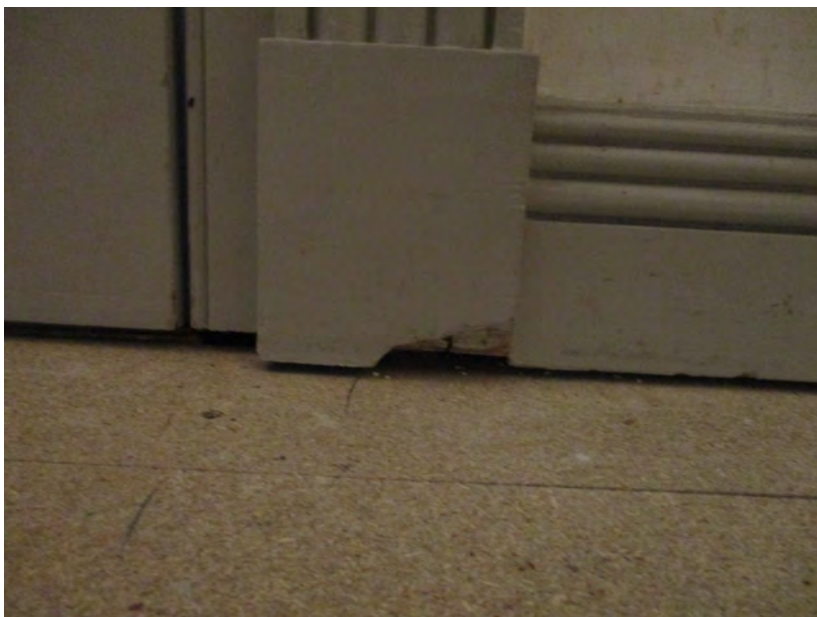
**Fig 16:**

First floor, F.14 R & D Office; showing df.06 softwood timber right plinth block with timber section missing

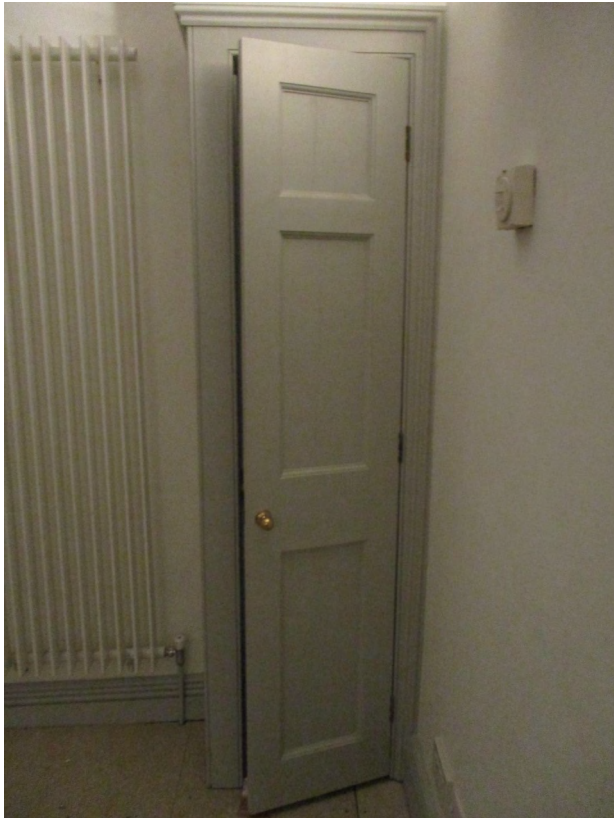
**Fig 17:**

| REFERENCE | ITEM | OBSERVATIONS | RECOMMENDATIONS | CLIENT COMMENTS |
|---|---|---|---|---|
| | Cupboard | Softwood timber panelled cupboard and door<br><br>Split in timber panels running vertically from top to base across all three panels; evidence of previous remedial repairs. General wear/tear from use and localised damage in several places around the room | -<br><br><i>Prepare and paint surface with a vapour permeable or microporous paint</i> | |

First floor, F.14 R & D Office; showing softwood timber cupboard with generally localised cosmetic damage and split down panelling

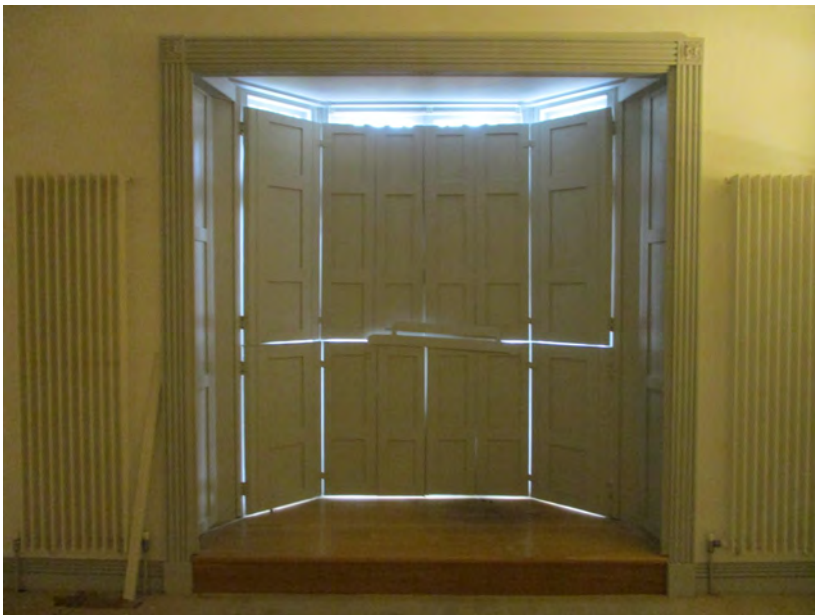
**Fig 18:**

| REFERENCE | ITEM | OBSERVATIONS | RECOMMENDATIONS | CLIENT COMMENTS |
|---|---|---|---|---|
| <b>SNA3.1.3</b><br>F.14 R & D Office | Architrave and shutters wf.10 | Softwood tier-on-tier solid panelled shutters. Each side was divided into three folding sections. Reeded architrave with corner and plinth blocks.<br><br>Loss of timber to middle section of top right tier. General wear/tear from use and localised damage toward north-west corner. Cracking to paint surface around joints<br><br>Shutters did not close properly<br><br>Note water staining to ceiling of bay window<br><br>Also note hinges still had some original screws but some had been replaced with modern cross heads | -<br><br><i>Prepare and paint surface with a vapour permeable or microporous paint</i><br><br><i>Shutter hinges may need to be rehung or altered so that the shutters close flush</i><br><br><i>Further investigation by H+R may be necessary</i><br><br>- | |

First floor, F.14 R & D Office; showing wf.10 softwood timber with generally localised cosmetic damage

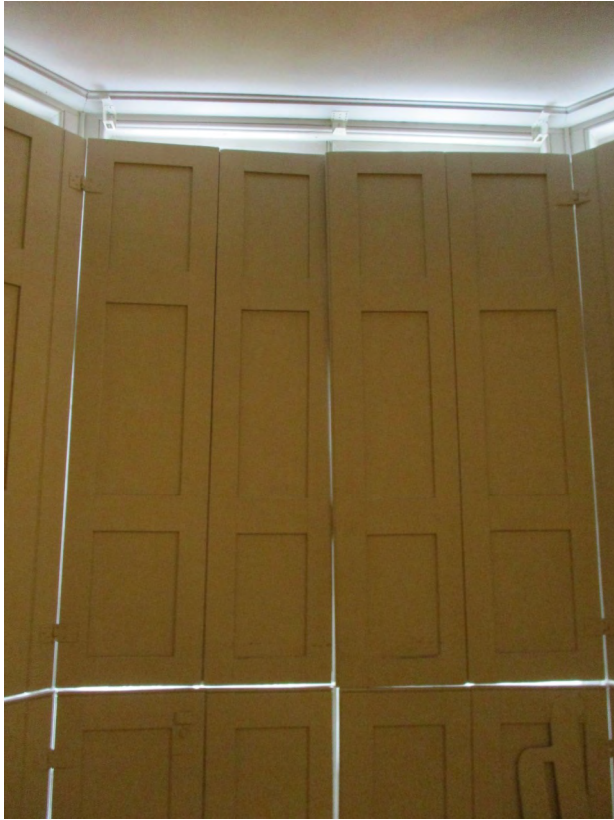
**Fig 21:**

First floor, F.14 R & D Office; showing df.06 shutters were out of alignment

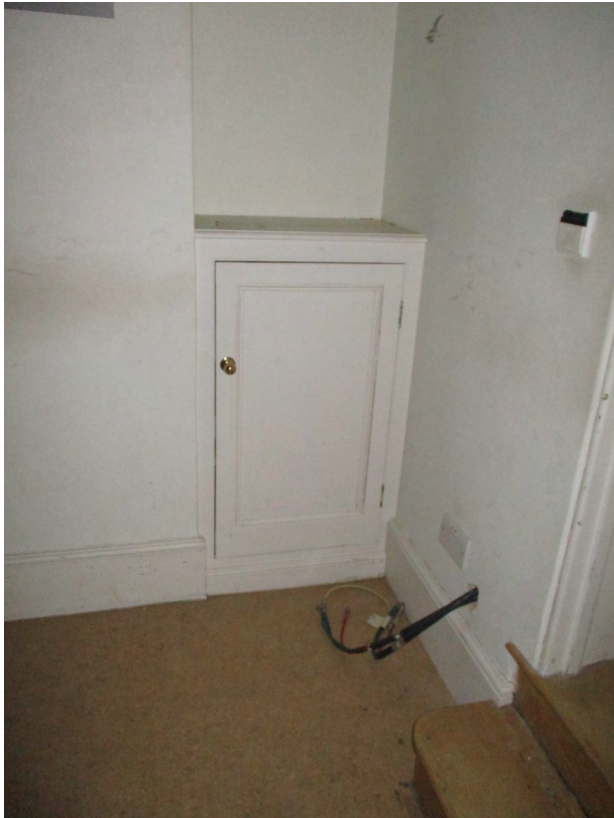
**Fig 23:**

| REFERENCE | ITEM | OBSERVATIONS | RECOMMENDATIONS | CLIENT COMMENTS |
|---|---|---|---|---|
| | Cupboard | Softwood timber panelled cupboard door. Door furniture appeared to be brass<br><br>Localised cosmetic damage generally edges of door | -<br><br><i>Prepare and paint surface with a vapour permeable or microporous paint</i> | |

First floor, F.15/F16 R & D Lab 3;  
showing softwood timber cupboard and  
skirting with generally localised  
cosmetic damage

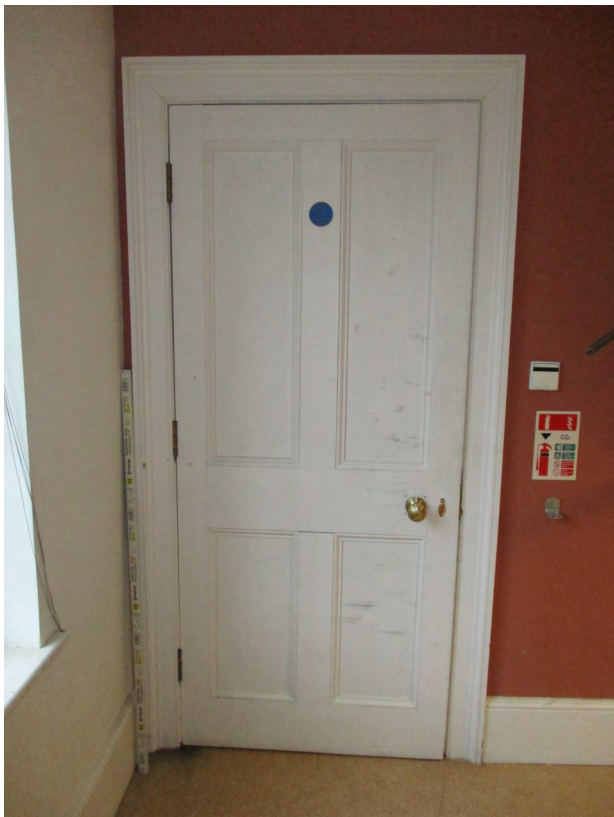
**Fig 24:**

| REFERENCE | ITEM | OBSERVATIONS | RECOMMENDATIONS | CLIENT COMMENTS |
|---|---|---|---|---|
| | Door, door frame and architrave df.07 | Softwood timber panelled door and simple architrave. Door furniture appeared to be brass<br><br>There was wear to the door furniture from general use<br><br>Localised cosmetic damage generally towards the base of the architrave and door | -<br><br><i>No action required</i><br><br><i>Prepare and paint surface with a vapour permeable or microporous paint</i> | |

First floor, F.15/F16 R & D Lab 3;  
showing df.07 softwood timber with  
generally localised cosmetic damage

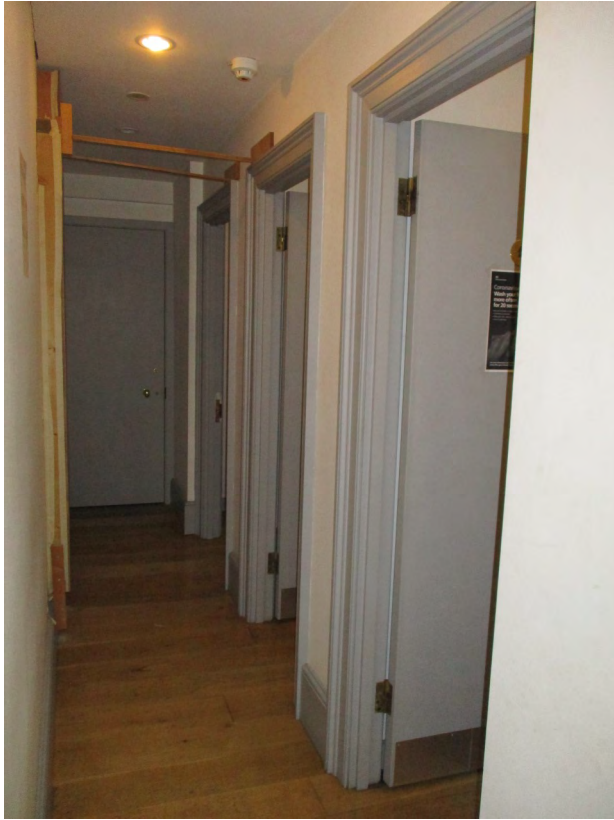
**Fig 25:**

| REFERENCE | ITEM | OBSERVATIONS | RECOMMENDATIONS | CLIENT COMMENTS |
|---|---|---|---|---|
| <b>SNA3.1.7</b><br>F.04 Toilets | Door, door frame and architrave df.20 | Door appears to be modern fire door<br><br>General wear/tear from use | -<br><br><i>Prepare and paint surface with a vapour permeable or microporous paint</i> | |
| | Door, door frame and architrave df.21 | Door appears to be modern fire door<br><br>General wear/tear from use | -<br><br><i>Prepare and paint surface with a vapour permeable or microporous paint</i> | |
| | Door, door frame and architrave df.22 | Door appears to be modern fire door<br><br>General wear/tear from use | -<br><br><i>Prepare and paint surface with a vapour permeable or microporous paint</i> | |
| | Door, door frame and architrave df.23 | Door appears to be modern fire door<br><br>General wear/tear from use | -<br><br><i>Prepare and paint surface with a vapour permeable or microporous paint</i> | |

First floor, F.04 Toilets; showing softwood timber df.20, df.21, df.22 and df.23 with generally localised cosmetic damage

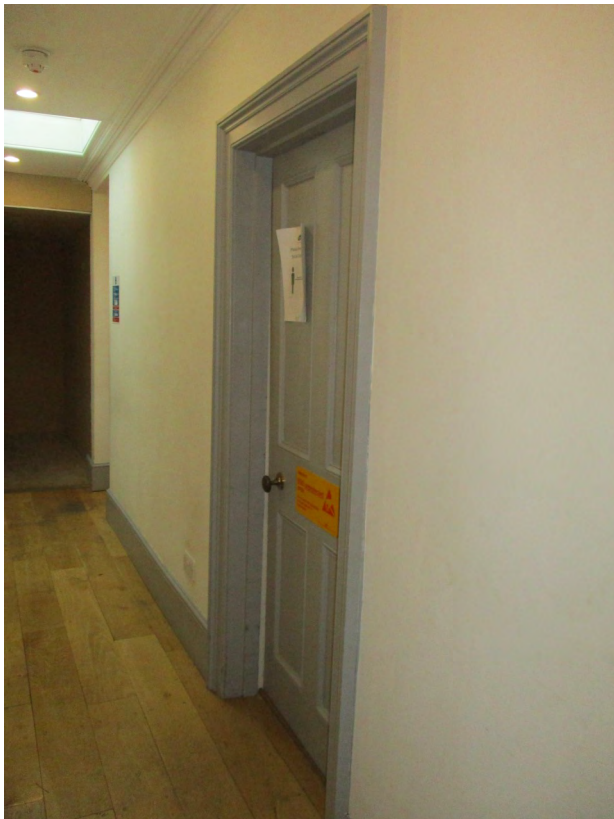
**Fig 26:**

First floor, F.05 R & D Lab 1; showing df.10 softwood timber with generally localised cosmetic damage

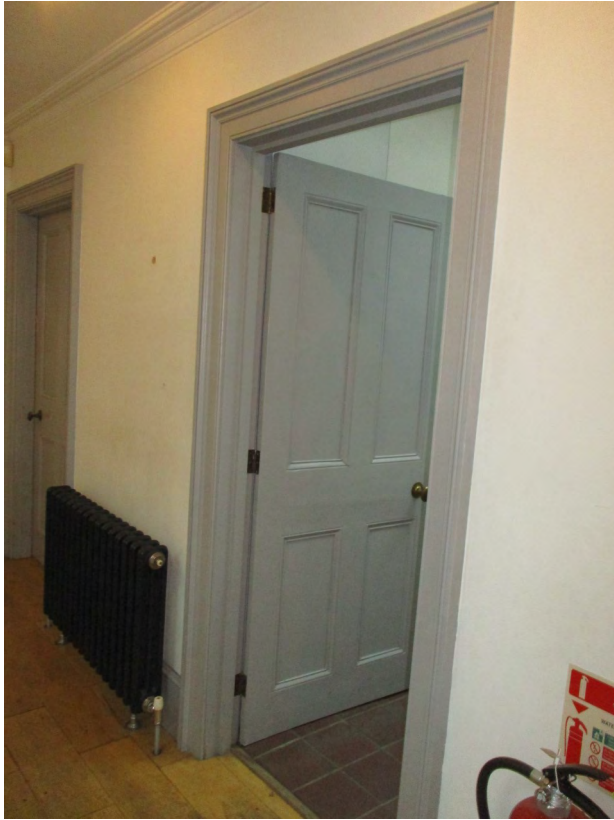
**Fig 29:**

First floor, F.08 Kitchenette; showing  
df.12 softwood timber with generally  
localised cosmetic damage

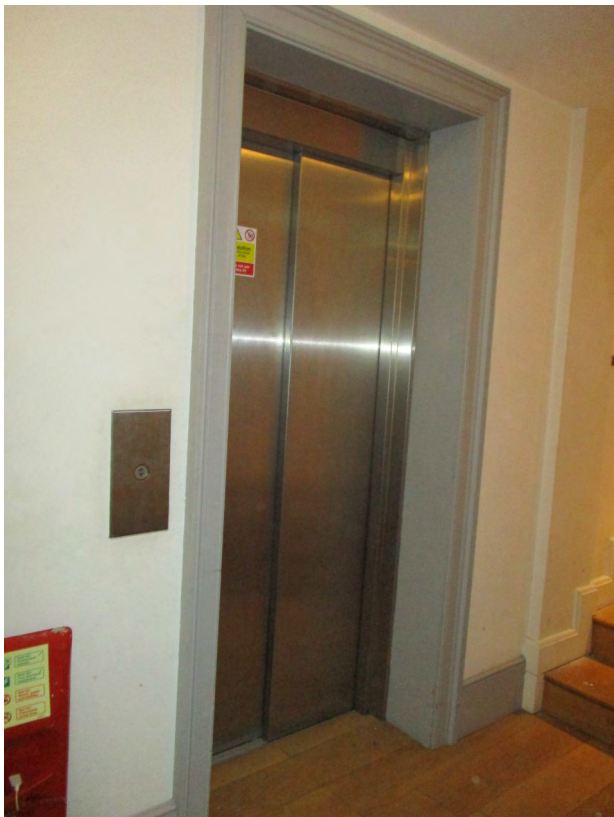
**Fig 30:**

| REFERENCE | ITEM | OBSERVATIONS | RECOMMENDATIONS | CLIENT COMMENTS |
|---|---|---|---|---|
| | Architrave for lift | Softwood timber Ogee style architrave<br><br>Localised minor cosmetic damage generally towards the base of the architrave | -<br><br><i>Prepare and paint surface with a vapour permeable or microporous paint</i> | |

First floor, F.03 Back Corridor; showing  
softwood timber architrave with  
generally localised cosmetic damage

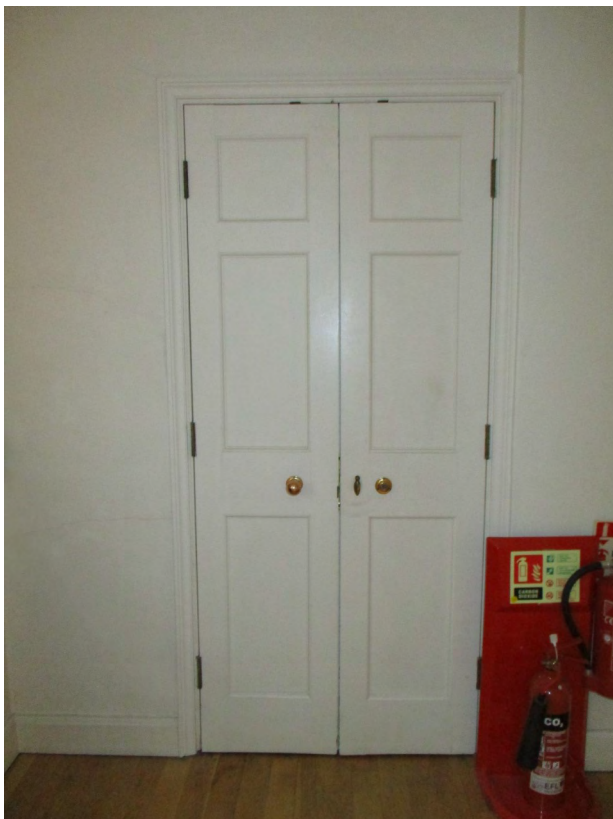
**Fig 32:**

First floor, F.09 Landing; showing df.14 softwood timber with generally localised cosmetic damage and detached right handle

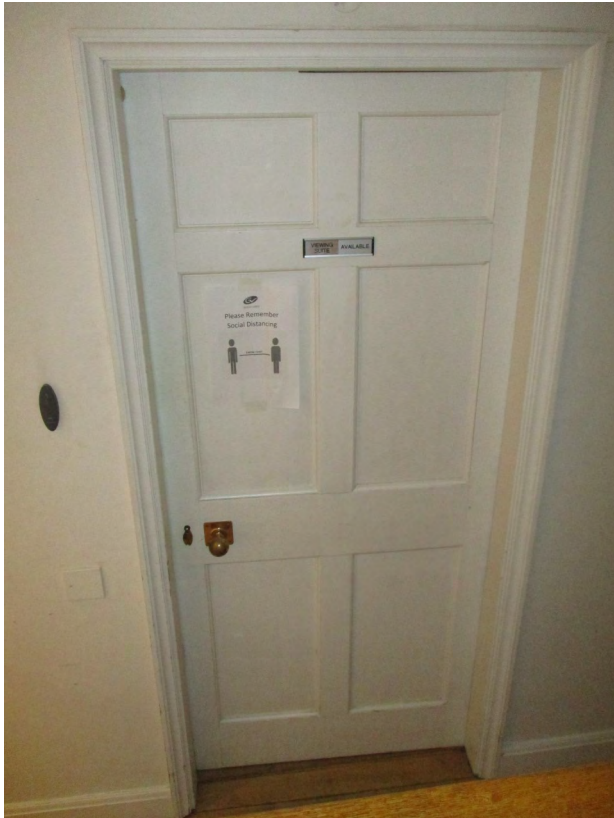
**Fig 33:**

First floor, F.10 Office; showing df.16 softwood timber with generally localised cosmetic damage

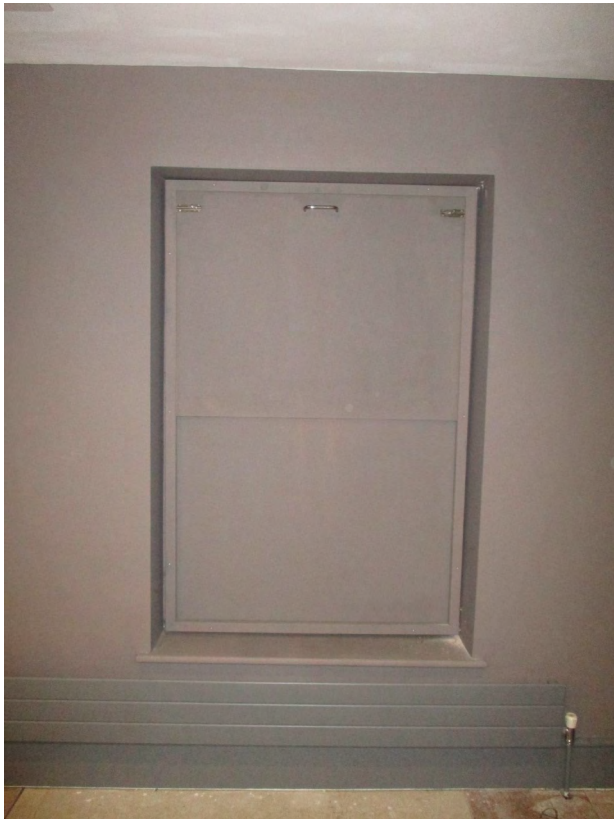
**Fig 35:**

First floor, F.10 Office; showing wf.36  
MDF sheets in softwood timber frame  
with generally localised cosmetic  
damage

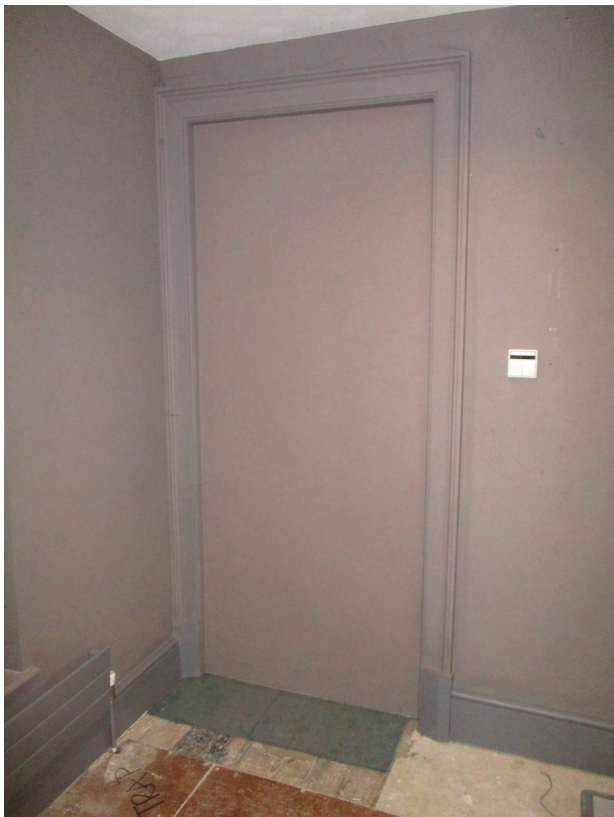
**Fig 36:**

First floor, F.10 Office; showing df.17  
boarded up from west

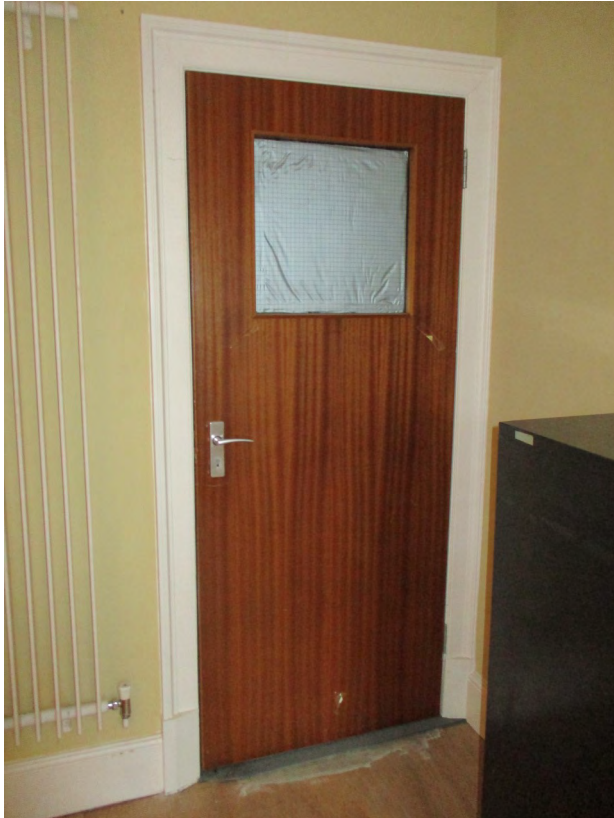
**Fig 37:**

First floor, F.11 Office; showing df.17 modern timber door with reinforced glazing. Localised damage to painted architrave and dent to lower half of door

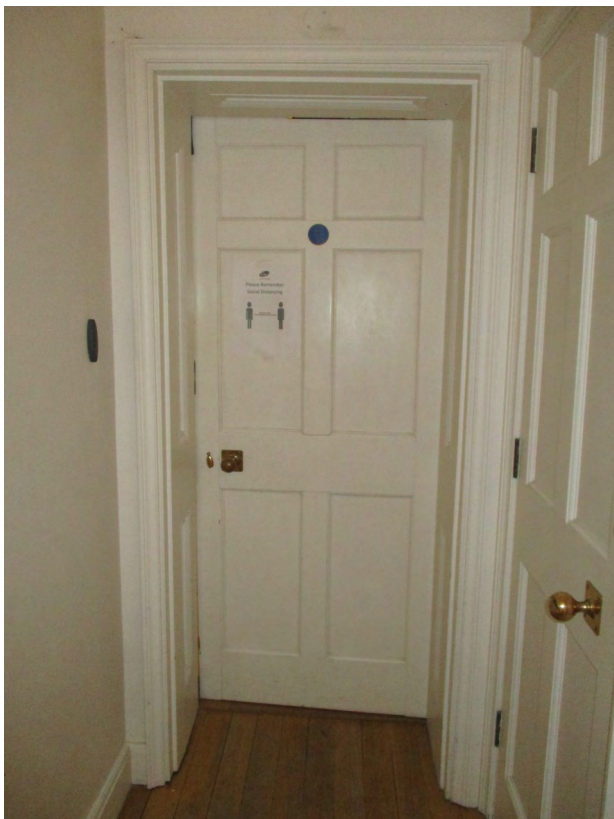
**Fig 38:**

First floor, F.11 Office; showing df.18 softwood timber with generally localised cosmetic damage

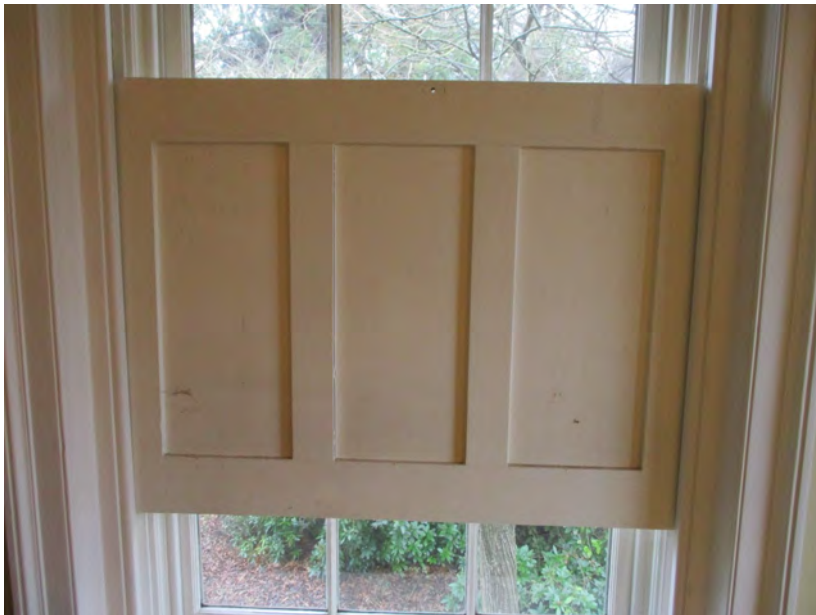
**Fig 40:**

First floor, F.11 Office; showing wf.37 softwood timber panelled shutters with generally localised cosmetic damage

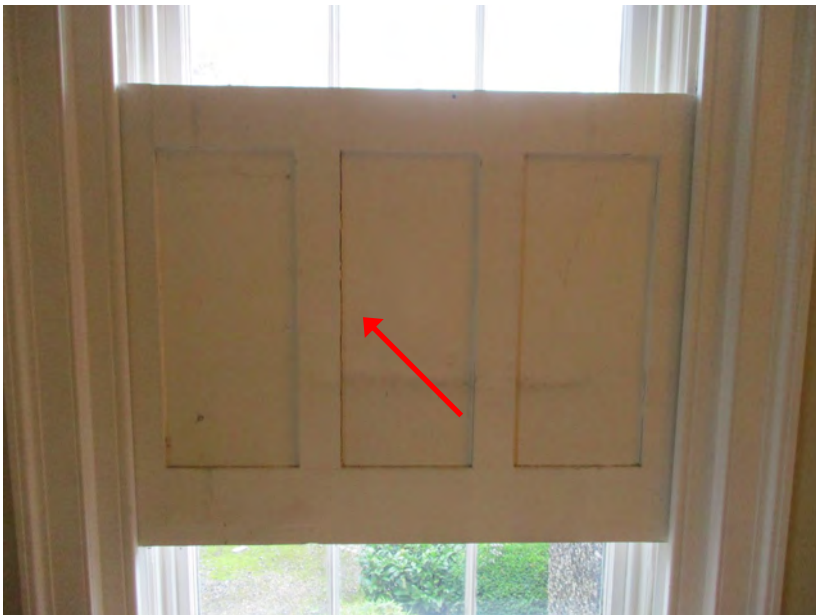
**Fig 42:**

First floor, F.11 Office; showing wf.38 softwood timber panelled shutters with generally localised cosmetic damage and opening up of joints was not structurally significant

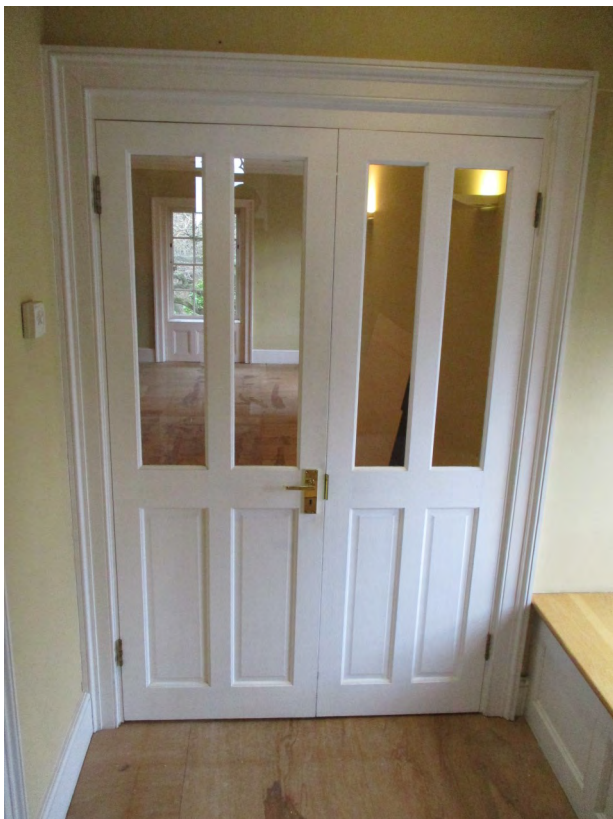
**Fig 44:**

First floor, F.11 Office; showing modern doors softwood timber with glazing panes. Painted timber panels had localised cosmetic damage

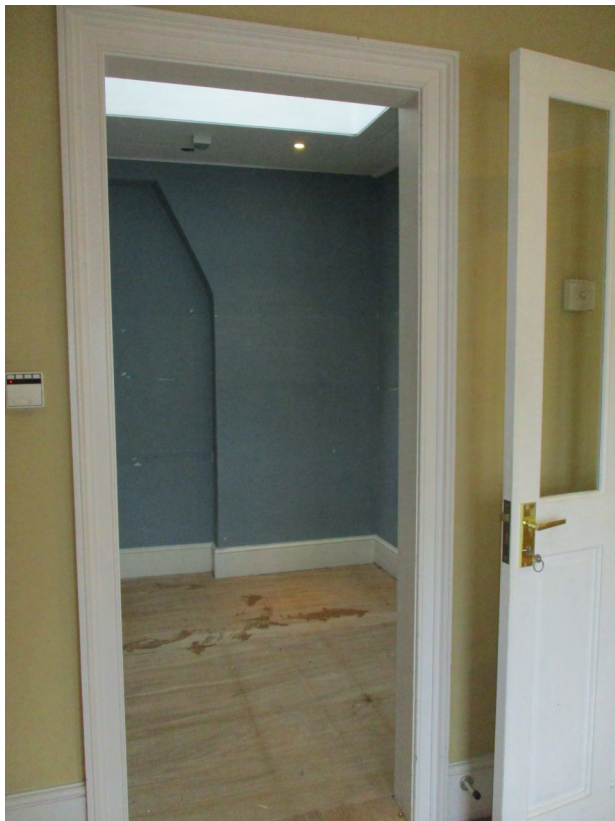
**Fig 45:**

First floor, F.11 Office; showing wf.38 softwood timber panelled architrave with generally localised cosmetic damage

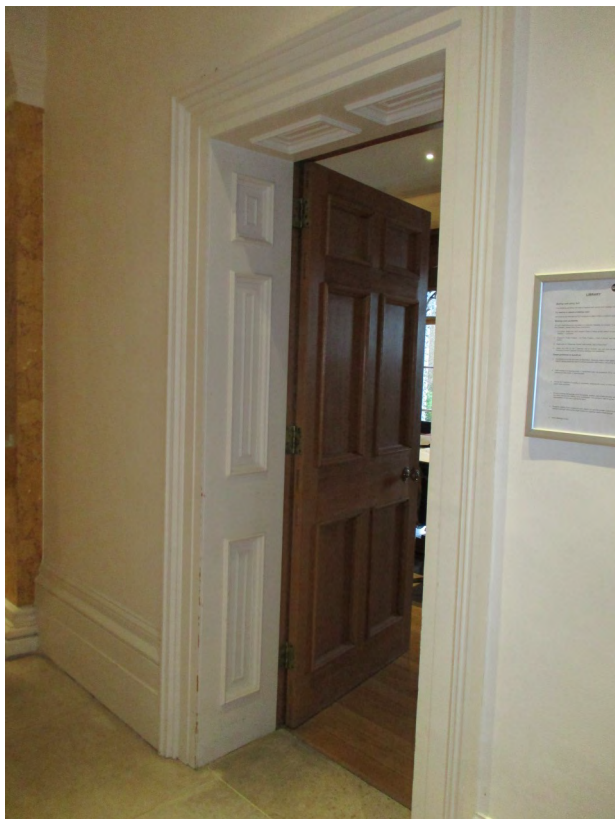
**Fig 46:**

Ground floor, G.13 Library; showing dg.02 softwood timber architrave and deep panelled reveal with oak veneered door. Localised cosmetic damage to paintwork and slight opening up of joints in panels of oak door

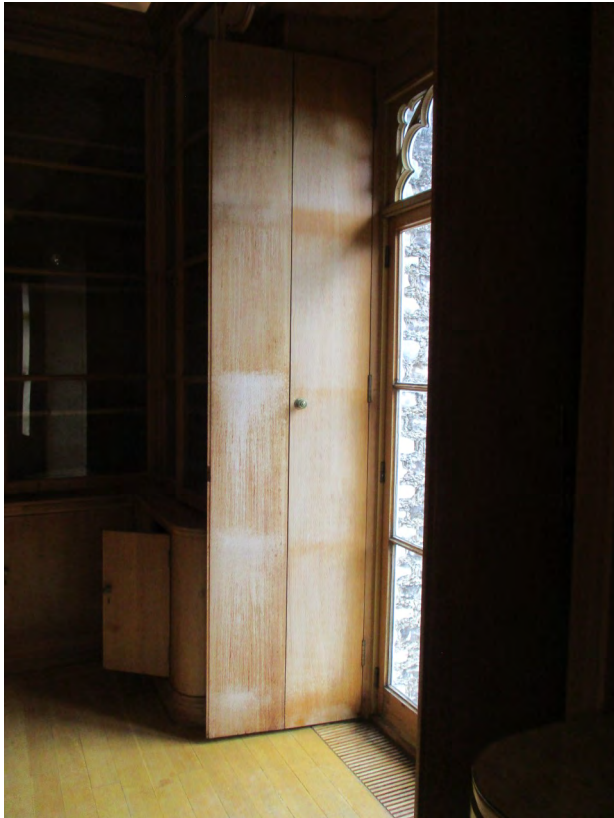
**Fig 49:**

Ground floor, G.13 Library; showing wg.01 oak veneered shutters and architrave. The external face of the veneer showed evidence of UV damage to the finish

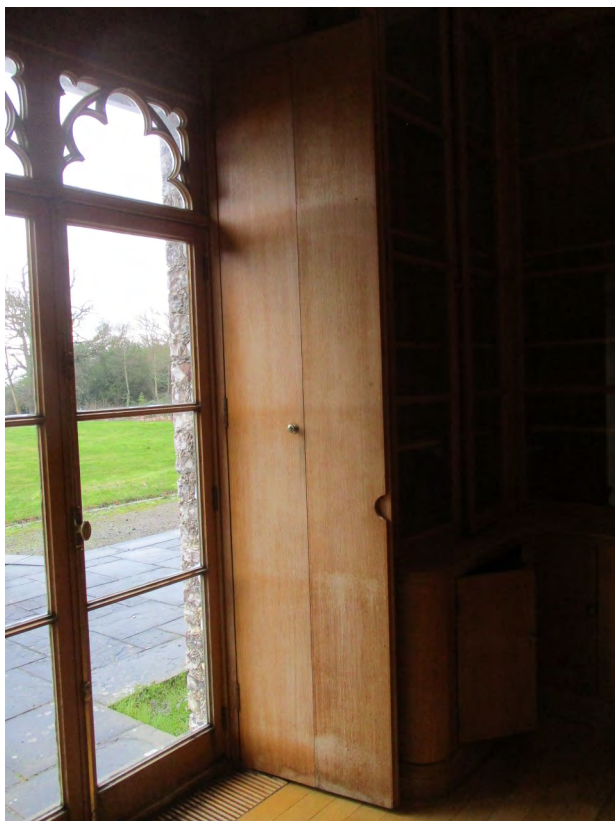
**Fig 51:**

Ground floor, G.13 Library; showing wg.02 oak veneered shutters and architrave. The external face of the veneer showed evidence of UV damage to the finish

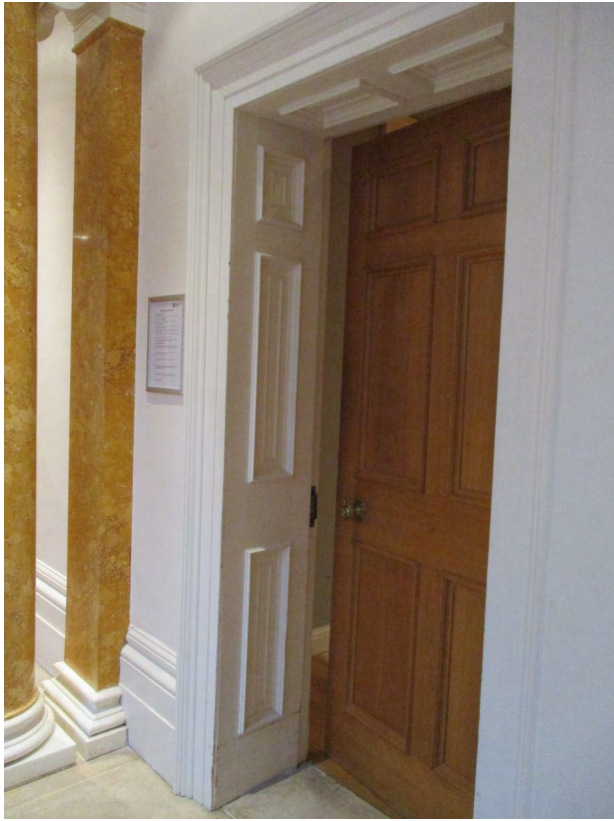
**Fig 55:**

Ground floor, G.14 Electronic Boardroom; showing dg.03 softwood timber architrave and deep panelled reveal with oak veneered door. Localised cosmetic damage to paintwork and opening up of panelling joints of oak door

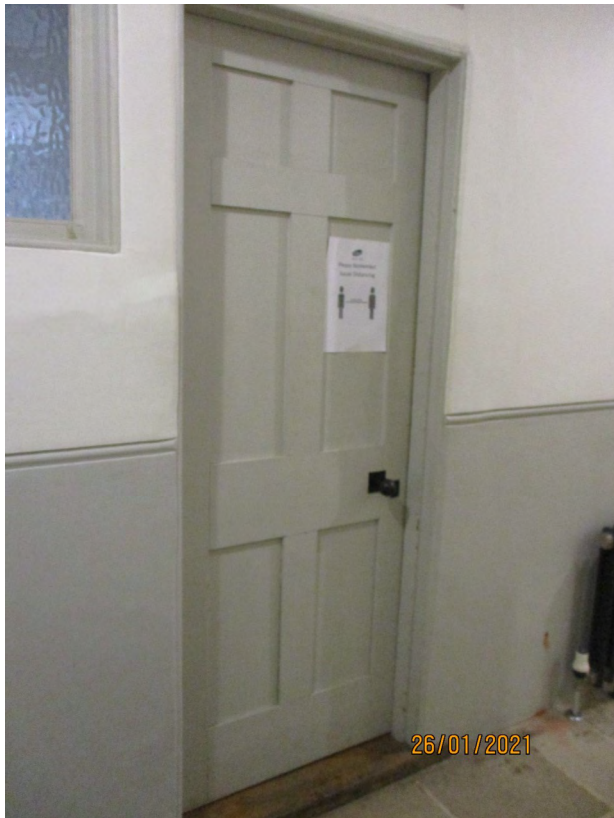
**Fig 85:**

Ground floor, G.05 R&D Lab; showing dg.28 softwood timber architrave. Localised cosmetic damage to paintwork at low level

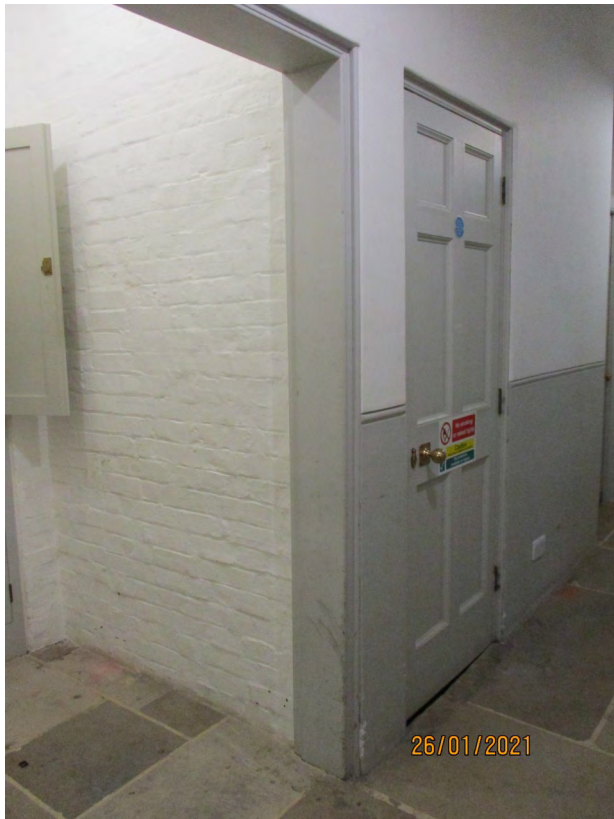
**Fig 91:**

Ground floor, G.17 former Wine Store;  
showing softwood timber architrave.  
Very localised damage to low level  
paintwork

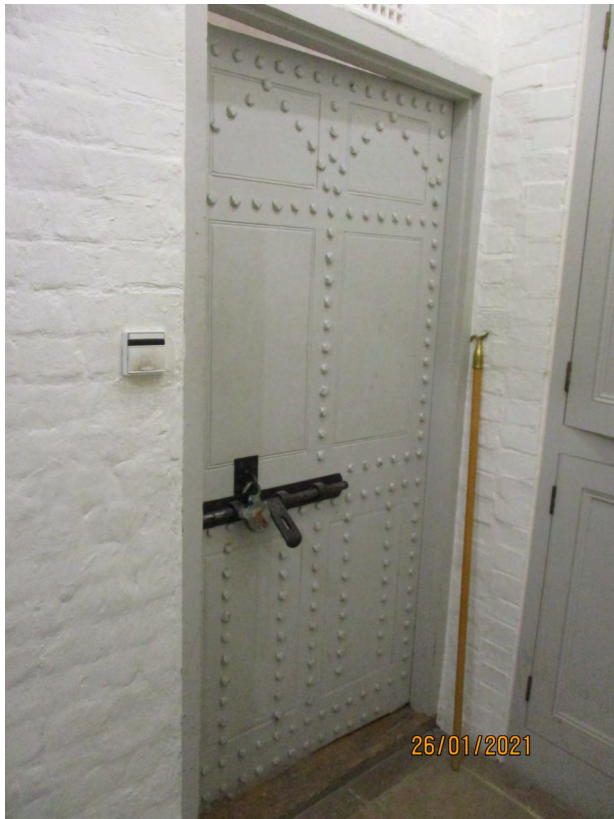
**Fig 93:**

Ground floor, G.17 former Wine Store;  
showing dg.17 softwood timber  
architrave with iron door studs and  
bolt. Very localised damage to  
paintwork at low level from general use

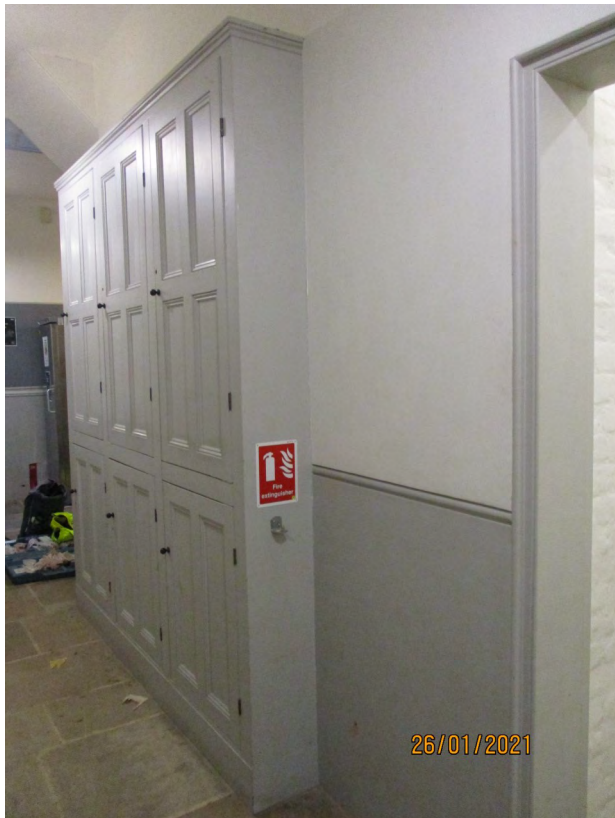
**Fig 97:**

Ground floor, G.04 Back Corridor;  
showing softwood timber architrave .  
Very localised damage to paintwork at  
low level from general use and a crack  
to the middle panel near the door  
handle
