# Hutton + Rostron Environmental Investigations Limited

## Southleigh Park House: Joinery condition investigation

Site note A3 for 26 January 2021, job no. 152.09

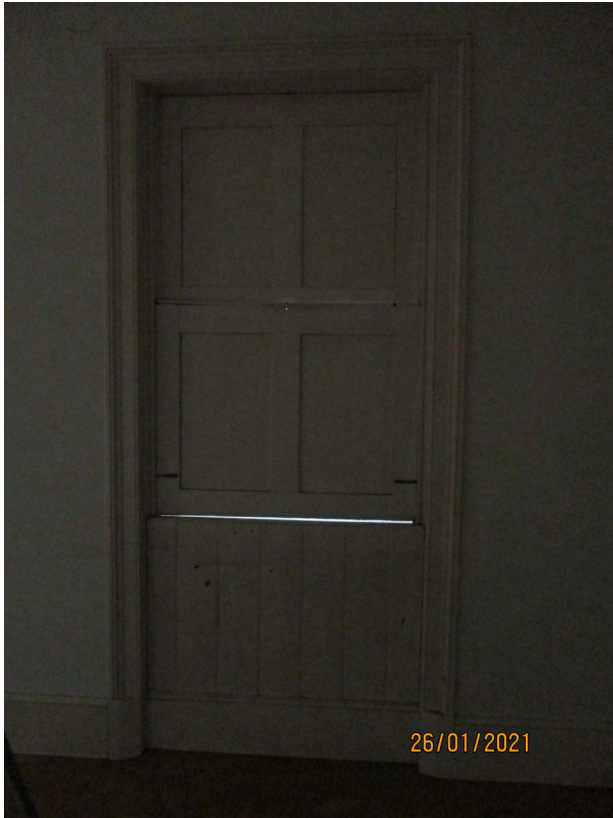
**Fig 101:**

Ground floor, G.07 IT Office; showing wg.30 softwood timber panelled vertical sliding shutters. There was general wear and tear damage to the paint work to all elements and some cracking to the paintwork around joints in the panelling. There was also localised damage to paintwork on the edges of the architrave

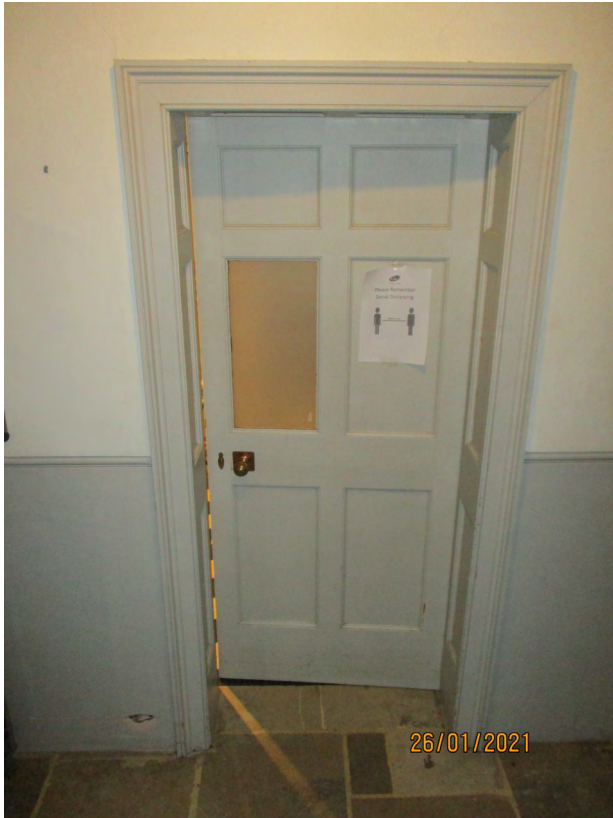
**Fig 103:**

Ground floor, G.04 Back Corridor;  
showing dg.16 softwood timber door  
with glazing pane. There was general  
wear and tear damage to the paint  
work to all elements

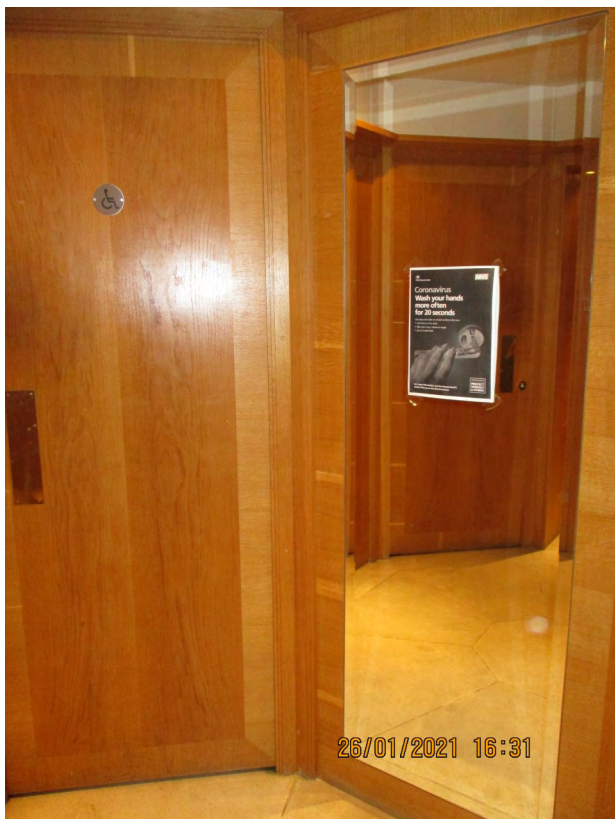
**Fig 109:**

Ground floor, G.10 Toilets; showing general view of doors and panels. There was slight damage to the base of the panelling and doors which was likely due to water damage, possible from mopping and other cleaning/building maintenance

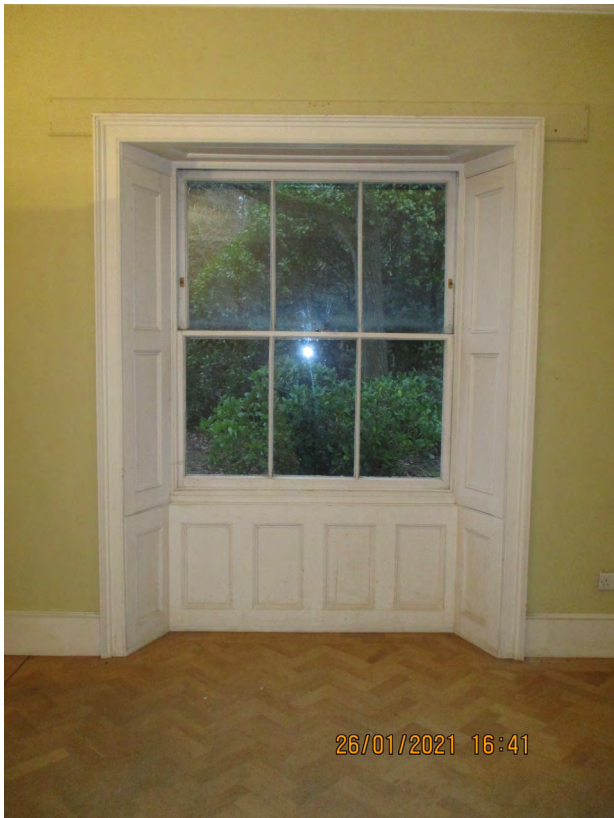
**Fig 113:**

Ground floor, G.011 Office (former morning room); showing wg.33 solid softwood timber panelled shutters. There was general wear/tear from use and localised damage toward north-west corner of the skirting
