# Hutton + Rostron Environmental Investigations Limited

## Southleigh Park House: Roof timbers investigation

Site note A1 for 27 January and 5 February 2021, job no. 152.09

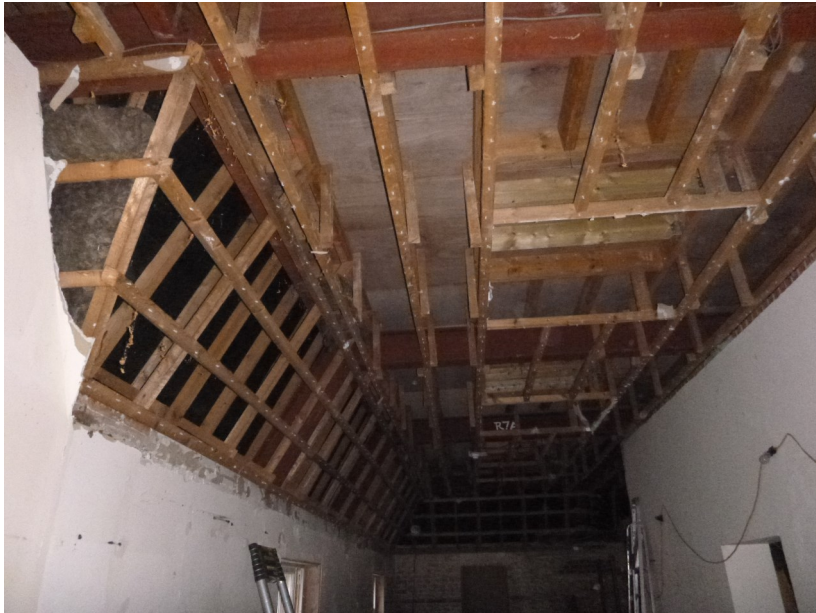
**Fig 1:**

H+R roof 1; showing general view

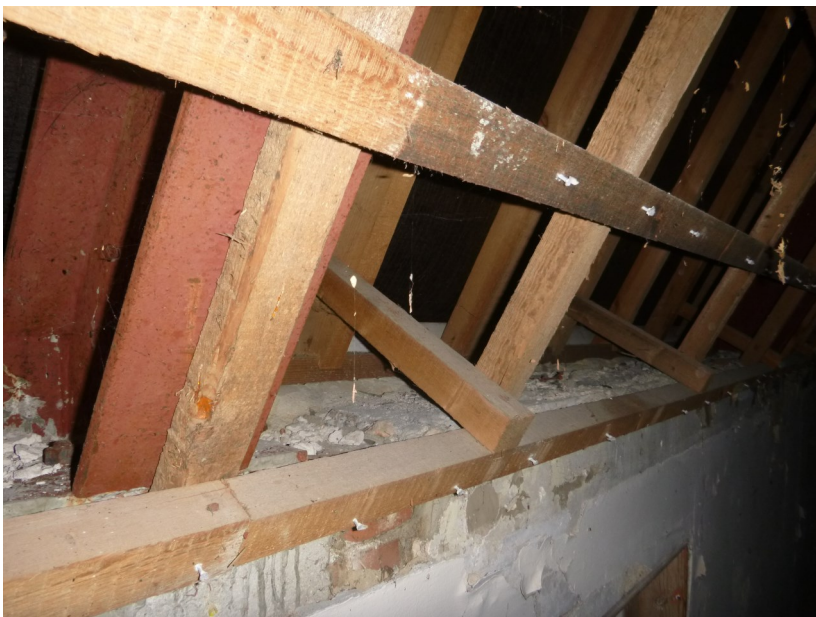
**Fig 2:**

| REFERENCE | ITEM | OBSERVATIONS | RECOMMENDATIONS | CLIENT COMMENTS |
|---|---|---|---|---|
| <b>SNa1.1.2</b> | Condition | <p>Access was available to the majority of the structure for inspection. A small part of the north mansard remained enclosed although there was no evidence that this disguised decay</p> <p>There was no decay detected to roof timbers abutting the perimeter masonry of the north, east and west (despite water ingress to masonry slightly below the roof line, arising from defective eaves guttering shown on plans)</p> <p>Along the south parapet gutter, there were general problems of long term and recurrent condensation, leading to beetle and wet rot damage in gutter sole timbers. Condensation was visible at time of survey, apparently due to a 'cold-bridge' defect arising from an insulated rafter void adjacent to an un-insulated steel beam below the gutter. Surface moisture contents in timbers were generally ~16 per cent which was sufficient to support minor ongoing beetle activity. A slight leak at the east end of the gutter had allowed a small area of more significant decay, deep moisture contents here were 30 per cent</p> | <p><i>No chemical treatments required</i></p> <p><i>The roof was generally suitable for retention, subject to no further water penetration and at the discretion of the Structural Engineer</i></p> <p><i>As part of replacing roof finishes, allow to remove gutter sole formwork from the south parapet and to replace in new. These timbers should be isolated from the masonry by air gaps and/or strips of DPC. The Architect should review detailing for insulation and ventilation</i></p> | |

H+R roof 1; showing north eaves detail

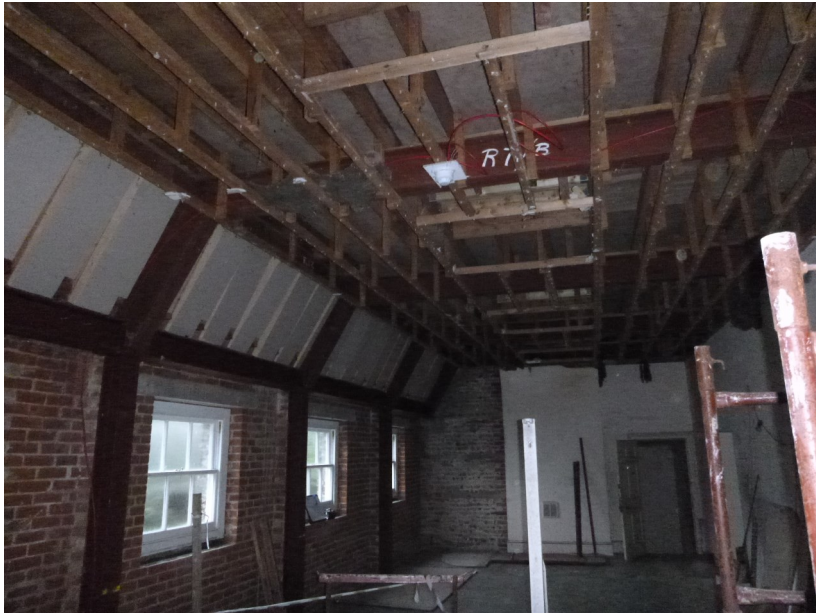
**Fig 3:**

H+R roof 1; showing general view

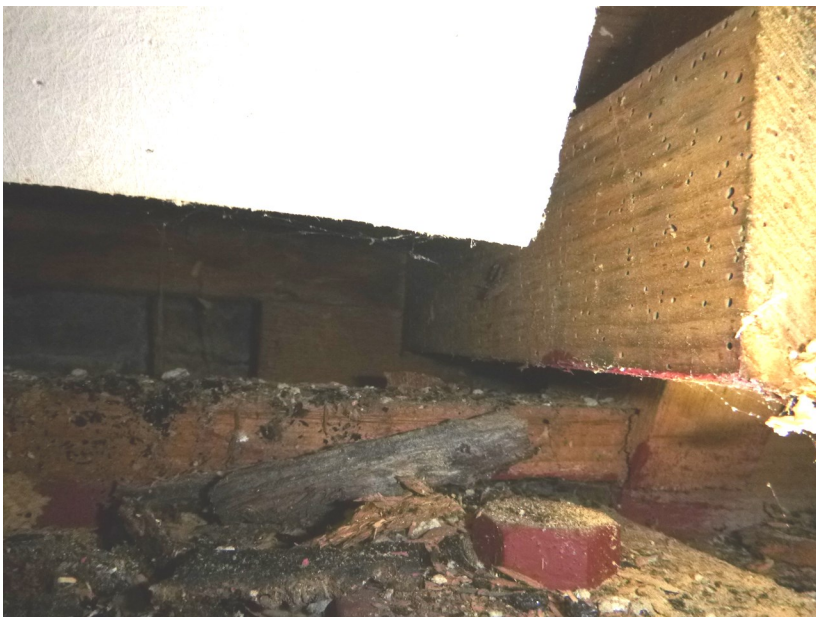
**Fig 4:**

H+R roof 1; showing beetle activity below south gutter

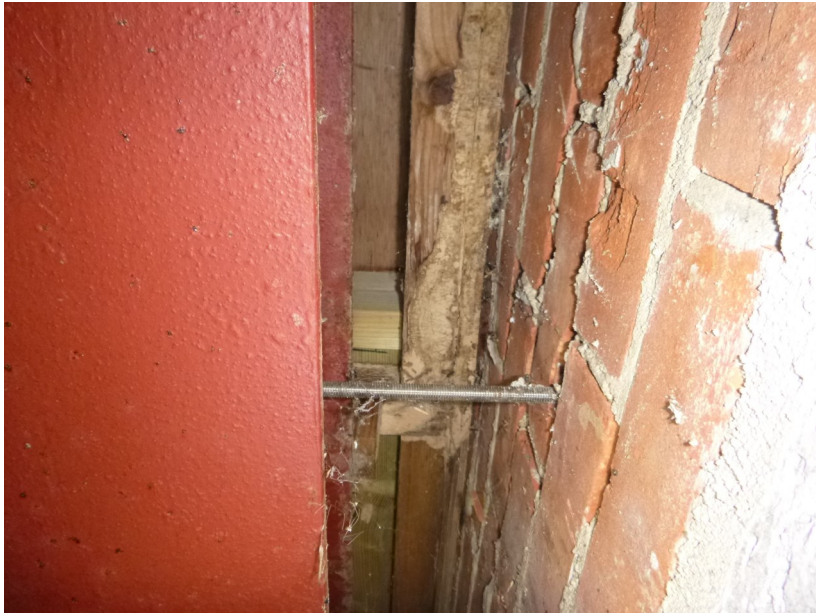
**Fig 5:**

H+R roof 1; showing wet rot and beetle activity below south gutter

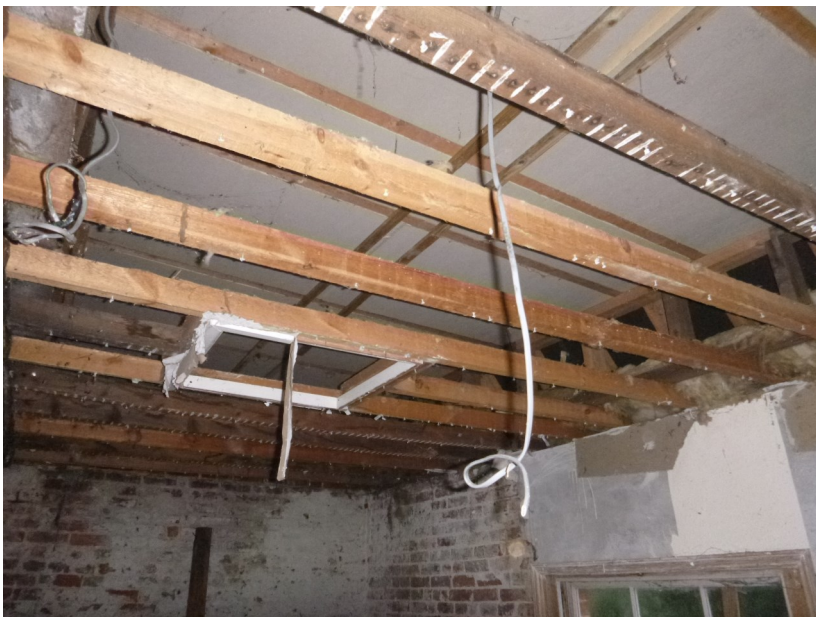
**Fig 6:**

H+R roof 1a; showing general view

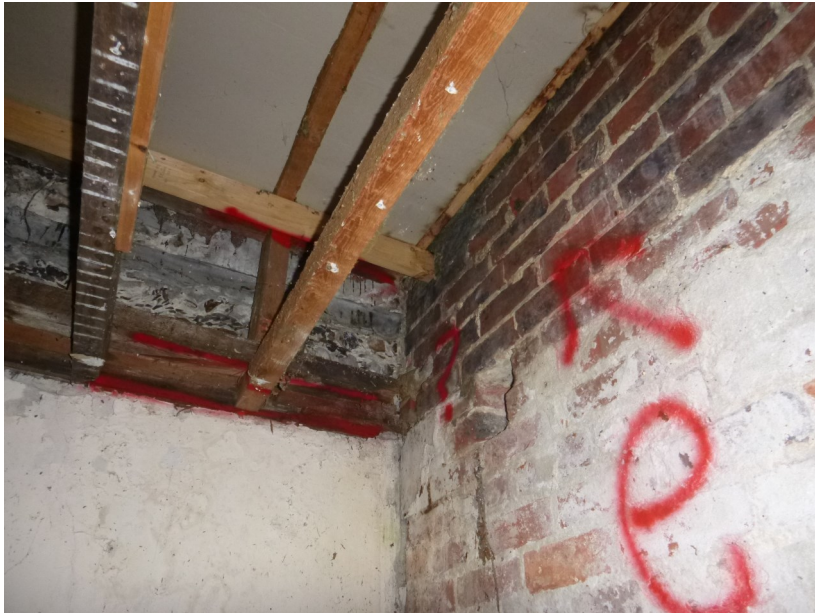
**Fig 7:**

| REFERENCE | ITEM | OBSERVATIONS | RECOMMENDATIONS | CLIENT COMMENTS |
|---|---|---|---|---|
| <b>SNa1.2.2</b> | Condition | <p>The ladder beam carrying the east side of the roof was structurally decayed at its south bearing and partially decayed at the north bearing</p> <p>The eaves wall plate carrying the west side of the roof was structurally decayed for 1000mm at its south end, along with 2no. ceiling joist bearings and 2no. mansard rafter feet</p> <p>Cold bridge condensation and resultant beetle damage affected the west side of the roof generally</p> | <p><i>No chemical treatments required</i></p> <p><i>H+R suggest that it may be most efficient and sustainable to entirely replace this structure to an improved/simplified design</i></p> <p><i>It may be possible to repair the existing structure by propping the flat roof joists and entirely replacing the bearing details along the east and west sides of the roof (perhaps by new steels spanning north-south). These timbers should be isolated from the masonry by air gaps and/or strips of DPC. The Architect should review detailing for insulation and ventilation</i></p> | |

H+R roof 1a; showing decay at south-east corner

Note ladder beam support arrangement

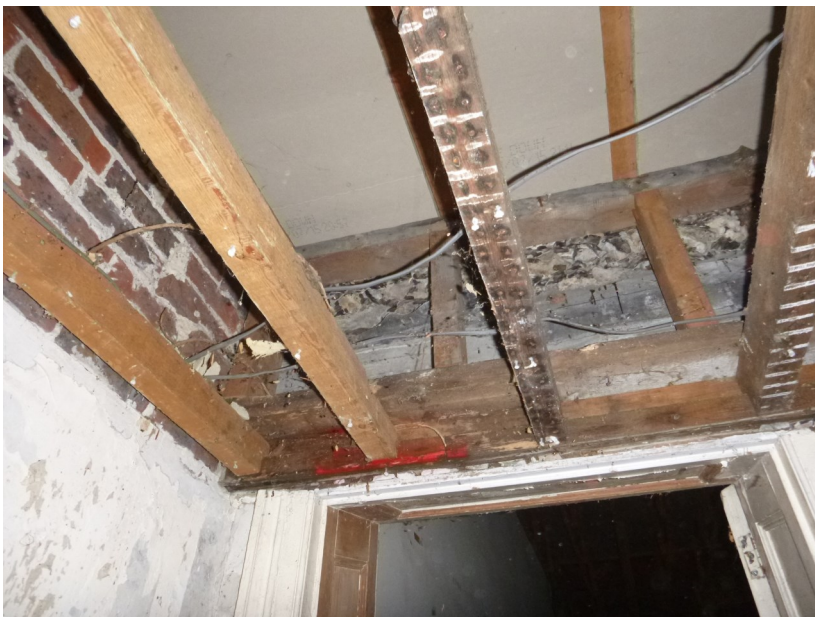
**Fig 8:**

H+R roof 1a; showing decay at north-east corner

Note ladder beam support arrangement

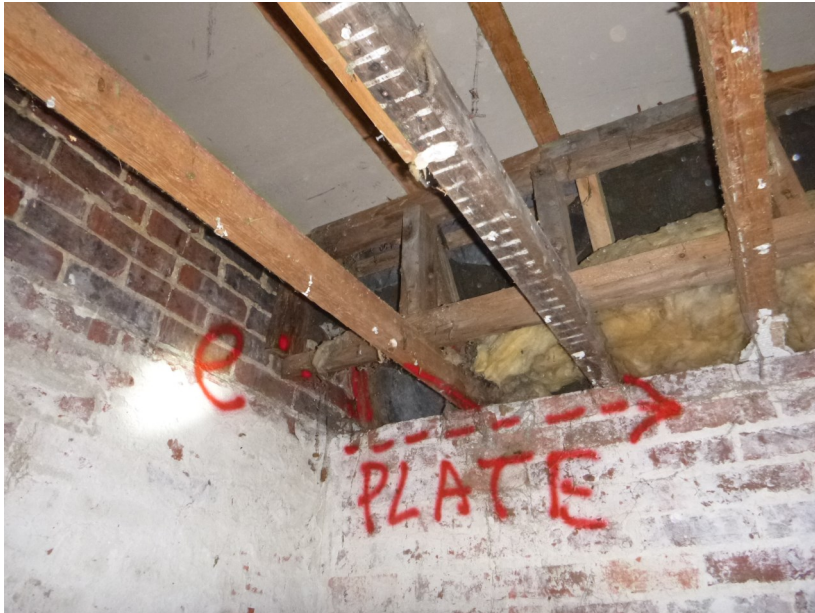
**Fig 9:**

H+R roof 1a; showing decay at south-west corner

Note ladder beam support arrangement

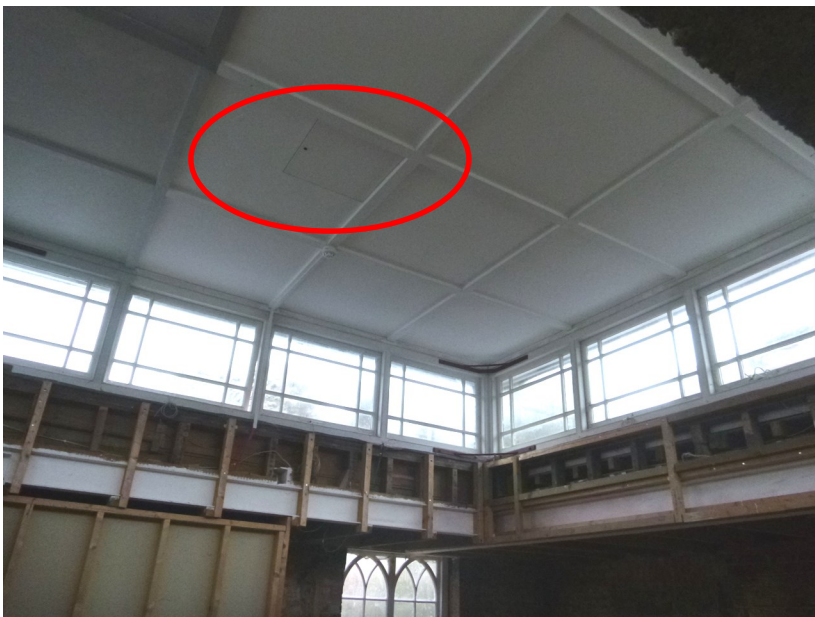
**Fig 10:**

H+R roof 2; showing general view

Access hatch noted but inaccessible

| REFERENCE | ITEM | OBSERVATIONS | RECOMMENDATIONS | CLIENT COMMENTS |
|---|---|---|---|---|
| <b>SNa1.3.1</b> | Construction | <p>Pyramid lantern roof over double volume space/void, dating from 2000 works</p> <p>There was no access to the shallow roof void (although a ceiling hatch was present)</p> | <i>H+R can inspect further when access is available to the hatch entry, if instructed</i> | |

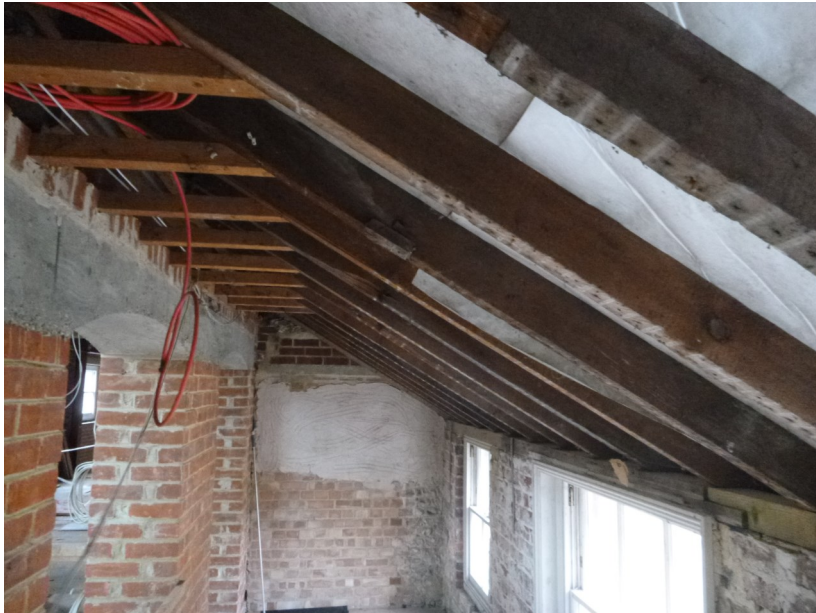
**Fig 11:**

| REFERENCE | ITEM | OBSERVATIONS | RECOMMENDATIONS | CLIENT COMMENTS |
|---|---|---|---|---|
| <b>SNa1.4.2</b> | Condition | <p>As part of works dating from ~2000, the eaves plate had been replaced at both the east and west ends. End-rafters had been locally replaced at this time also</p> <p>There was no decay detected and deep moisture contents were 'dry'</p> <p>An eaves ventilation strip was visible as the rafter void had not been fitted with insulation (works left incomplete, as found in Roofs 1 and 1a)</p> | <p><i>No chemical treatments required</i></p> <p><i>The roof was deemed suitable for retention, subject to no further water penetration and at the discretion of the Structural Engineer</i></p> <p><i>The Architect should review detailing for insulation and ventilation</i></p> | |

H+R roof 2a; showing general view

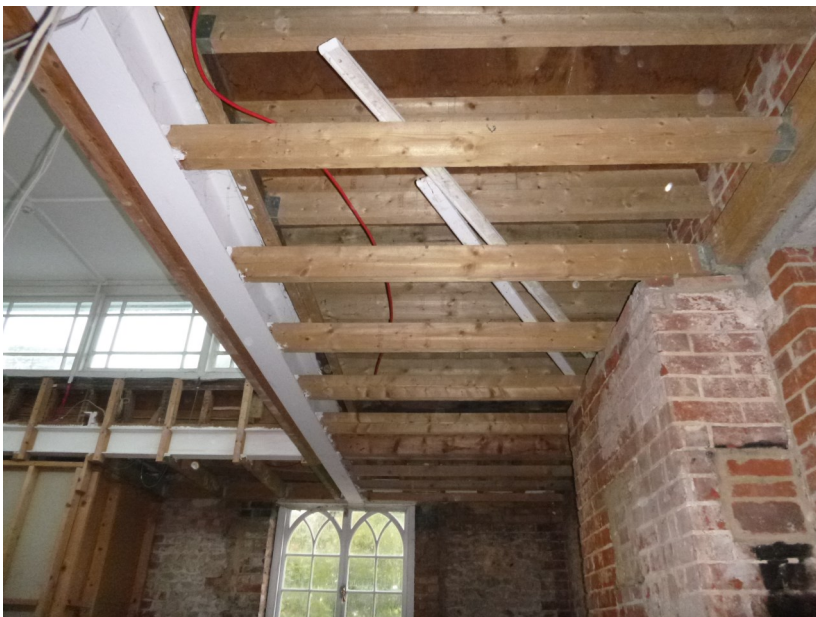
**Fig 12:**

H+R roof 2b; showing general view

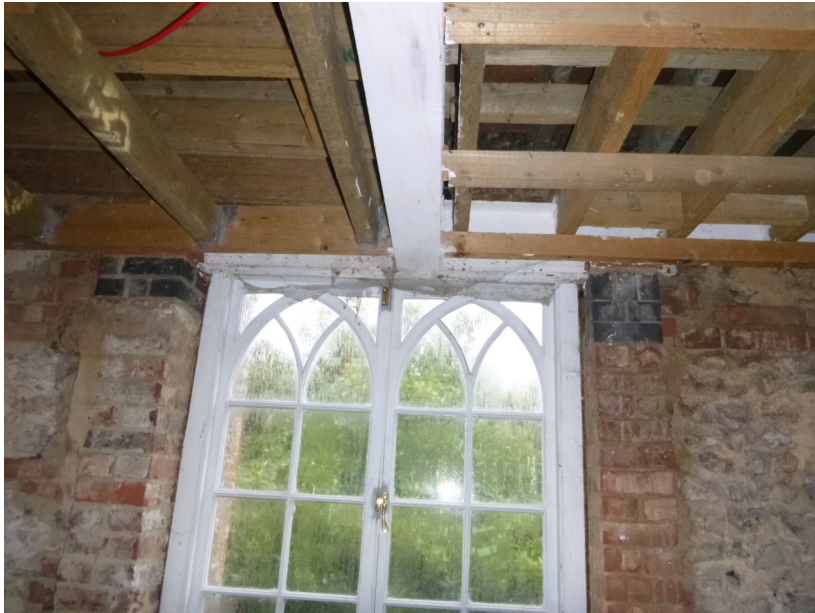
| REFERENCE | ITEM | OBSERVATIONS | RECOMMENDATIONS | CLIENT COMMENTS |
|---|---|---|---|---|
| <b>SNa1.5.2</b> | Condition | <p>There was no decay detected and deep moisture contents were 'dry'</p> <p>There was good detailing for isolating timbers from the external masonry using air gaps</p> <p>The bearing of the primary steelwork (supporting the lantern aperture for roof 2) at the south elevation showed some deficiency in the supporting masonry</p> | <p><i>No chemical treatments required</i></p> <p><i>The roof was deemed suitable for retention, subject to no further water penetration and at the discretion of the Structural Engineer</i></p> <p><i>The Architect should review detailing for insulation and ventilation</i></p> <p><i>Structural Engineer to review adequacy of steelwork bearings</i></p> | |

H+R roof 2b; showing steel bearing detail at south wall

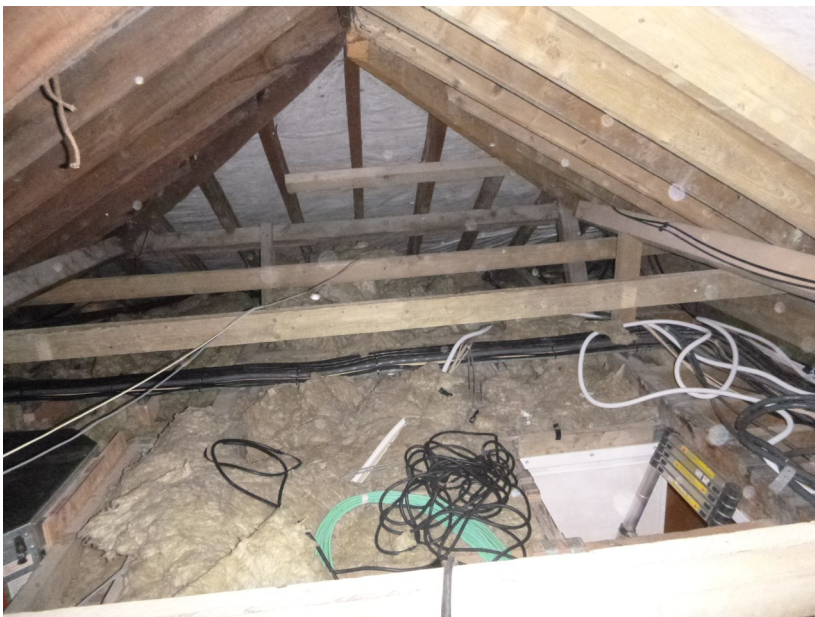
**Fig 14:**

H+R roof 3; showing east void

Note modern collars and (south pitch) rafters

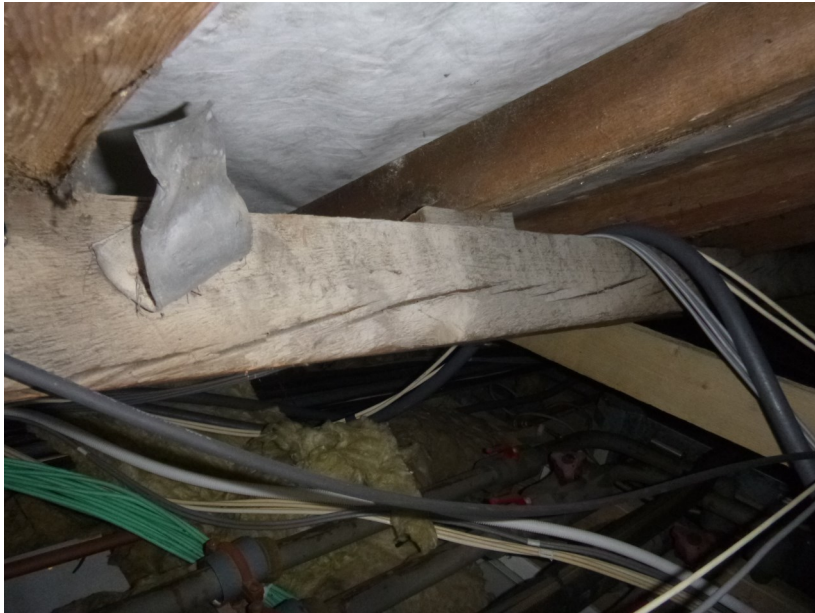
**Fig 15:**

H+R roof 3; showing east void

Note fissures in purlin

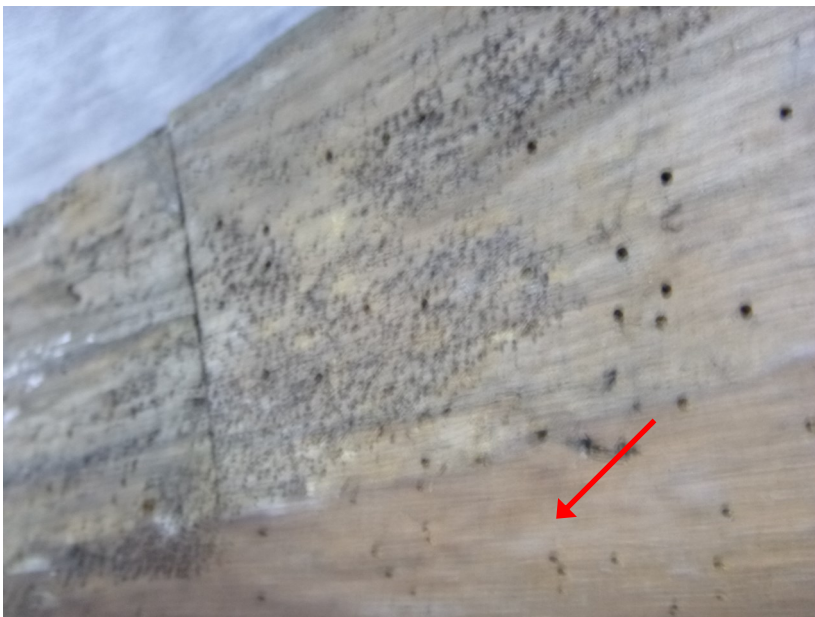
**Fig 16:**

| REFERENCE | ITEM | OBSERVATIONS | RECOMMENDATIONS | CLIENT COMMENTS |
|---|---|---|---|---|
| <b>SNa1.6.2</b> | Condition | <p>There was no structurally significant decay detected and deep moisture contents were 'dry'</p> <p>Historic partial decay had affected the north eaves plate in a sample area, this was not deemed structurally significant</p> <p>Throughout the roof, there had been a history of superficial damage by common furniture beetle, arising from elevated surface moisture contents (condensation)</p> <p>Beetle activity had been limited to the outer 'sapwood' of individual elements but had left the 'heartwood' intact</p> <p>There had been a history of minor structural defects in the east half of the roof; originally there were no tie beams to restrain spread and the purlins were not braced/carried at their spans. There was some evidence of fissures in the north pitch purlin. Previous remedial collars had been installed which appeared effective in strengthening the roof. Rafters had been replaced in the south pitch</p> <p>The second tie beam from the west showed a lack of connection to the eaves plate at the north end</p> | <p><i>No chemical treatments required</i></p> <p><i>The roof was deemed suitable for retention, subject to no further water penetration and at the discretion of the Structural Engineer</i></p> <p><i>The Architect should review detailing for insulation and ventilation</i></p> <p><i>Structural Engineer can consider reinstating the missing tie beam to eaves plate connection using steel strapping/brackets</i></p> | |

H+R roof 3; showing typical beetle damage on timber surfaces, tending to favour sapwood which has often been lost in the past (arrow)

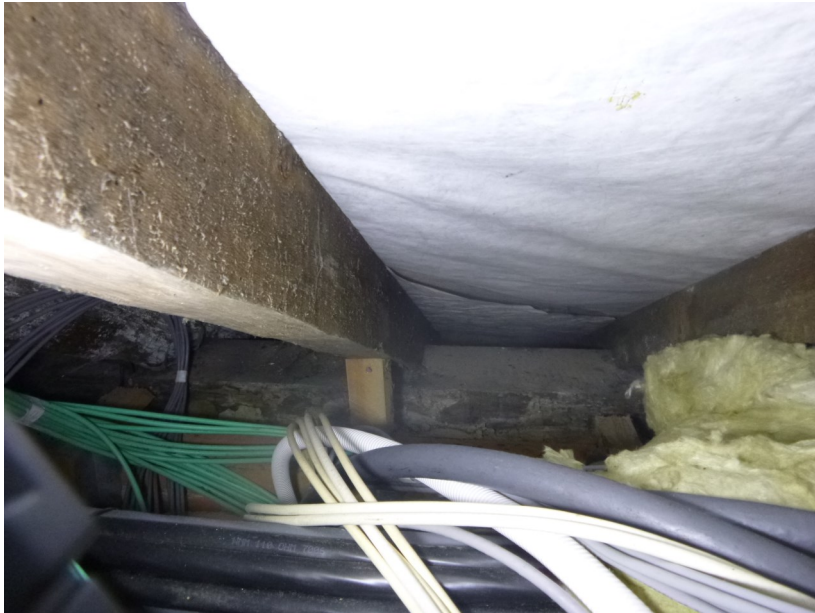
**Fig 17:**

H+R roof 3; showing east void

Note sample area of inspection to north eaves plate found to be partially decayed

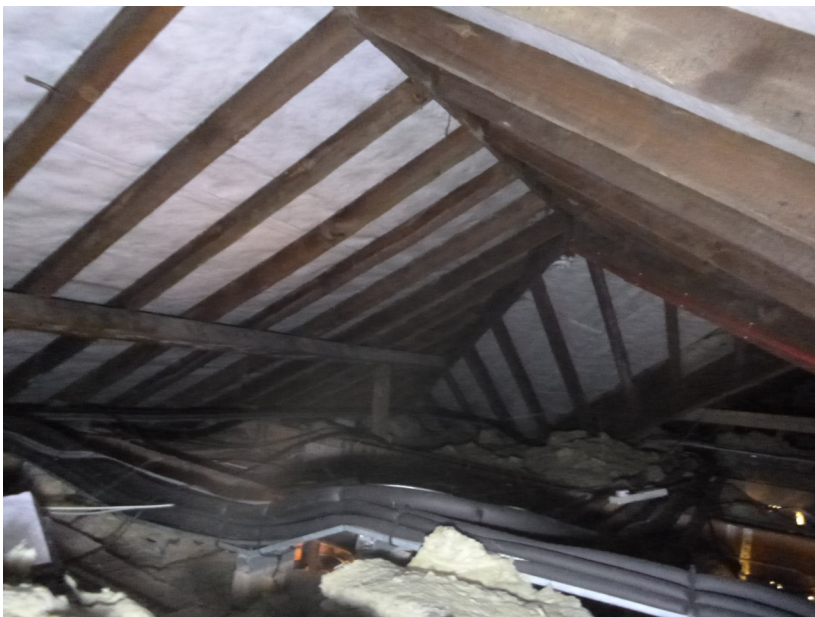
**Fig 18:**

H+R roof 3; showing west void

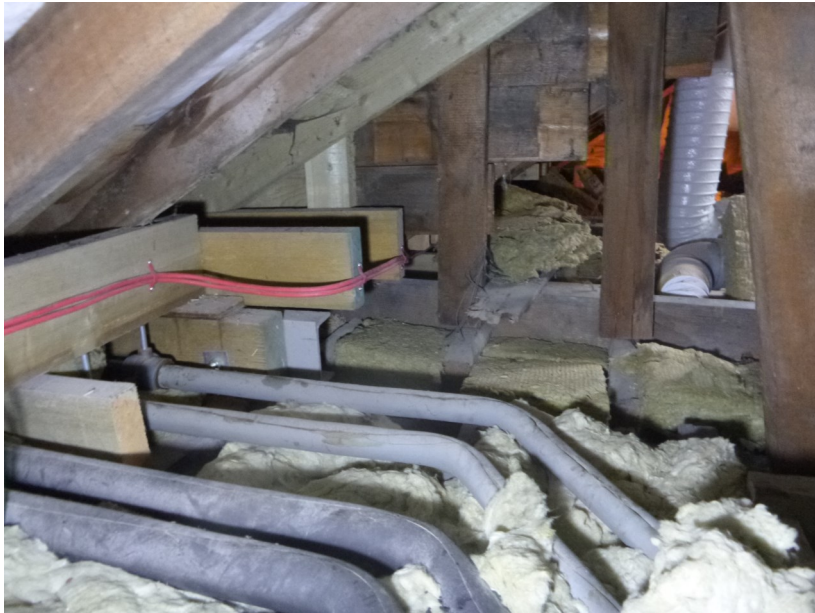
**Fig 19:**

H+R roof 3; showing west void

Note modern structures protruding from roof 3b

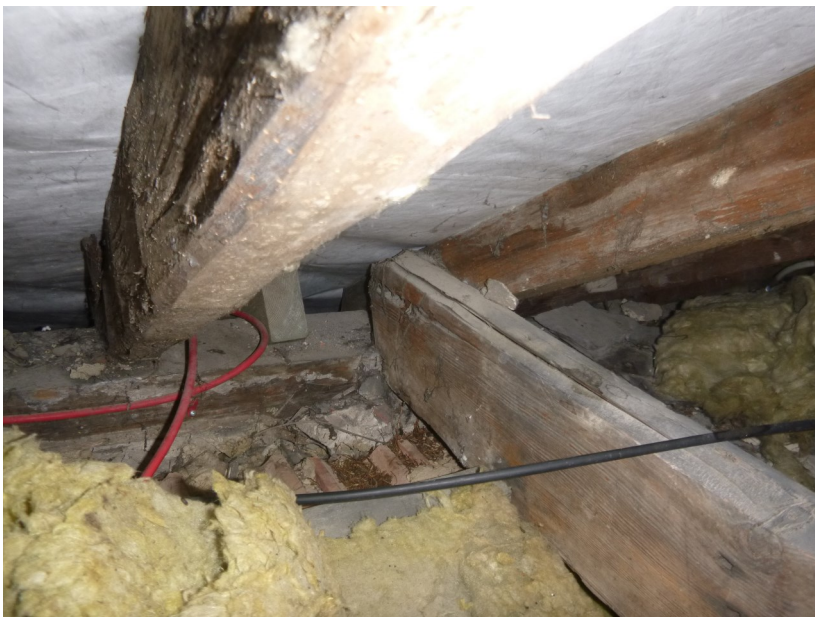
**Fig 20:**

H+R roof 3; showing west void

Note poor tie beam connection at north side
