**VERIFICATION REPORT**

**PLOTS 117-118 & 136-138**

**WOODCROFT FARM, WOODCROFT LANE,**

**VISTRY SOUTHERN**

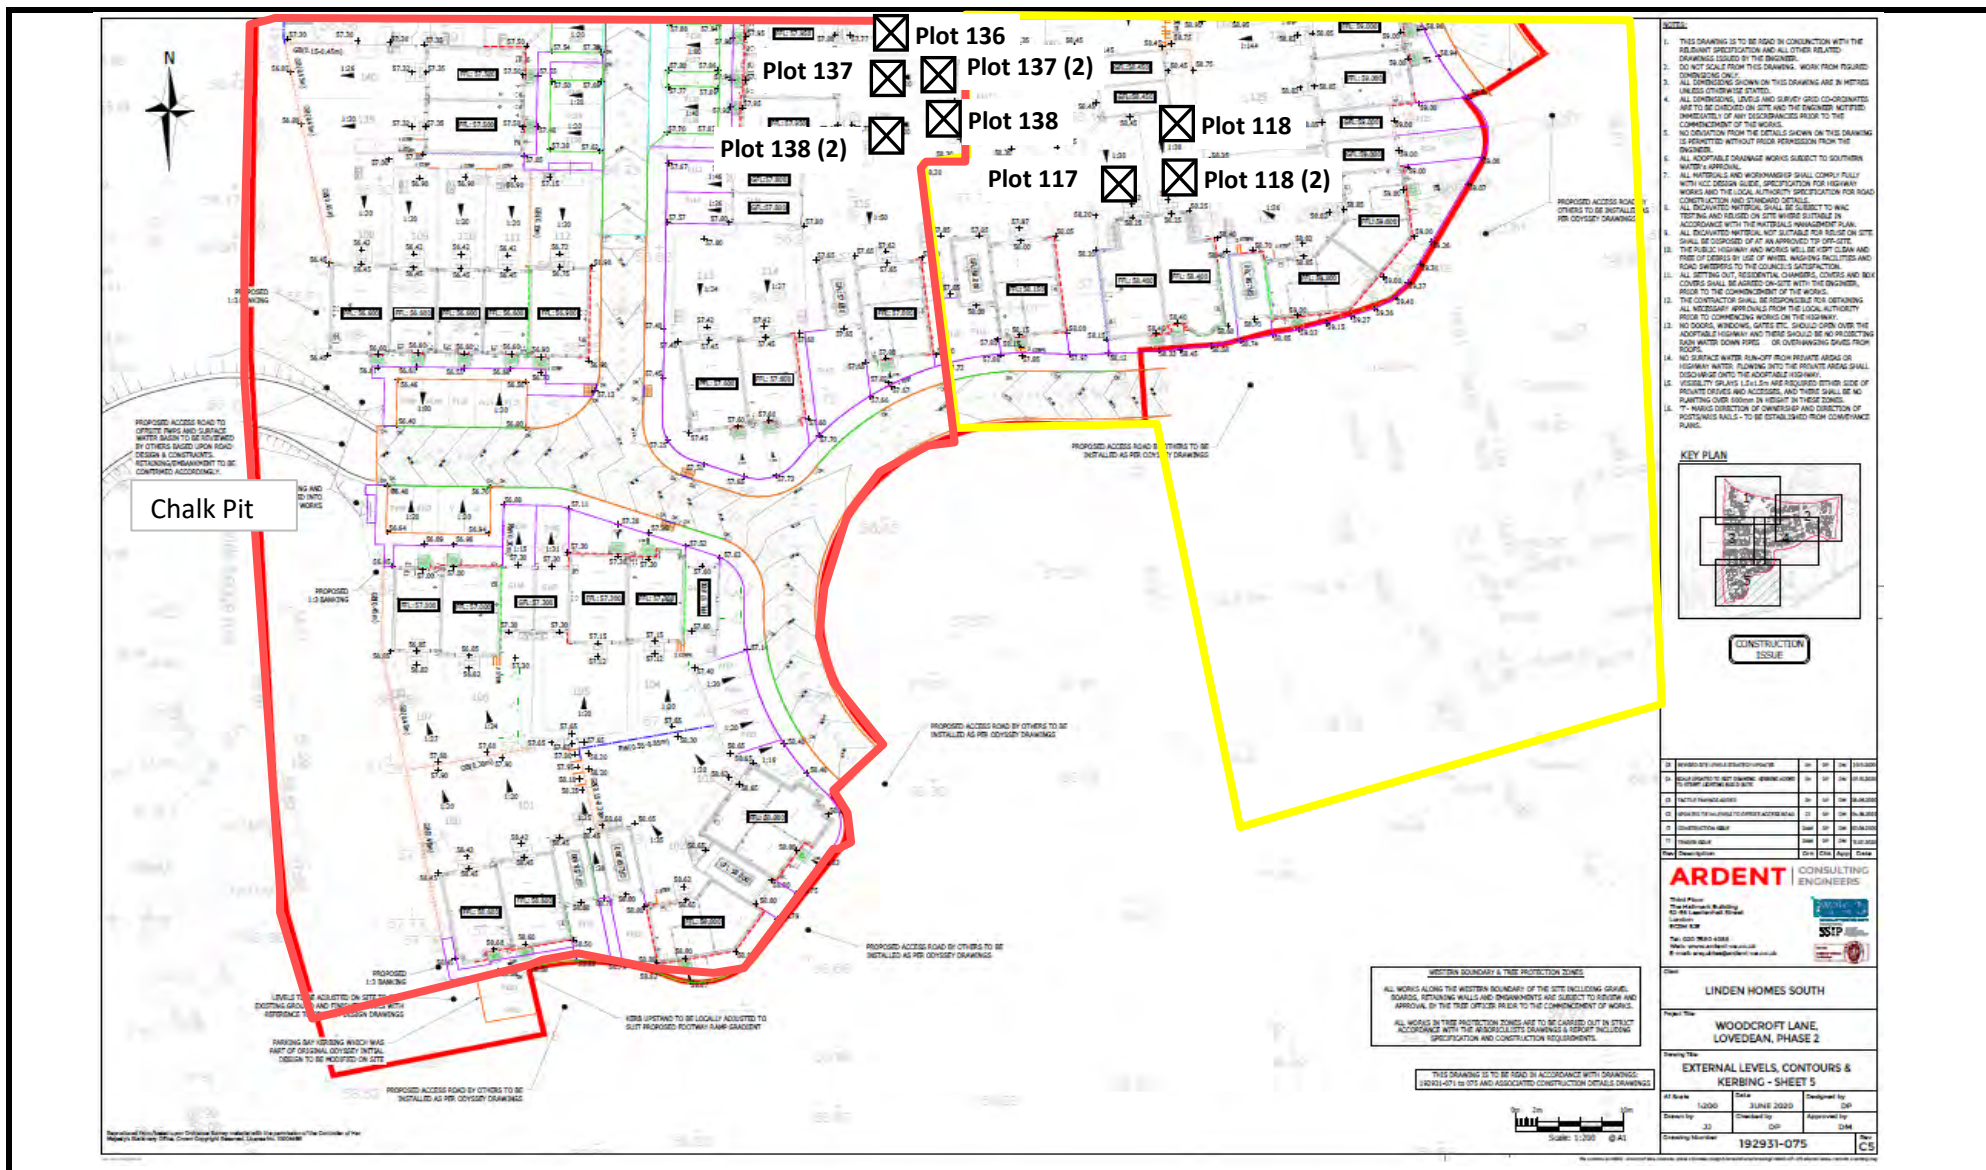
The inspection confirmed that within the inspection pits, subsoil was found to be 300mm in thickness and Topsoil was found to be 300mm in thickness within all the inspected areas. It should be noted that the soil cover system comprised both subsoil and Topsoil and both the subsoil and Topsoil utilised within Plots 117-118 and 136-138 comprised site-won soils which had previously been deemed suitable for re-use, as reported in the RSVP for the chalk pit area (GE16943/RSVP-CP-V6.0/DEC21) and the RSVP for the farm yard area (GE16943/RSVP-FY-

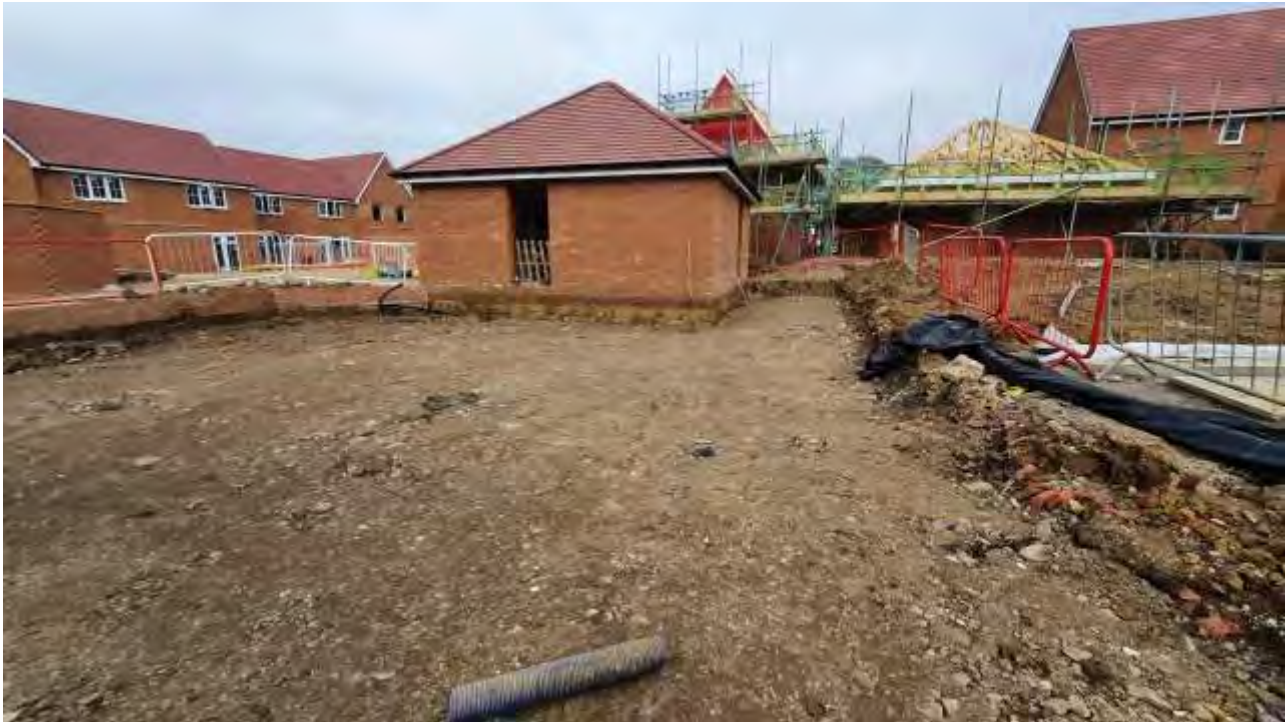
Plate 1 – View of crushed concrete installed across Plots 117-118

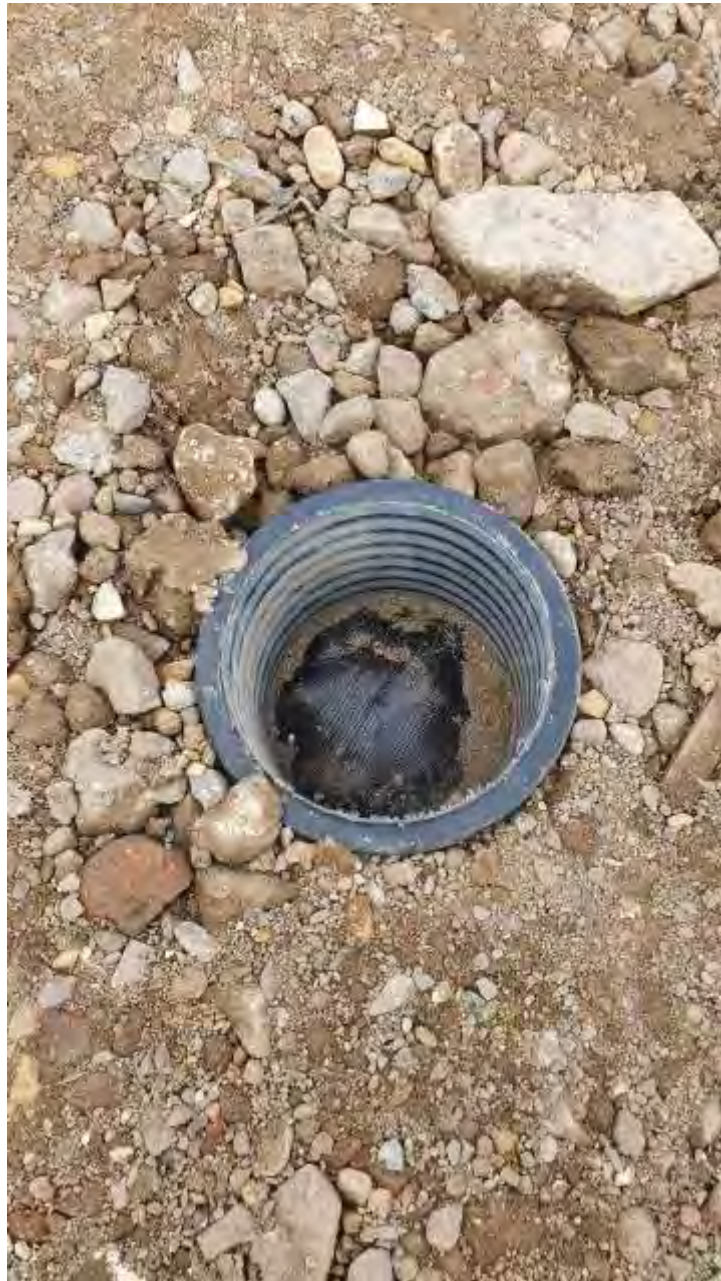
Plate 2 – View of geotextile membrane installed beneath the crushed concrete in Plot 117

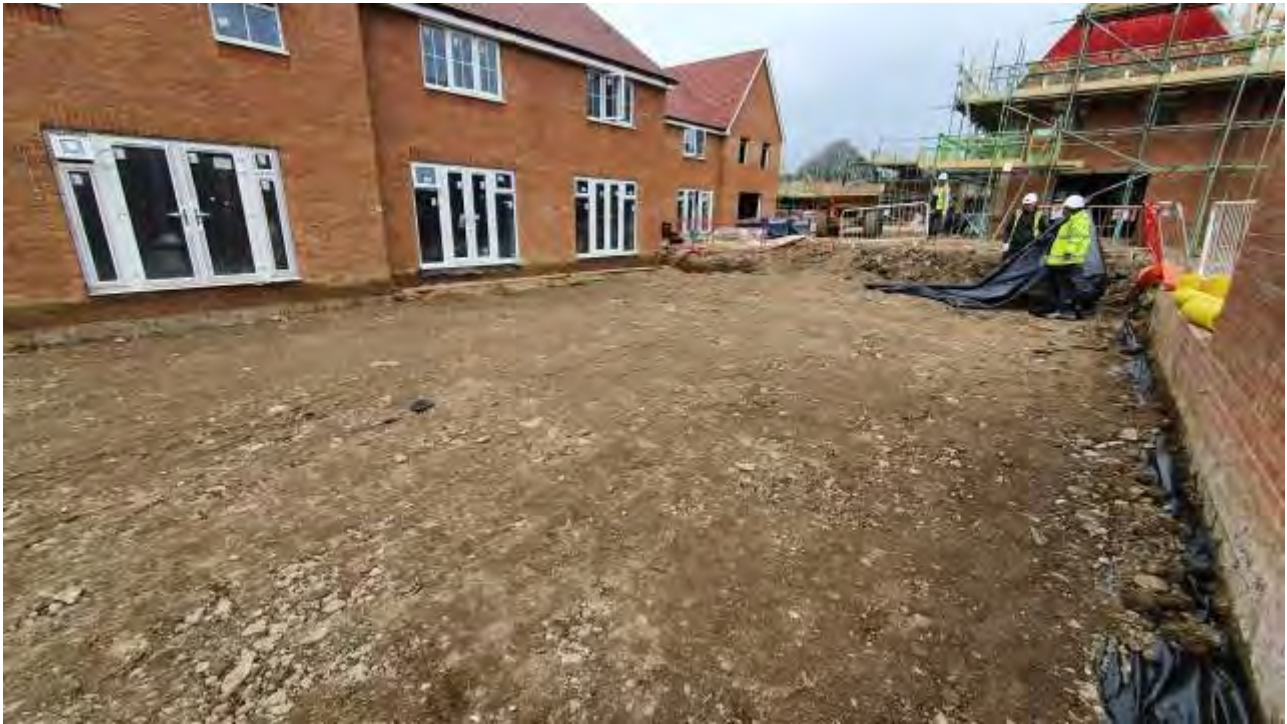
Plate 3 – Crushed concrete installed across Plots 136-138

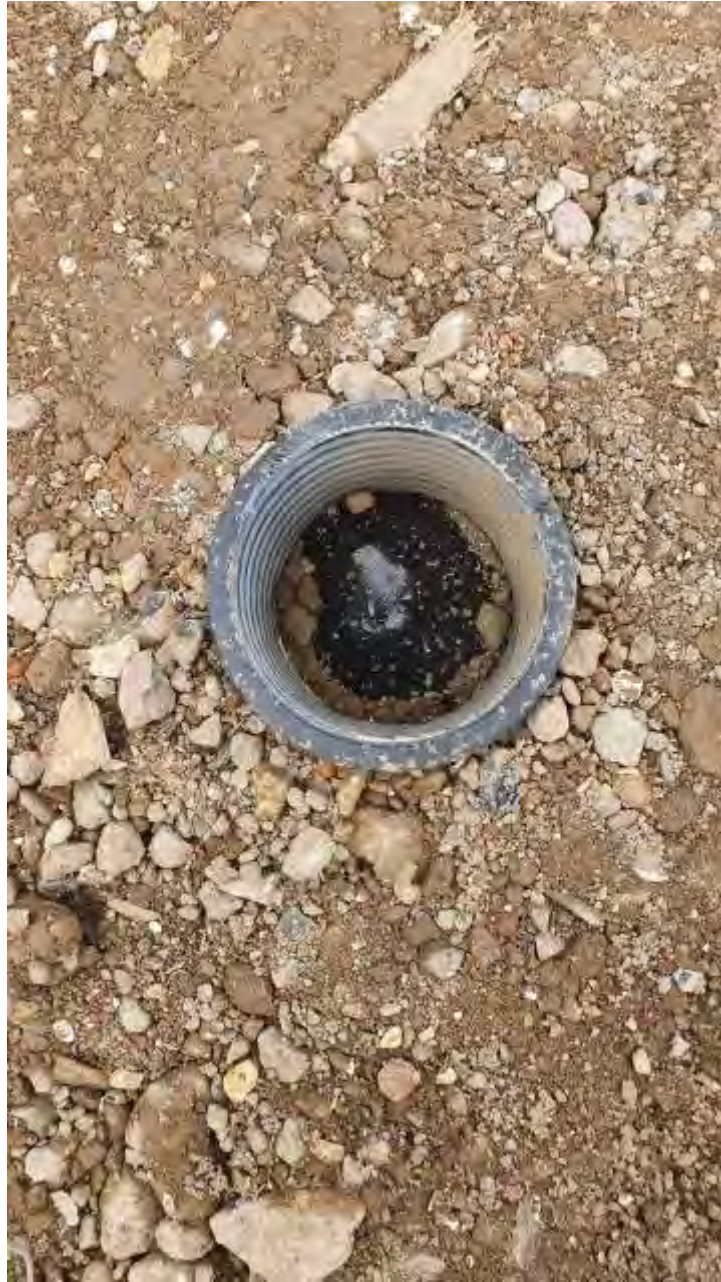
Plate 4 – Geotextile membrane installed beneath crushed concrete in Plot 136

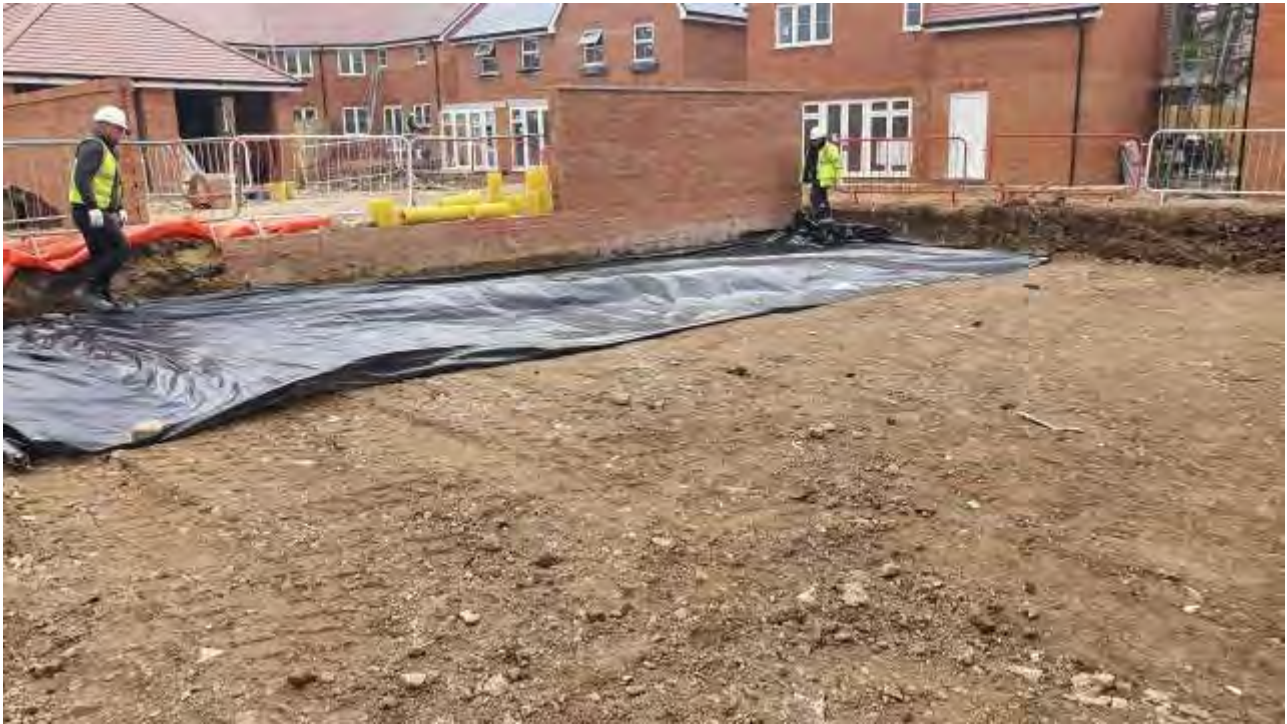
Plate 5 – View geotextile membrane being installed above crushed concrete in Plots 136-138
