# Hutton + Rostron Environmental Investigations Limited

## Southleigh Park House: Chimneystack condition investigation

Site note A12 for 5 February 2021, job no. 152.09

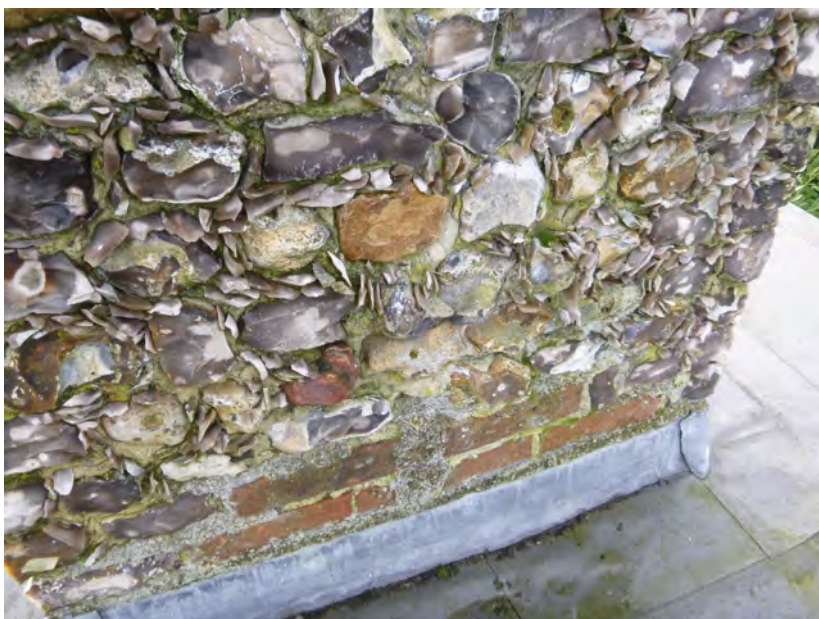
**Fig 6:**

North; showing detail of joints and  
brickwork evident in supporting  
structure

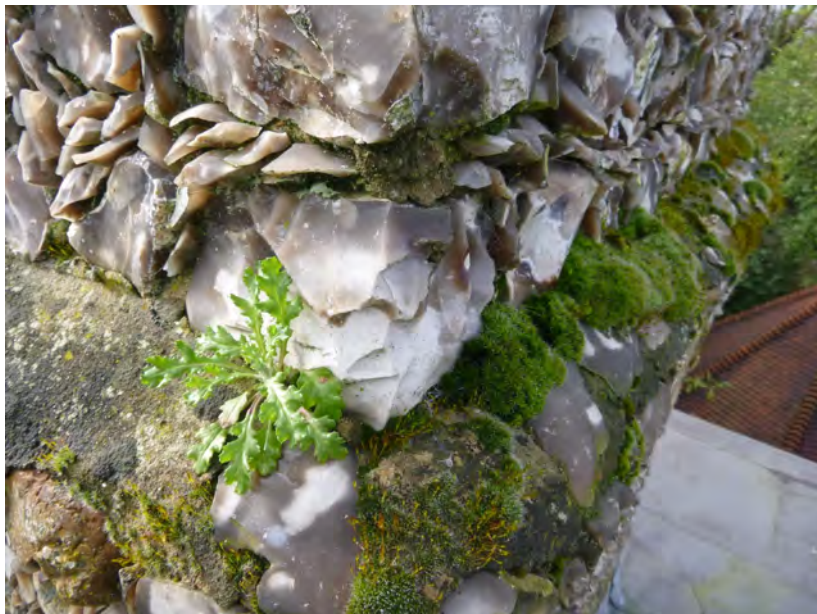
**Fig 7:**

| REFERENCE | ITEM | OBSERVATIONS | RECOMMENDATIONS | CLIENT COMMENTS |
|---|---|---|---|---|
| <b>SNa12.1.2</b> | Condition | General moss growth at head and exposed ledges<br><br>No significant defects noted | <i>No remedial works anticipated at this stage</i><br><br><i>Removal of moss is not recommended due to risk of damaging/disturbing the substrate</i> | |

String ledge; showing typical biological growth

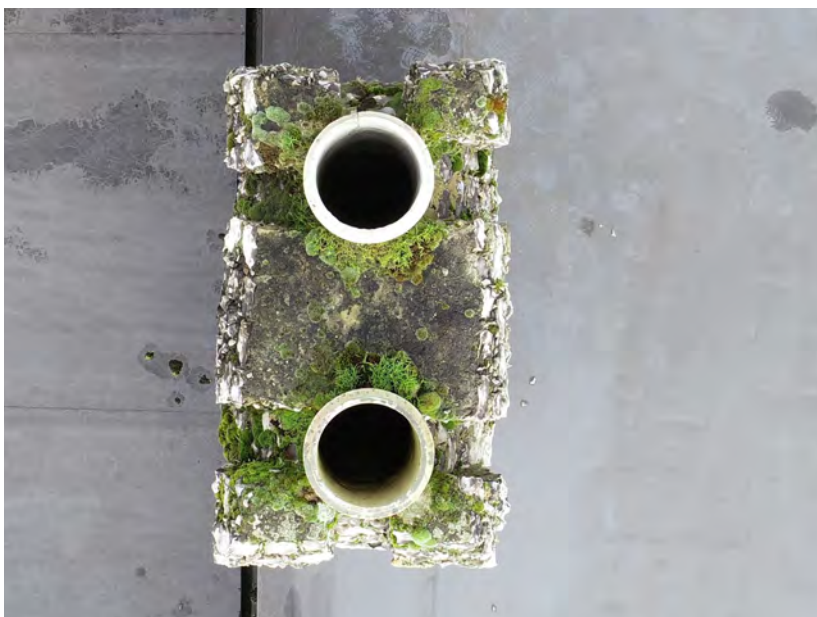
**Fig 8:**

| REFERENCE | ITEM | OBSERVATIONS | RECOMMENDATIONS | CLIENT COMMENTS |
|---|---|---|---|---|
| <b>SNa12.2.2</b> | Condition | Open pots will permit direct water ingress<br><br>North pot cracked, though firmly held by flintwork built-up surrounding<br><br>General moss growth at head and exposed ledges<br><br>Some slight weakening of bed mortar at string ledge, some flints could be removed due to weathering of exposed surface<br><br>No significant defects noted | <i>Allow to fit 2no. yellow clay 'mushroom' cowls</i><br><br><i>Action not deemed necessary in relation to cracked pot</i><br><br><i>Removal of moss is not recommended due to risk of damaging/disturbing the substrate</i><br><br><i>At this time, action to renew localised areas of slightly degraded mortar was not deemed necessary</i> | |

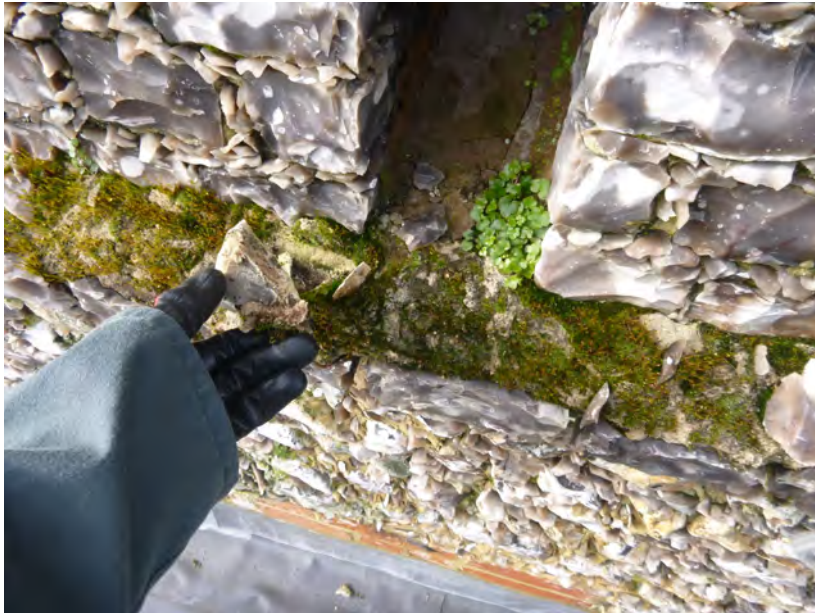
**Fig 13:**

String ledge; showing minor dislodgement in bed mortar under heavy weathering

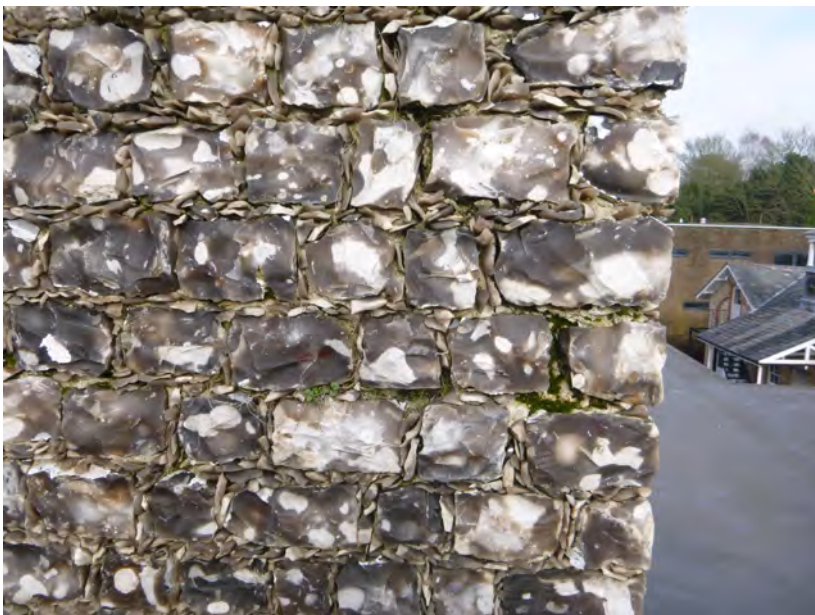
**Fig 14:**

South; showing detail of tightly jointed flint

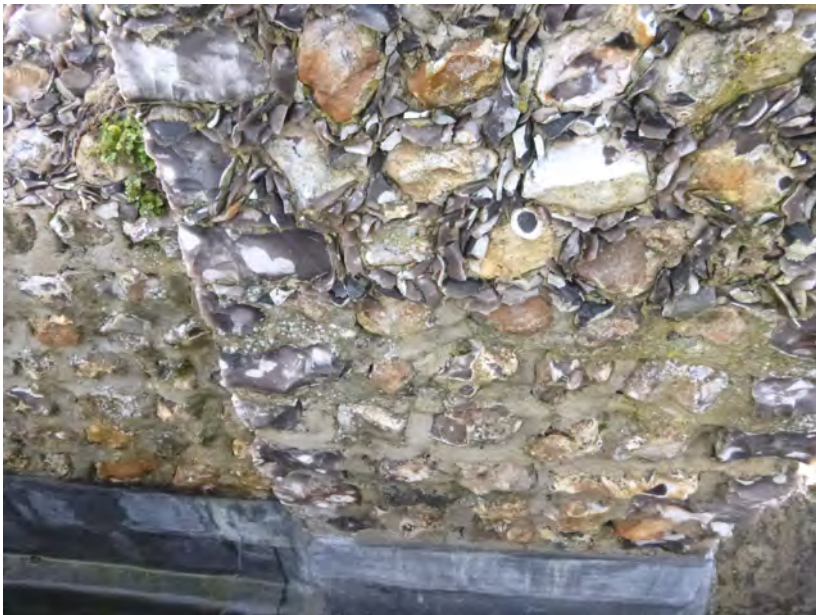
**Fig 18:**

| REFERENCE | ITEM | OBSERVATIONS | RECOMMENDATIONS | CLIENT COMMENTS |
|---|---|---|---|---|
| <b>SNa12.3.2</b> | Condition | Pointing repairs evident within parapet interior<br><br>No significant defects noted | <i>No remedial works anticipated at this stage</i> | |

North; showing previous repairs to pointing within the parapet interior

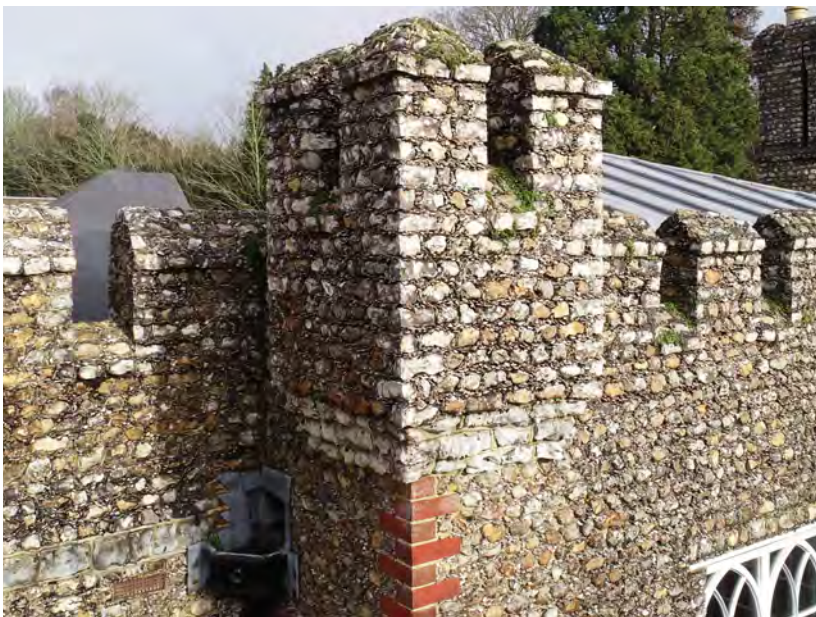
**Fig 24:**

| REFERENCE | ITEM | OBSERVATIONS | RECOMMENDATIONS | CLIENT COMMENTS |
|---|---|---|---|---|
| <b>SNa12.5.2</b> | Condition | <p>Mortar repairs evident in corbel courses</p> <p>No significant defects noted</p> | <i>No remedial works anticipated at this stage</i> | |

South and west; showing corbelling  
from façade below and use of  
brickwork at corner

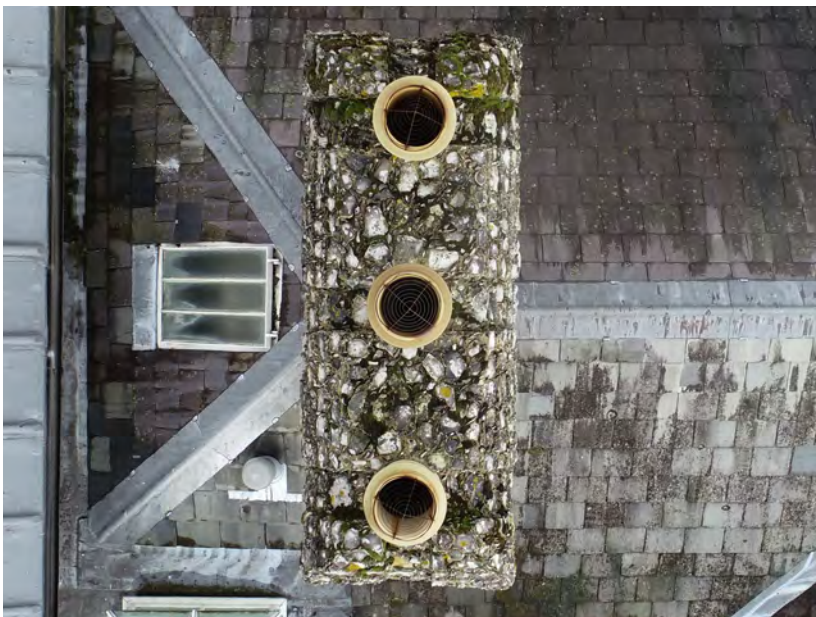
**Fig 28:**

| REFERENCE | ITEM | OBSERVATIONS | RECOMMENDATIONS | CLIENT COMMENTS |
|---|---|---|---|---|
| <b>SNa12.7.2</b> | Condition | <p>Mortar repairs evident in upper corbel courses, modern render used above flashings at north and south sides</p> <p>No significant defects noted</p> <p>Open pots will permit direct water ingress</p> | <p><i>No remedial works anticipated at this stage</i></p> <p><i>If flues are to be taken out of use, allow to fit 3no. yellow clay 'mushroom' cowls</i></p> | |

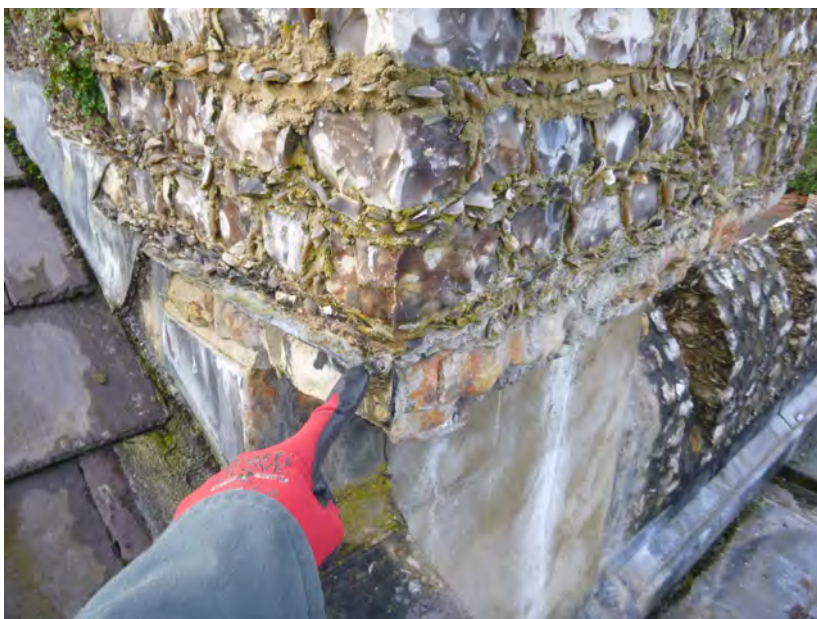
**Fig 38:**

| REFERENCE | ITEM | OBSERVATIONS | RECOMMENDATIONS | CLIENT COMMENTS |
|---|---|---|---|---|
| <b>SNa12.8.2</b> | Condition | <p>Pointing repairs evident around corbel courses</p> <p>Lime leaching emergence around lead flashing line (effective DPC/tray?) indicates moisture soaking into the masonry head and existing/drying shortly below</p> <p>No significant defects noted</p> | <i>No remedial works anticipated at this stage</i> | |

North; showing lead flashing line which may serve as a DPC/tray

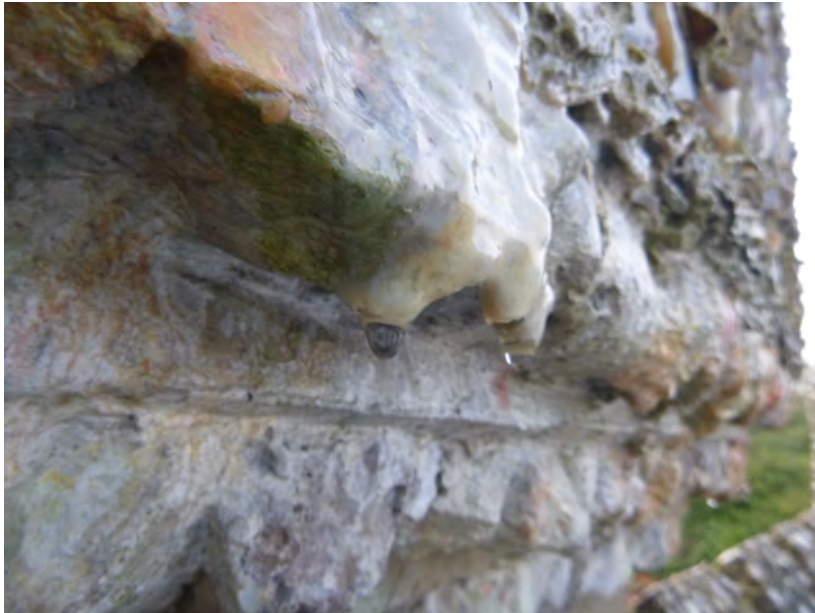
**Fig 39:**

North; showing lime leaching from the masonry due to high volume water passage

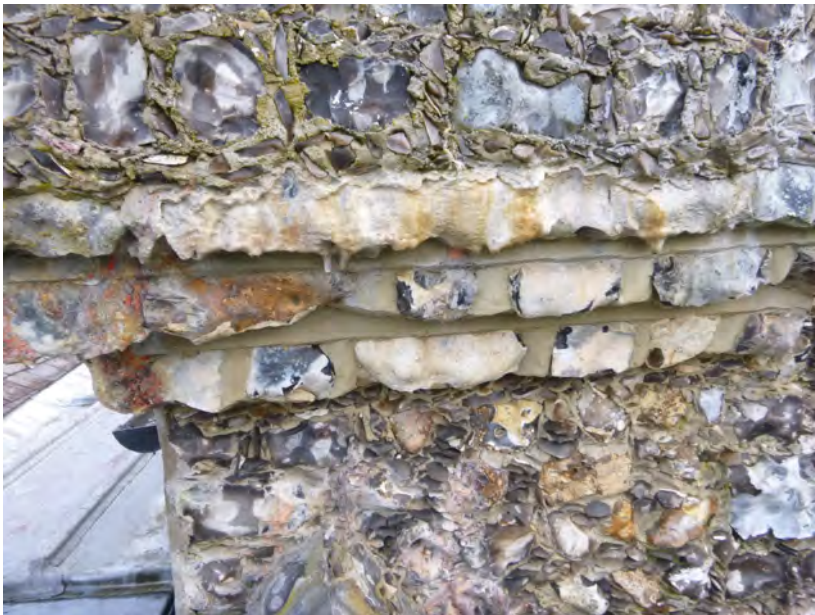
**Fig 40:**

West; showing previous repairs to corbel courses
