**Southleigh Park House**

Photographs

January 2021

Job.No. 152-09 Site Note A1 Page12 © Copyright Hutton+Rostron 2021

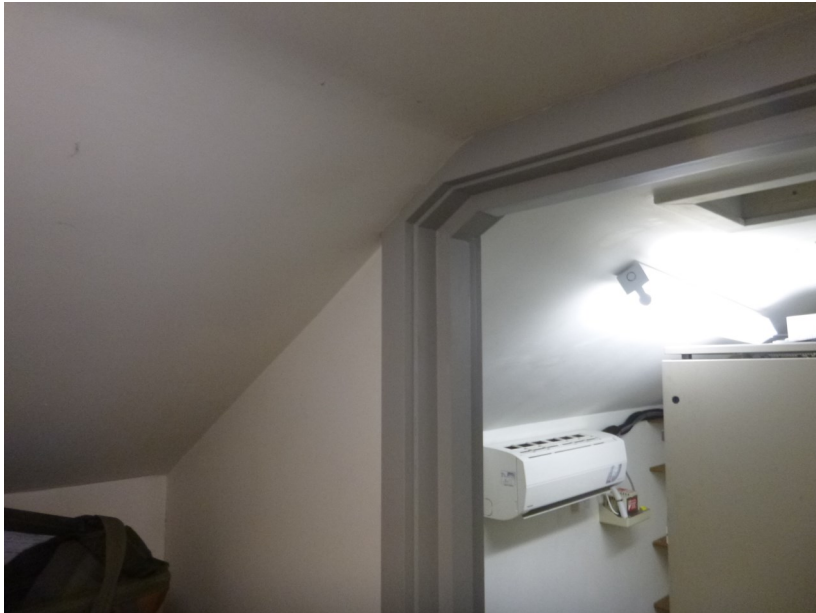
**Fig 21:**

H+R roof 3a; showing general view

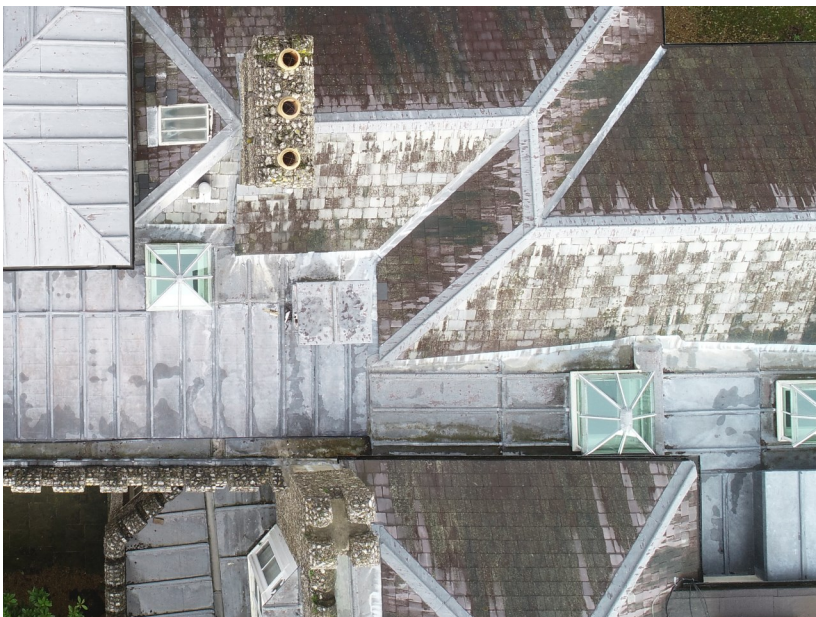
**Fig 22:**

H+R roof 3b; showing external view

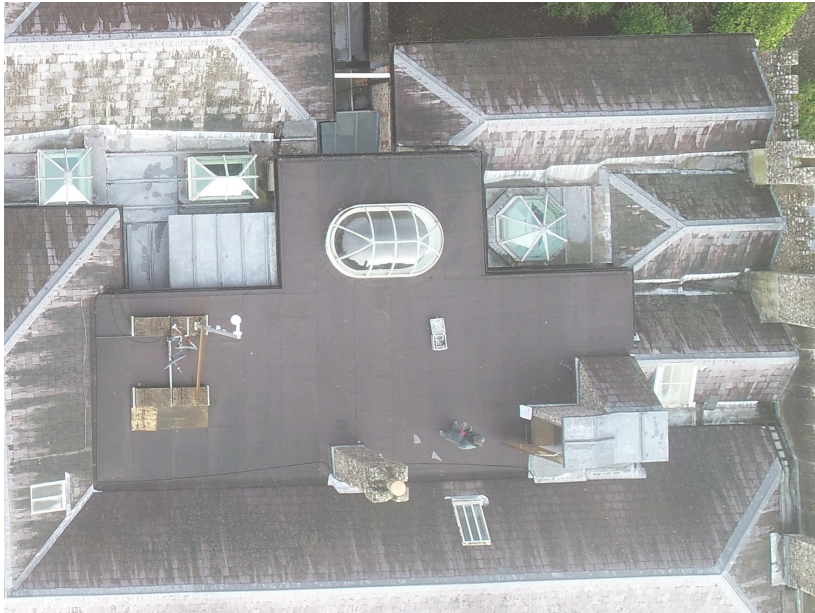
**Fig 23:**

H+R roof 4; showing general view

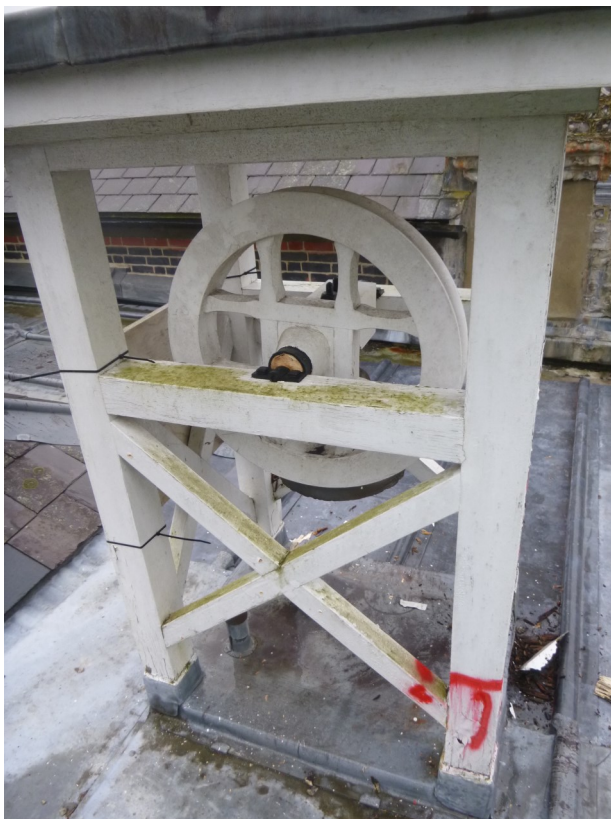
**Fig 24:**

H+R roof 5; showing north side

Decay marked in red spray

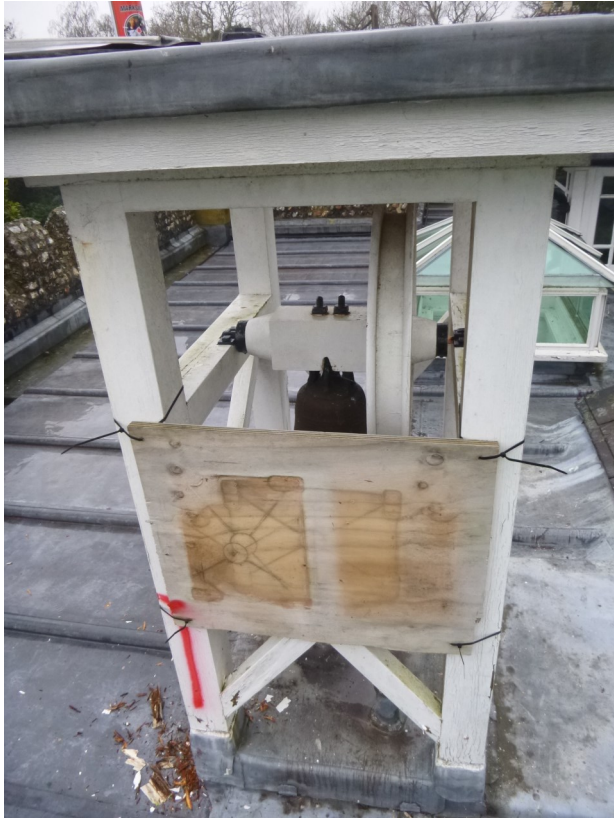
**Fig 25:**

H+R roof 5; showing east side

Decay marked in red spray

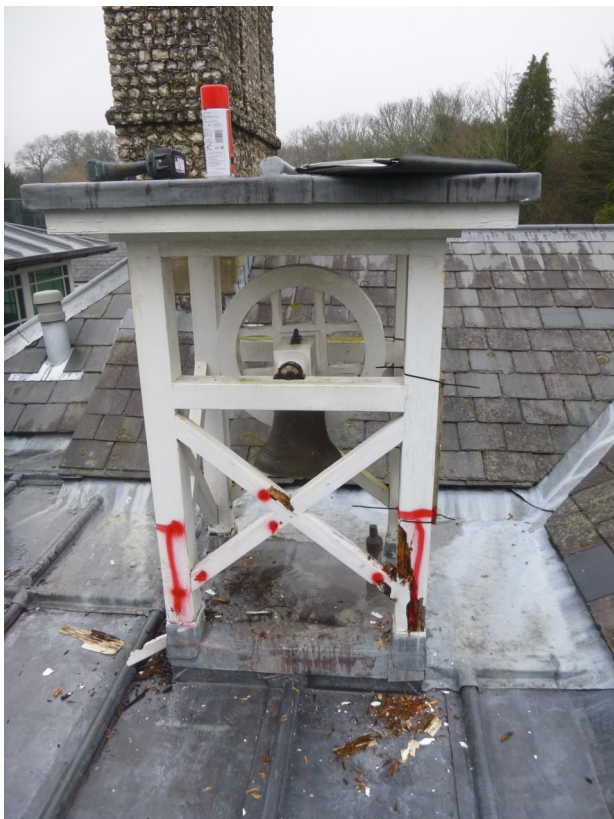
**Fig 26:**

H+R roof 5; showing south side

Decay marked in red spray

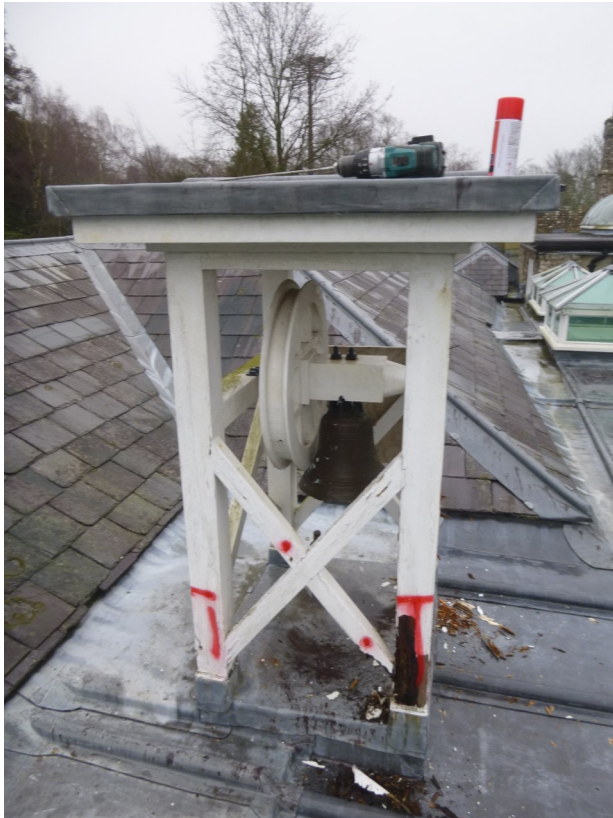
**Fig 27:**

H+R roof 5; showing west side

Decay marked in red spray

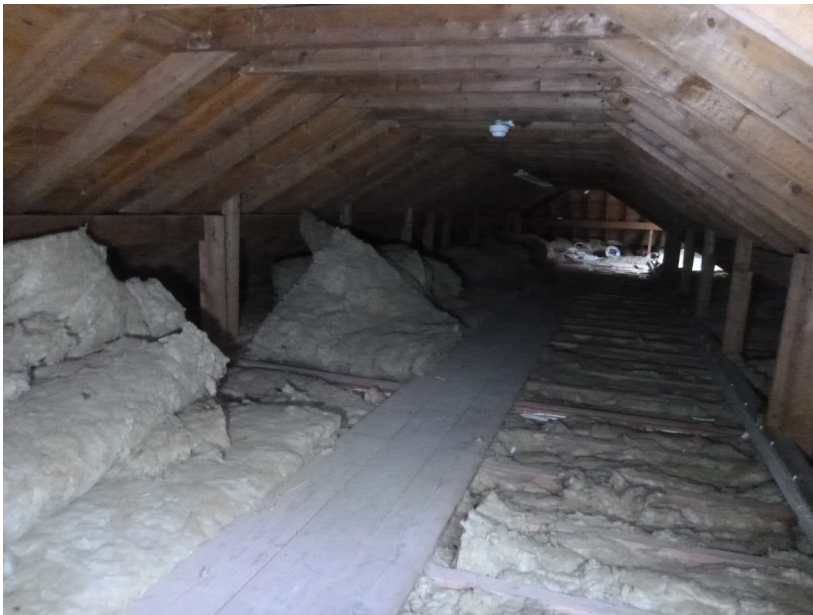
**Fig 28:**

H+R roof 6; showing general view

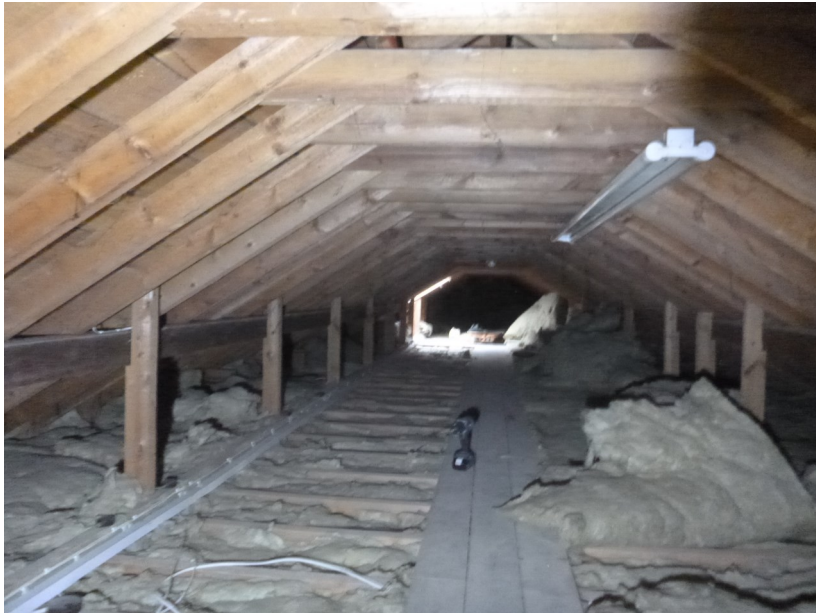
**Fig 29:**

H+R roof 6; showing general view

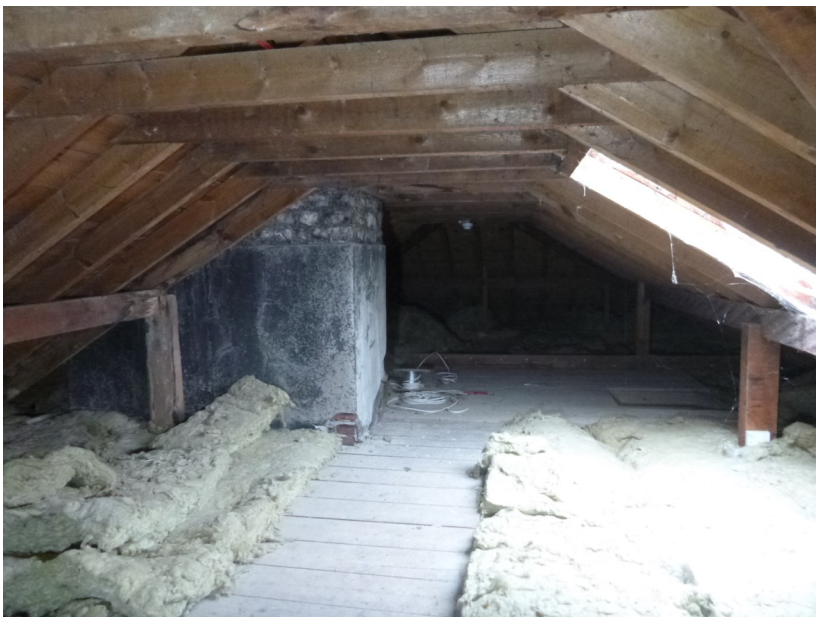
**Fig 30:**

H+R roof 6, west side; showing general view

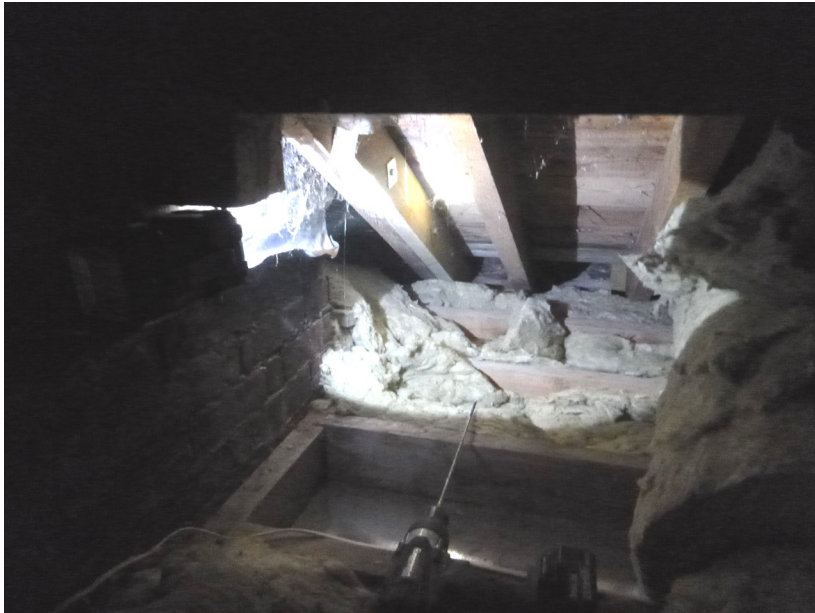
**Fig 31:**

H+R roof 6, west side; showing previous repairs made in the vicinity of a chimney penetration

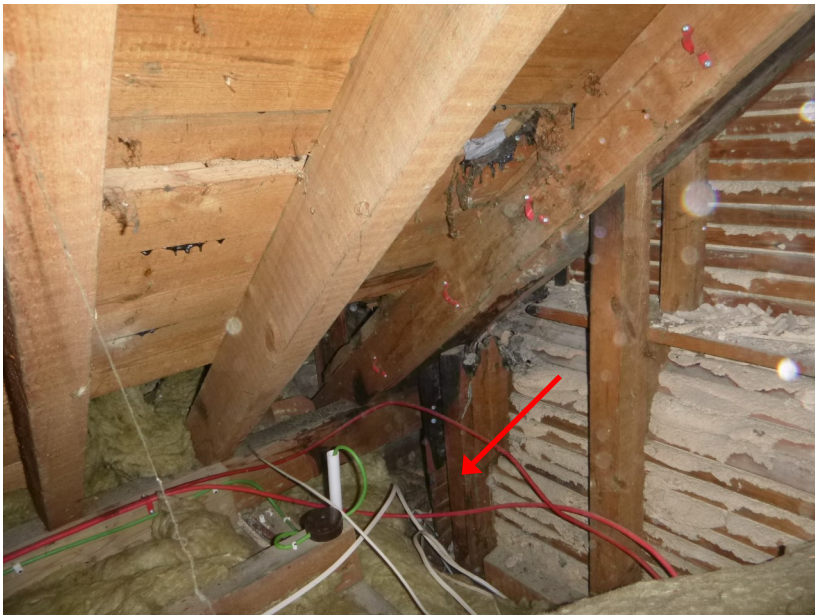
**Fig 32:**

H+R roof 7; showing general view

Location of damage to internal finishes by leak indicated (arrow)

Previous timber replacements made post-fire circa Edwardian works

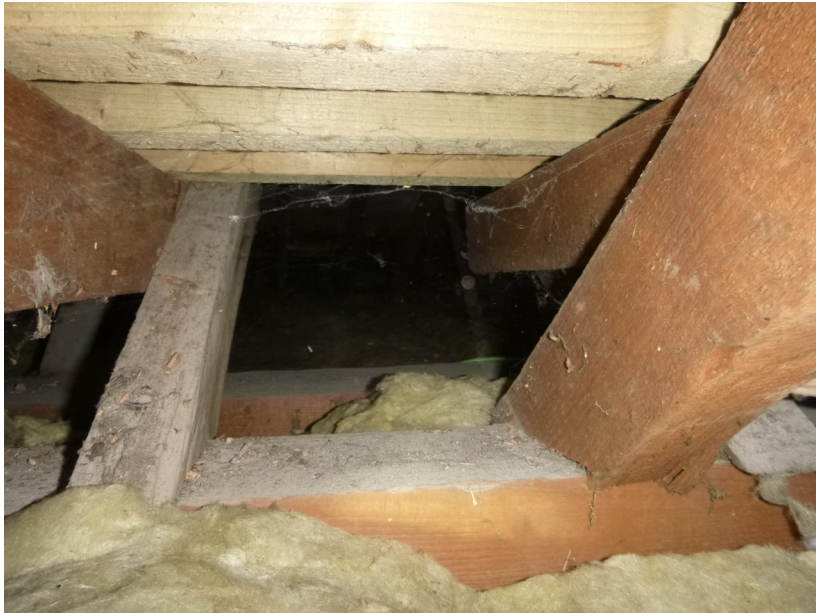
**Fig 33:**

H+R roof 7; showing north valley arrangement and interface with roof 8

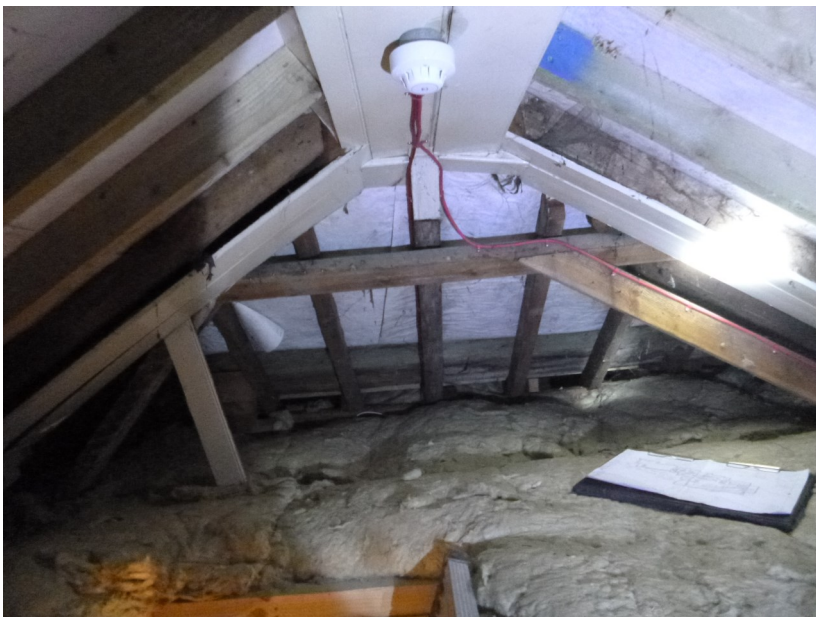
**Fig 34:**

H+R roof 8; showing general view

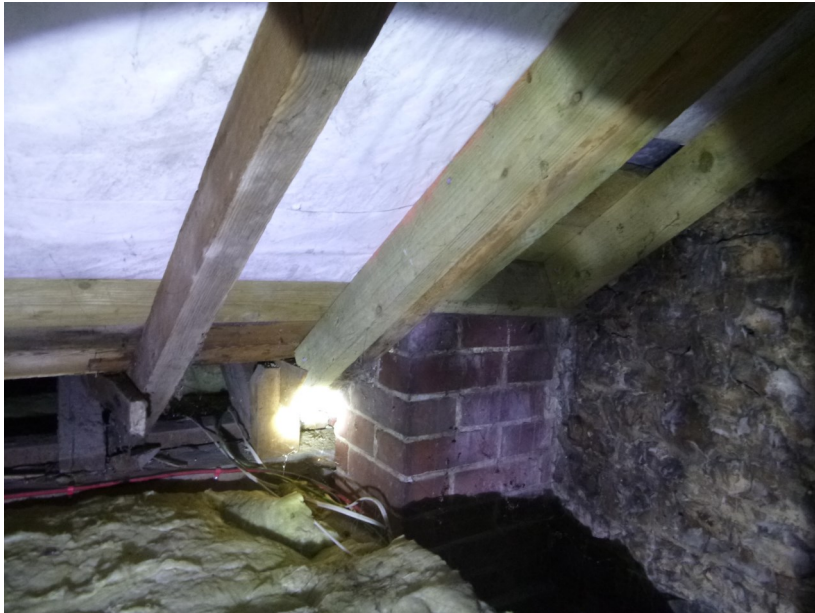
**Fig 35:**

H+R roof 8; showing general view

Note modern timber replacements  
made at east side

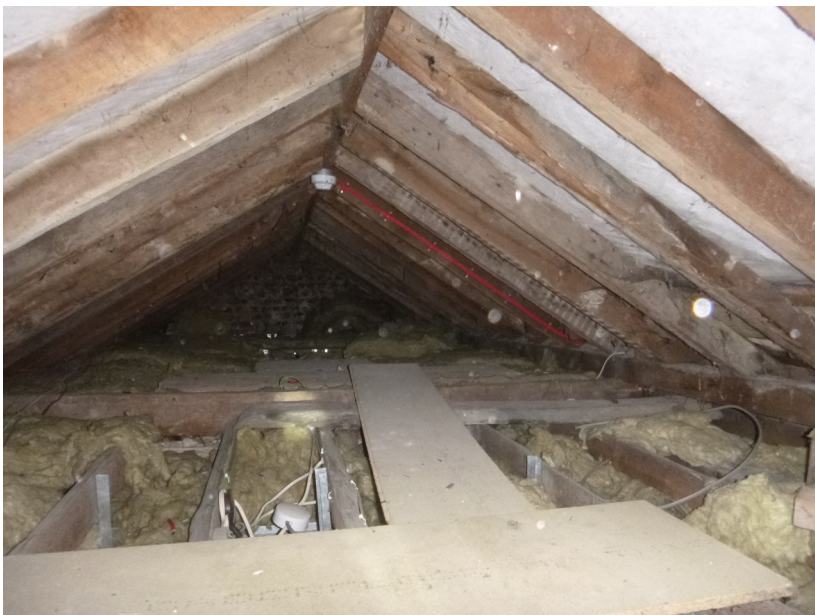
**Fig 36:**

H+R roof 9; showing general view

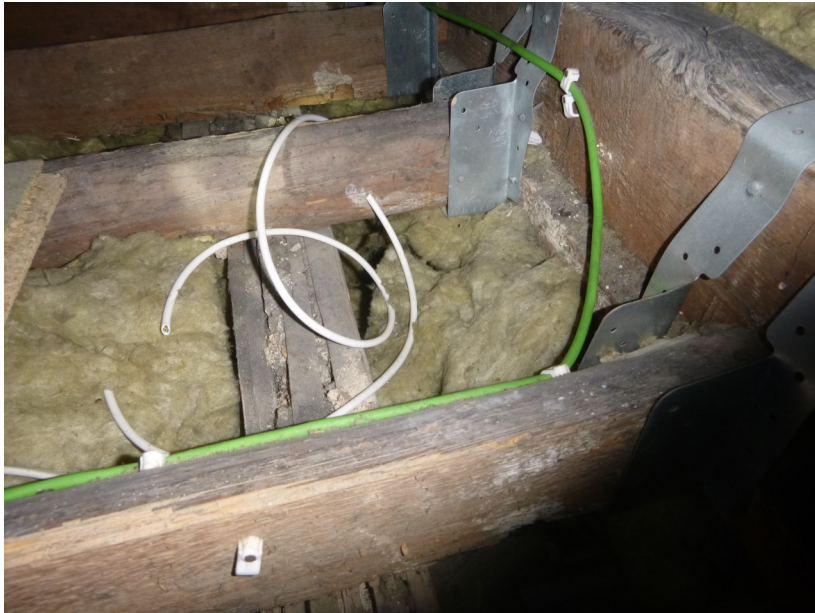
**Fig 37:**

H+R roof 9; showing modern strengthening of ceiling joist joints

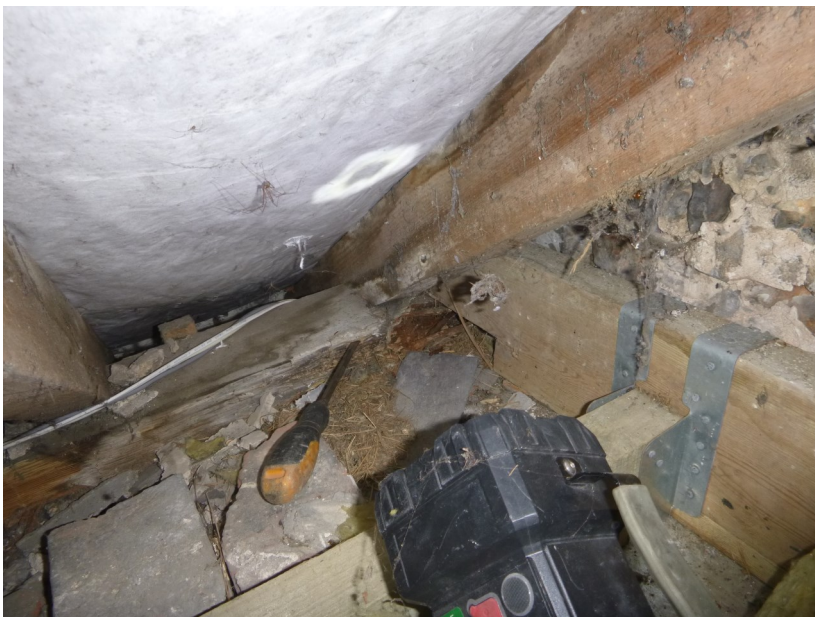
**Fig 38:**

H+R roof 9; showing partially decayed eaves plate at north-east corner

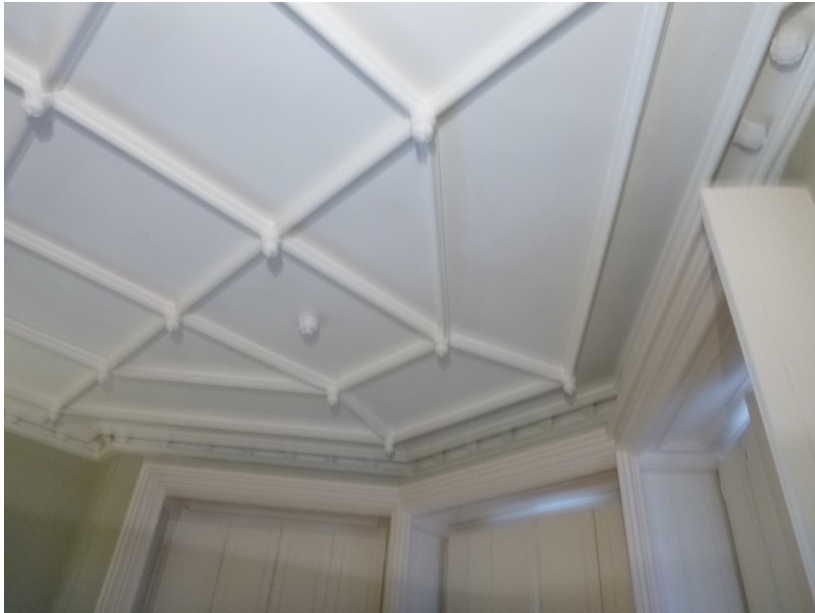
**Fig 39:**

H+R roof 10; showing general view

Note lack of access/exposure

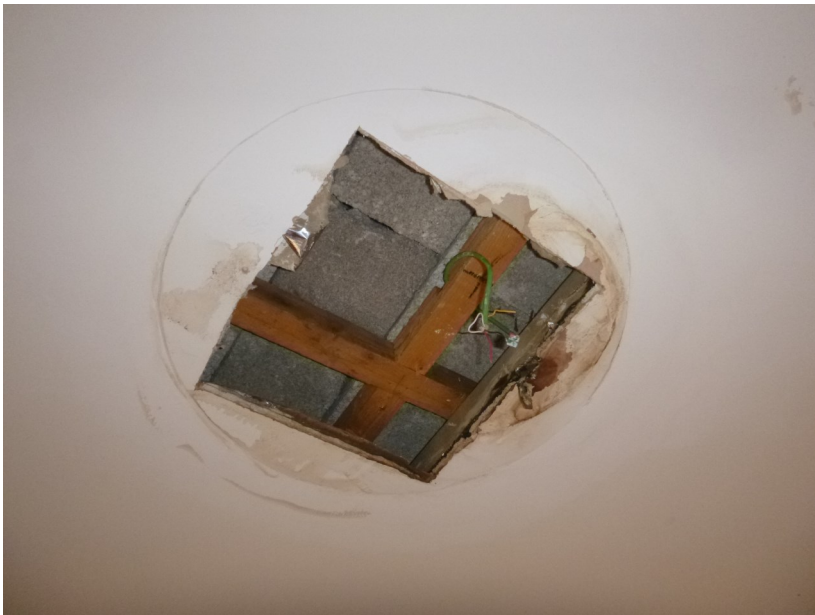
**Fig 40:**

H+R roof 11; showing view of solid slab structure

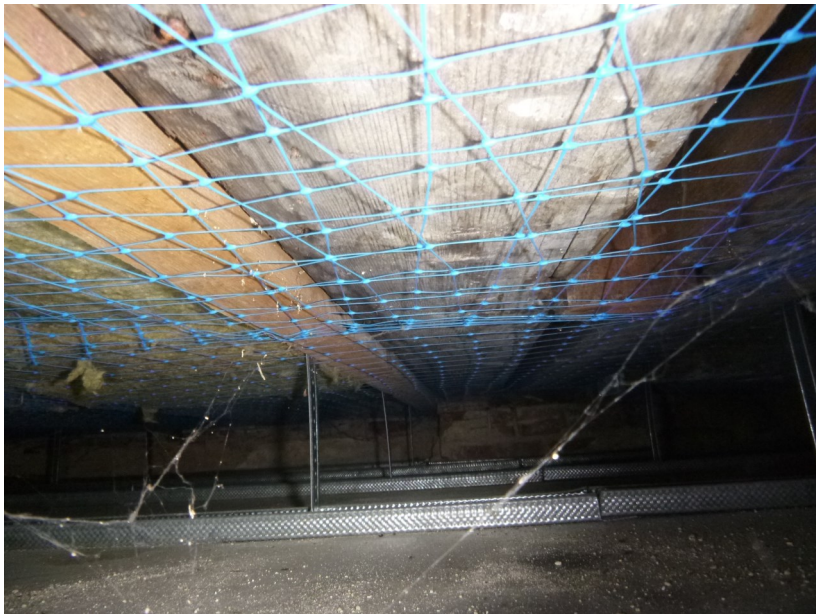
**Fig 41:**

H+R roof 12; showing limited view of flat roof void and bressummer beam carrying wall above

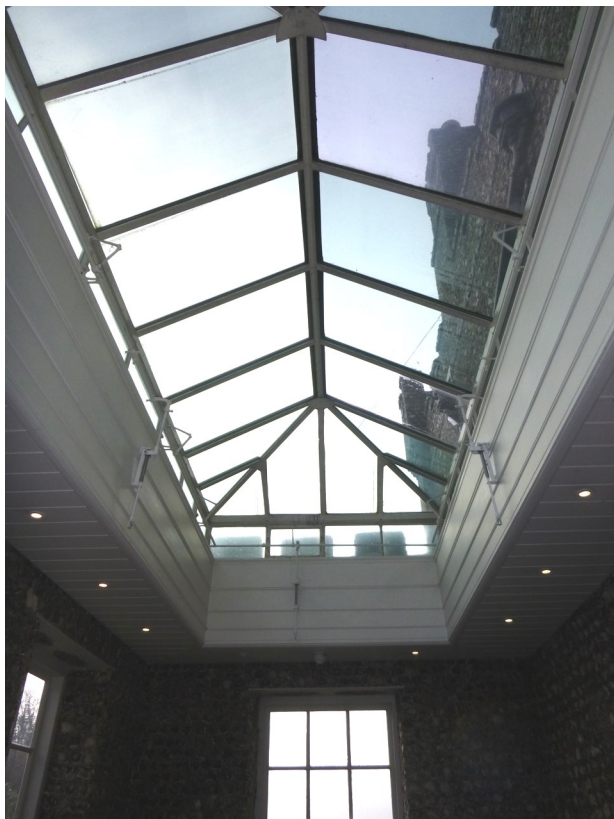
**Fig 42:**

H+R roof 13; showing general view

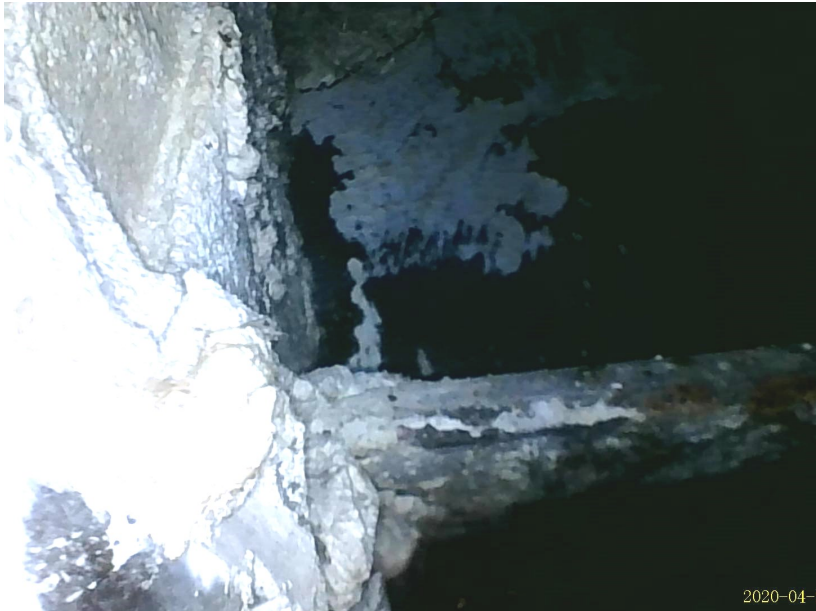
**Fig 43:**

H+R roof 13; showing borescope image of steel bearing at south-west corner

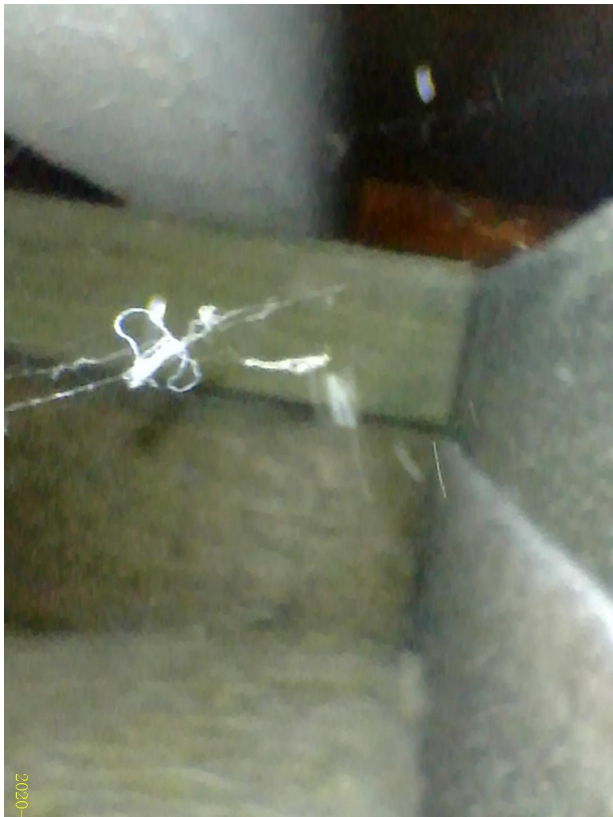
**Fig 44:**

H+R roof 13; showing borescope image timber infill within void
