**VERIFICATION REPORT**

**PLOTS 123-126**

**WOODCROFT FARM, WOODCROFT LANE,**

| Reference: | GE19455/VR/PLOTS 123-126/MAR22 |

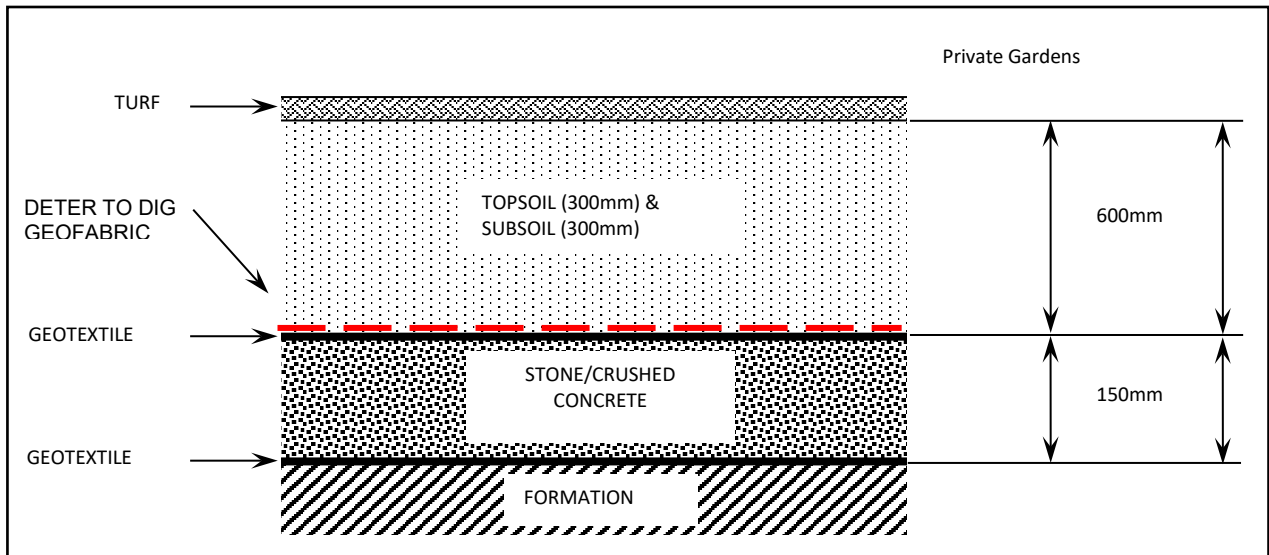
An example of the recommended cover system for use in private gardens where Made Ground remain in-situ is provided below:

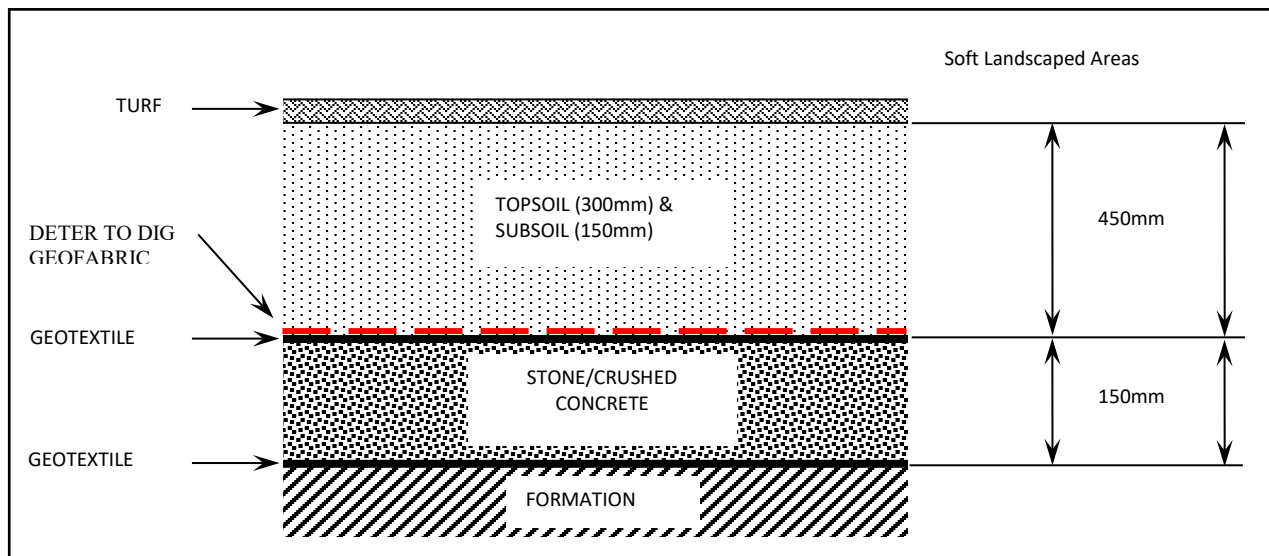
An example of the recommended cover system for use in areas of communal soft landscaping where Made Ground was to remain in-situ is provided below:

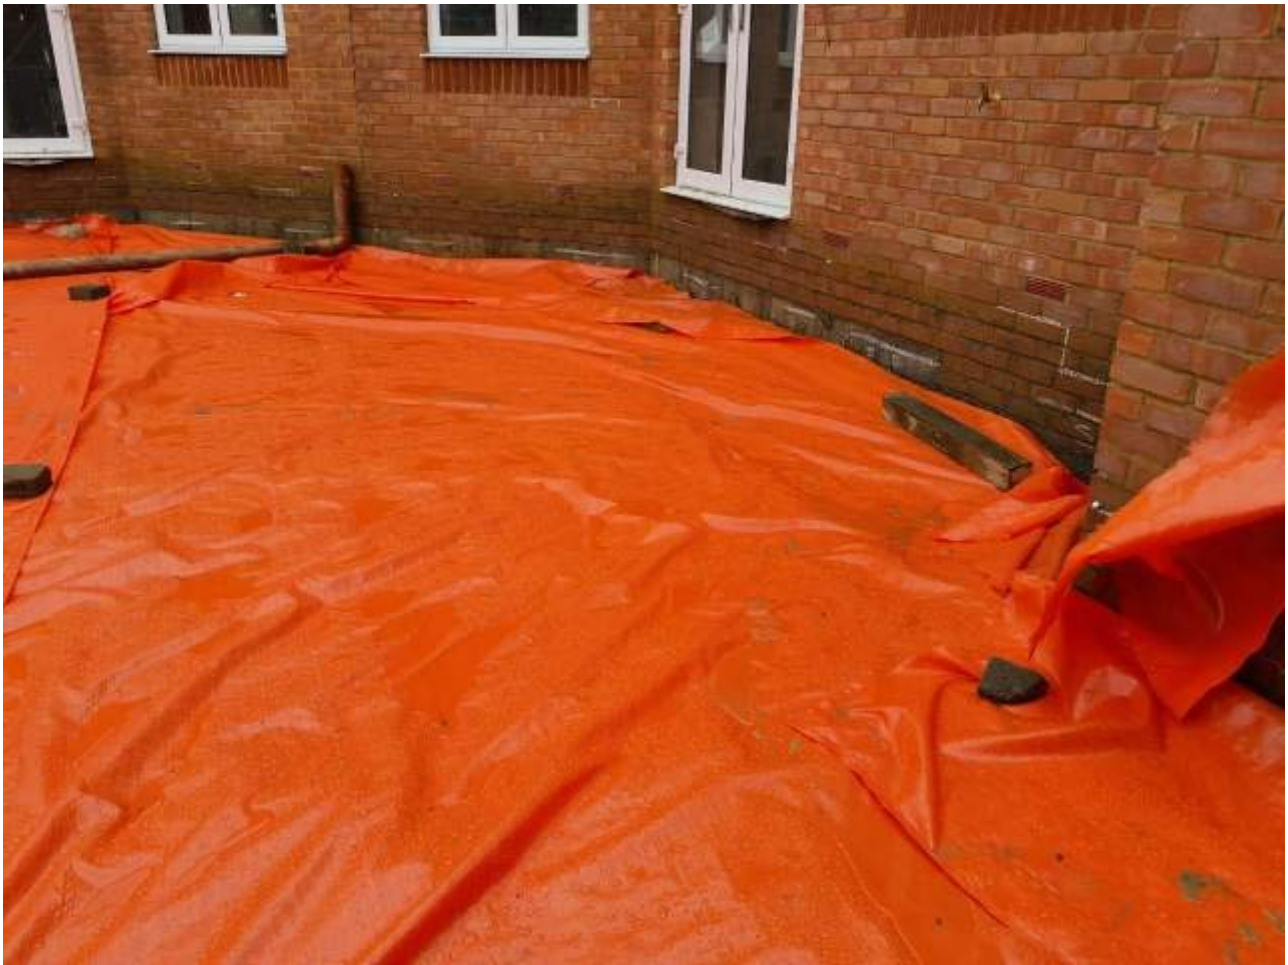
Plate 1 – Orange geotextile laid over crushed concrete layer on Plot 123

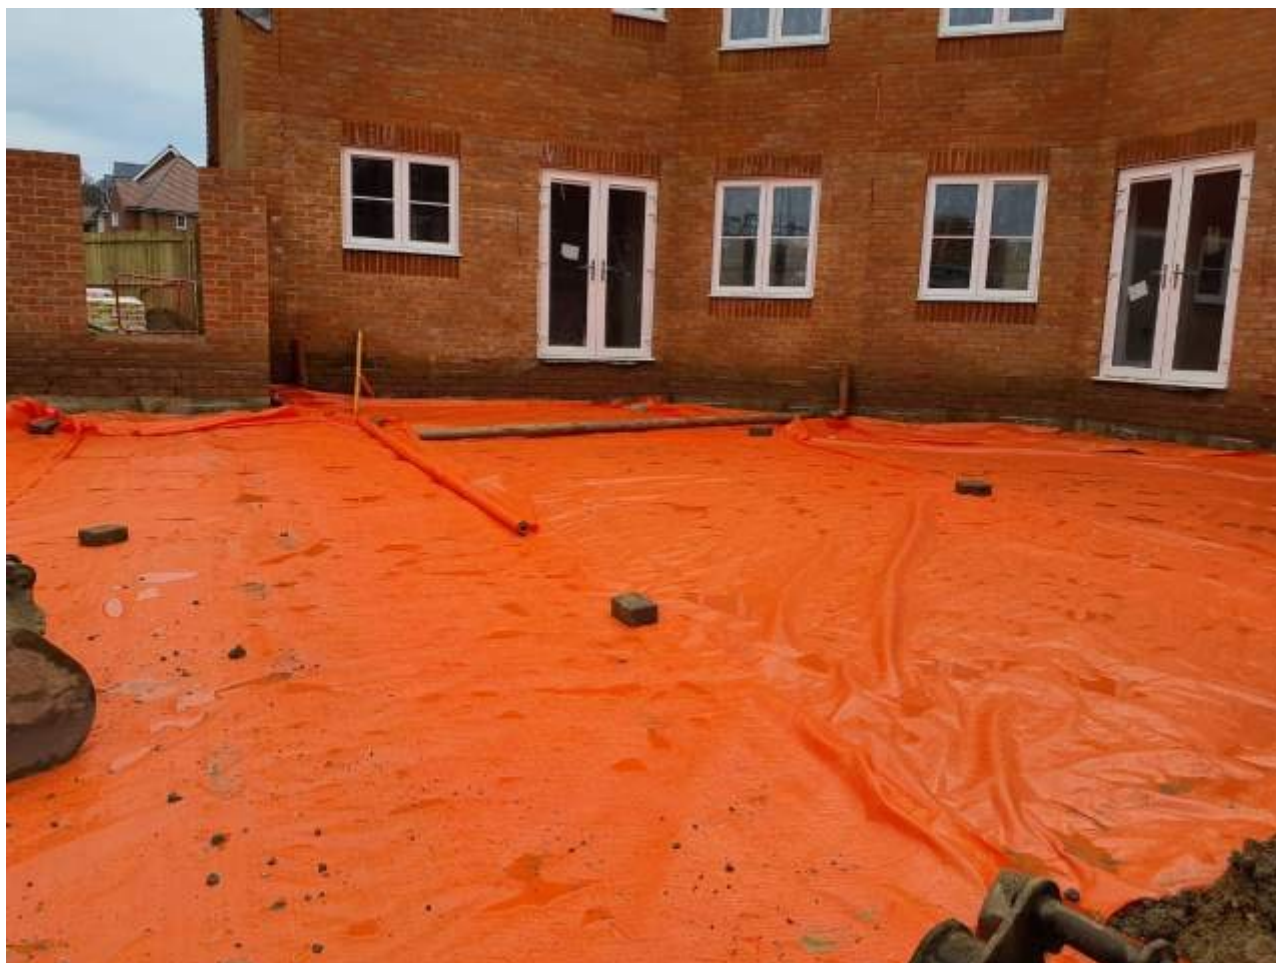
Plate 2 – Orange geotextile laid over crushed concrete layer on Plot 124

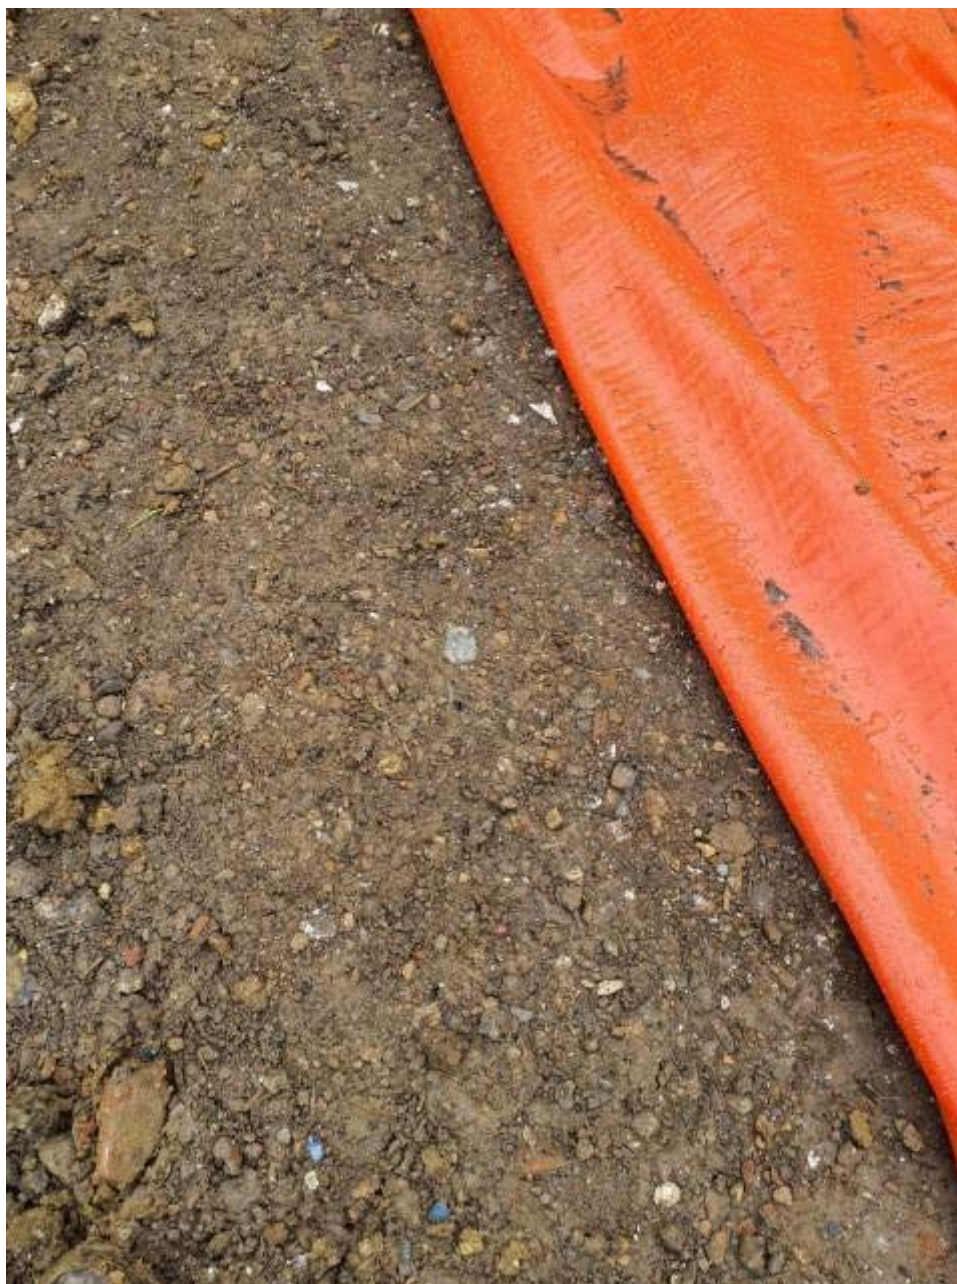
Plate 3 – Orange membrane rolled back to reveal crushed layer

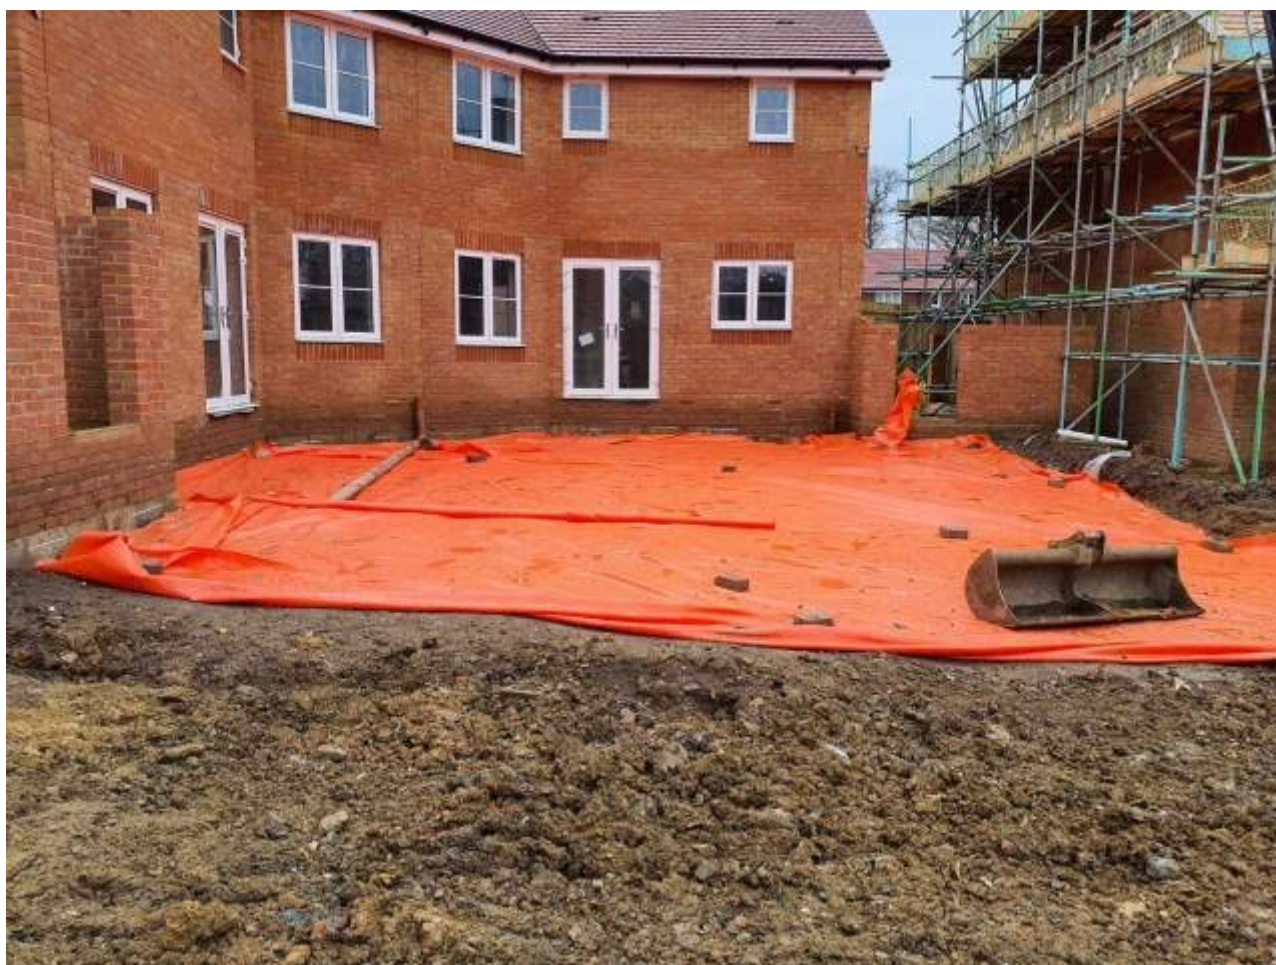
Plate 4 – Orange geotextile laid across plots

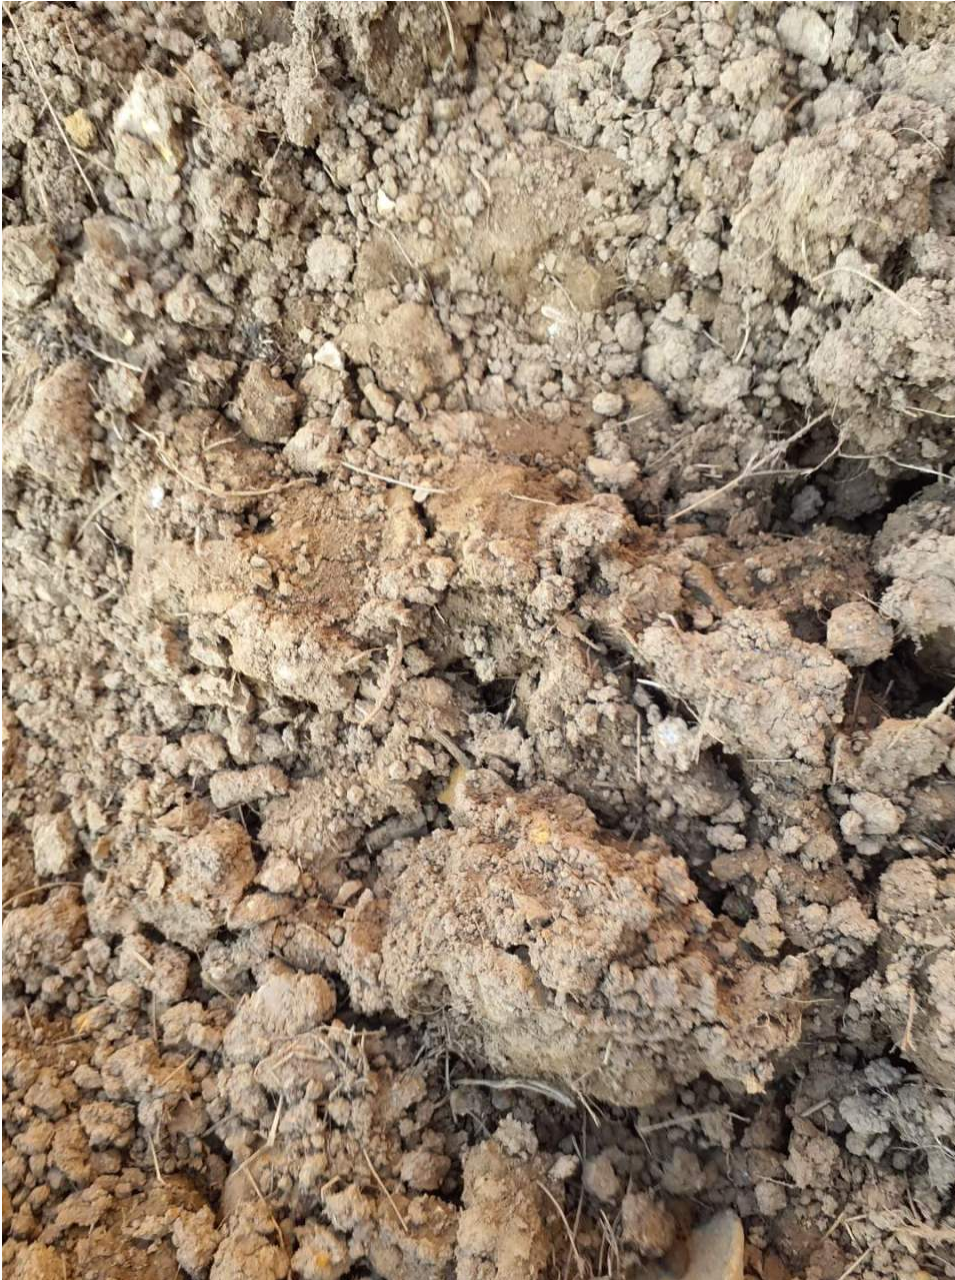
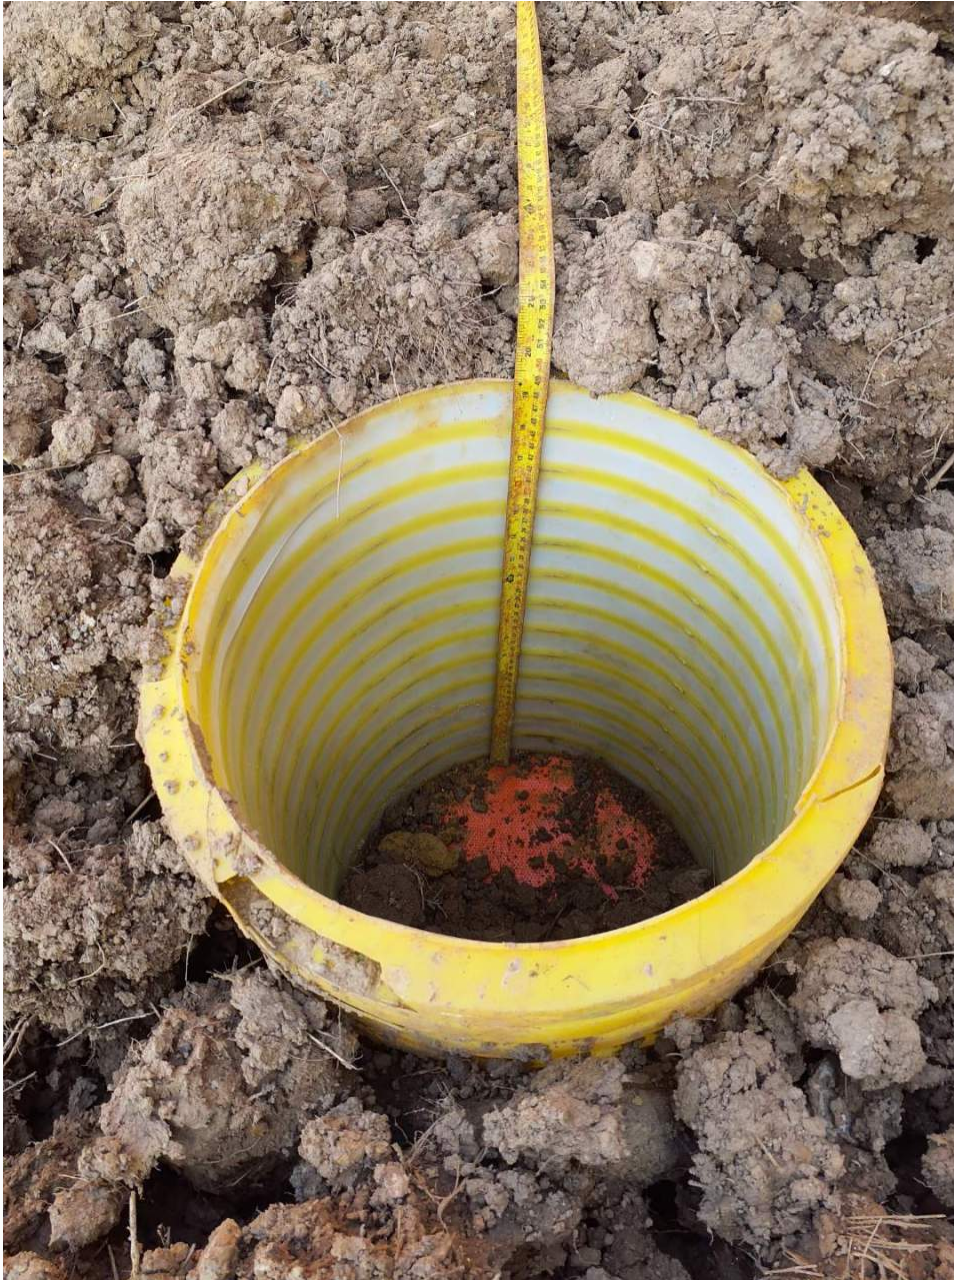
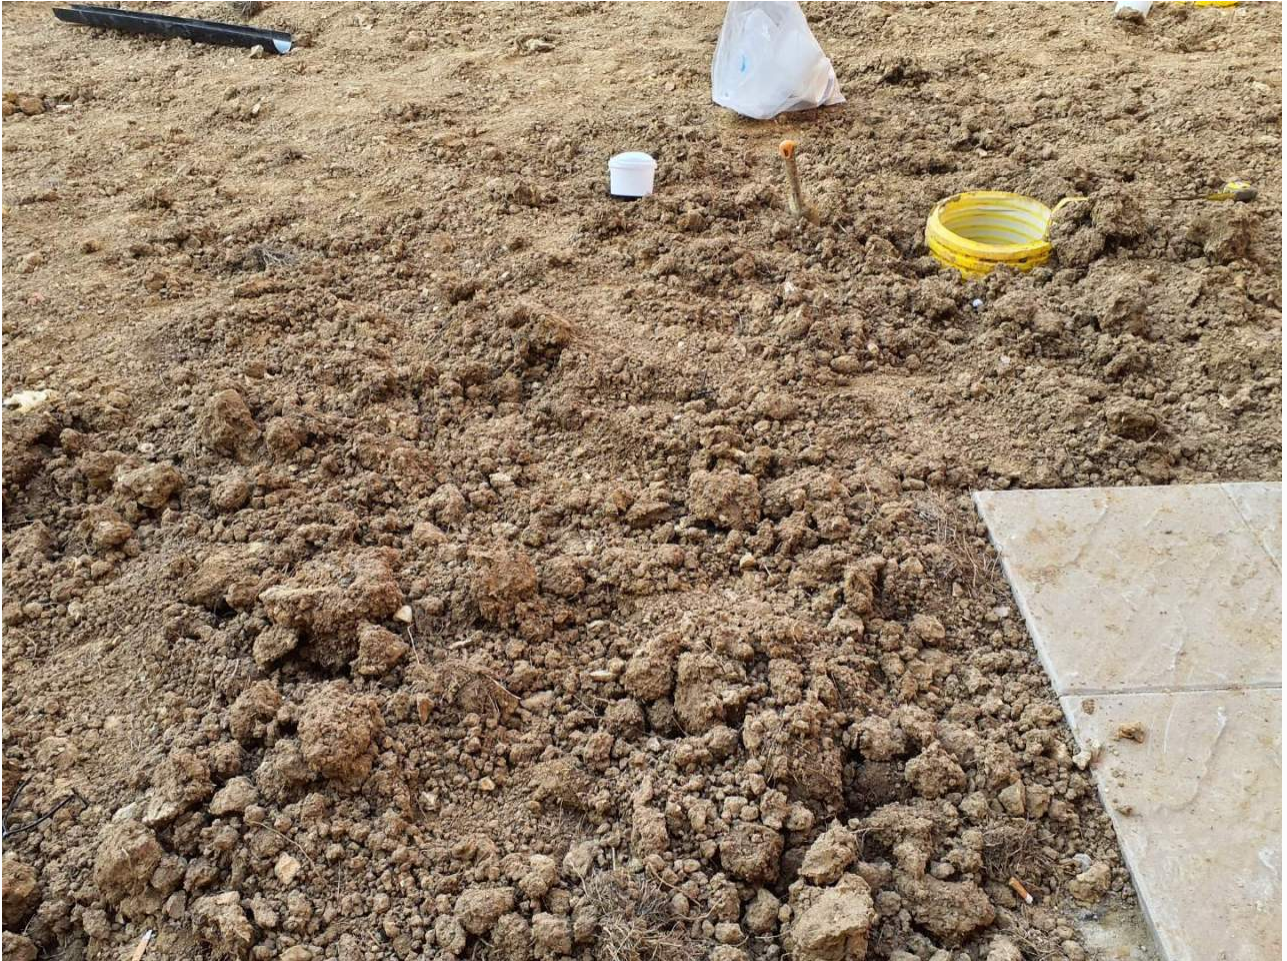
Plot 123

The inspection confirmed that within the inspection pits, Topsoil was found to be between 500mm and 550mm in thickness within all the inspected areas. It should be noted that the soil cover system only comprised Topsoil, and the Topsoil utilised within Plots 123-126 comprised site-won Topsoil which had previously been deemed suitable for re-use, as reported in the RSVP for the farmyard area (GE16943/RSVP-FY-V6.0/DEC21).

Pass/Fail (X) Pass  
( ) Fail
