# Hutton + Rostron Environmental Investigations Limited

## Southleigh Park, Mansion House: Masonry damp and damp-proof course investigation

Site note A6 for 18 January 2021, job No. 152.09

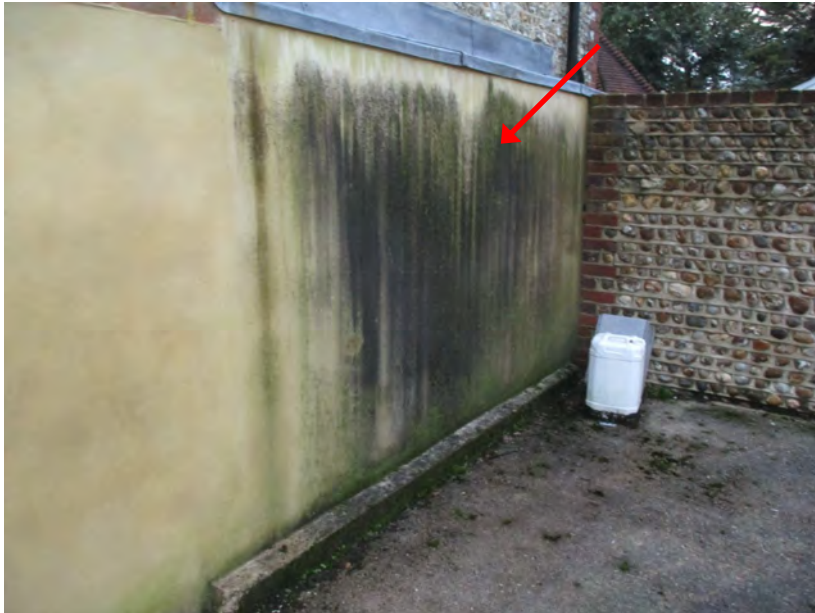
**Fig 1:**

3.1.1, east side; showing biological growth and staining to render below a cover flashing installed on recent refurbishment

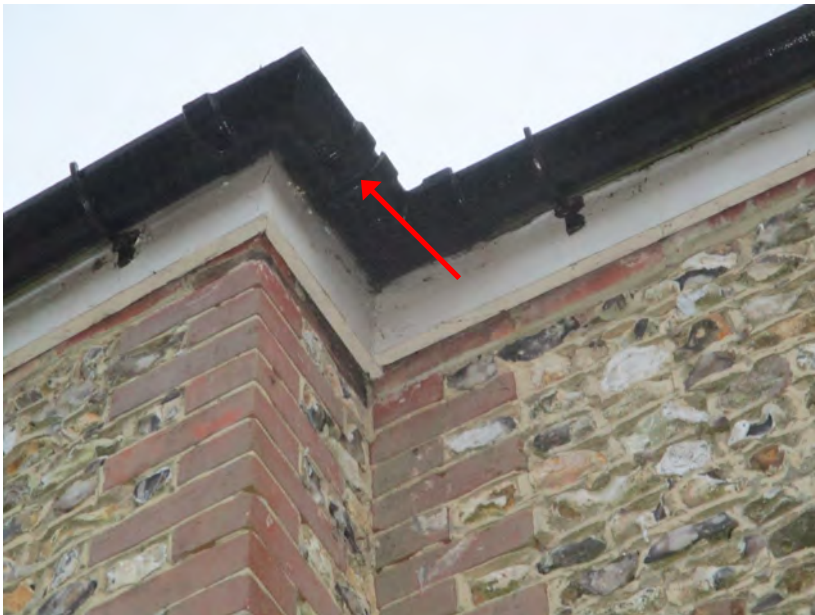
**Fig 2:**

3.1.1, central section; showing 'dog leg' in gutter which increased the risk of blockage and overflow locally

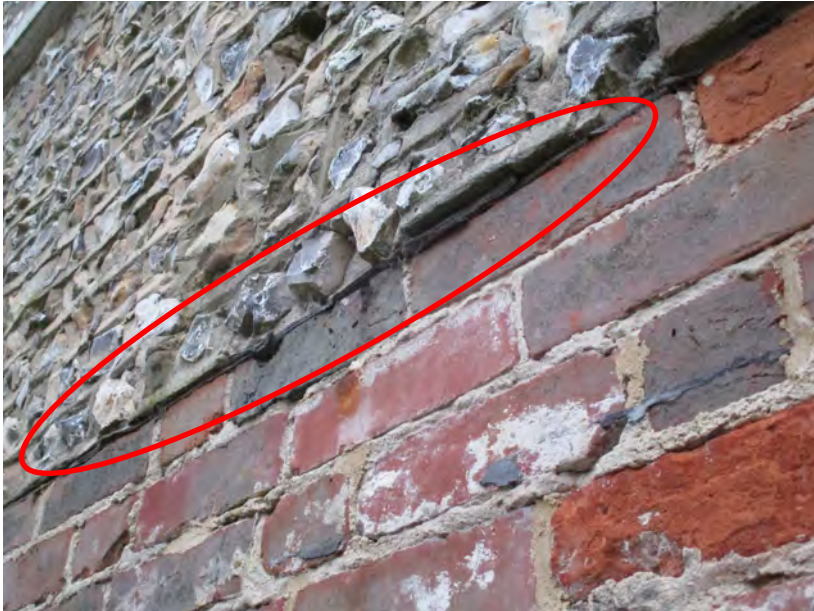
**Fig 3:**

1.1.1, west side; showing residual flashing chased into masonry indicating the presence of lean-to structure, subsequently demolished

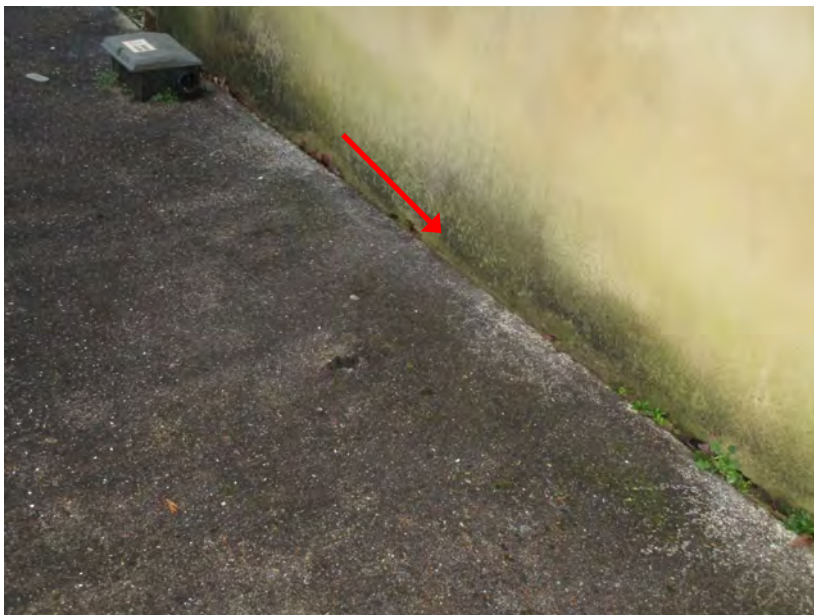
**Fig 4:**

1.1.1, east side; showing water splashing back onto elevation render from hardstanding, increasing the risk of water penetration into the structure and interior

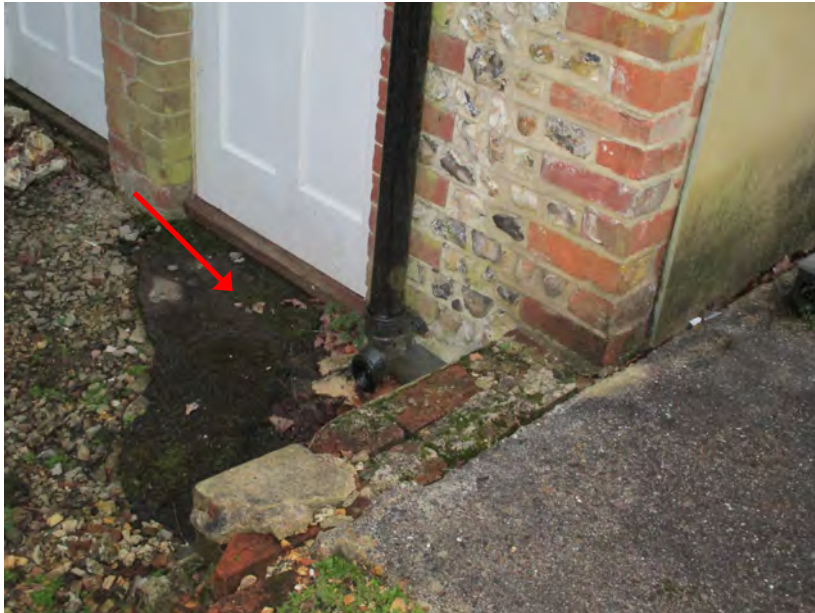
**Fig 5:**

1.1.1, east end; showing external ground levels approximately 300mm above finished floor level on the interior, relative to the door threshold

Allowance should be made for a reduction in external ground levels around the base of the structure where these rise to within 200mm of internal floor levels. Surface drainage provision on the north side should be reviewed and enhanced, generally to intercept ground and surface water draining towards the building from the north and direct it clear of the foundations and bases of external walls. Below ground drainage pipework should be inspected in detail using CCTV equipment as required and maintained free of obstruction pending, during and after refurbishment. Additional drainage capacity may be required to meet modern standards and to accommodate any increases in roof drainage capacity after refurbishment

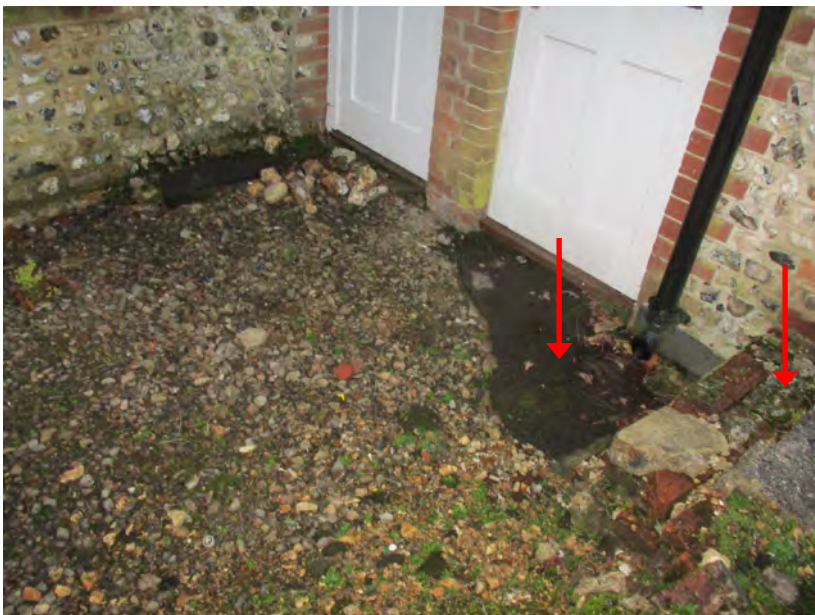
**Fig 6:**

1.1.2, west side; showing residual hardstanding forming a level threshold to the entrance doors in the east-facing return wall. Note biological growth at the base of the north façade, consistent with water splashing back onto the structure following failure of the eaves gutter

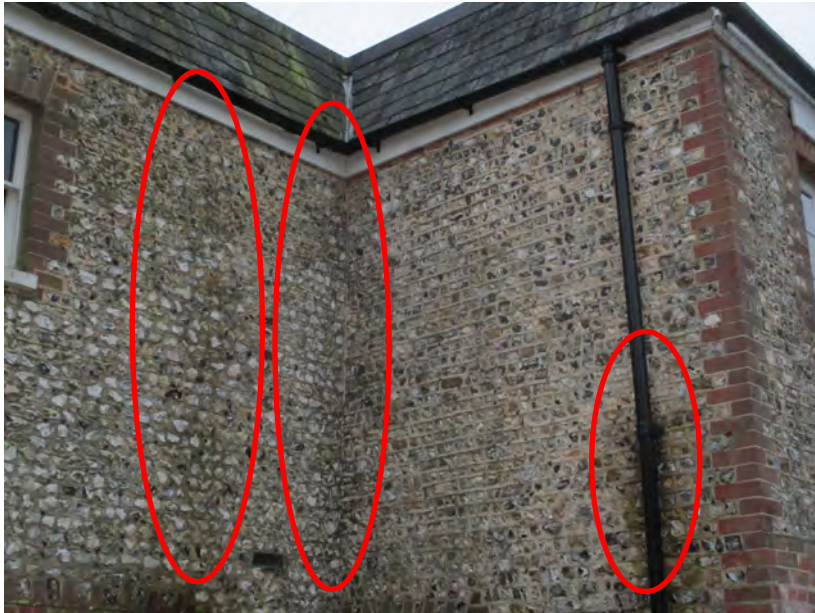
**Fig 7:**

1.1.2, west side; showing 3 no. areas of staining to façade masonry, consistent with localised failure of the provision for roof drainage

| LOCATION | OBSERVATION TYPE | OBSERVATIONS | COMMENTS |
|---|---|---|---|
| 1.1.2 | Roof drainage | Biological growth affected masonry at high level in three locations: approximately 1m east of the return corner, below a joint in the eaves gutter and behind the rainwater downpipe at the north end of the return. All these defects were consistent with intermittent blockage and overflow of the roof drainage system due to reduced maintenance, allowing water to drain over the elevation masonry, supporting biological growth and increasing the risk of damp penetration to the interior | |

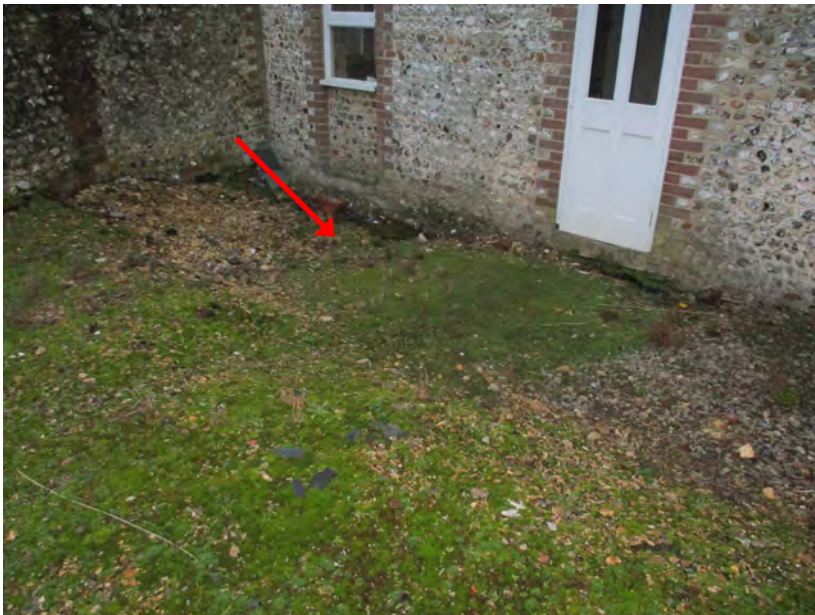
**Fig 8:**

1.1.2, central section; showing general fall of ground from north to south, draining surface and ground water into the footings of the north elevation

| LOCATION | OBSERVATION TYPE | OBSERVATIONS | COMMENTS |
|---|---|---|---|
| | | The general fall of ground was from north to south, towards the masonry and foundations of the structure. It was highly likely that ground in contact with the footings was persistently saturated, which may have increased the residual moisture content of loadbearing masonry locally. A surface drainage gulley was noted below the east ground floor window but this was 150mm above grade, preventing it from receiving any surface water run-off. It was likely that paving or hardstanding served by this gulley had been broken up since installation | |

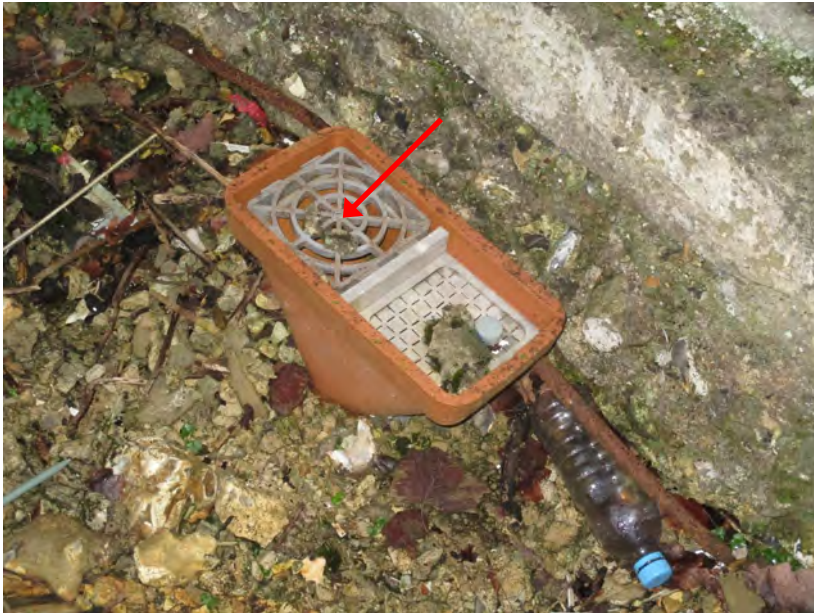
**Fig 9:**

3.1.2, east side; showing redundant surface drainage gulley significantly above grade, where hardstanding locally was assumed to have been broken up

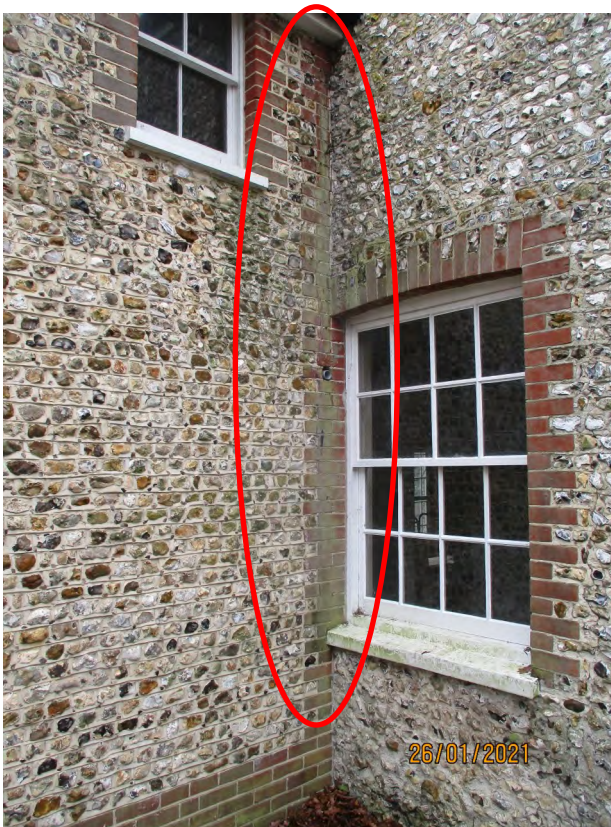
**Fig 10:**

1.1.3, west end; showing biological growth on masonry to full height, indicating intermittent failure of the provision for roof drainage. Note biological growth on east facing ground floor sills consistent with restricted drying

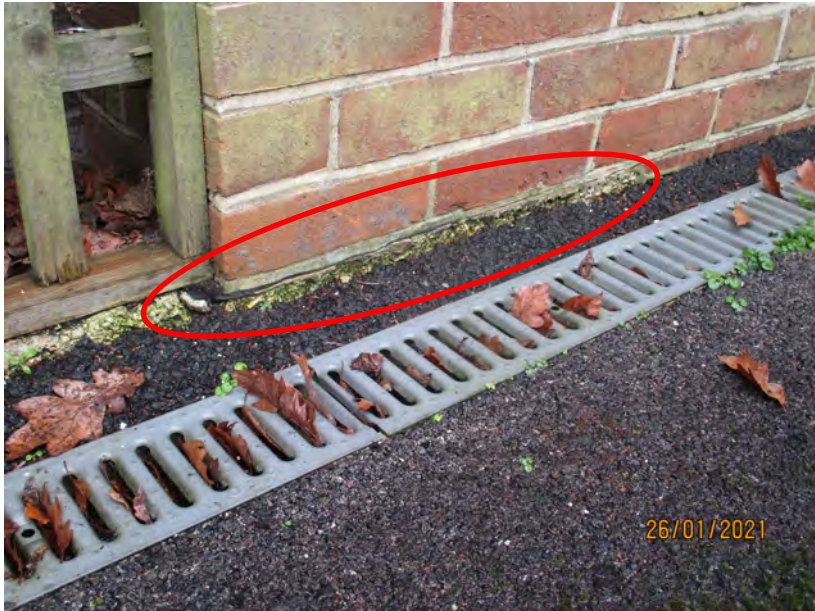
**Fig 11:**

1.1.3, north facing elevation, central section; showing partial damp-proof course in brickwork, installed on a previous refurbishment. Ground levels had risen to the level of the DPC, increasing the risk of water penetration to the structure

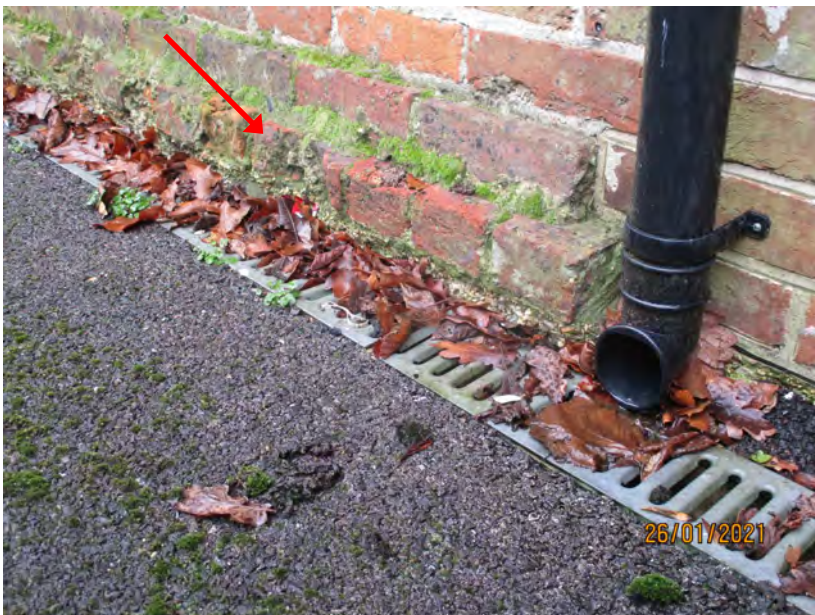
**Fig 12:**

1.1.3, central section of north facing elevation; showing partial dpc installed in new brickwork, constructed on a previous refurbishment. Note biological growth on tarmac surfaces and 'step out' brickwork, consistent with intermittent failure of the roof drainage system and water ponding intermittently against the structure

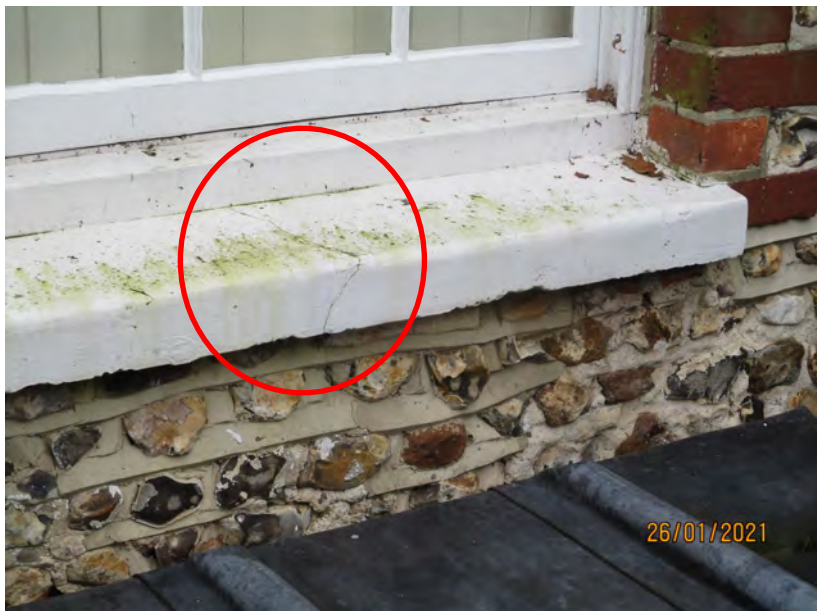
**Fig 13:**

1.1.4, ground level sill; showing vertical crack through masonry and patch repairs to façade below, indicating previous problems of intermittent water penetration

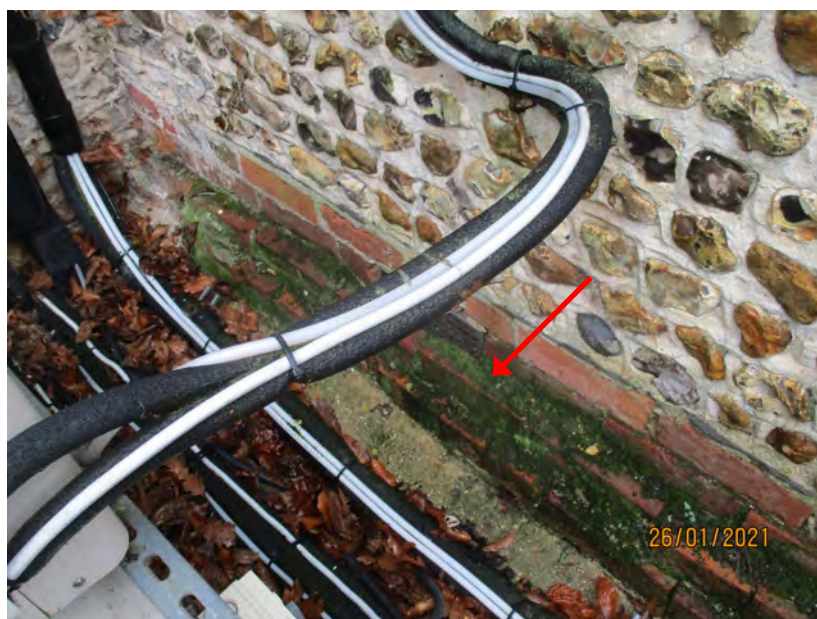
**Fig 14:**

1.1.4, west side; showing biological growth on brickwork indicating persistently damp conditions at the base of the façade, where drying was restricted by a ventilation housing

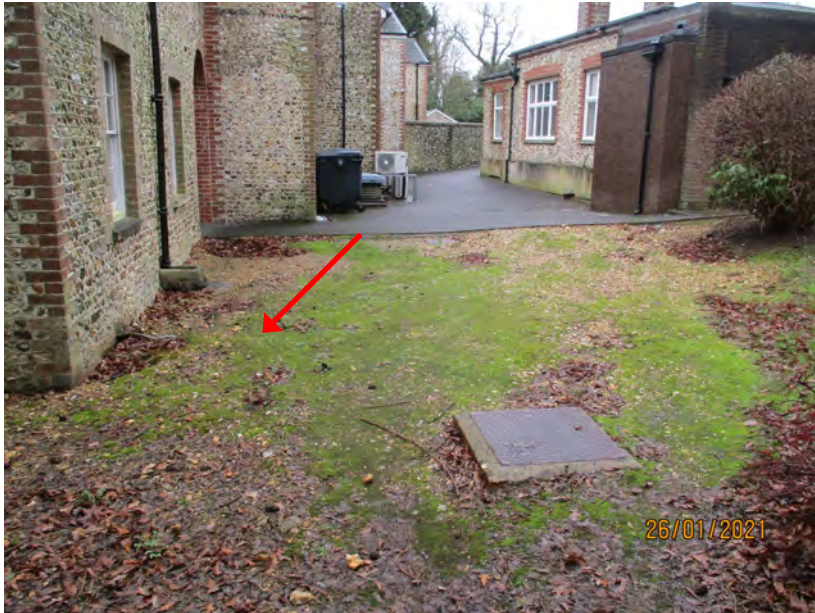
**Fig 15:**

1.1.4 and 1.1.5; showing general fall of ground from north-west to south-east, directing ground and surface water towards the masonry and foundations of the structure

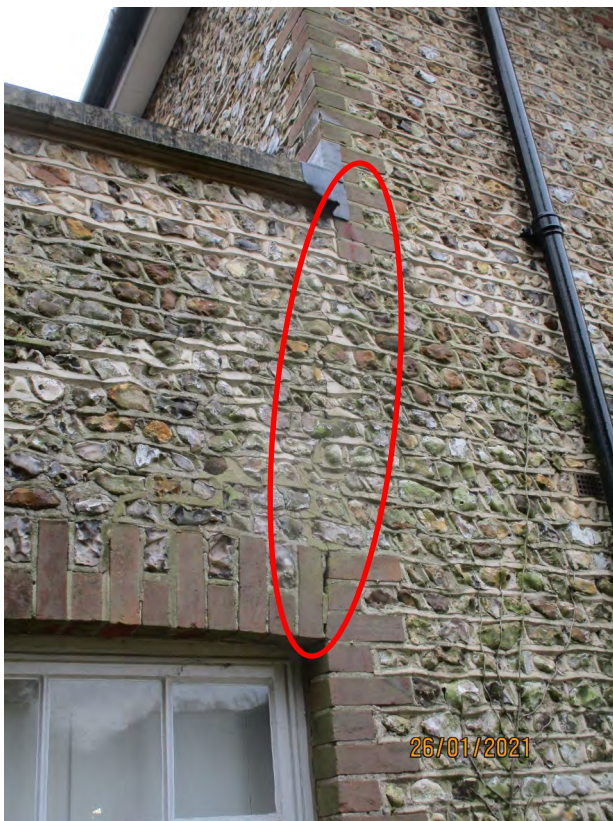
**Fig 16:**

1.1.5, masonry above east ground floor window; showing vertical crack in structure which may indicate progressive settlement

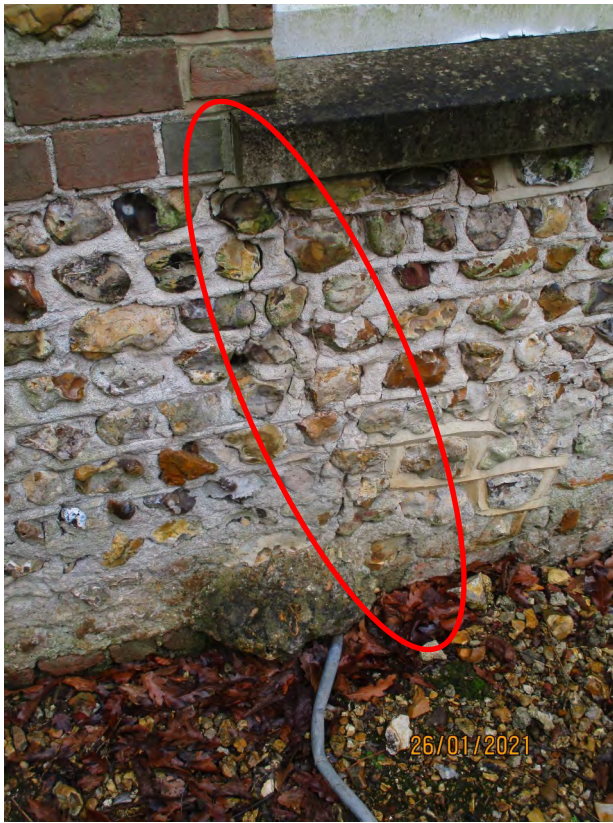
**Fig 17:**

1.1.5, lower east side of east ground floor window; showing vertical crack in masonry which may allow water penetration to the structure. Note weathering and efflorescence affecting pointing mortars at low level and previous patch repairs

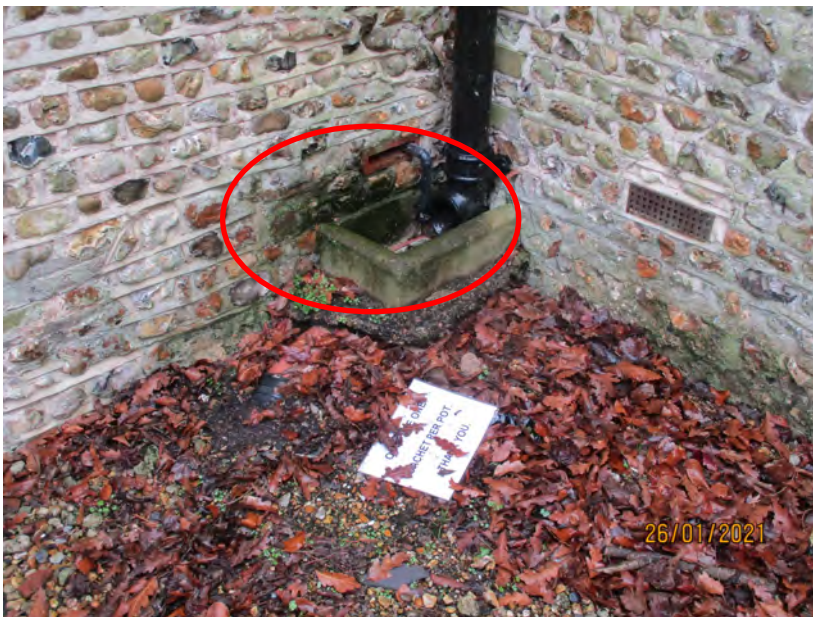
**Fig 18:**

1.1.6, west end; showing damp affected masonry and concrete bunding around a rainwater gully at ground level, indicating intermittent failure of the provision for roof drainage

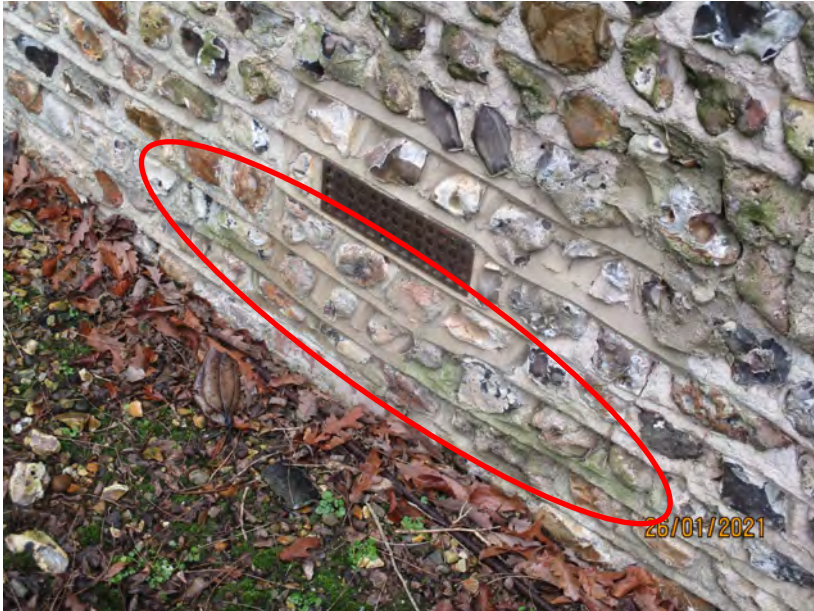
**Fig 19:**

1.1.6, central section; showing 'weather struck' pointing at low level, which may have been intended to throw surface water clear of the base of the structure. No provision for horizontal damp-proofing was identified

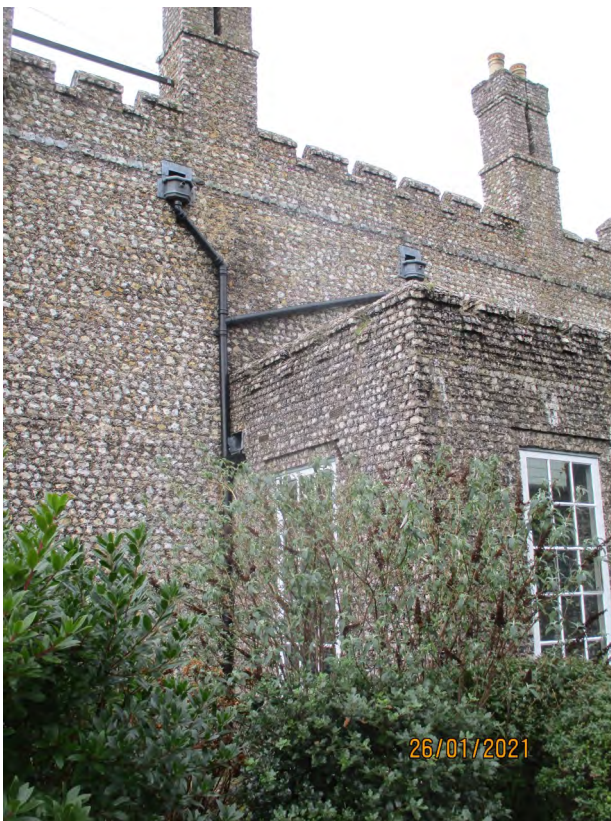
**Fig 20:**

1.2.1; showing general arrangement of galetted flint façade finishes and generally good condition of 2 no. rainwater outlets and associated downpipes at high level

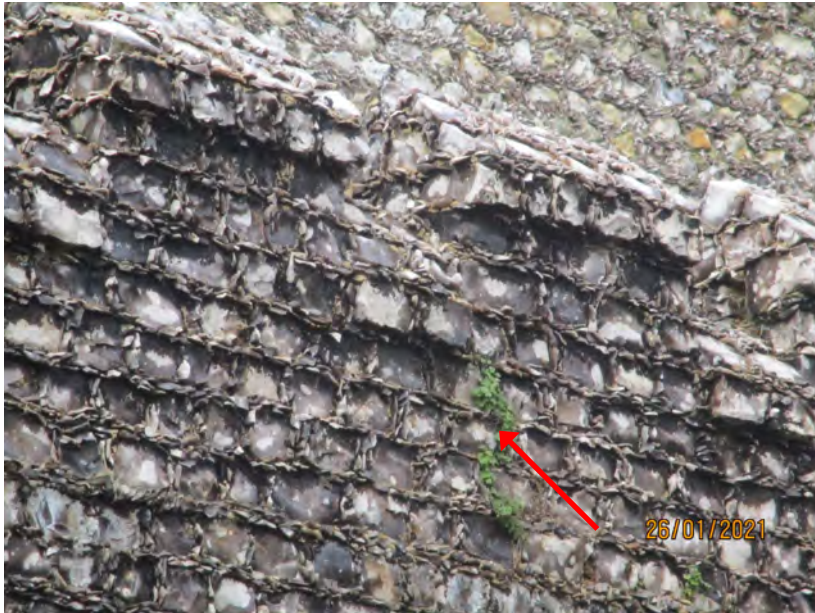
**Fig 21:**

1.2.2, central area; showing biological growth affecting masonry at high level, indicating raised exposure to weathering and possible intermittent failure of the provision for roof drainage on the reverse of the parapet wall

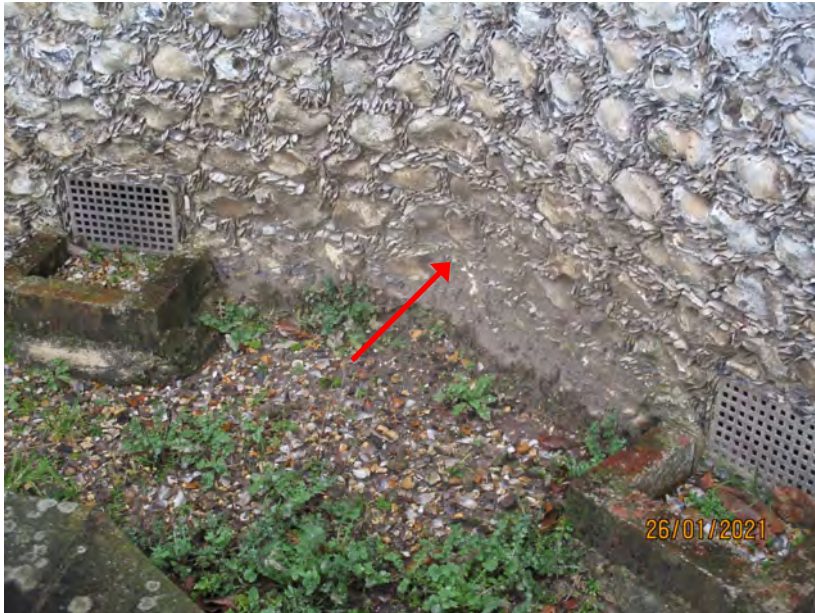
**Fig 25:**

1.3.1, west side of central bay;  
showing soiling of the façade where  
water splashed back from ground  
having drained over projecting  
architectural details at high level

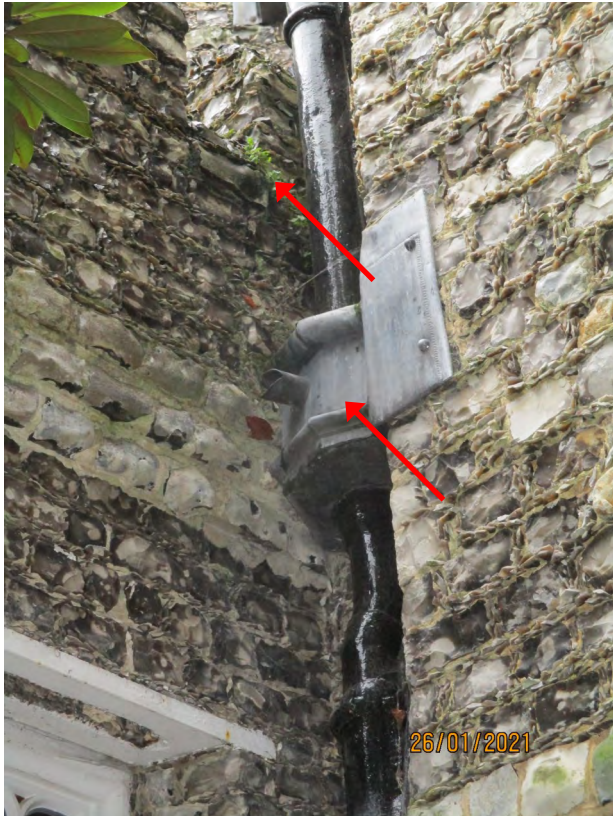
**Fig 27:**

1.4.2, rainwater downpipe on south side; showing lead fittings retained on previous refurbishments. Note colonisation of adjacent masonry by plant growth which may indicate intermittent failure of the provision for roof drainage during and since previous occupancy

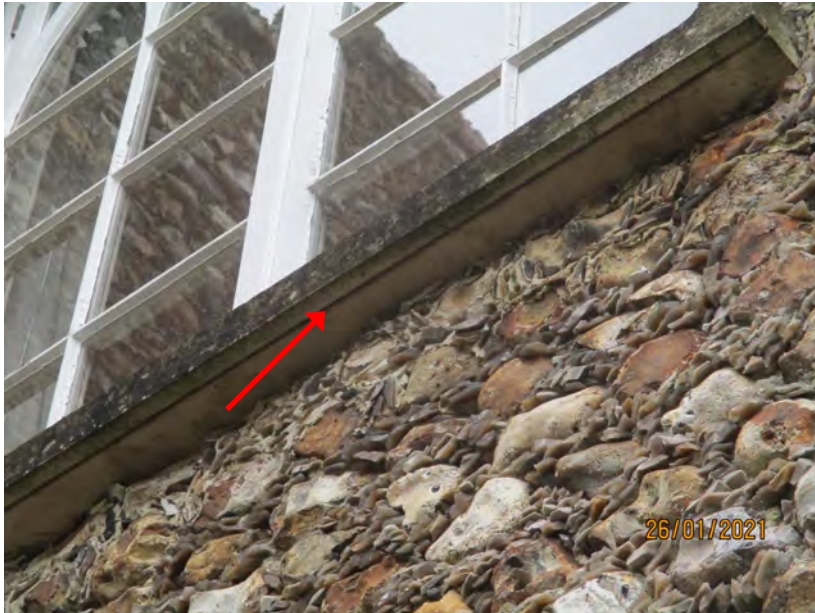
**Fig 29:**

1.3.2, east side; showing drip rebate formed in external masonry sill to first floor window on previous refurbishment and repointing of galeted flints below

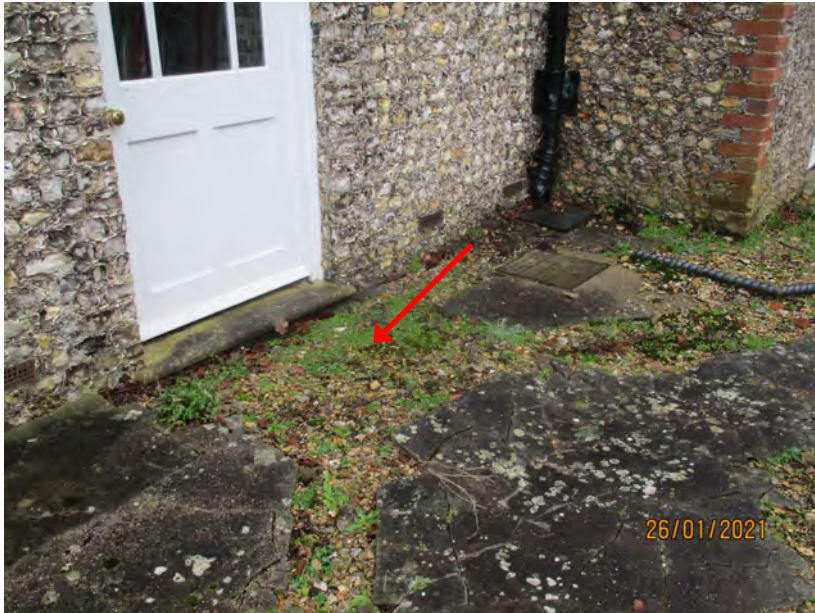
**Fig 31:**

1.3.3, west end; showing made ground and residual concrete paving approximately level with floor finishes on the interior. Note rainwater downpipe discharging onto ground with no provision for surface drainage

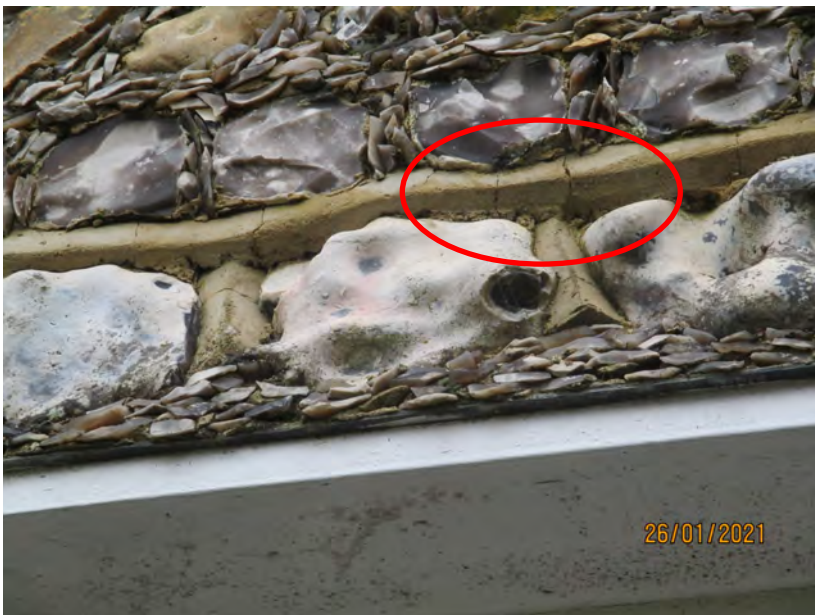
**Fig 32:**

1.3.3, central section; showing weather struck pointing to dressed flint details above ground floor window and door openings. Note vertical cracks through pointing indicating that mortar was of cementitious type and vulnerable to shrinkage and failure caused by thermal movement

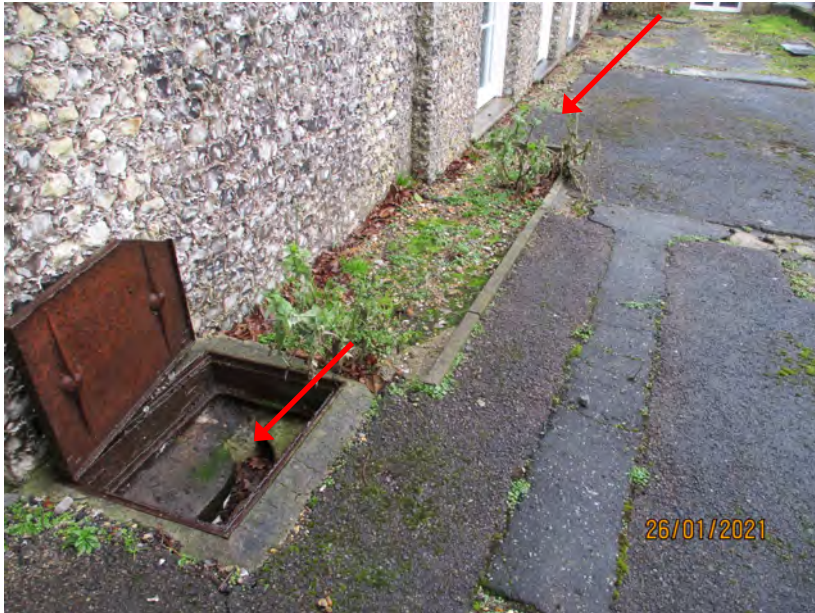
**Fig 33:**

1.3.3, west end; showing made ground and tarmac hardstanding in contact with the façade. Note redundant drain at south-west corner of structure, which may have been part of a previous ground and surface drainage system

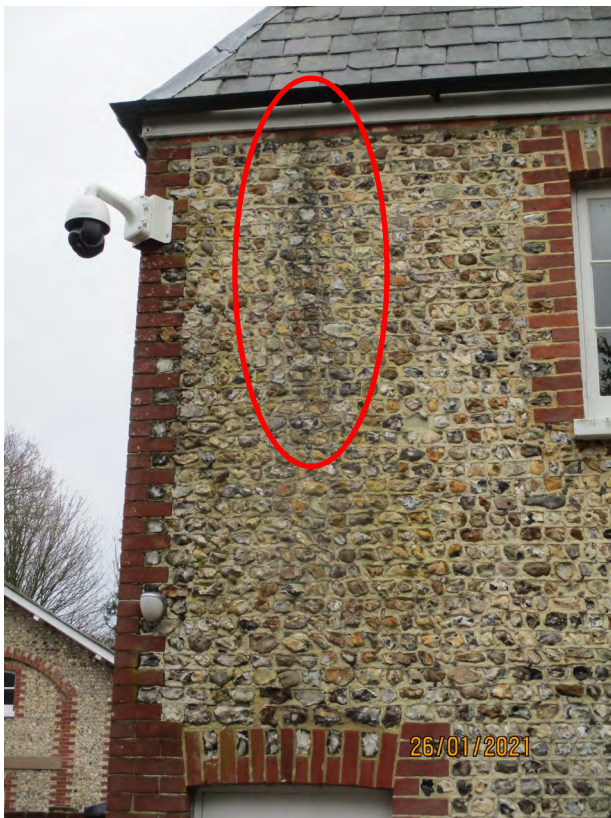
**Fig 34:**

1.4.3, north end; showing staining to masonry below a defective joint in eaves guttering, allowing intermittent escape of water

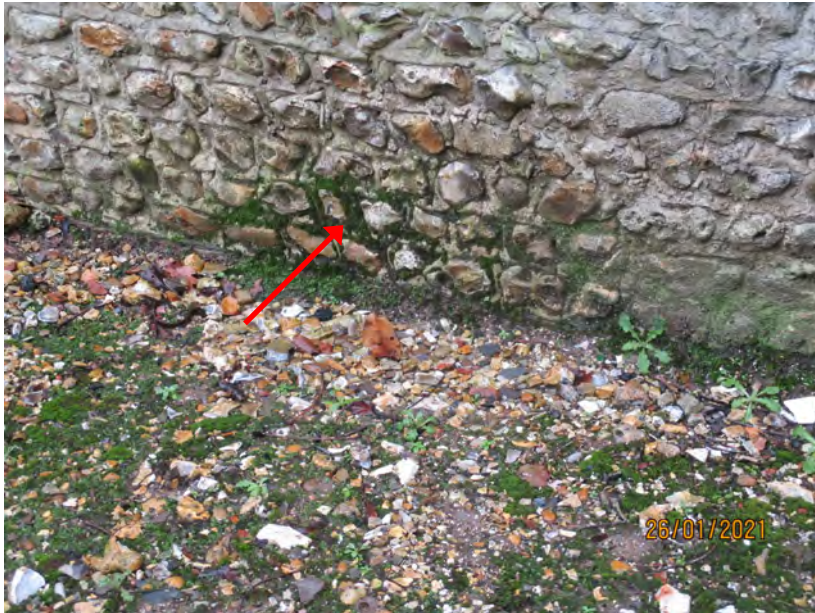
**Fig 35:**

1.4.3, central section; showing biological growth on masonry at the base of the façade, where water splashed back from made ground at the base of the wall

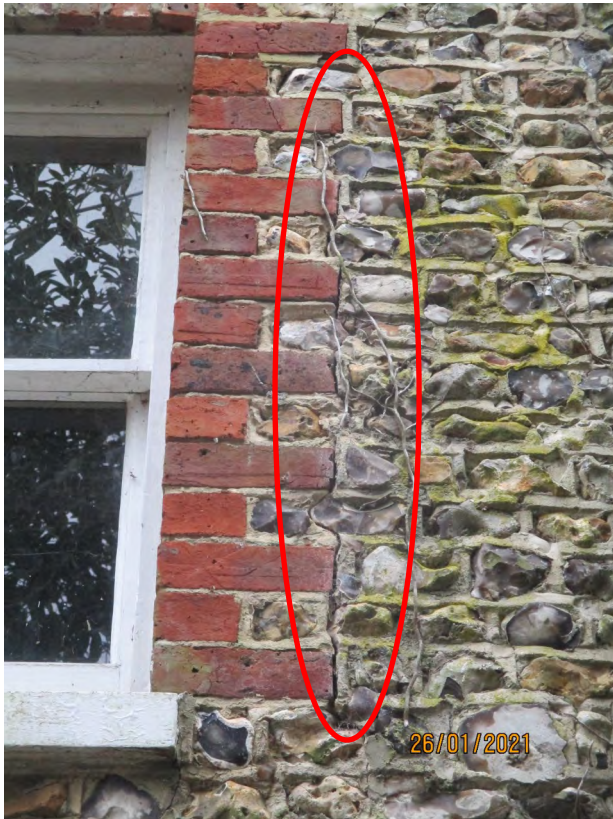
**Fig 37:**

1.4.3, south end; showing vertical crack in masonry between brick embellishments to the first-floor window and surrounding coursed flints

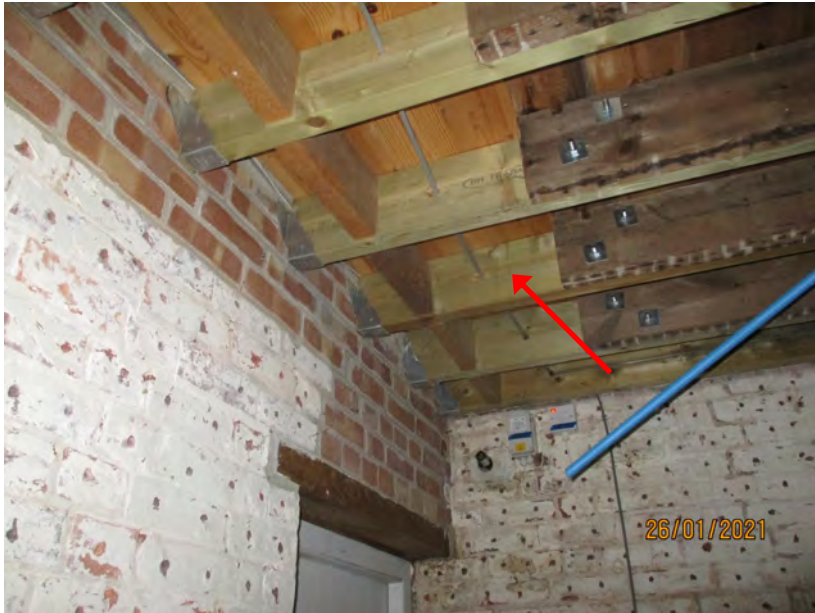
**Fig 39:**

West wing, north-west corner; showing structural repairs to suspended timber first floor structures, consistent with a previous outbreak of timber decay

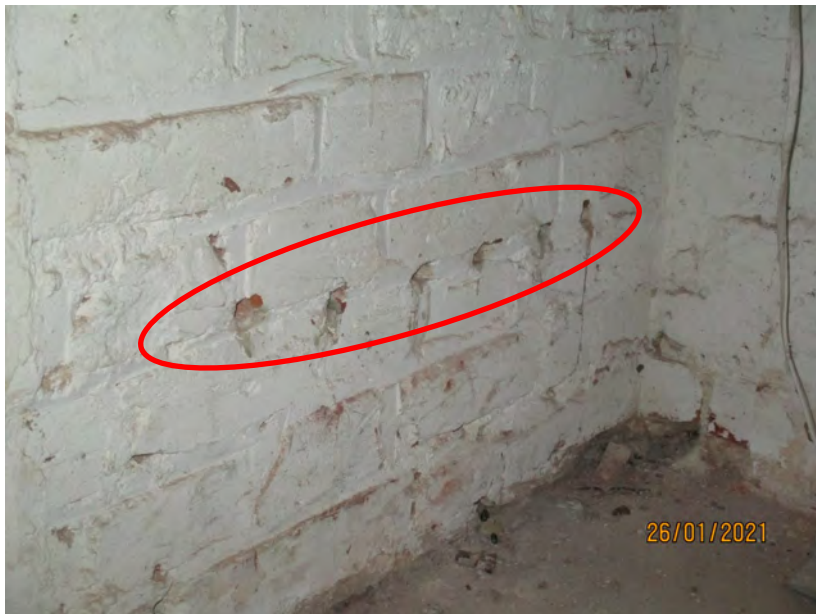
**Fig 41:**

West wing, electrical inlet room on north side; showing rows of horizontal holes drilled in external wall masonry, consistent with the installation of a chemical injected dpc on a previous refurbishment

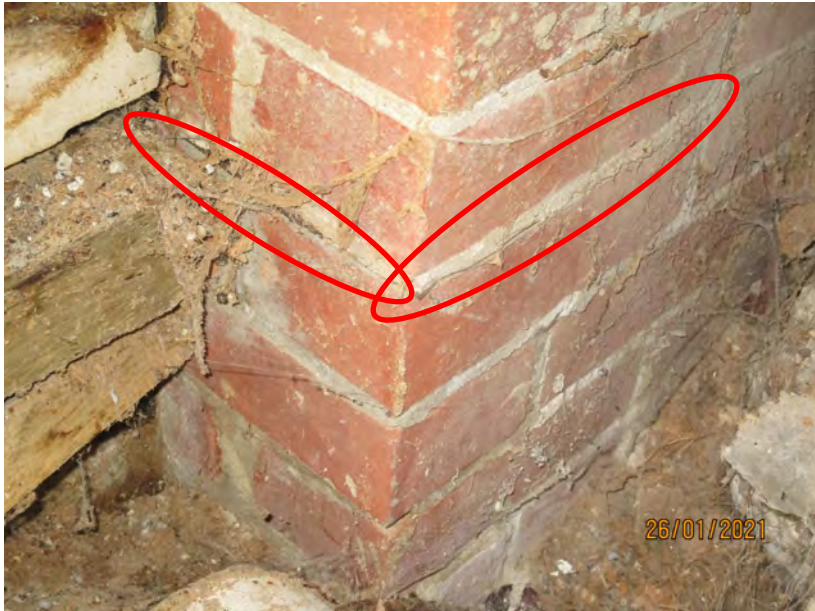
**Fig 43:**

West wing, south side; showing internal brick structures assumed to be of more recent construction than the main house, with a flexible plastic horizontal dpc below the level of floor finishes

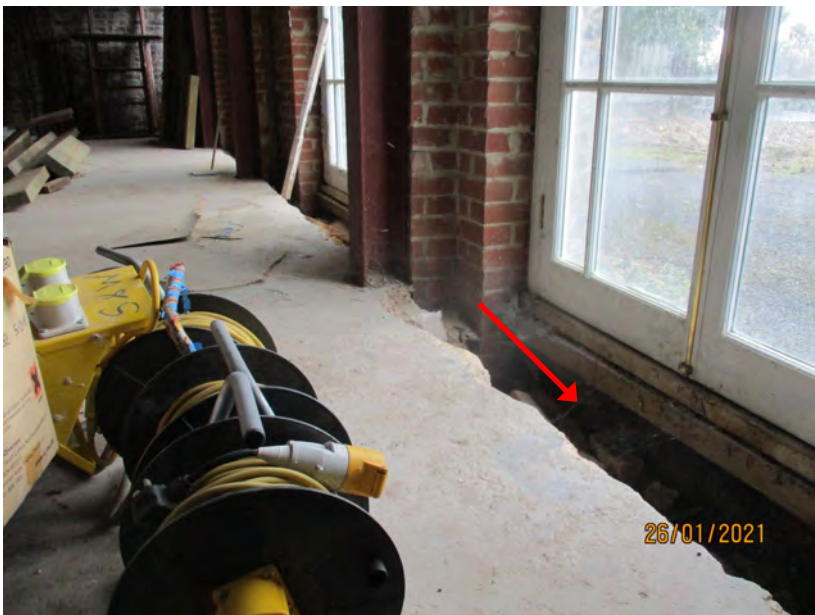
**Fig 44:**

West wing, south side; showing floor structures broken out clear of the south elevation, where raised external ground levels had increased the risk of damp penetration to the interior

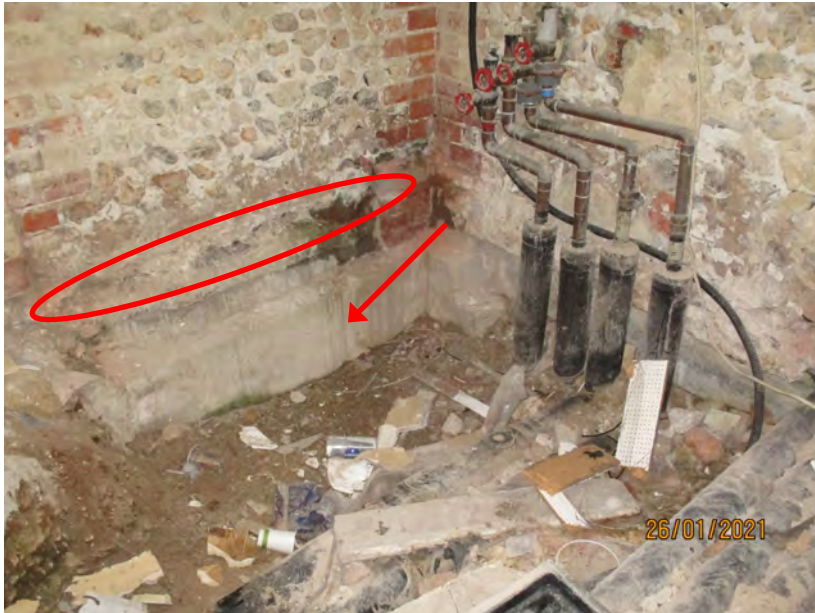
**Fig 45:**

West wing, north-east corner; showing horizontal rows of holes drilled into masonry indicating installation of a chemical injected damp-proof course on a previous refurbishment. Note underpinning concrete below the east end of the north wall

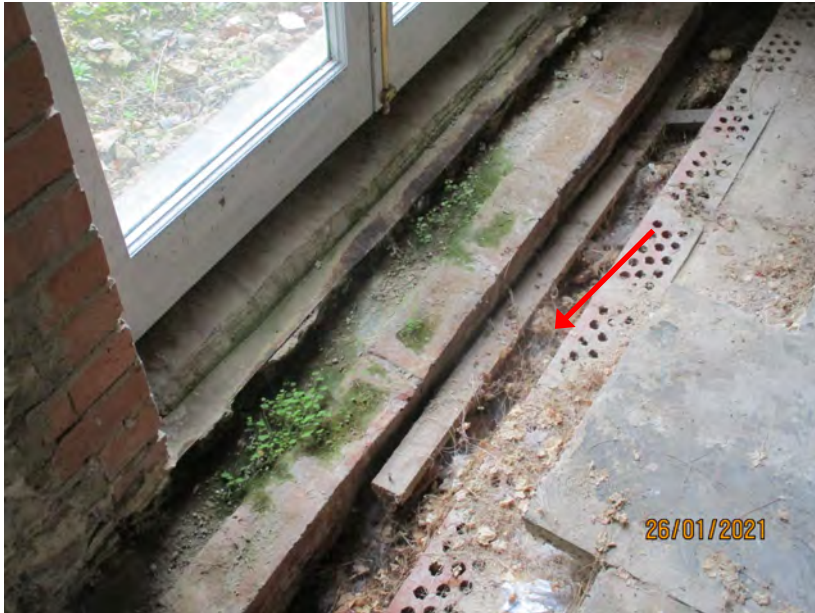
**Fig 47:**

West wing, east end of south wall; showing internal floor structures isolated from evidently damp masonry at the base of the south elevation by a trench, assumed to have been an underfloor heating detail

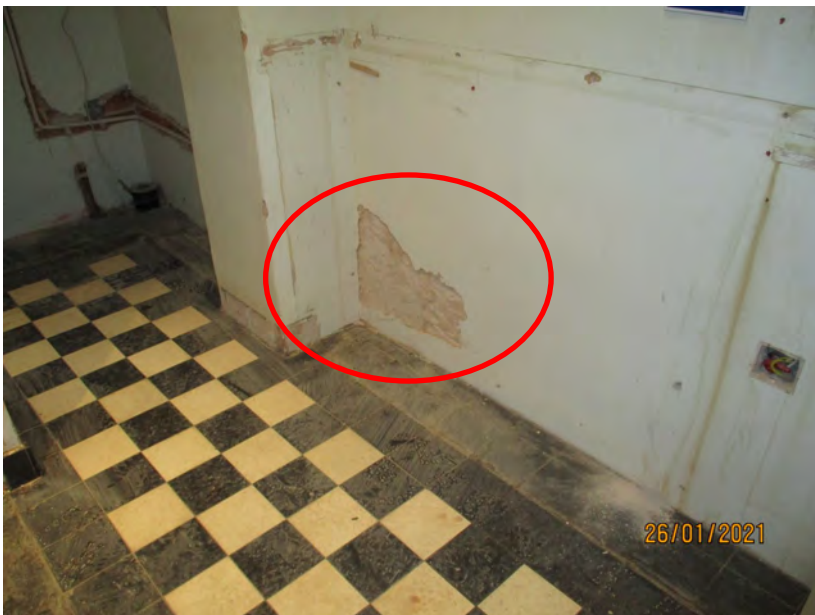
**Fig 50:**

Kitchens on north-east side of main house; showing typical isolated defect to decorative finishes and skim plaster, which may indicate problems of surface and interstitial condensation behind units on previous occupancy

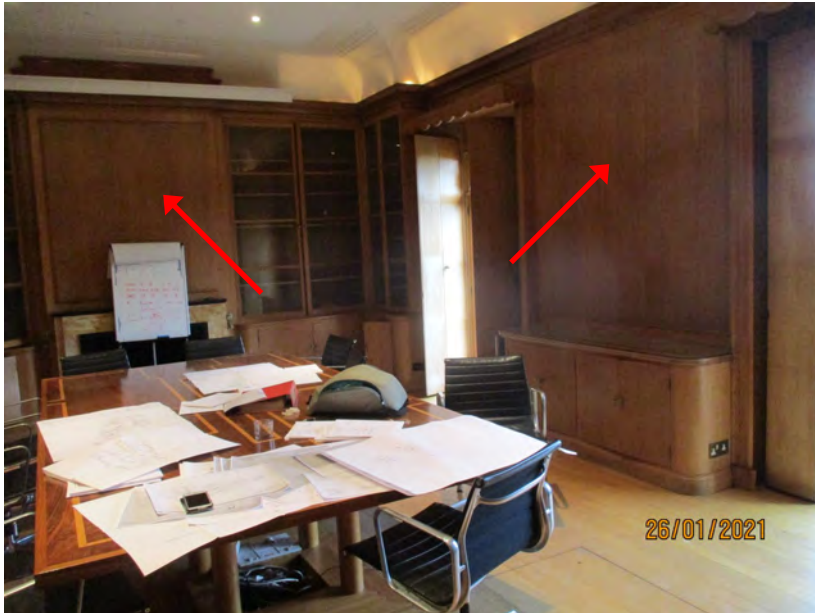
**Fig 53:**

Main house, library on south side; showing walls detailed with high quality solid oak and veneer panelling to full height, restricting detailed inspection of loadbearing masonry walls

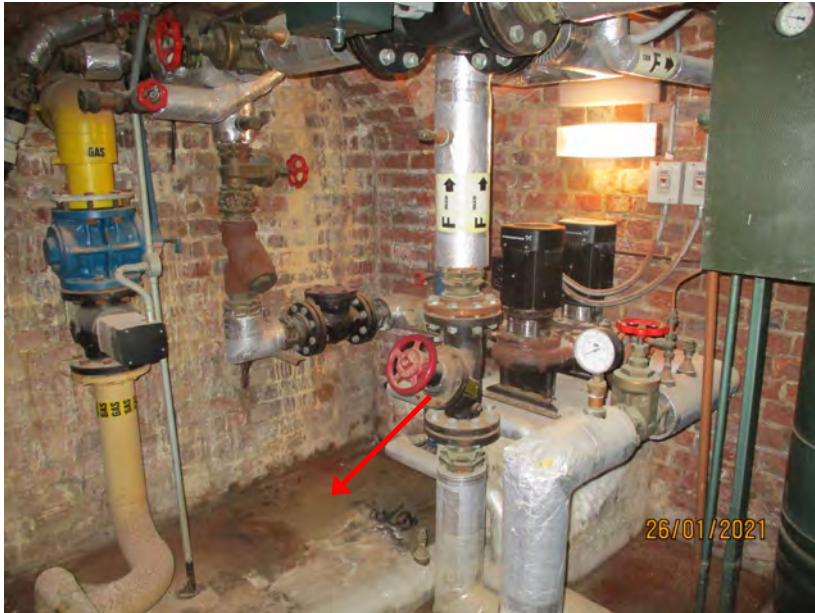
**Fig 59:**

Cellar, north-east corner; showing water ponding on floor surfaces, assumed to have escaped from plumbing systems. Water may also have been draining into the wall/floor junction from retained soil on the north side
