# Building Survey and Report

30 Christopher Way

Emsworth

Prepared for:  
Mr and Mrs Haskell

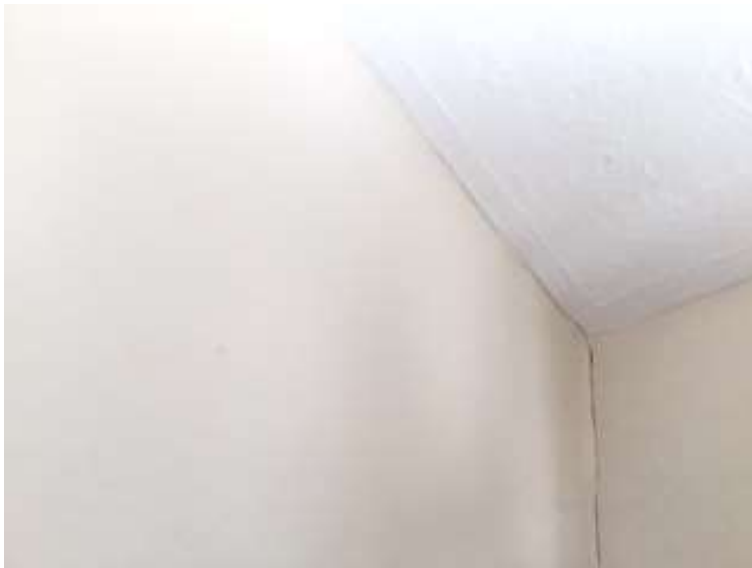
### **Kitchen Area wall between the kitchen and garage**

Cracking to the plasterwork, Category 2-3 at the abutment to the wall and ceiling then translateral vertically down the wall.

There is also a crack to the ceiling plasterwork.

The door in this area has also been affected and has subsequently been re-aligned to allow it to open.

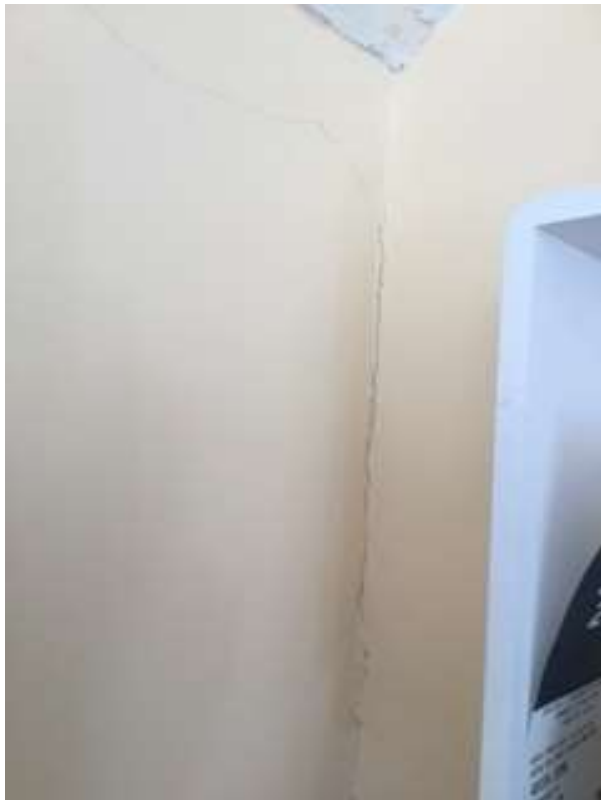
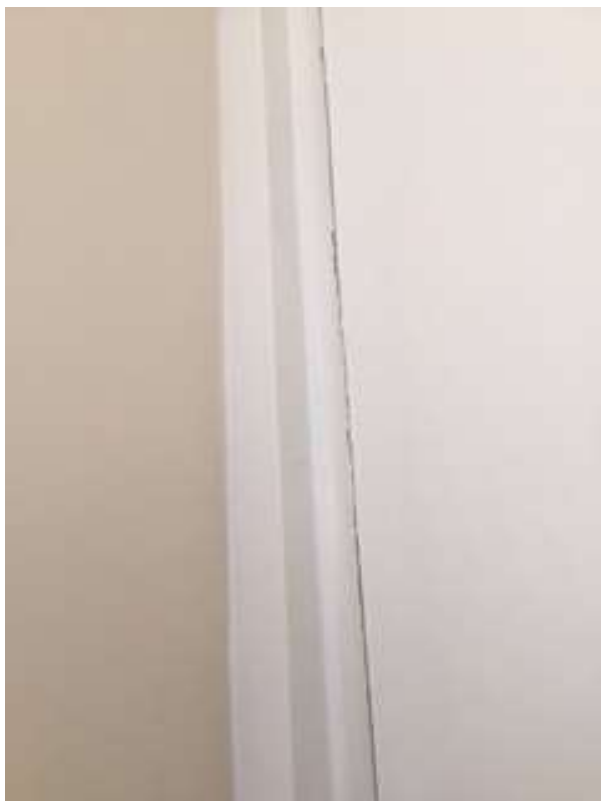
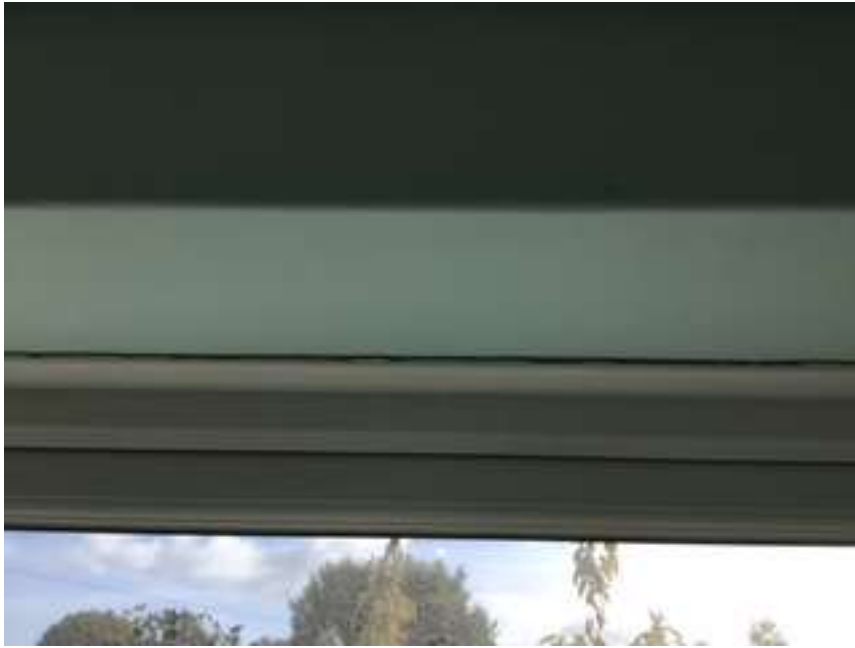
The cracks are predominantly situated within right hand side [when viewed from the road] and rear of the property but there are isolated though significant cracks throughout the property.

Below are a series of photographs giving an indication of the internal plasterworks.

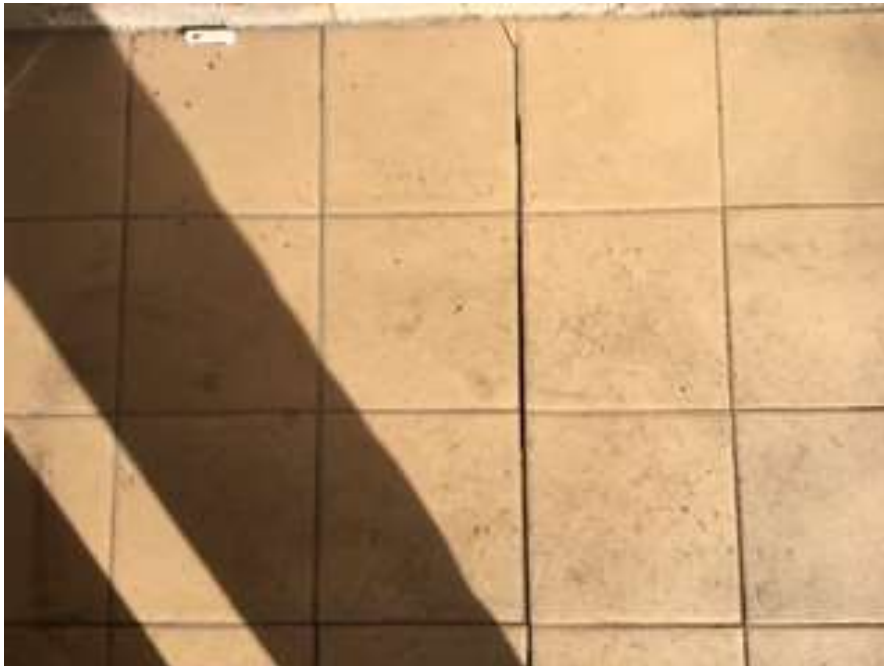
The porch entrance area has a quarry tiled surface and deflection of the floor is evident. There is a crack in the grouting of the tiles and distortion can be felt underfoot.

This is a Category 2 crack.

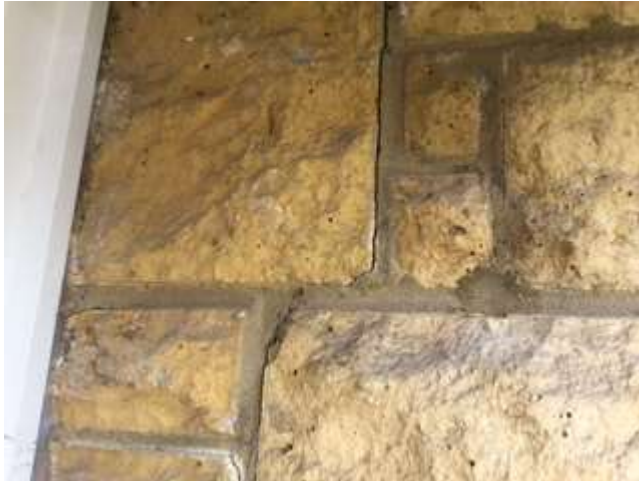
The wall adjacent to the tiled floor area within the porch is an external wall constructed of pre-cast re-constituted stone. There is a crack to the mortar joint which typifies the cracking which occurs during subsidence or heave.

This is a category 1-2 crack.

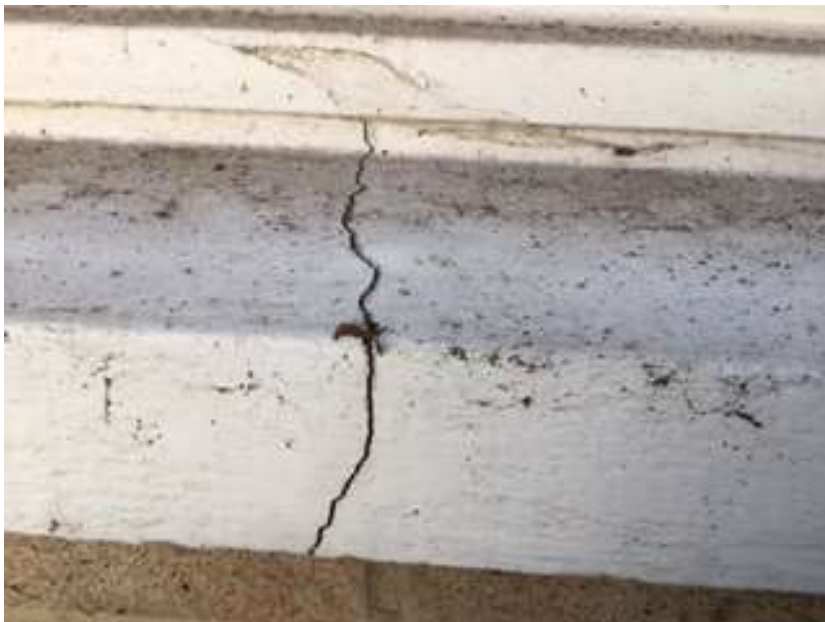
The photograph below shows a windowsill to the right-hand side elevation.

This is a category 2-3 crack and is a typical presentation of subsidence within a building that has caused the concrete still to shear in the vertical plane. Cracks of this nature are not caused by impact.

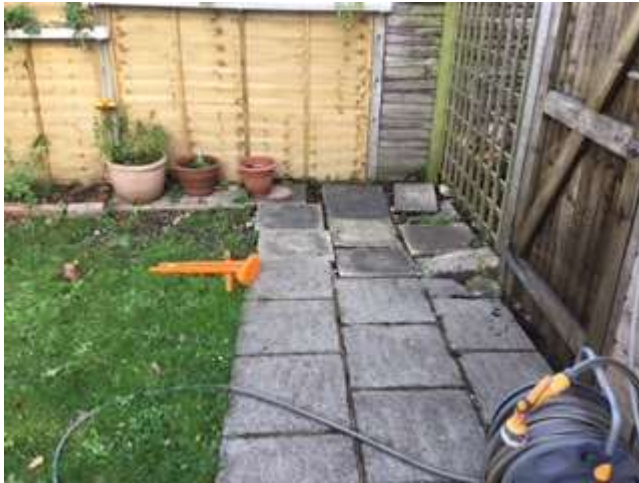
The photographs below shows distortion of the rear patio paving slabs, this is synonymous with ground movement.

The distortions indicated in the above photographs are undoubtedly occasioned by the activity of the Oak tree root system as they seek water in the surrounding sub strata.

There is substantial evidence and mitigation within both my report and the one conducted by B. Maule and Company in 2018 to effect the removal of the tree preservation order [TPO] and to significantly reduce the tree in height and spread or to remove the tree from the premises entirely.

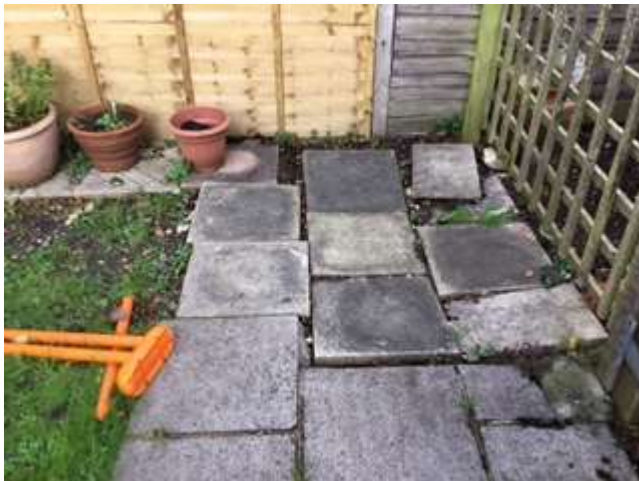
The photograph below shows significant distortion of the paving slabs.
