# Hutton + Rostron Environmental Investigations Limited

## Southleigh Park – Stables: Lintel investigation

Site note C2 for 8 January 2021, job no. 152.09

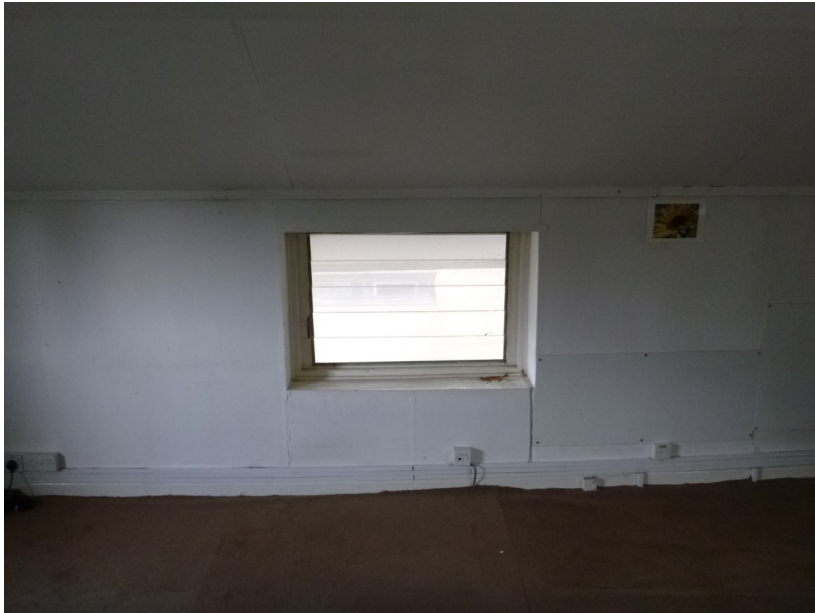
1F.A1

| REFERENCE | ITEM | OBSERVATIONS | RECOMMENDATIONS | CLIENT COMMENTS |
|---|---|---|---|---|
| <b>SNc2.1.1</b> | 1F.A1<br>(H+R code for first floor, aperture 1) | Integral with roof structure, eaves rafter plate spans over window aperture forming a lintel<br><br>Softwood, 100 x 120mm<br><br>No decay detected upon drilling, deep moisture content too dry for decay to occur | <i>No chemical treatments required</i><br><br><i>Lintel may be retained, subject to no further water penetration occurring and at the discretion of the Structural Engineer</i> | |

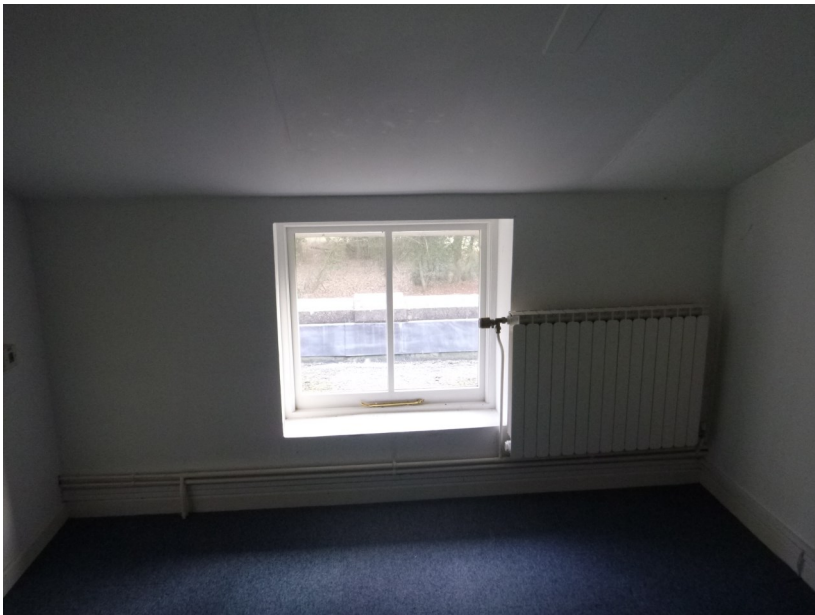
| REFERENCE | ITEM | OBSERVATIONS | RECOMMENDATIONS | CLIENT COMMENTS |
|---|---|---|---|---|
| <b>SNc2.1.2</b> | 1F.A2 | As for 1F.A1 | <i>As for 1F.A1</i> | |

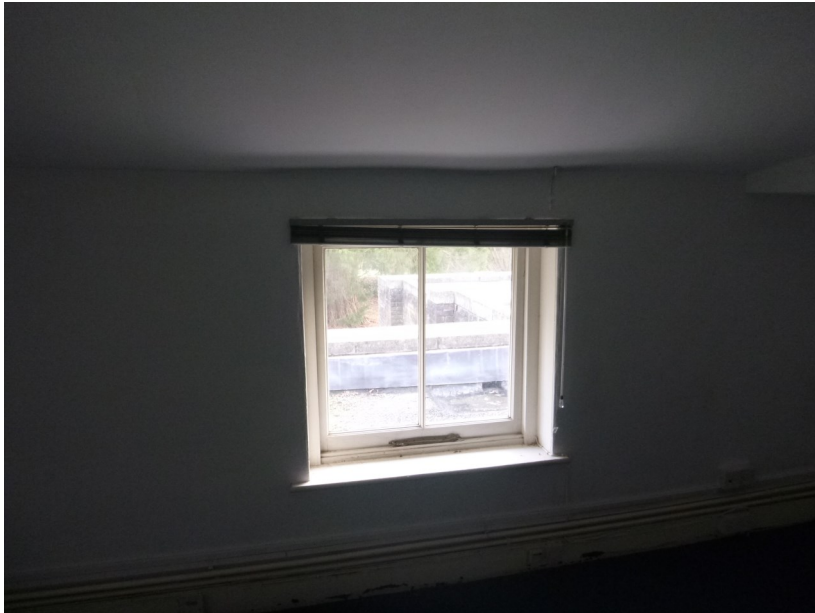
| REFERENCE | ITEM | OBSERVATIONS | RECOMMENDATIONS | CLIENT COMMENTS |
|---|---|---|---|---|
| <b>SNc2.1.3</b> | 1F.A3 | As for 1F.A1 | <i>As for 1F.A1</i> | |

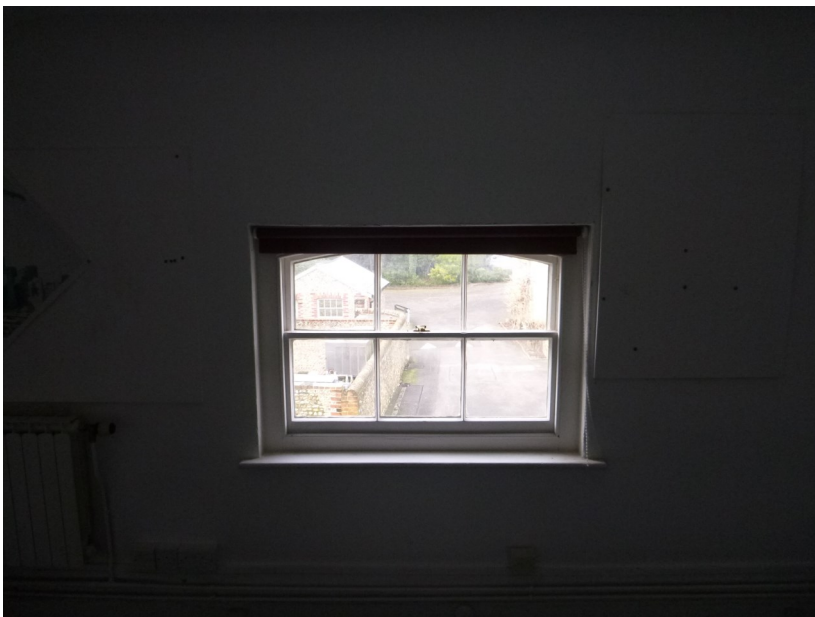
| REFERENCE | ITEM | OBSERVATIONS | RECOMMENDATIONS | CLIENT COMMENTS |
|---|---|---|---|---|
| <b>SNc2.1.4</b> | 1F.A4 | Hardwood, oak. Perhaps historic timber salvaged from an earlier structure or the most original form of the stables<br><br>120mm high, 150mm deep?<br><br>No decay detected upon drilling, deep moisture content too dry for decay to occur | <i>No chemical treatments required</i><br><br><i>Lintel may be retained, subject to no further water penetration occurring and at the discretion of the Structural Engineer</i> | |

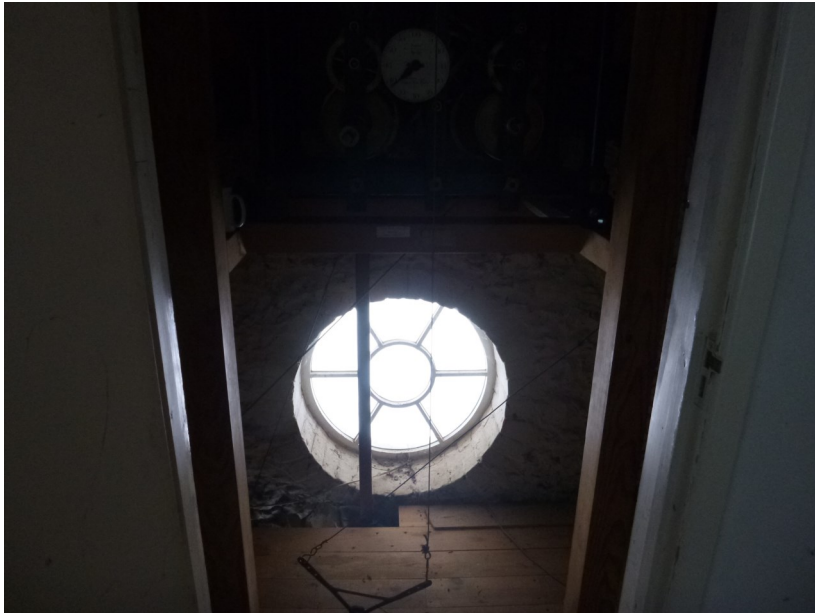
| REFERENCE | ITEM | OBSERVATIONS | RECOMMENDATIONS | CLIENT COMMENTS |
|---|---|---|---|---|
| <b>SNc2.1.5</b> | 1F.A5 | Brick arch, circular aperture | <i>Lintel may be retained, at the discretion of the Structural Engineer</i> | |

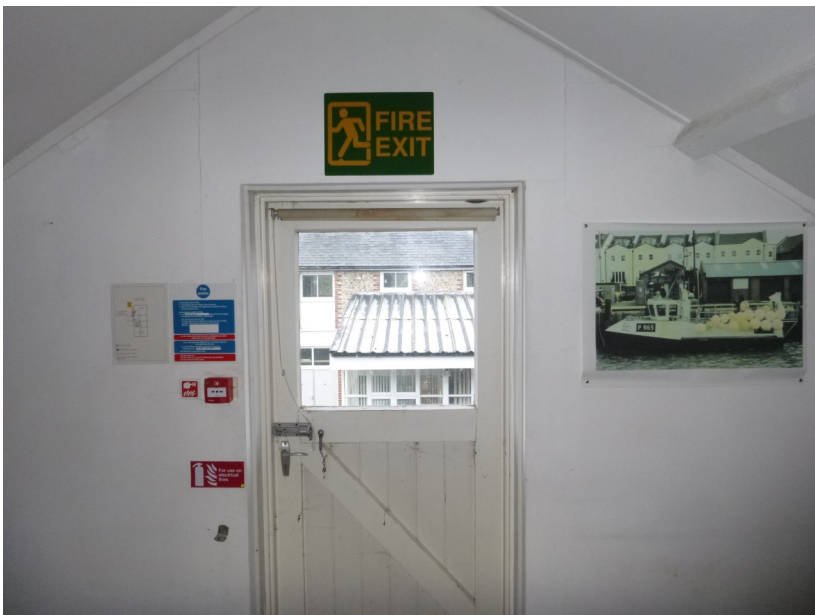
| REFERENCE | ITEM | OBSERVATIONS | RECOMMENDATIONS | CLIENT COMMENTS |
|---|---|---|---|---|
| <b>SNc2.1.6</b> | 1F.A6 | Steel, modern, branded 'catnic' | <i>Lintel may be retained, at the discretion of the Structural Engineer</i> | |

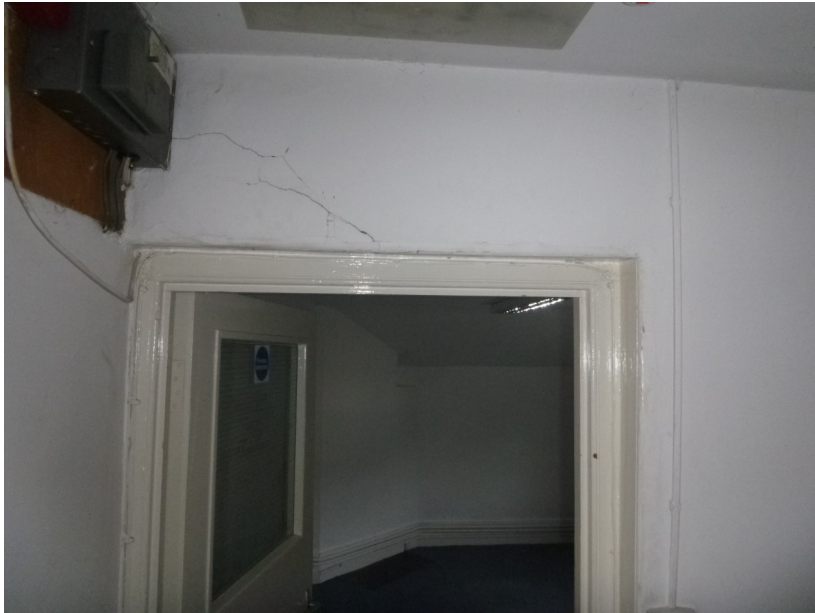
| REFERENCE | ITEM | OBSERVATIONS | RECOMMENDATIONS | CLIENT COMMENTS |
|---|---|---|---|---|
| <b>SNc2.1.7</b> | 1F.A7 | Softwood, 55 x 220mm<br><br>No decay detected upon drilling, deep moisture content too dry for decay to occur | <i>No chemical treatments required</i><br><br><i>Lintel may be retained, subject to no further water penetration occurring and at the discretion of the Structural Engineer</i> | |

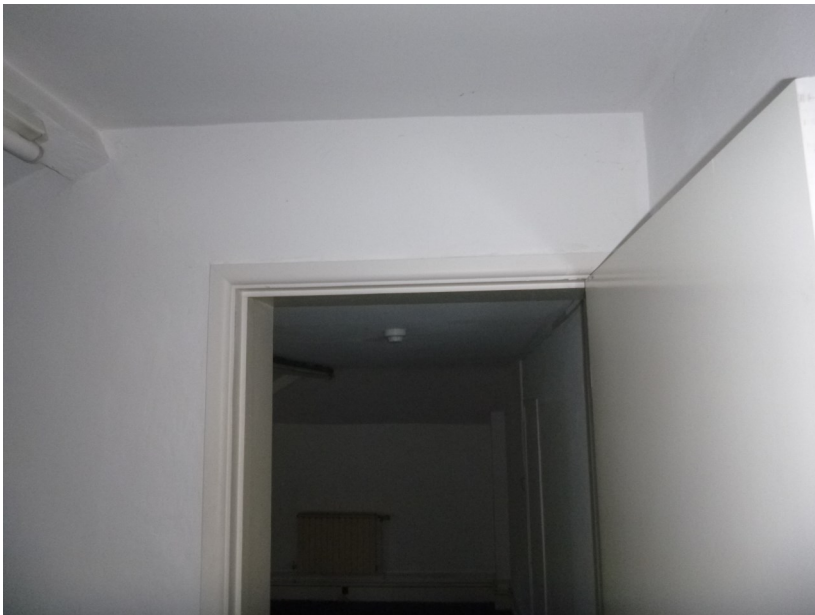
| REFERENCE | ITEM | OBSERVATIONS | RECOMMENDATIONS | CLIENT COMMENTS |
|---|---|---|---|---|
| <b>SNc2.1.8</b> | 1F.A8 | No lintel present, flint rubble walling bears onto timber doorframe | <i>Design team to consider generally the challenges of potential alterations to flint rubble walling which is not easily modified, compared to conventional brickwork</i> | |

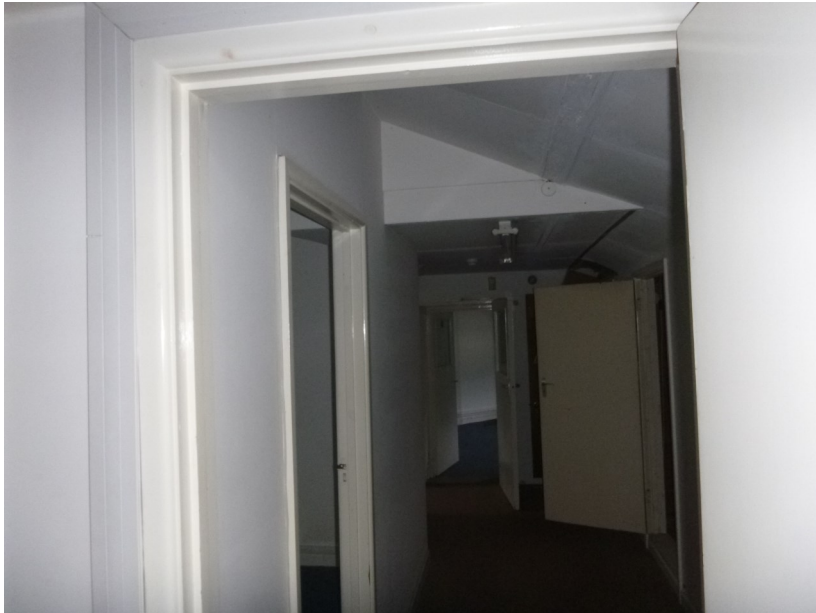
First floor; showing typical internal apertures supported by studwork

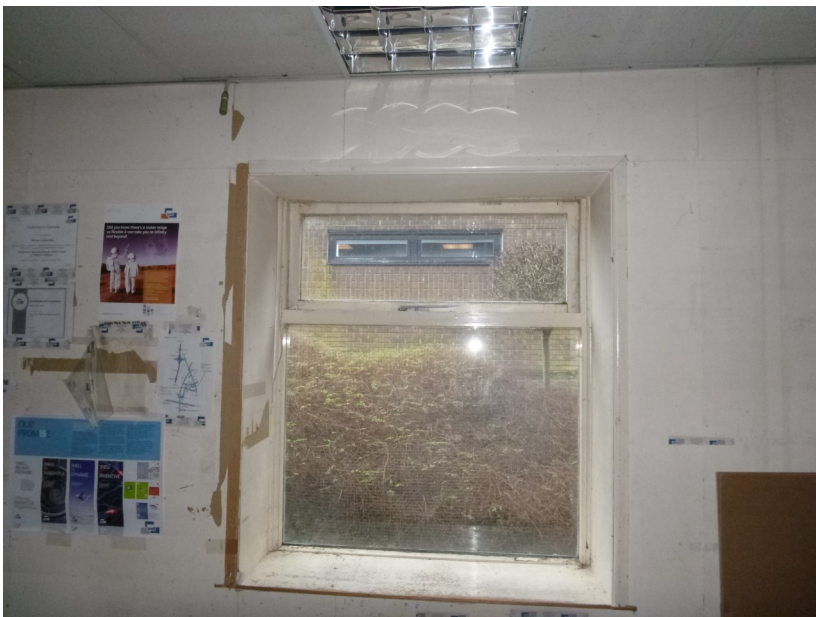
GF.A1

| REFERENCE | ITEM | OBSERVATIONS | RECOMMENDATIONS | CLIENT COMMENTS |
|---|---|---|---|---|
| <b>SNc2.2.1</b> | GF.A1<br>(H+R code for ground floor, aperture 1) | Softwood, 150mm high, 150mm deep?<br><br>No decay detected upon drilling, deep moisture content too dry for decay to occur | <i>No chemical treatments required</i><br><br><i>Lintel may be retained, subject to no further water penetration occurring and at the discretion of the Structural Engineer</i> | |

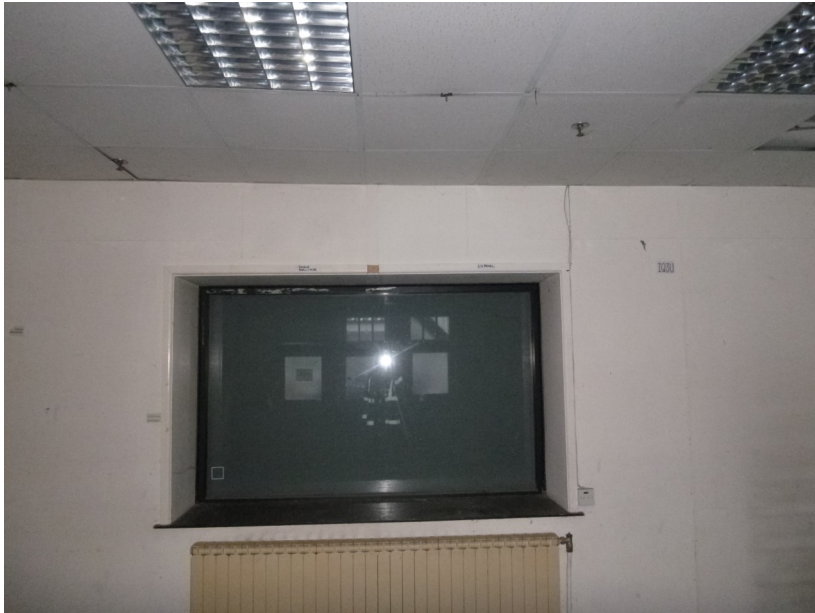
| REFERENCE | ITEM | OBSERVATIONS | RECOMMENDATIONS | CLIENT COMMENTS |
|---|---|---|---|---|
| <b>SNc2.2.2</b> | GF.A2 | Concrete, cast in-situ, assumed embedded steel reinforcement, 250 x 300mm<br><br>Dating from modern alternations and construction of adjoining new-build, supports flint rubble walling above | <i>Lintel may be retained, at the discretion of the Structural Engineer</i> | |

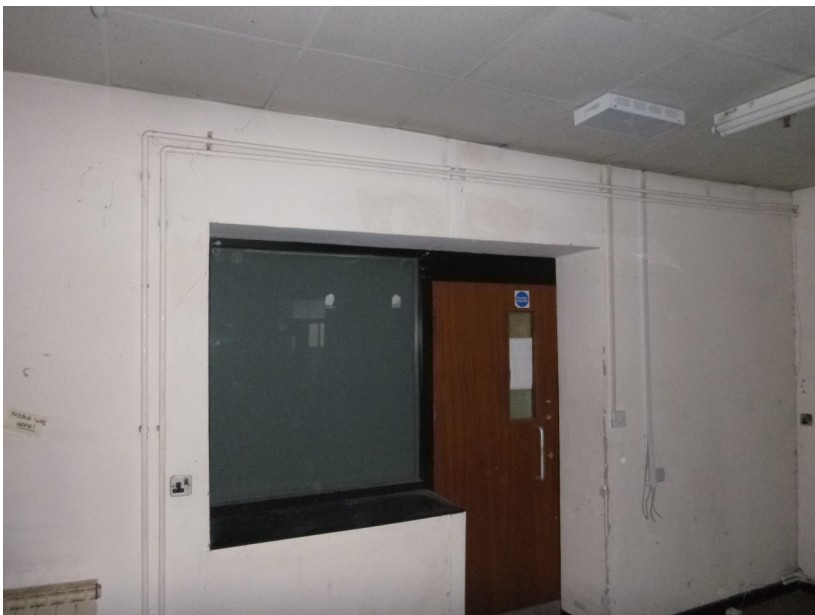
| REFERENCE | ITEM | OBSERVATIONS | RECOMMENDATIONS | CLIENT COMMENTS |
|---|---|---|---|---|
| <b>SNc2.2.3</b> | GF.A3 | As for GF.A2 | <i>As for GF.A2</i> | |

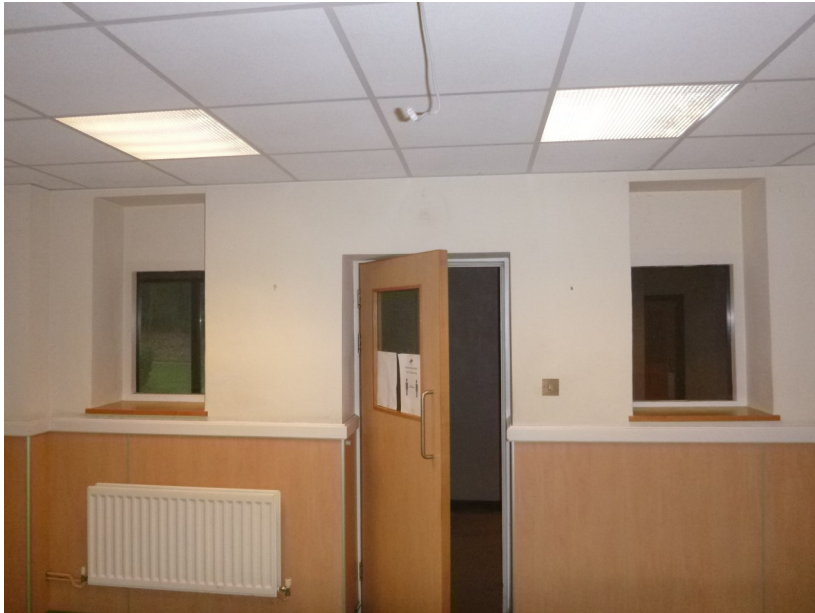
GF.A4  
GF.A5  
GF.A6

| REFERENCE | ITEM | OBSERVATIONS | RECOMMENDATIONS | CLIENT COMMENTS |
|---|---|---|---|---|
| <b>SNc2.2.4</b> | GF.A4 | Solid upon drilling, assumed concrete | <i>Lintel may be retained, at the discretion of the Structural Engineer</i> | |
| <b>SNc2.2.5</b> | GF.A5 | Void over doorhead inspected via videoscope<br><br>2no. small-section timber lintels, 65 x 110mm?, each supporting a single leaf of brickwork, no visible signs of decay<br><br>Concrete lintel may span over, some distance above | <i>Lintel may be retained, at the discretion of the Structural Engineer</i> | |
| <b>SNc2.2.6</b> | GF.A6 | Solid upon drilling, assumed concrete | <i>Lintel may be retained, at the discretion of the Structural Engineer</i> | |

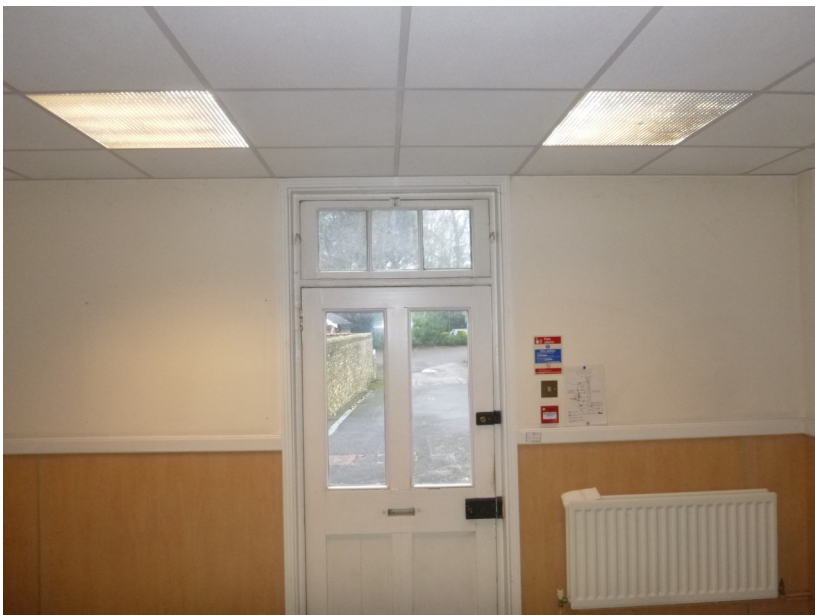
| REFERENCE | ITEM | OBSERVATIONS | RECOMMENDATIONS | CLIENT COMMENTS |
|---|---|---|---|---|
| <b>SNc2.2.8</b> | GF.A8 | Softwood<br><br>No decay detected upon drilling, deep moisture content too dry for decay to occur | <i>No chemical treatments required</i><br><br><i>Lintel may be retained, subject to no further water penetration occurring and at the discretion of the Structural Engineer</i> | |

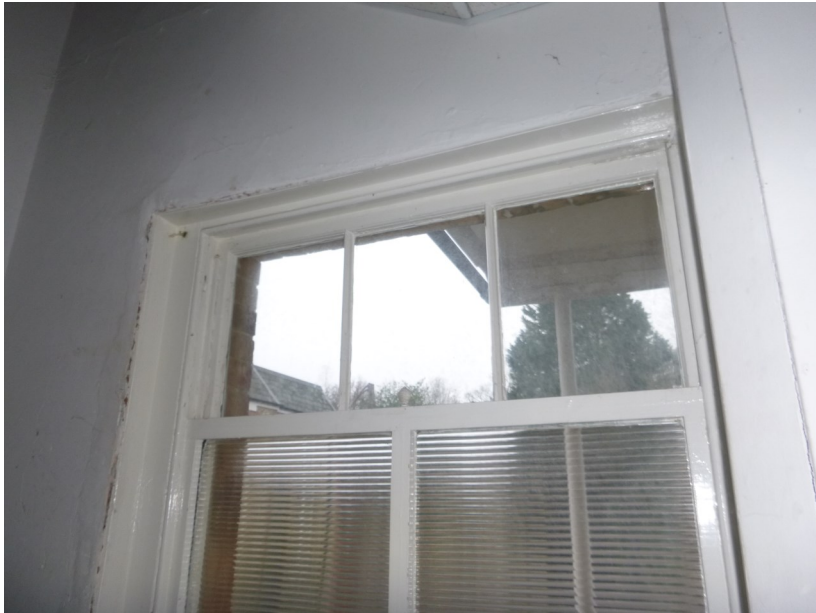
| REFERENCE | ITEM | OBSERVATIONS | RECOMMENDATIONS | CLIENT COMMENTS |
|---|---|---|---|---|
| <b>SNc2.2.9</b> | GF.A9 | Softwood, 110 x 150mm<br><br>No decay detected upon drilling, deep moisture content too dry for decay to occur<br><br>Evidence of historic water ingress from nearby rainwater hopper/downpipe. Resultant superficial deterioration has affected the lintel by wet rot and weevil, this was confirmed as non-structurally significant | <i>No chemical treatments required</i><br><br><i>Lintel may be retained, subject to no further water penetration occurring and at the discretion of the Structural Engineer</i><br><br><i>Care should be taken to refurbish and maintain roof drainage systems on an ongoing basis</i> | |

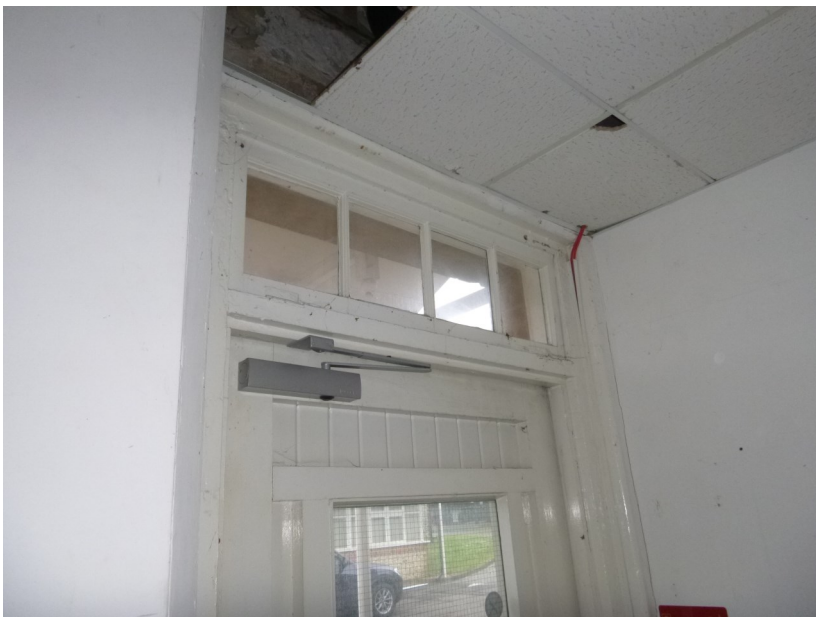
| REFERENCE | ITEM | OBSERVATIONS | RECOMMENDATIONS | CLIENT COMMENTS |
|---|---|---|---|---|
| <b>SNc2.2.10</b> | GF.A10 | Softwood, 110 x 150mm<br><br>No decay detected upon drilling, deep moisture content too dry for decay to occur<br><br>A horizontal rendered band spanning at the exterior of this aperture was probe drilled which revealed underlying brickwork | <i>No chemical treatments required</i><br><br><i>Lintel may be retained, subject to no further water penetration occurring and at the discretion of the Structural Engineer</i> | |

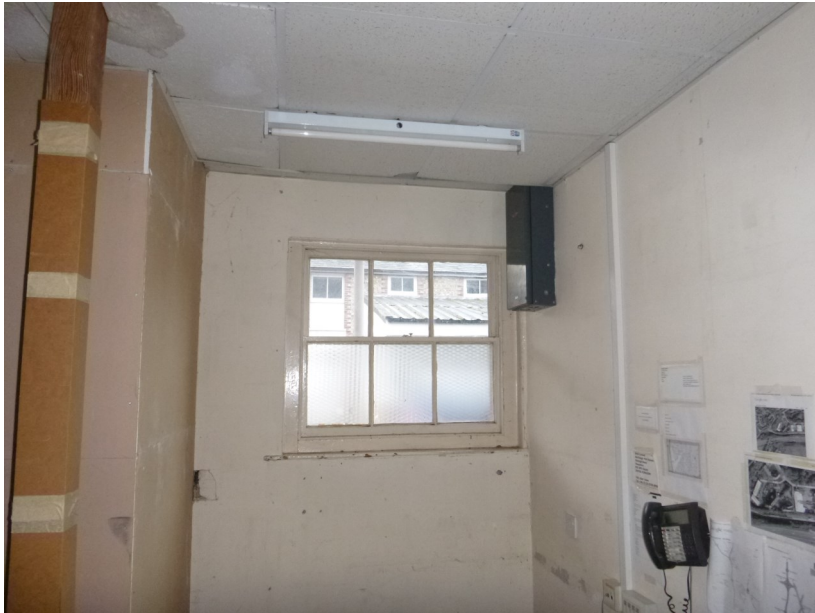
| REFERENCE | ITEM | OBSERVATIONS | RECOMMENDATIONS | CLIENT COMMENTS |
|---|---|---|---|---|
| <b>SNc2.2.11</b> | GF.A11 | Softwood<br><br>No decay detected upon drilling, deep moisture content too dry for decay to occur | <i>No chemical treatments required</i><br><br><i>Lintel may be retained, subject to no further water penetration occurring and at the discretion of the Structural Engineer</i> | |

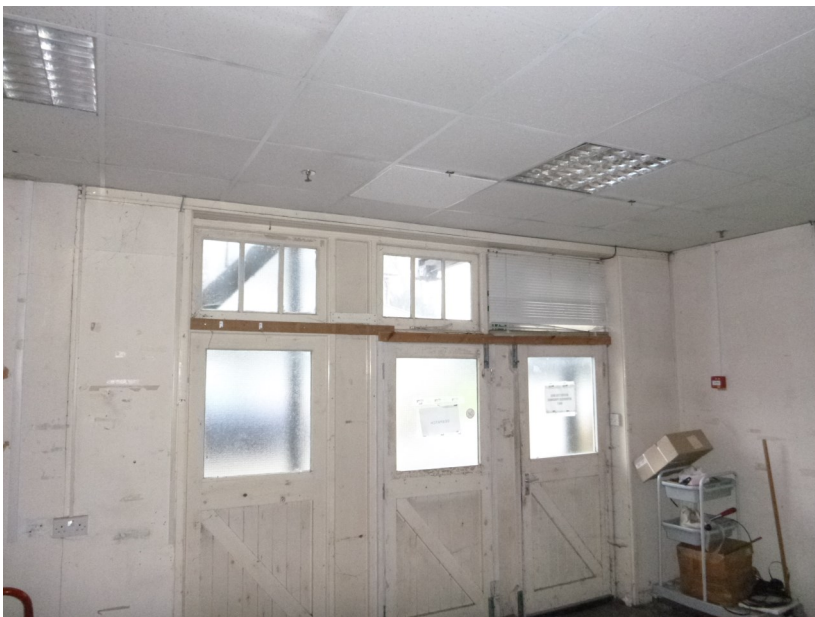
| REFERENCE | ITEM | OBSERVATIONS | RECOMMENDATIONS | CLIENT COMMENTS |
|---|---|---|---|---|
| <b>SNc2.2.12</b> | GF.A12 | Rolled steel, 'I' section<br><br>225 x 100mm overall<br>45 x 5mm flanges<br>5mm web thickness | <i>Lintel may be retained at the discretion of the Structural Engineer</i> | |

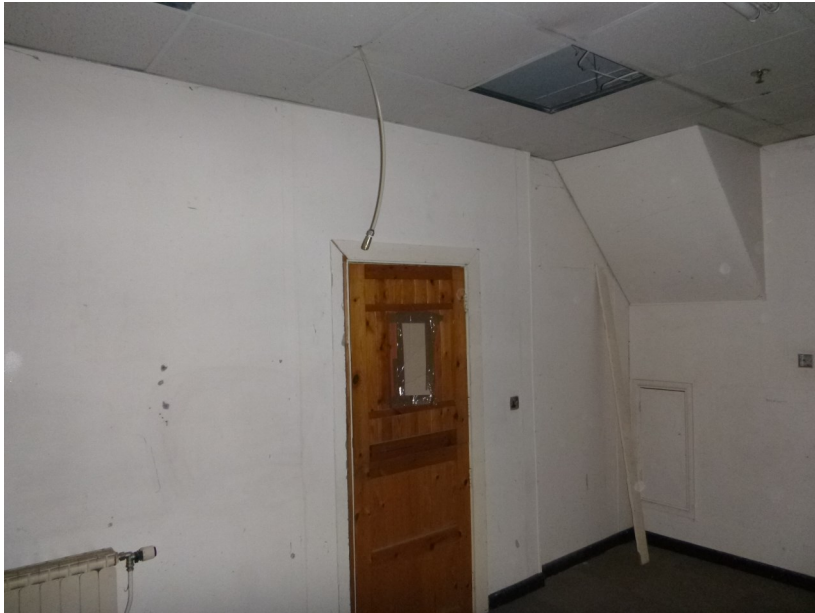
| REFERENCE | ITEM | OBSERVATIONS | RECOMMENDATIONS | CLIENT COMMENTS |
|---|---|---|---|---|
| <b>SNc2.2.13</b> | GF.A13 | No lintel present, flint rubble walling bears onto timber doorframe | <i>Design team to consider generally the challenges of potential alterations to flint rubble walling which is not easily modified, compared to conventional brickwork</i> | |

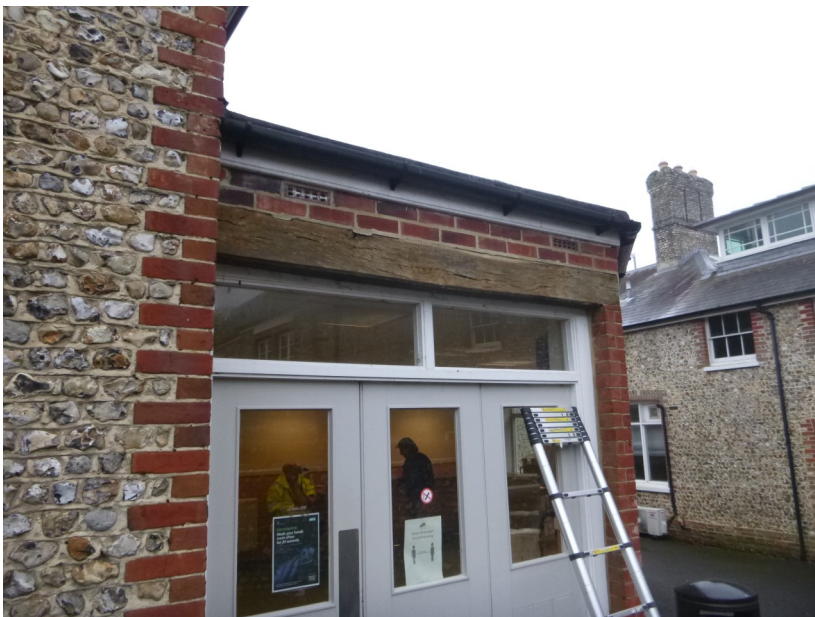
| REFERENCE | ITEM | OBSERVATIONS | RECOMMENDATIONS | CLIENT COMMENTS |
|---|---|---|---|---|
| <b>SNc2.2.14</b> | GF.A14 | Exposed external lintel, oak, 220 x 120mm, no decay detected<br><br>Internal lintel, oak, 200 x 120mm, pocket of partial decay at mid-span, ~20 per cent section loss at topside, not deemed active or structurally significant<br><br>Secondary internal lintel, softwood, 150 x 120mm, integral with joist plate of flat roof, no decay detected | <i>No chemical treatments required</i><br><br><i>Lintel may be retained, subject to no further water penetration occurring and at the discretion of the Structural Engineer</i> | |

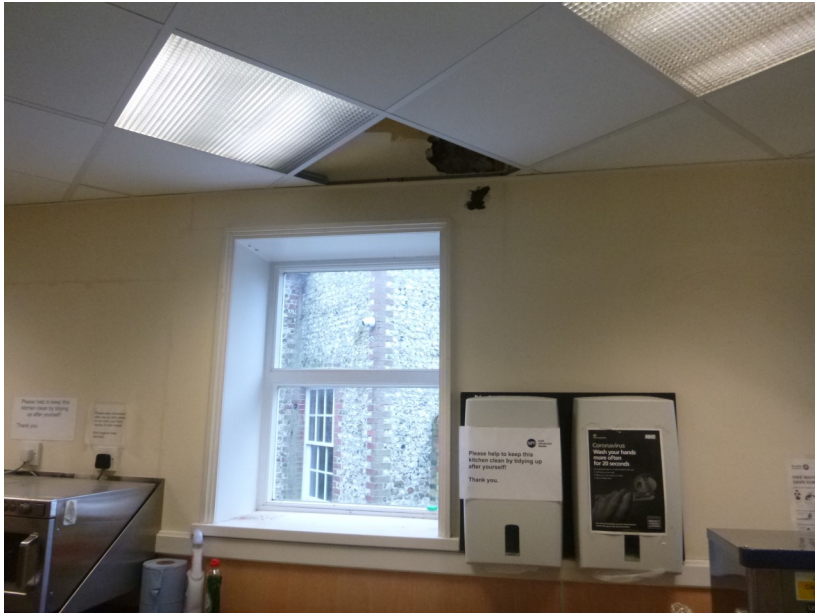
| REFERENCE | ITEM | OBSERVATIONS | RECOMMENDATIONS | CLIENT COMMENTS |
|---|---|---|---|---|
| <b>SNc2.2.15</b> | GF.A15 | Softwood<br><br>Structurally decayed by wet rot and beetle due to a history of leakage from flat roof above | <i>Lintel to be replaced in pre-cast concrete, as directed by the Structural Engineer</i> | |

Lintel was structurally decayed, to be replaced in pre cast concrete

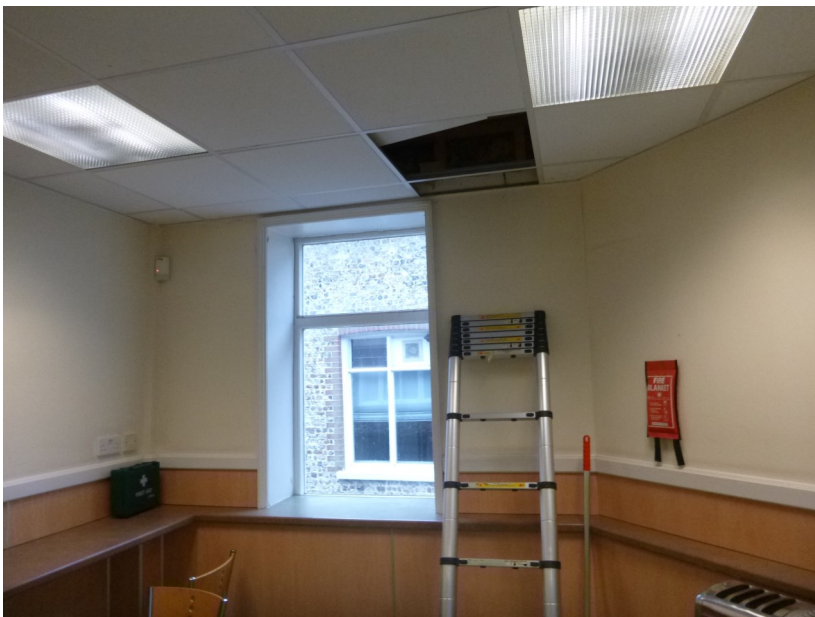
| REFERENCE | ITEM | OBSERVATIONS | RECOMMENDATIONS | CLIENT COMMENTS |
|---|---|---|---|---|
| <b>SNc2.2.16</b> | GF.A16 | Softwood<br><br>Partially decayed by beetle due. Active water ingress leading to saturated moisture contents and condition for further wet rot decay | <i>Lintel to be replaced in pre-cast concrete, as directed by the Structural Engineer</i> | |

Lintel was structurally decayed, to be replaced in pre cast concrete

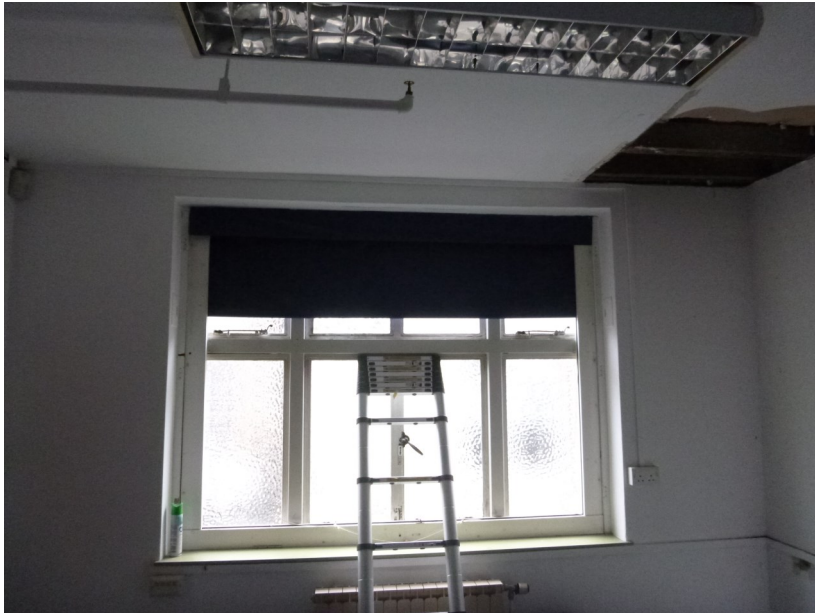
| REFERENCE | ITEM | OBSERVATIONS | RECOMMENDATIONS | CLIENT COMMENTS |
|---|---|---|---|---|
| <b>SNc2.2.17</b> | GF.A17 | Concrete, cast in-situ?<br><br>150mm high<br>150mm deep? | <i>Lintel may be retained at the discretion of the Structural Engineer</i> | |

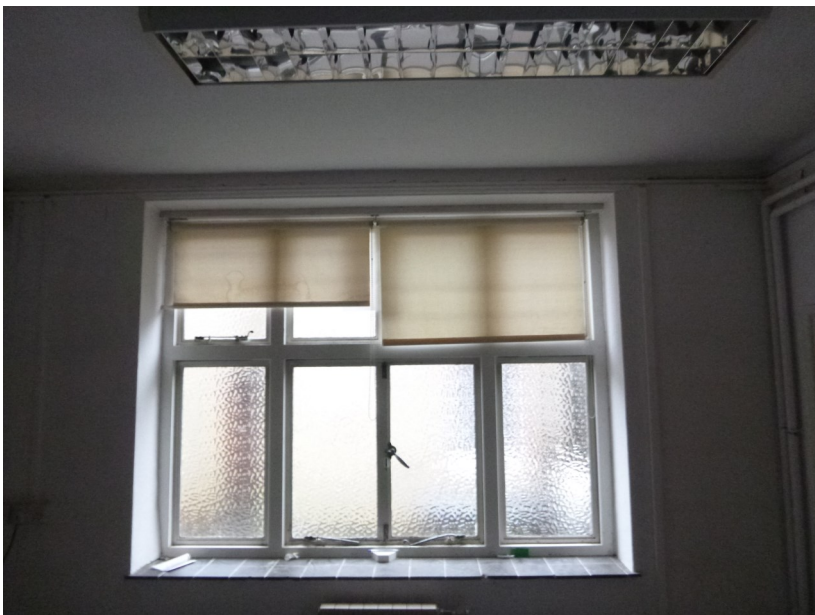
| REFERENCE | ITEM | OBSERVATIONS | RECOMMENDATIONS | CLIENT COMMENTS |
|---|---|---|---|---|
| <b>SNc2.2.18</b> | GF.A18 | Concrete, cast in-situ?<br><br>150mm high<br>150mm deep? | <i>Lintel may be retained at the discretion of the Structural Engineer</i> | |
