## TECHNICAL NOTE

Date: 24 March 2022  
To: Craig Burden – Redrow – Head of Planning  
Pete Hodgson – Redrow – Planner  
From: Stefan Kowalczyk – RPS – Senior Arb Consultant  
Pages: 7 inc. this page  
Regarding: Tree Protection Fencing at Camp Field, Havant

### Inspection of Tree Protection Fencing at Camp Field, Havant

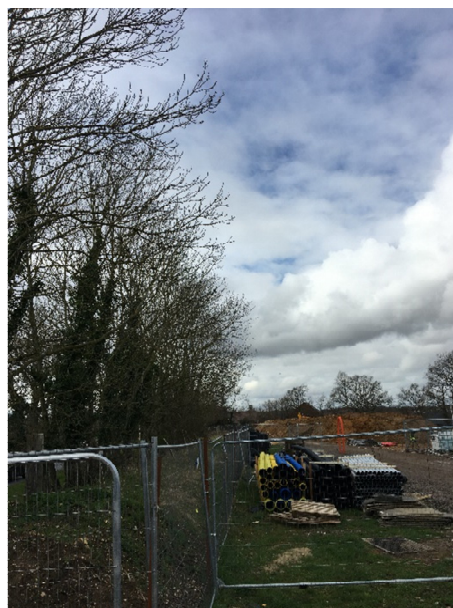
The Tree Protection Fencing (TPF) looks to be closer to the tree stems than specified on the Tree Protection and Removal Plan i.e., not in accordance with the approved plan, the fencing should cover more ground than is currently being protected.

However, given the quality of trees (category C) and their situation – on the southside of an existing bund, retaining the TPF in its current location is low risk and similarly, adequate to protect the likely rooting area of the relevant trees.

Figure 1. View looking westwards. Bartons Rd to the left.

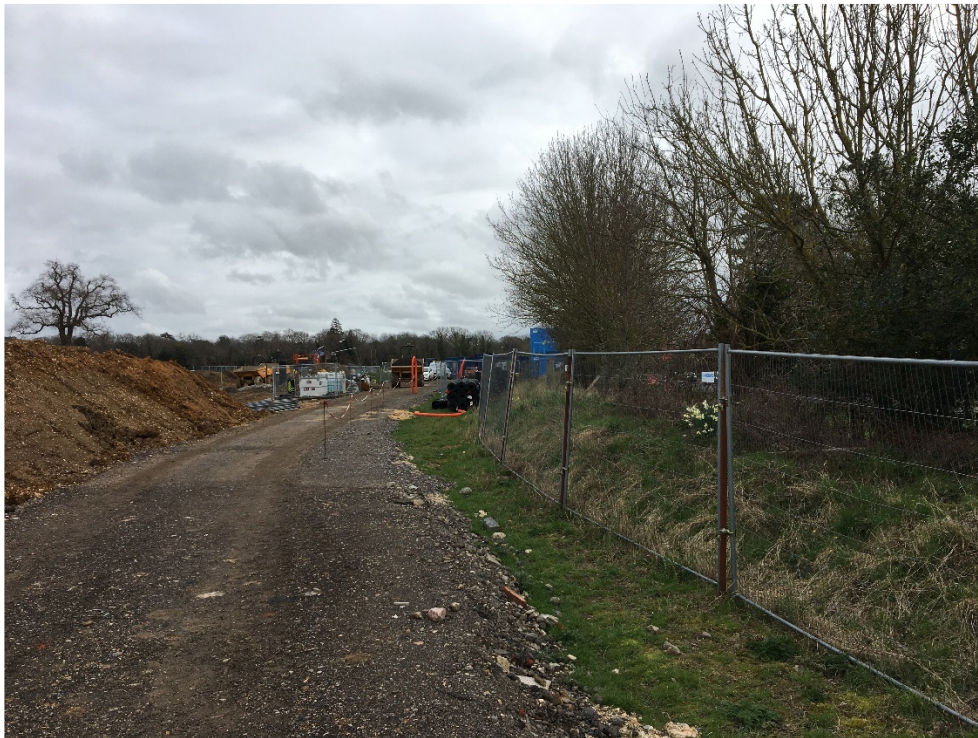
Figure 2. View looking eastwards. Bartons Rd to the right.

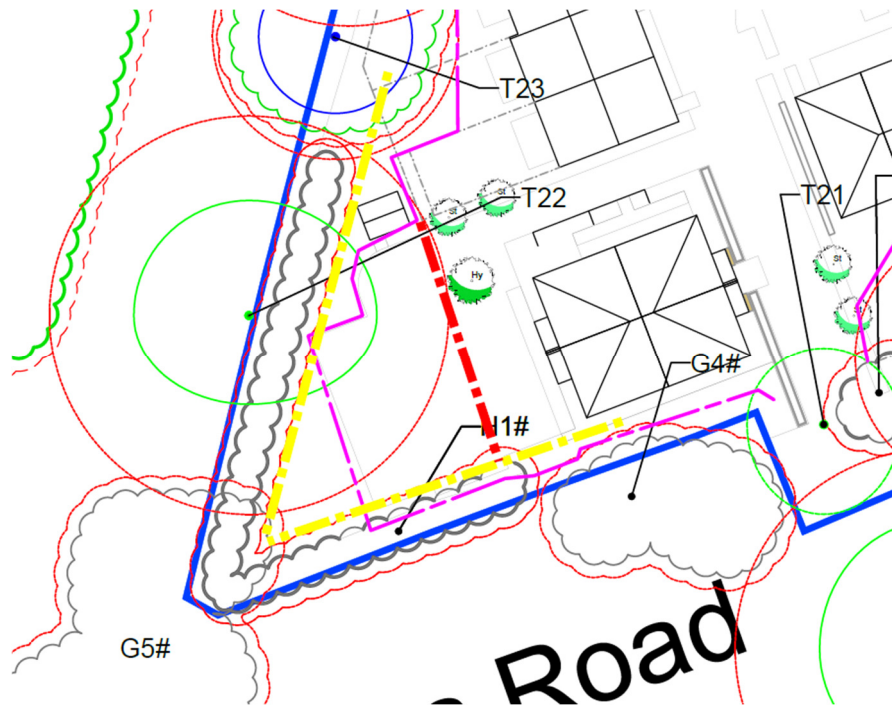
G4# and H1# is a continuation of the southern boundary tree line and is of no particular merit. T22, Oak, on the other hand is a high-quality tree with a large RPA located on the western boundary. TPF is currently positioned incorrectly.

- 1) Yellow (dash dot) line represents the current location of TPF.
- 2) Pink/Magenta (dash dot) line represents the approved location of TPF.
- 3) Red (dash dot) line represents the proposed line of TPF.

Furthermore, a pilling mat of hardcore has been laid within the area marked by the red line. This seems to be unnecessary due to the large distance between the pilling mat in this area and any proposed building foundation.

Figure 3. Snapshot of approved Tree Protection Plan existing, approved & proposed TPF location

- 1) Present question to construction asking whether the pilling mat can be removed from the area within the red line.
- 2) Re-instate TPF to the red line at best or pink/magenta lines at least.

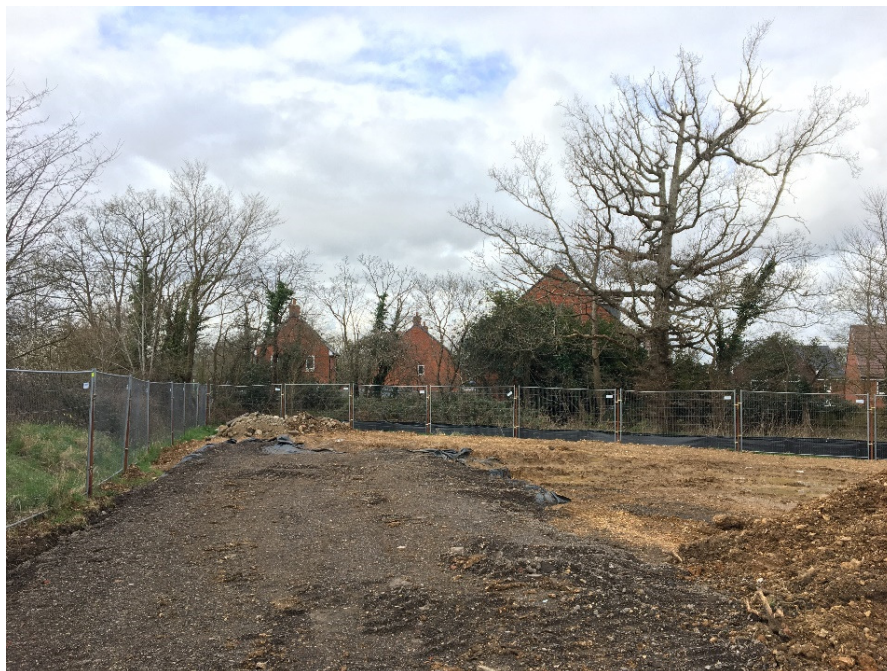
Figure 4. View looking westwards. T22 on the right side of the picture. Pilling mat in view.

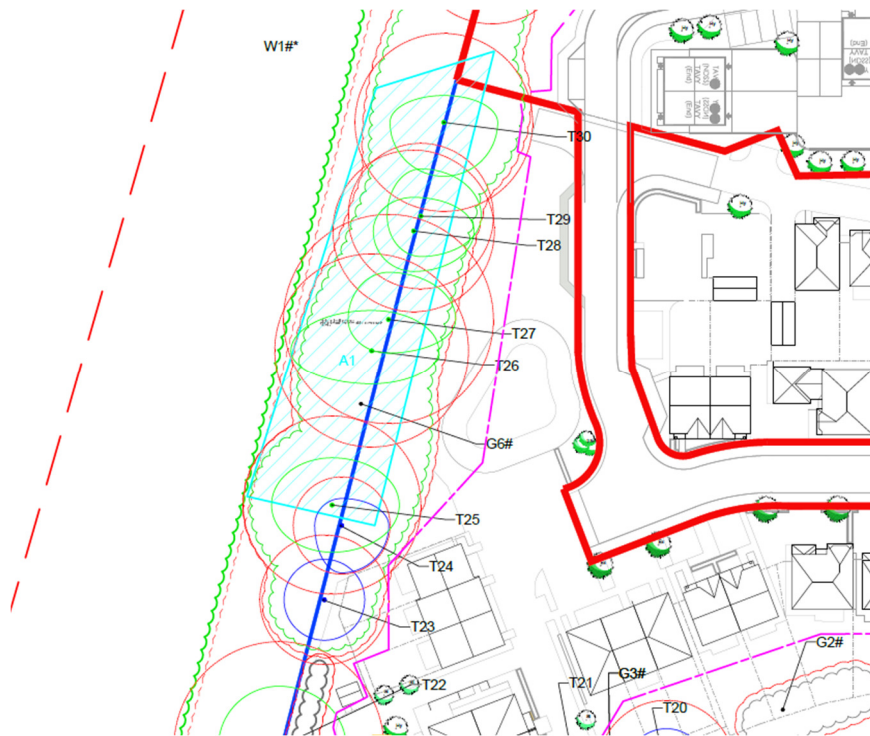
TPF is currently located well within the approved location as described on the Tree Protection Plan i.e., the TPF protects far less area than approved. There is an existing ditch within the RPA on the eastern side of the stem which may limit shallow rooting to the east somewhat. However, given the age and stature of these trees it is highly likely that roots have occupied the land east of the exiting ditch.

It is noted that a below ground attenuation tank is proposed in this area, the north-western corner of which protrudes significantly into RPA plus, reinforcing batter which will likely extent up to or close to the tree stem of T28 & T29 – there's a **high risk** of potentially damaging structural root systems and destabilising large mature Oak trees.

There's also a **high risk** in terms of tree protection fencing being in the wrong location around TPO'ed boundary trees. Similarly, topsoil has been removed within RPA. Note: The TPO legally protects all parts of the tree, even those parts which are below ground.

Figure 5. Tree Protection Plan showing trees along western boundary

- 1) Present question to construction of whether firstly, the location of the tank can be altered to avoid RPA. Secondly (and perhaps more realistically) raise the question of using a sheet pile type reinforcement to avoid the requirement of batter/excavation up to/close to stems of TPO'd trees.

- 2) Retain TPF in its current location in order to install below ground attenuation tank and attenuation basin but, re-instate topsoil and fencing in areas that don't restrict construction.
- 3) If the traditional batter back cannot be altered to less intrusive method, ensure excavation within RPAs is overseen by an Arboricultural Consultant to ensure any evidence of root severance is documented. Collected information can be used to inform any mitigating measures required such as crown/weight reduction works to the canopy or, removal of the tree due to extensive root severance or, no works.

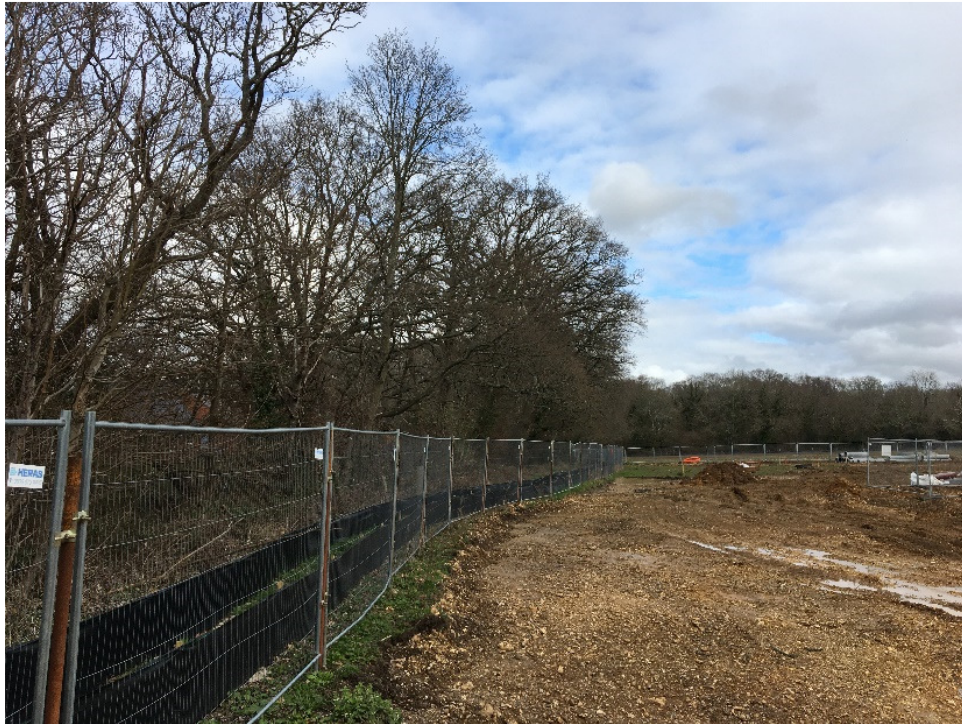
Topsoil within the RPA has been removed back to the existing fencing line. Fortunately, there were no obvious signs of exposed roots. However, as above, it is likely that the roots have established in the sub-soil outside of the current location of the TPF.

Figure 6. View looking north. Western site boundary righthand side of photo

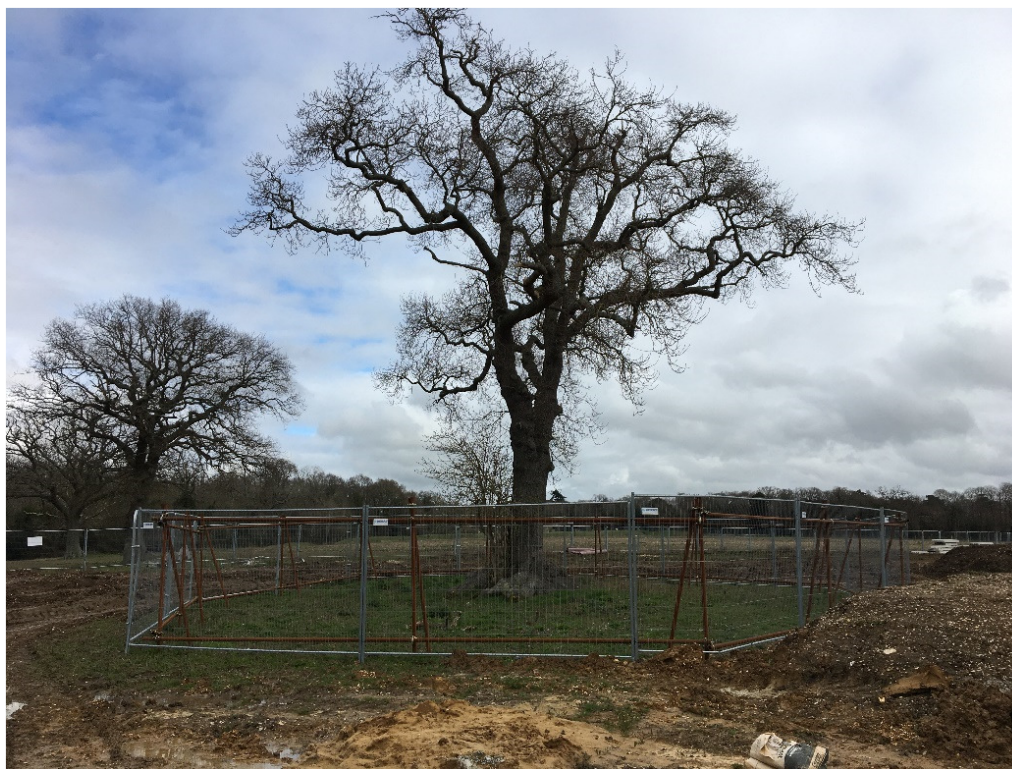
Figure 7. T22 - view looking east

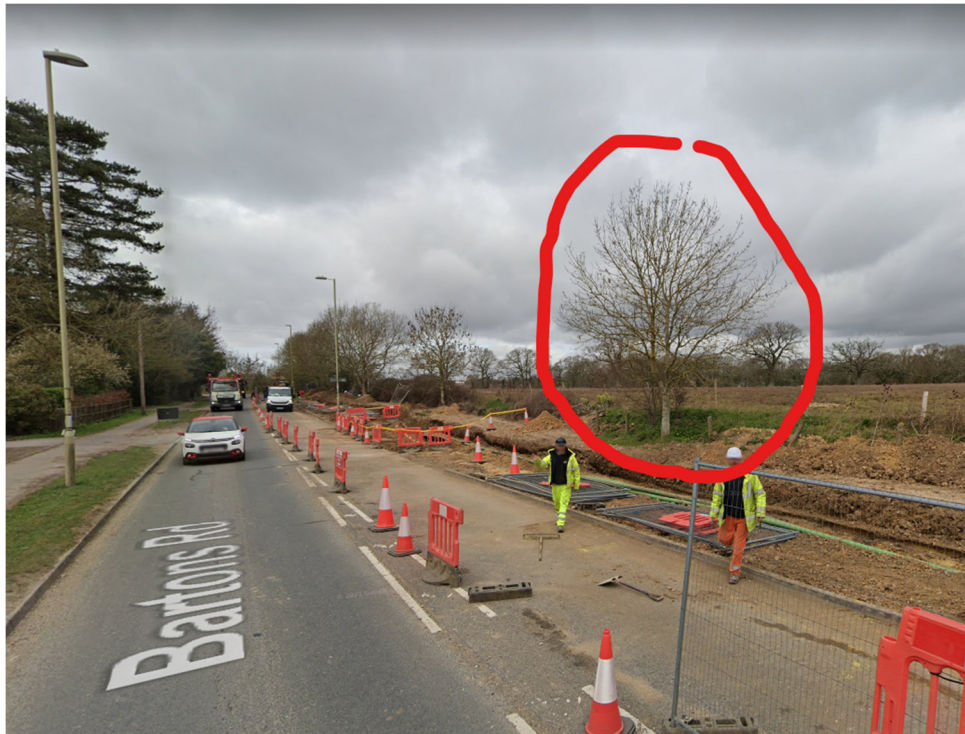
Figure 8. Google St view, Mar 2021, showing T13

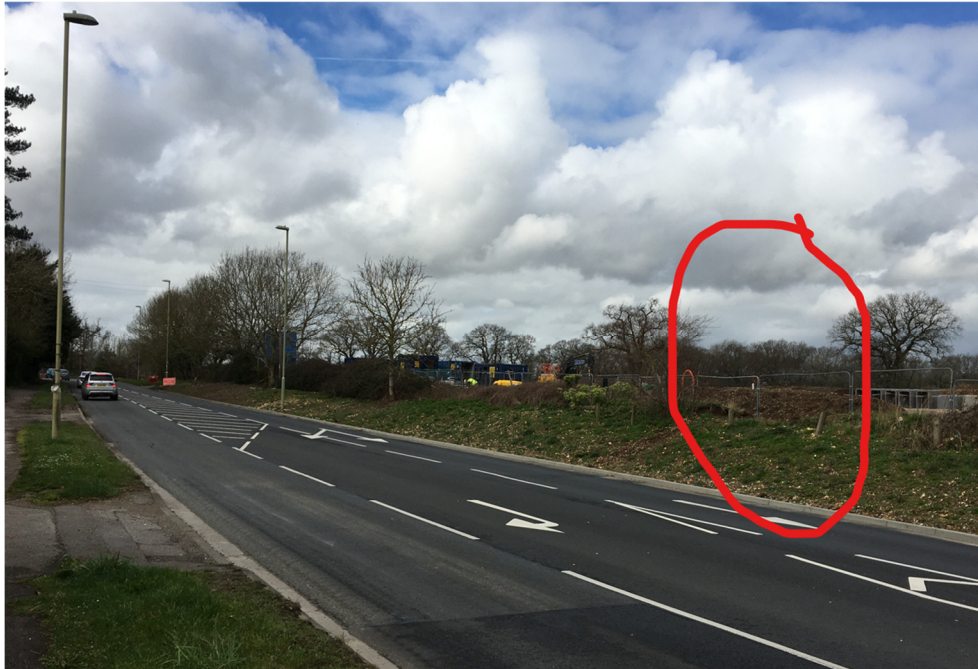
T13 has been removed. There is no remaining evidence of the tree other than its roots. The stump has been removed. Ownership of this tree is unclear and should be clarified.

**Risk** – if the tree was owned by the Highways Authority and removed without permission. In this scenario, the Highways Authority are likely to require retrospective payment for the tree. The value of which is generally established through the completion of a retrospective CAVAT assessment. If enforced by the highways Authority the CAVAT value is likely to be in the region of £10,000 – to be agreed with the Highways Authority.

Figure 9. Current image taken 14th Mar 2022. T13 missing
