**VERIFICATION REPORT**

**PLOTS 145-148**

**WOODCROFT FARM, WOODCROFT LANE,  
LOVEDEAN, PO8 9QA**

| Reference: | GE19455/VR/PLOTS 145-148/OCT22 |

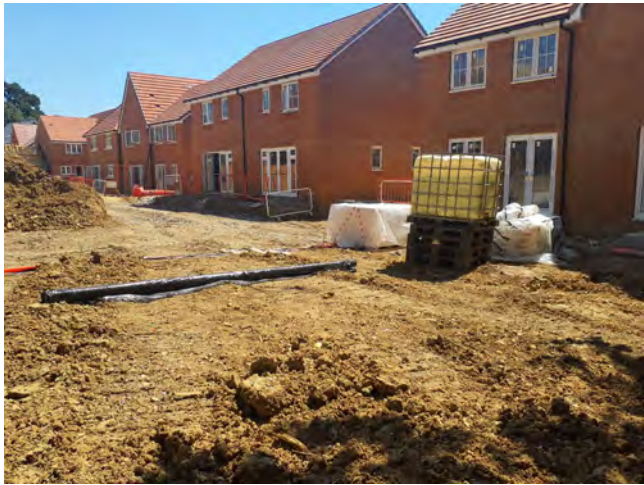
Description      Plots 145-148 in progress

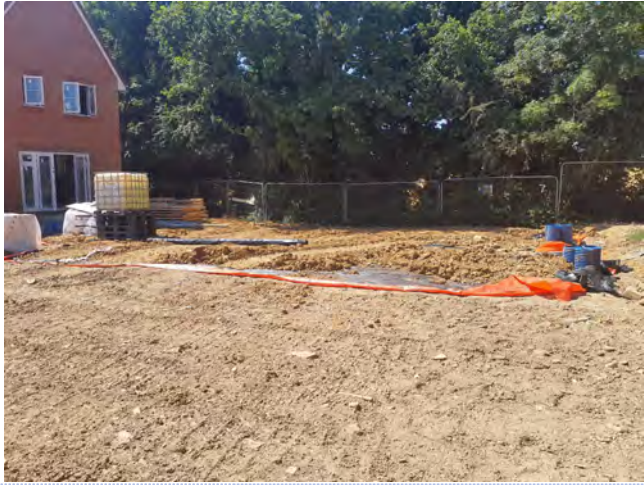
At the time of the visit the crushed concrete layer had been installed within Plots 145-148 and was visible within Plots 146-148. An orange geotextile and a black geotextile had been laid above the crushed concrete layer within Plot 145, with a thin layer of subsoil above. It should be noted that no soft landscaping was evident to the front of these plots, nor is it understood to be proposed.

Description      Plot 145 in progress

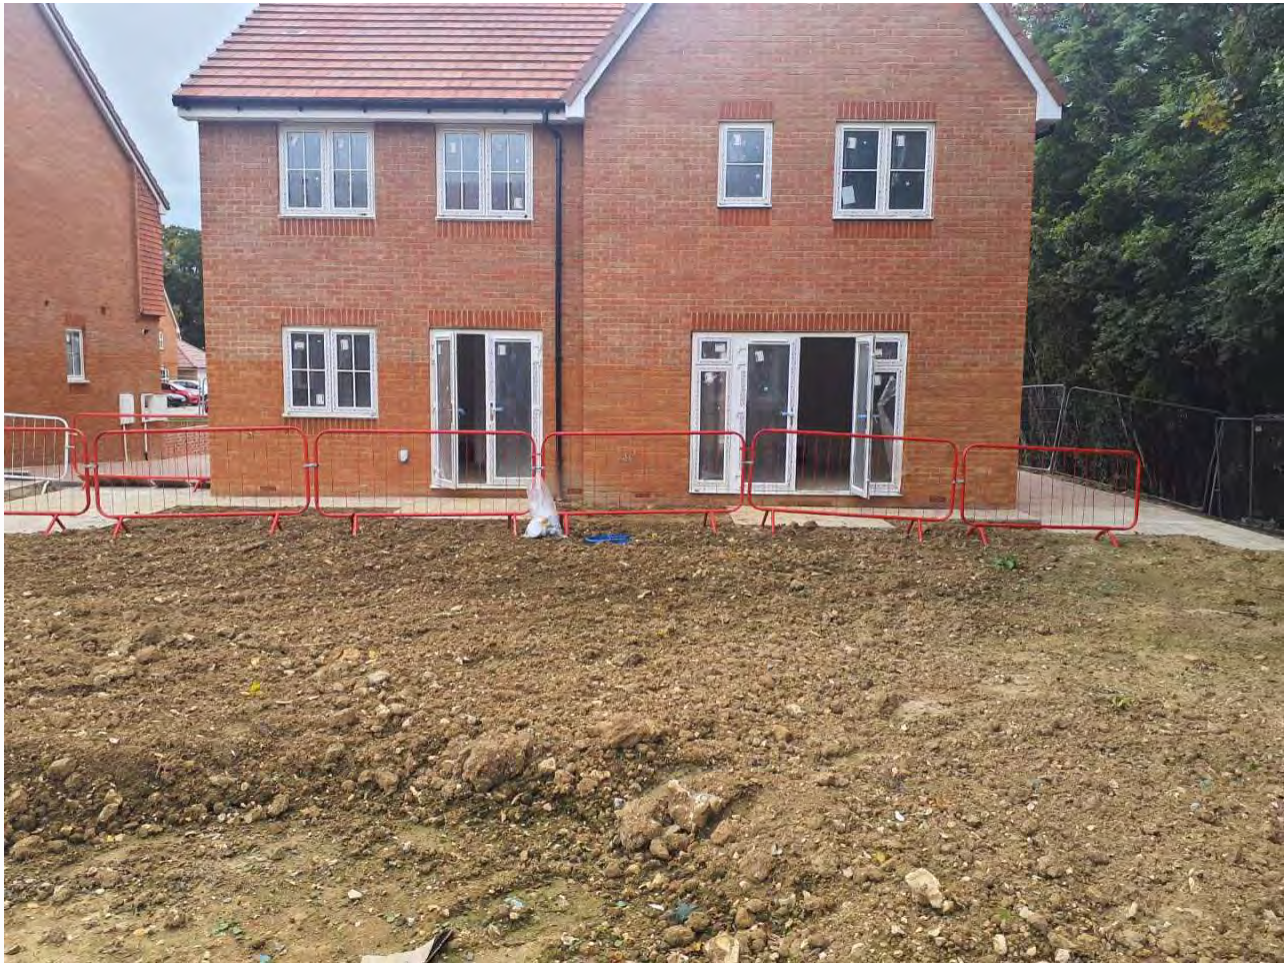
Plots 145-146

The inspection confirmed that within the inspection pits, Topsoil was found to be between 560mm and 600mm in thickness within all the inspected areas. It should be noted that the soil cover system comprised Topsoil only and this Topsoil utilised within Plots 145-147 comprised site-won soils which had previously been deemed suitable for re-use, as reported in the RSVP for the horse arena area (GE16943/RSVP-HA-V6.0/FEB21).

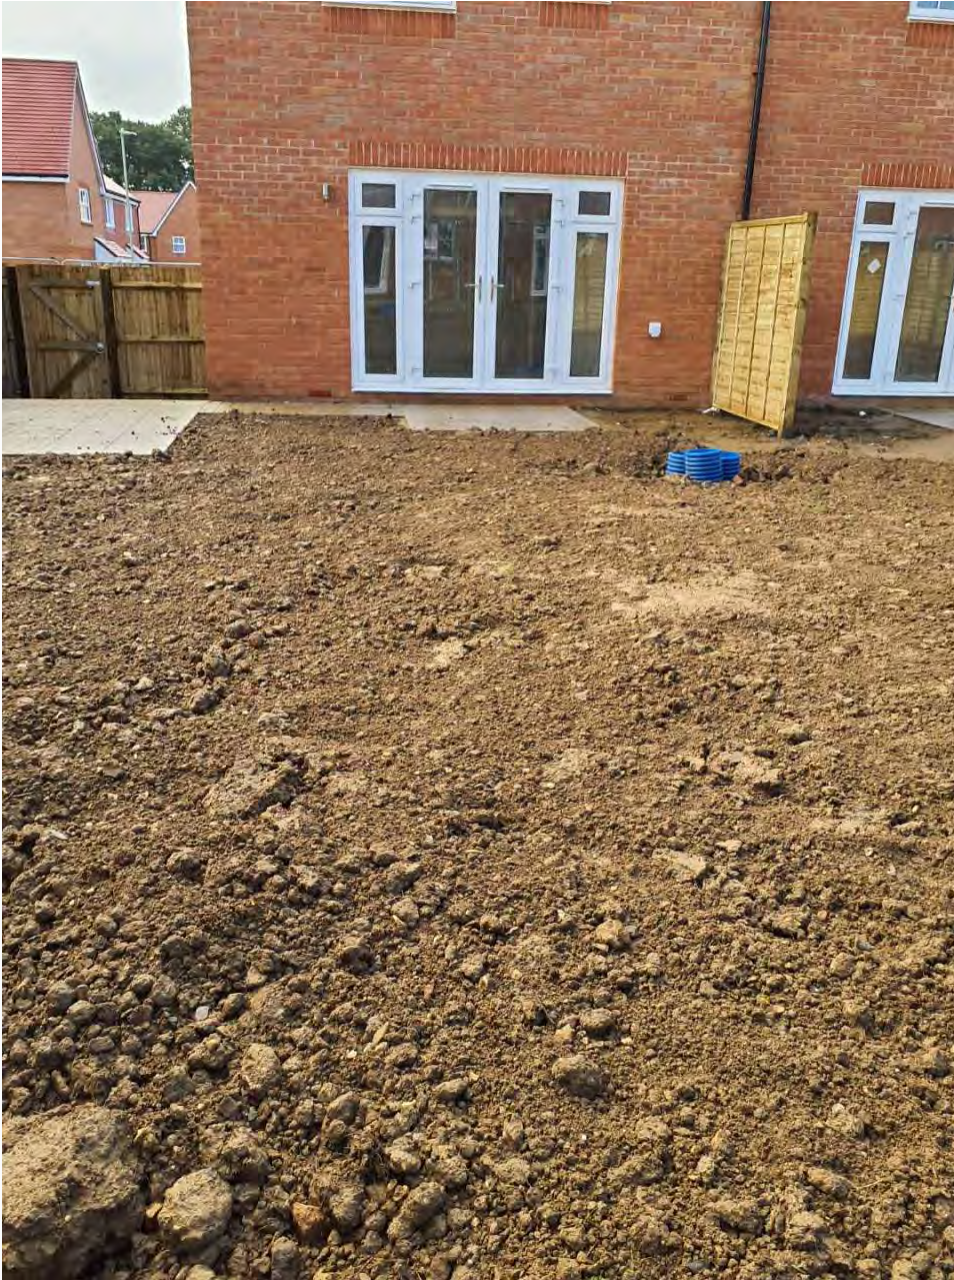
The inspection confirmed that within the inspection pit, Topsoil was found to be 550mm in thickness within the inspected area. It should be noted that the soil cover system comprised Topsoil only and this Topsoil utilised within Plot 148 comprised site-won soils which had previously been deemed suitable for re-use, as reported in the RSVP for the horse arena area (GE16943/RSVP-HA-V6.0/FEB21).
