**Tree condition survey of  
1 no. black pine *Pinus nigra* and 1 no. yew *Taxus baccata*  
at**

**14 First Avenue, Havant, PO9 2QN  
///ends.cafe.candle**

*Report date*  
20<sup>th</sup> January 2023

*Report reference*  
J1466

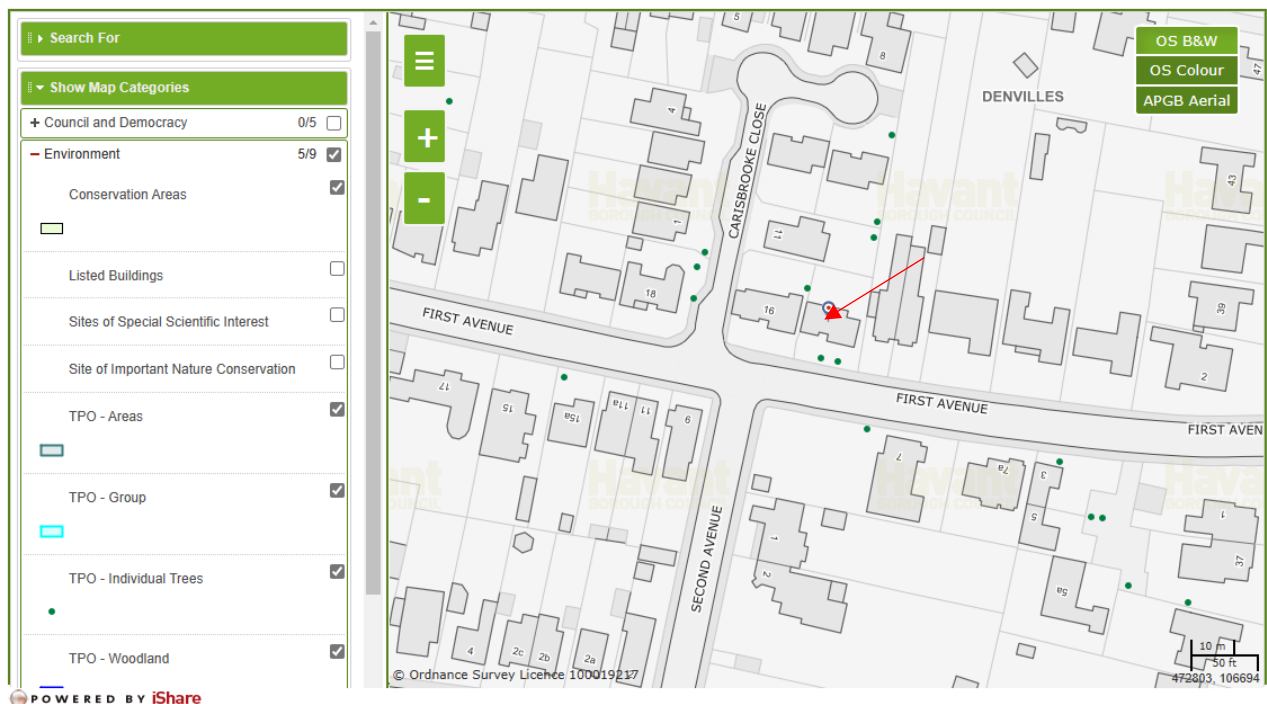
SAL1 Data provided by planning authority website<sup>1</sup>. Red arrow identifies 14 First Avenue.

- 3.2 Due to the position of the two trees on the frontage relating to the image SAL1, I believe that T1 and T2 are subject to Tree Preservation Order.

- 3.3 As the trees are subject to TPO, a Town and Country Planning (Tree Preservation) (England) Regulations 2012 s16 Tree Works Application<sup>2</sup> will need to be issued to the planning authority and 'Consent' received prior to tree works commencing. Such tree works identified within any Consent will normally need to be complete before a 2 year period from the date of the Consent. Additional information on the process can be found at the government website<sup>3</sup>. This tree condition survey can be used to inform such a Tree Works Application.

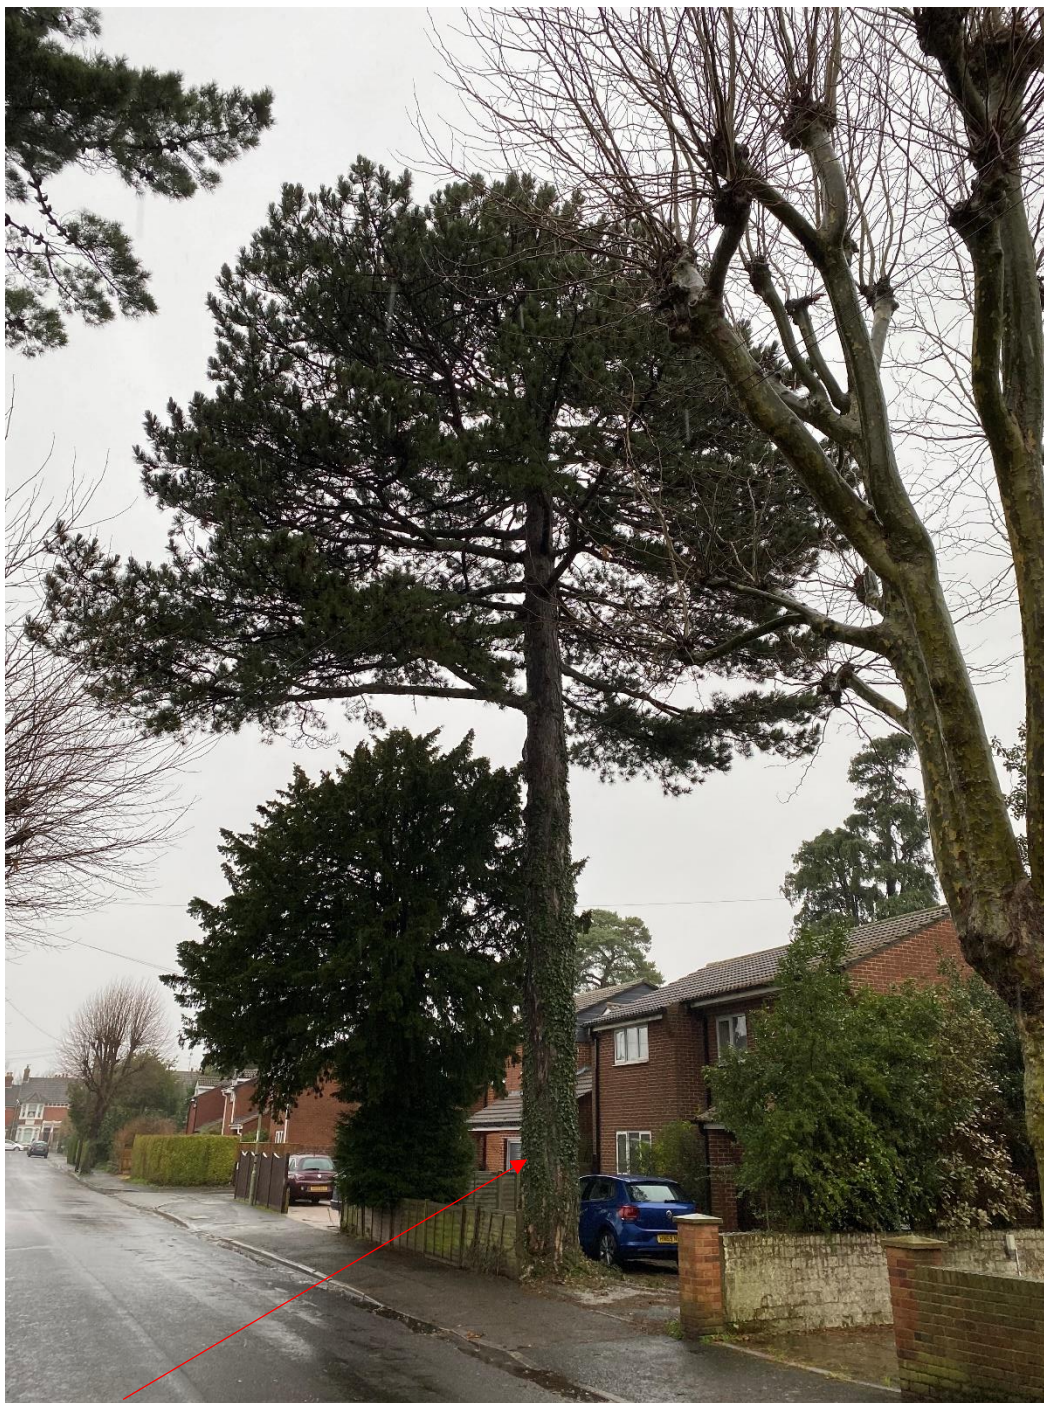
| Designation | Reference number | Species | Height (m) | Age class | Physiological condition | Structural condition | Condition notes | Condition related tree works | Priority |
|---|---|---|---|---|---|---|---|---|---|
| T | 1 | Black pine <i>Pinus nigra</i> | 21.5 | Mature | Good | Good | 89cm diameter at 1.5m. 9m horizontal canopy spread. Slight overlong branches. Previously crown lifted to c9m with series of crown lifting wounds on the lower stem. 4.5m from the dwelling. Disrupted asphalt driveway adjacent. Growing north of the footway, west of the driveway and within the lawn area. | Selective tip reduction of branches to create an even horizontal canopy spread of 7.5m with a natural canopy form and a maximum wound diameter of 75mm. Pruning wounds to natural arget pruning points. Remove deadwood more than 25mm diameter. | Low |

SAL2 T1 black pine at vehicle and pedestrian entrance with T2 to the left.

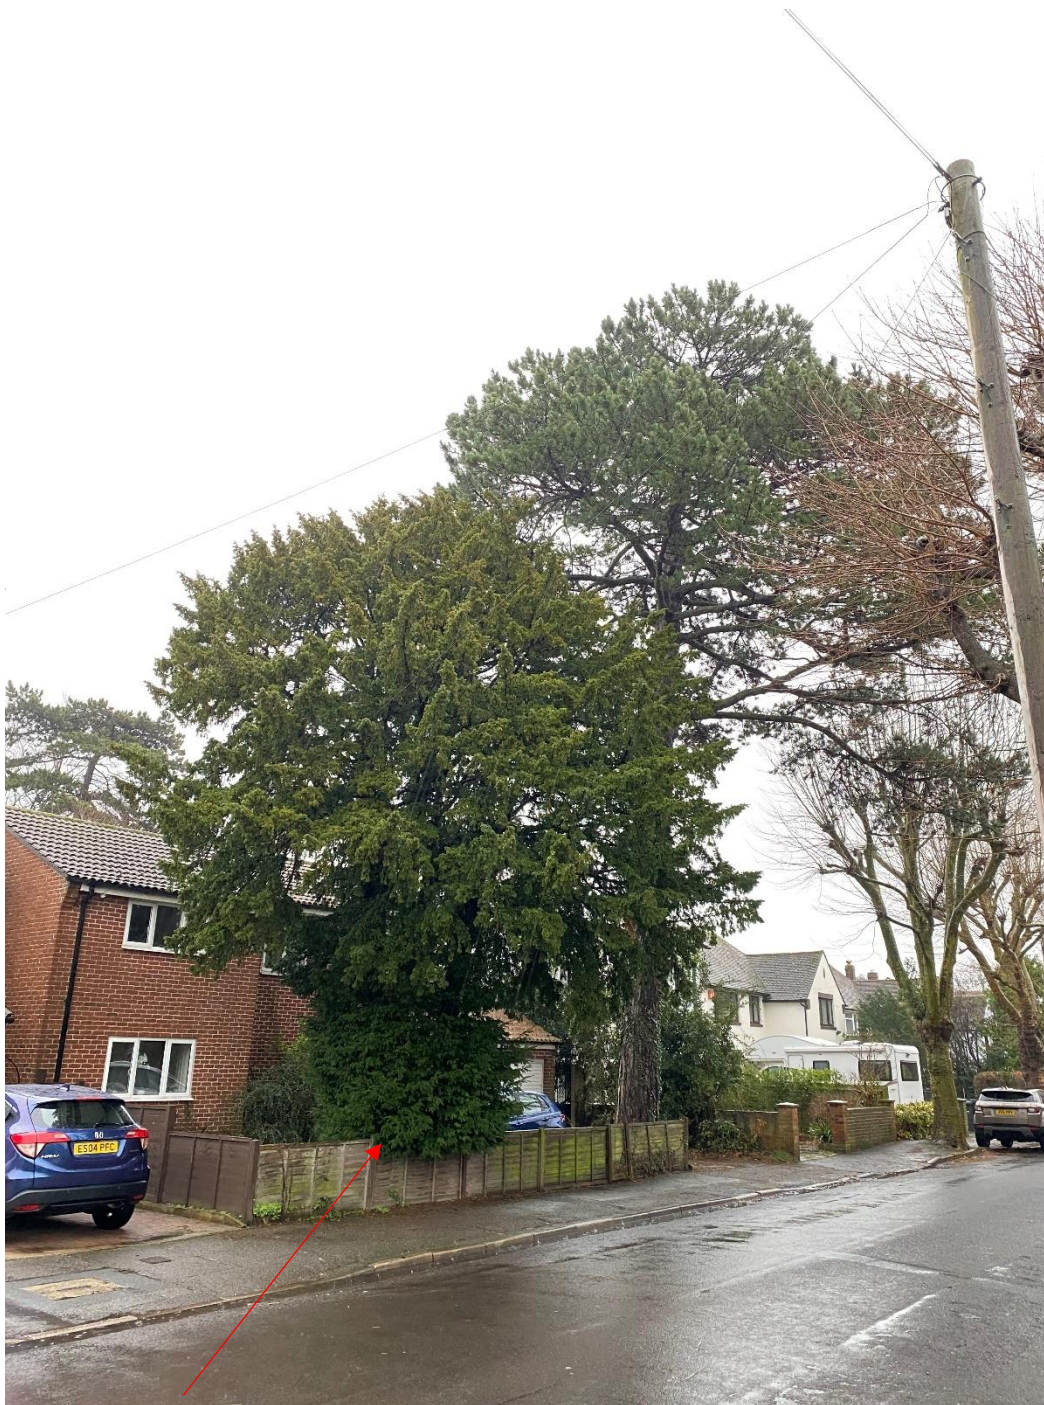
| Designation | Reference number | Species | Height (m) | Age class | Physiological condition | Structural condition | Condition notes | Condition related tree works | Priority |
|---|---|---|---|---|---|---|---|---|---|
| T | 2 | Yew <i>Taxus baccata</i> | 11.6 | Mature | Good | Good | 4.8m horizontal canopy spread. Two main stems from the base obscured by foliage. Further stem divisions through the tree structure. Low branches over the highway and garden. Growing adjacent to footpath and within the lawn. | Crown lift to 5m over the carriageway and 3m over the remainder. Remove low growth foliage to within 1cm of the original parent material to allow inspection. | Low |

SAL3 T2 yew adjacent to the boundary fence with T1 to the right.

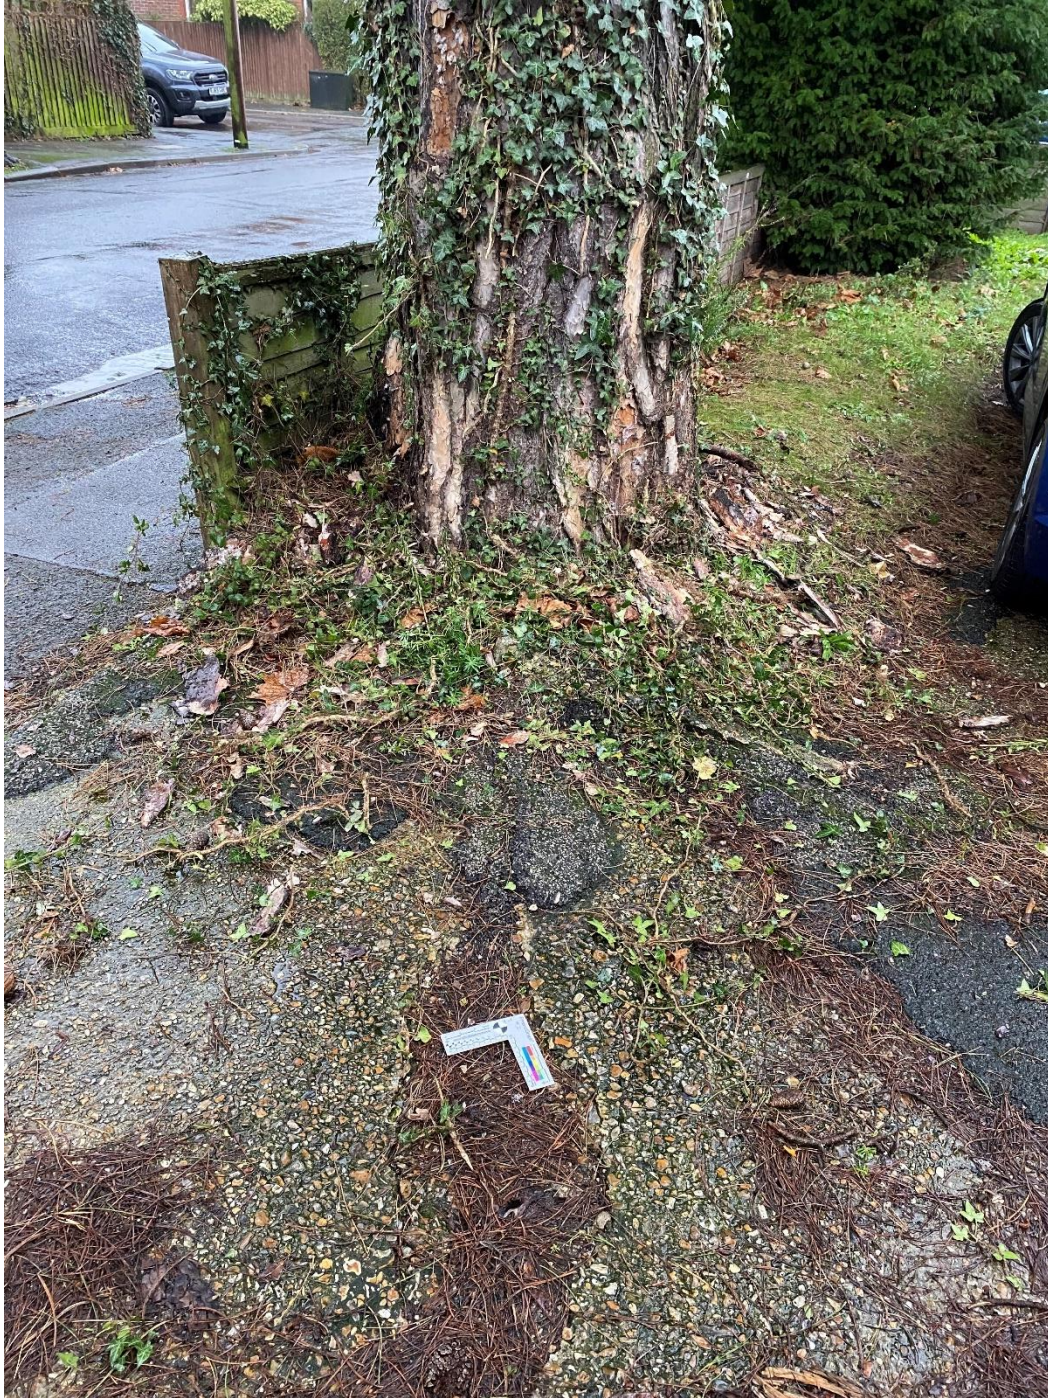
- 6.2 There is disruption to the existing vehicle and pedestrian access which is commensurate with incremental tree root growth and adaptive growth through wound response producing calluses lifting the hard standing from beneath (direct damage). This disruption may cause a trip hazard to users and visitors to the property. To remediate the potential trip hazard, it is appropriate to remove the existing hard standing, excavate to 100mm depth beneath the existing hardstanding and remove tree roots less than 25mm diameter. Roots larger than 25mm diameter are to be excavated beneath and lowered to a lower level avoiding excess damage or bending of the root. These excavation works are likely to require Consent from the planning authority and require Arboricultural Consultant supervision. Reform the bedding layer and install a porous base course<sup>6</sup> and wearing course<sup>7</sup>. It is likely that such tree root growth has occurred since the construction of the hard standing and therefore removal of tree roots less than 25mm diameter disrupting the hard surface is unlikely to affect the stability or physiology of the trees. During these remedial works, it is also appropriate to allow for additional tree stem growth and remove the hard standing closest to the tree to allow for incremental stem growth. These works are separate from the works relating to the tree condition and, therefore, are not listed in Appendix 1.

SAL4 T1 with direct damage to access driveway.

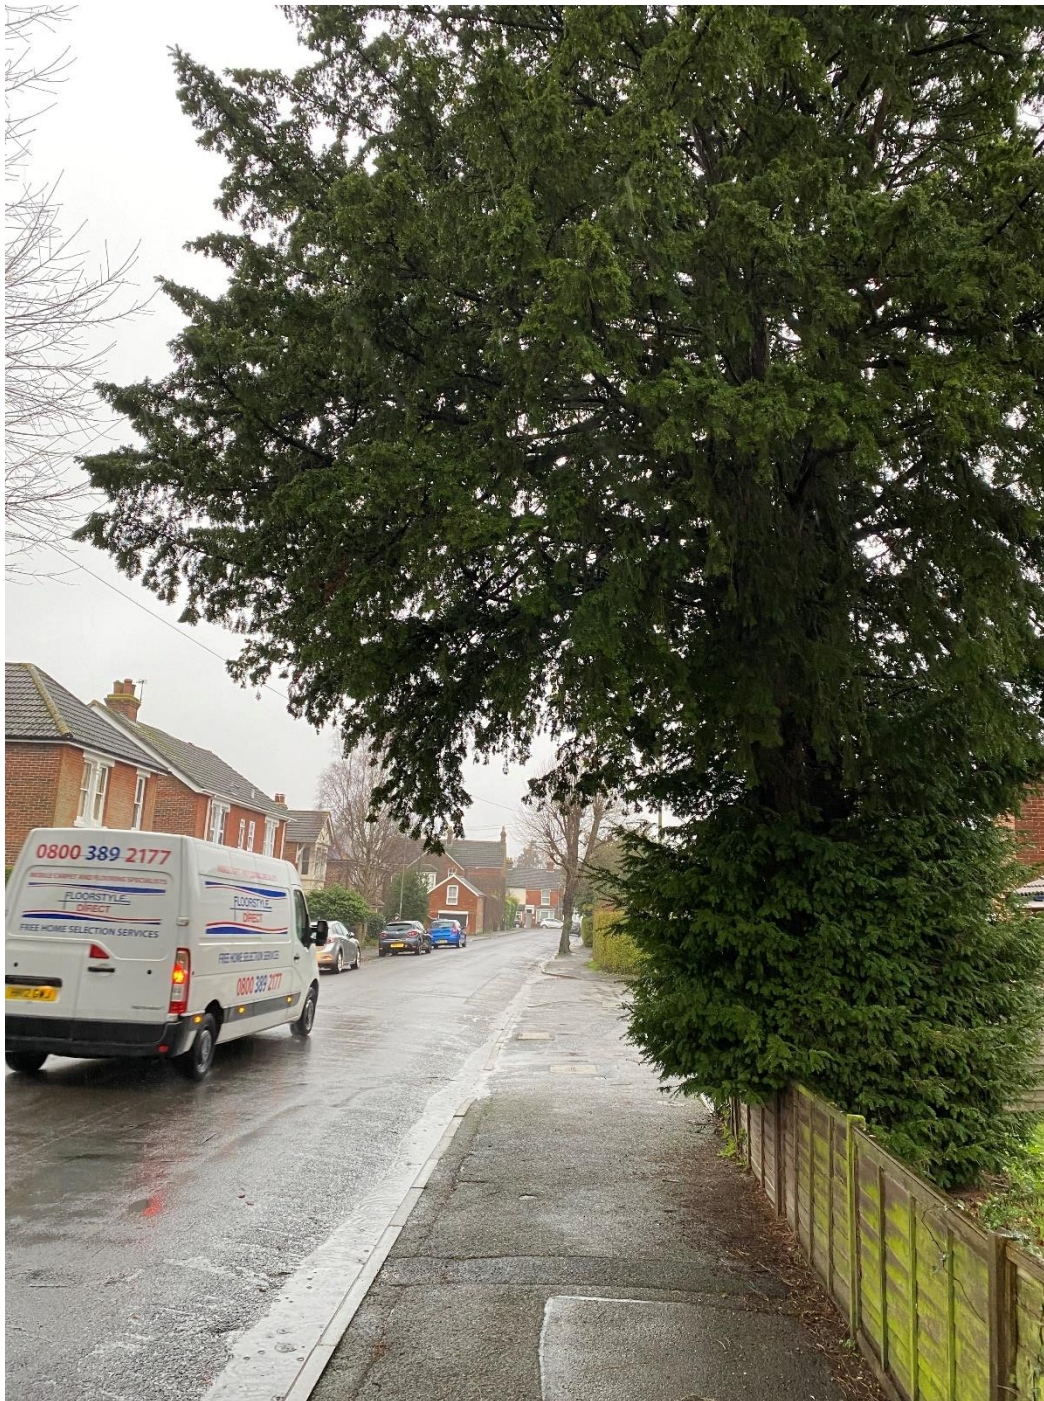
- 6.3 The Highways Act s154<sup>8</sup> requires branches impeding the safe use of the highway to be cut back. The low branches on T2 fall within this requirement where they overhang the highway.

SAL5 T2 and low branches over the carriageway and footway.
