**VERIFICATION REPORT**

**PLOTS 127-128**

**WOODCROFT FARM, WOODCROFT LANE,**

**VISTRY SOUTHERN**

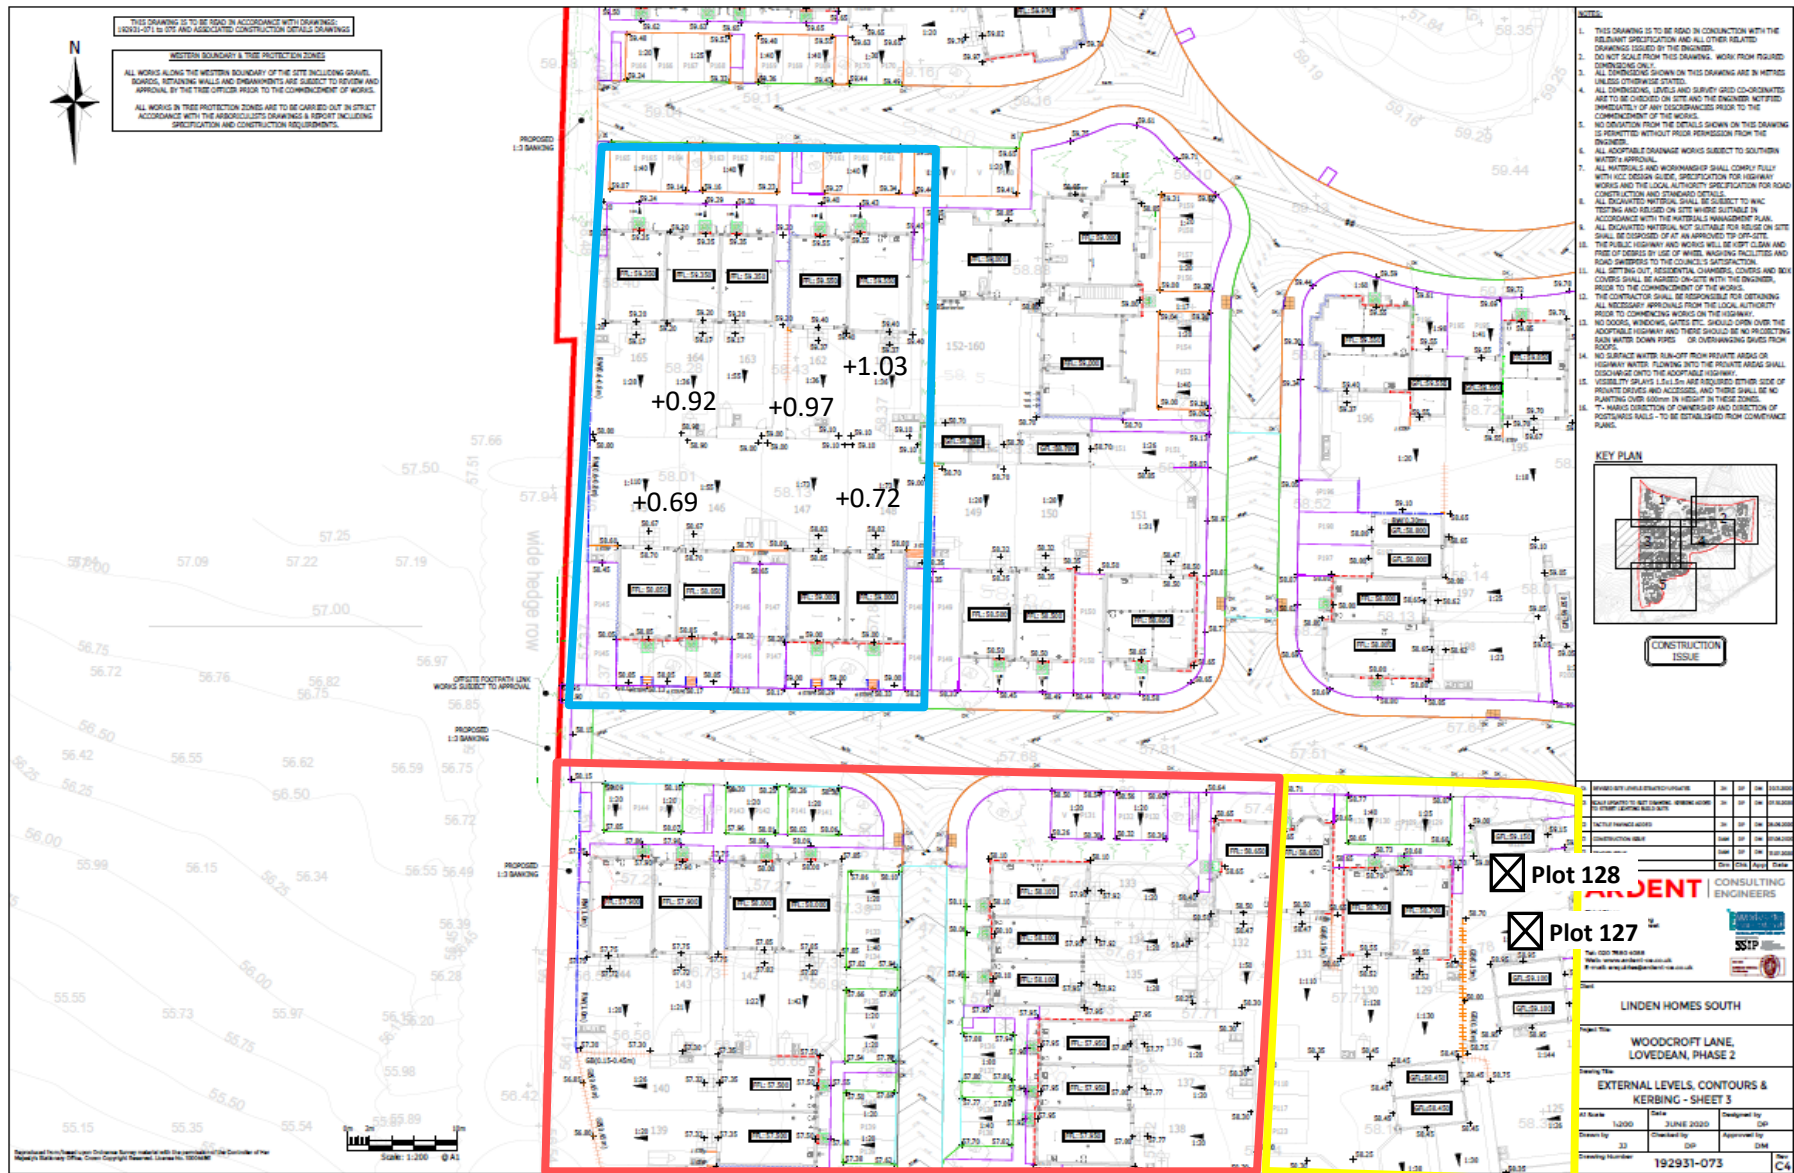
**Title** Validation Location Plan

The collected samples were referenced Plot 127 A at 0.20m bgl and Plot 128 B at 0.10m bgl. The laboratory test results are presented within Appendix C.

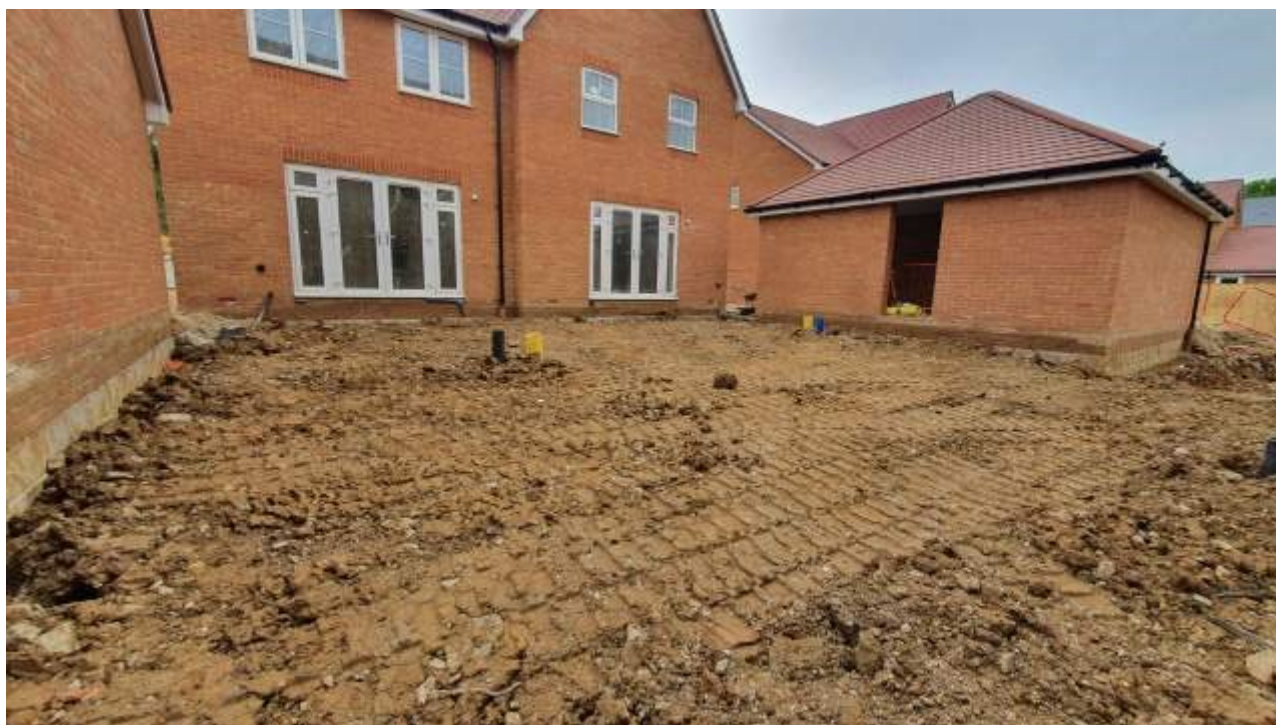
Plate 1 – Overview of the subsoil laid across Plots 127-128

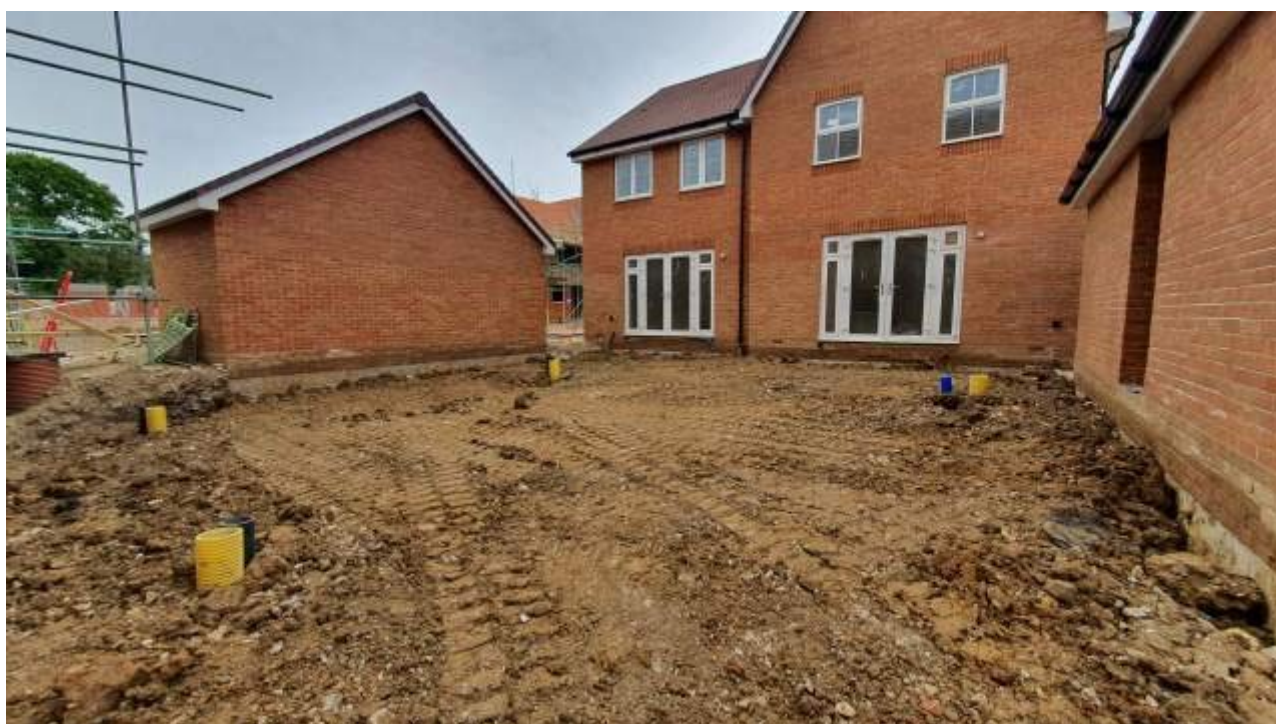
Plate 2 – Subsoil laid across Plots 127-128

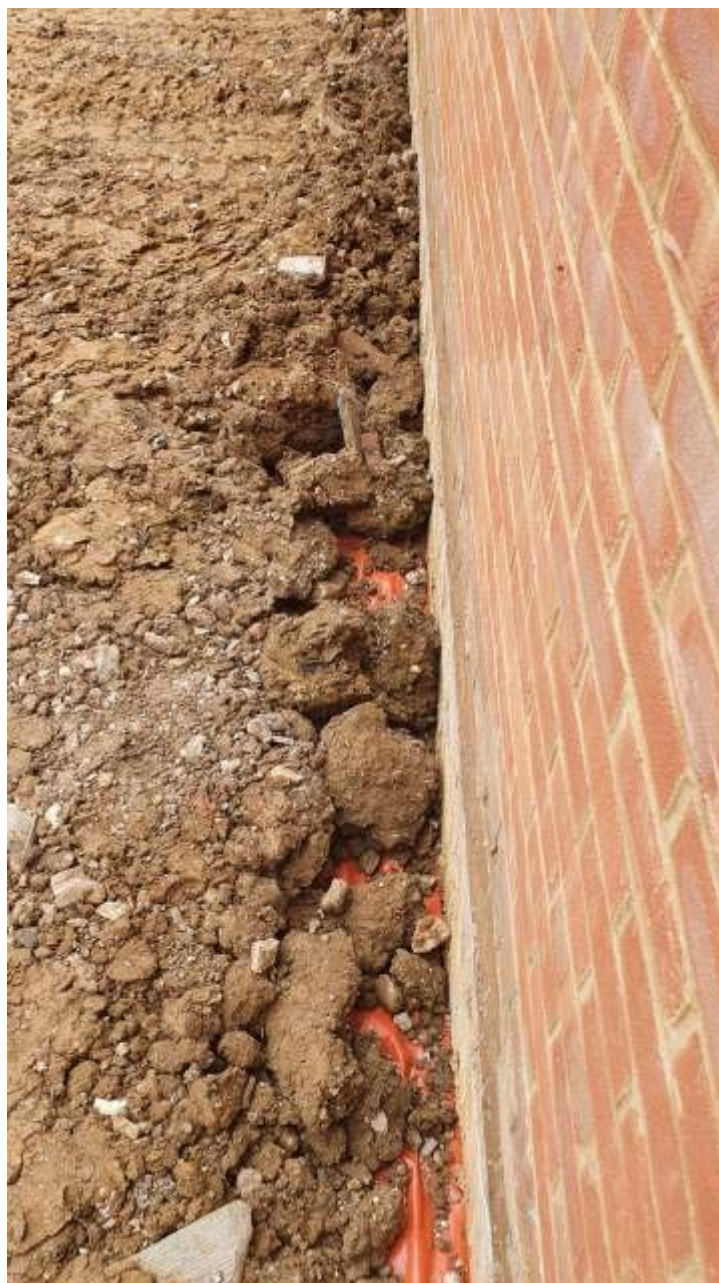
Plate 3 – Orange geotextile membrane visible beneath installed subsoil

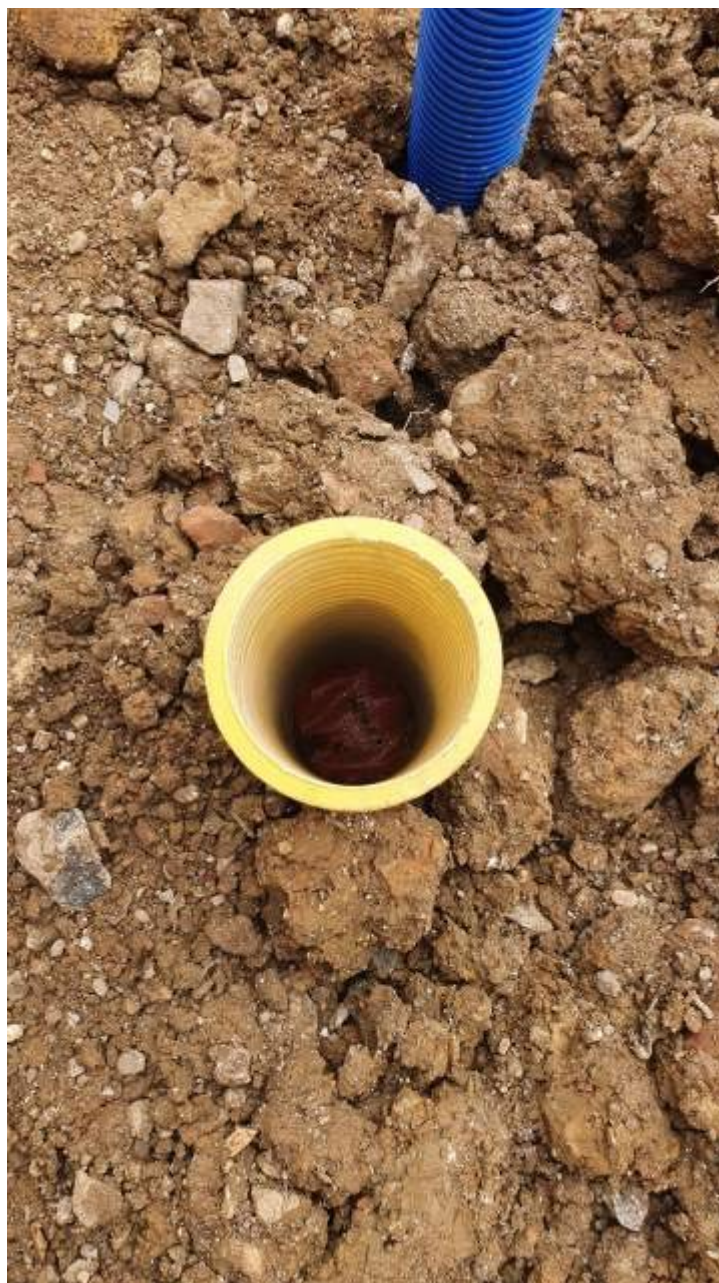
Plate 4 – Orange geotextile beneath subsoil in base of inspection pipe

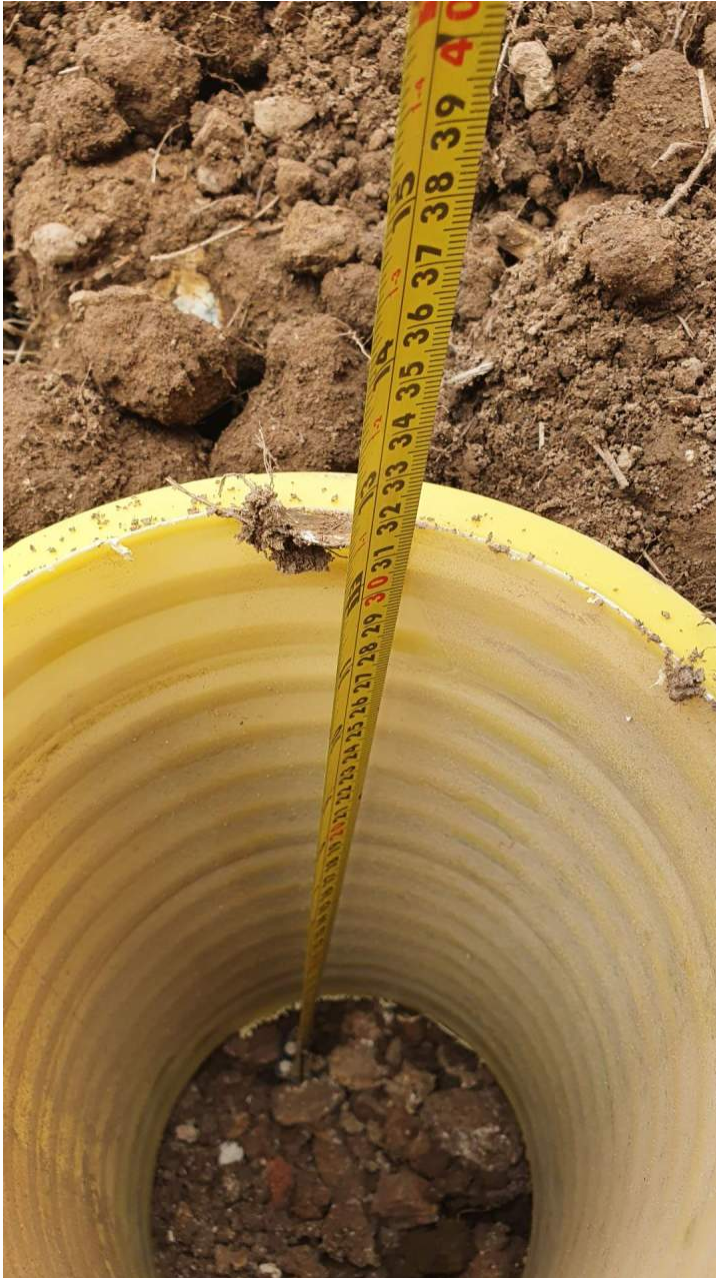
| Remarks | Subsoil and lower portion of the cover system were inspected during g a previous visit | | |

Photo of hole with tape in place

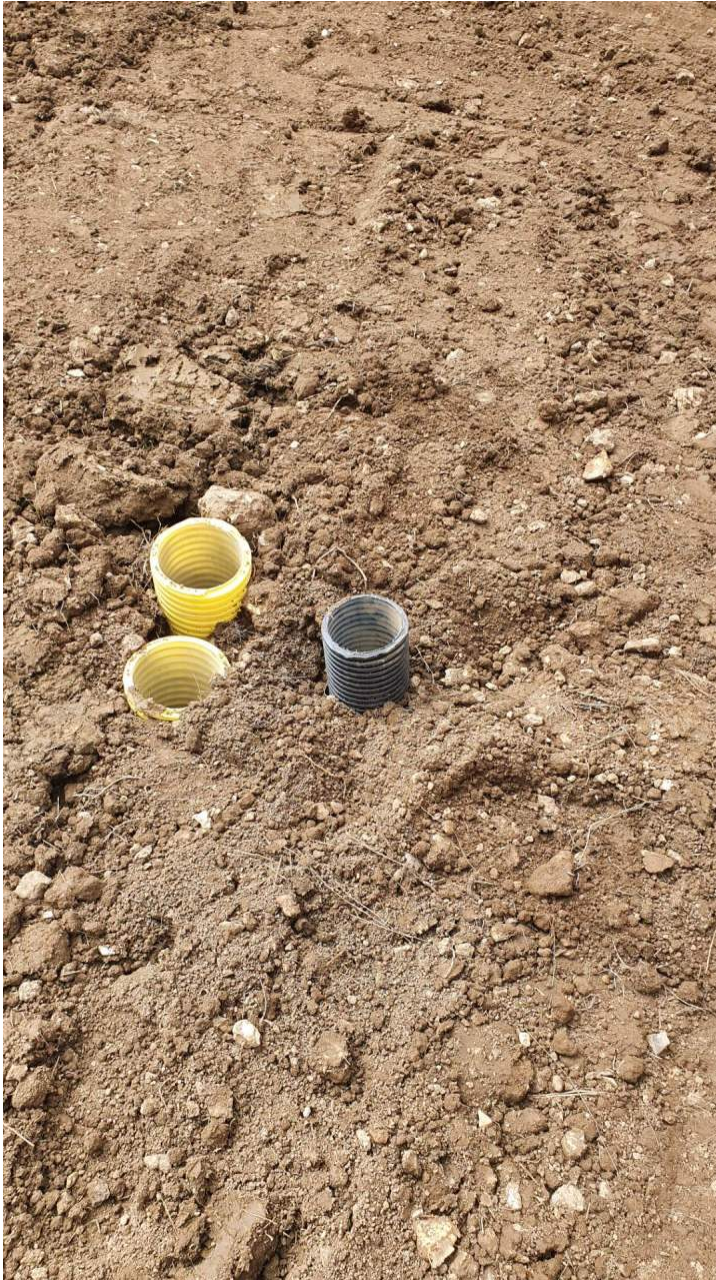
Subsoil and lower portion of cover system inspected previously

Photo of hole with tape in place
