# Arboricultural Consultancy for Lloyds Bank

| Insured | Mr Andrew Hunnibal | Address | Longacre, Emsworth, PO10 7UR | | |
| Client | Subsidence Management Services | Contact | John Morrison | Claim No. | IFS-LBG-SUB-20-0089388 |
| Report Date | 09/02/2021 | | | | |

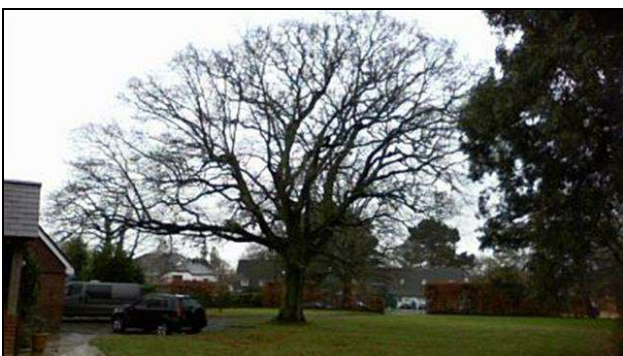
T7 - Oak

Site Investigations revealed the presence of roots below foundation level in TP/BH1. These roots were identified (using anatomical analysis) as having emanated from the genus *Quercus* spp. (Oak). Roots were also found in TP/BH2 and they were identified as *Populus* spp (Poplar)

Our survey of the site identified T4 (Poplar) & T7 (Oak), given their position relative to the damage it is our opinion that the roots identified emanate from this vegetation.

Based on our site investigations, and taking account of vegetation location, relative to the focal area of movement/ damage, it is our opinion that, T3 (Prunus), T4 (Poplar) & T7 (Oak) are considered the dominant feature(s) and accordingly we have identified them as the principal cause of the subsidence damage.

Removal of T3, T4 & T7 will offer the most certain and reliable Arboricultural solution likely to restore long-term stability.

| Tree No. | Species | Age Cat | Approx. Height (m) | Distance to Building (m) * | Ownership | Action | Requirement |
|---|---|---|---|---|---|---|---|
| T7 | Oak | 3 | 17 | 16.4 | C - Insured | Remove | Remove close to ground level and treat stumps to inhibit regrowth. |

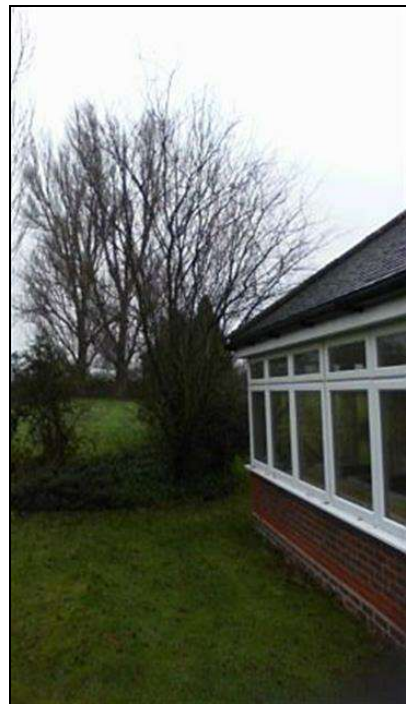
T3 - Prunus

Whilst not directly implicated by positive root analysis, based on our site investigations, and taking account of vegetation location, relative to the focal area of movement / damage, it is our opinion that T3 (Prunus) also retain the capacity to be extending roots below the focal areas of movement. The influence of this vegetation is determined by their size and proximity relative to the area of damage; it is our opinion on balance of probability that roots from this vegetation will be in proximity to footings of the insured property.

| Tree No. | Species | Age Cat | Approx. Height (m) | Distance to Building (m) * | Ownership | Action | Requirement |
|---|---|---|---|---|---|---|---|
| T3 | Prunus | 2 | 7.9 | 1.9 | C - Insured | Remove | Remove close to ground level and treat stumps to inhibit regrowth. |

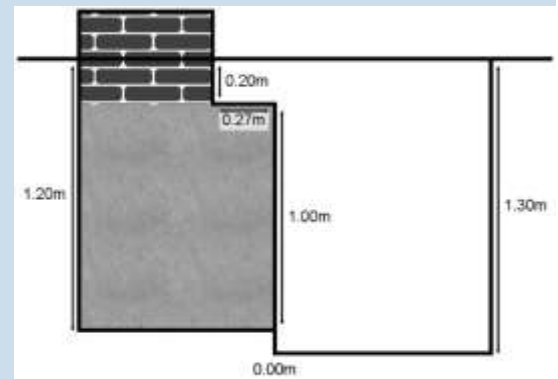
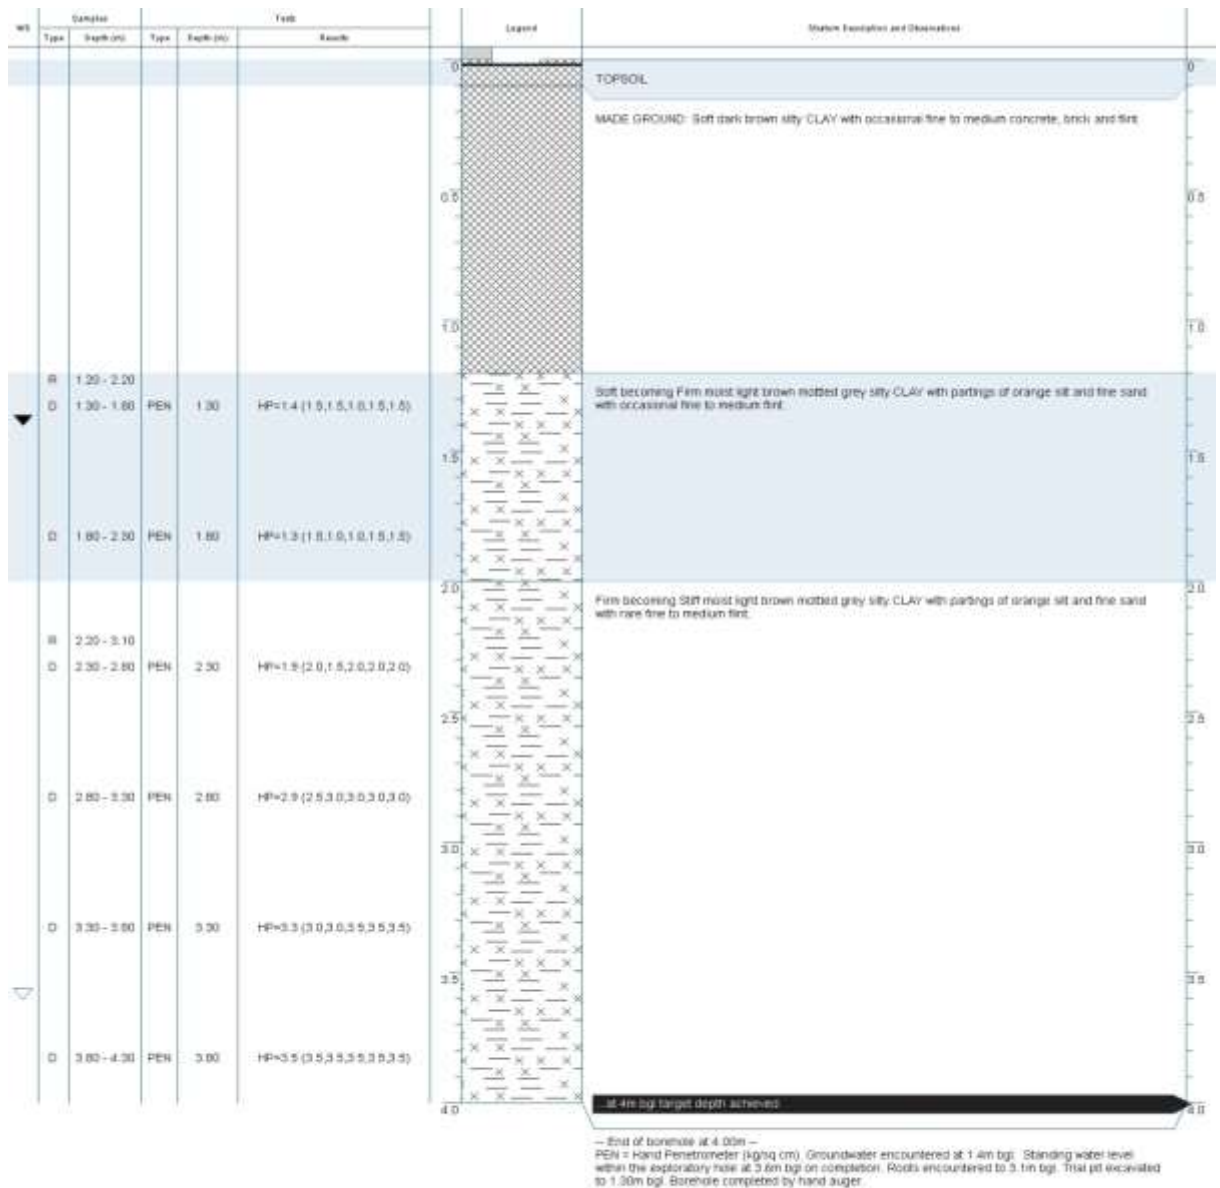
## TP/BH1 Foundation Detail and Borehole Log

Porch foundation comprised of brick wall to 200mm bgl, bearing on concrete to an estimated depth of 1200mm bgl, with a total projection of 270mm from the elevation. Underside of foundation (USF) was estimated by pushing a probe, approximately 160mm back from the face of the foundation, at an angle with no apparent contact with the face of the foundation beyond the estimated depth.

A water strike (WS) was encountered in the clay at 1.4m bgl (TP/BH1). Standing water level within the exploratory hole at 3.6m bgl on completion.

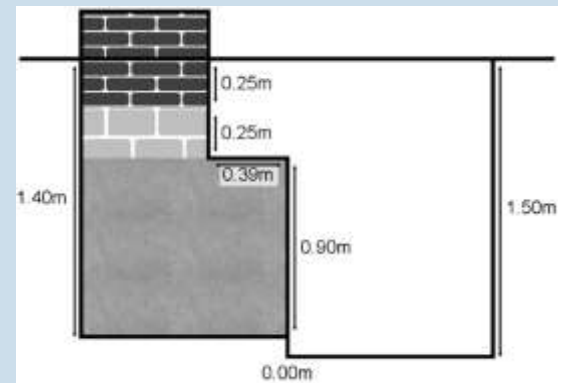
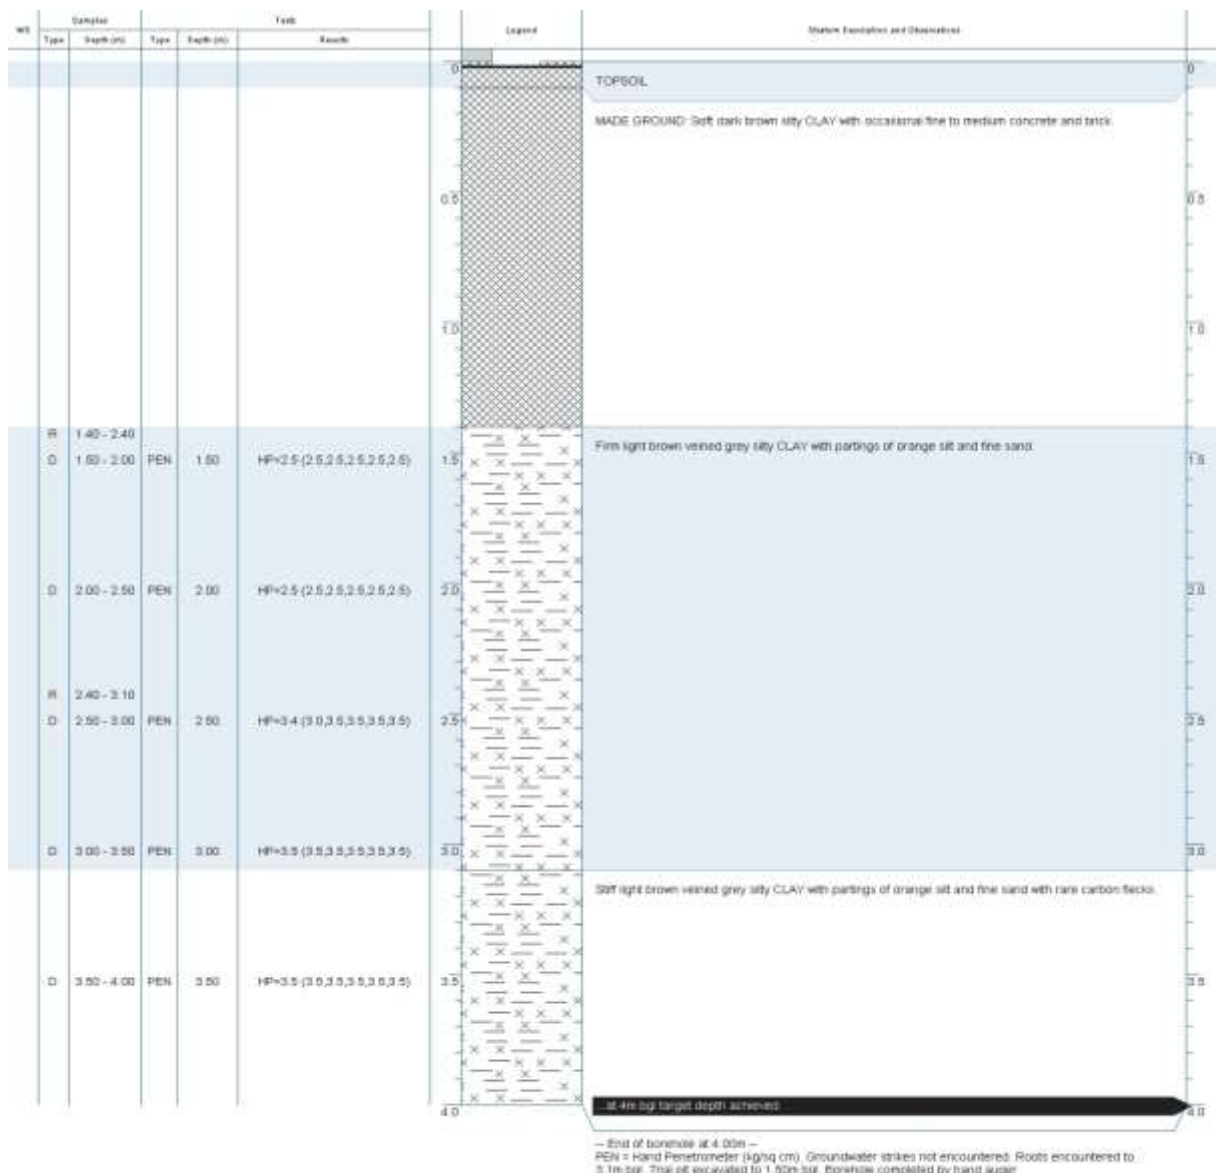
## TP/BH2 Foundation Detail and Borehole Log

Conservatory foundation comprised of brick & blockwork wall to 500mm bgl, bearing on concrete to an estimated depth of 1400mm bgl, with a total projection of 390mm from the elevation. Underside of foundation (USF) was estimated by pushing a probe, approximately 100mm back from the face of the foundation, at an angle with no apparent contact with the face of the foundation beyond the estimated depth.
