## Southleigh Park, Coach House: Investigation of masonry damp and damp-proof courses

Site note B3 for 18 January 2021, job no. 152.09.

The aim of this survey was to investigate defects likely to have allowed water penetration to the structure and to assess the extent and distribution of surplus residual moisture in the load bearing masonry structures of the ground floor

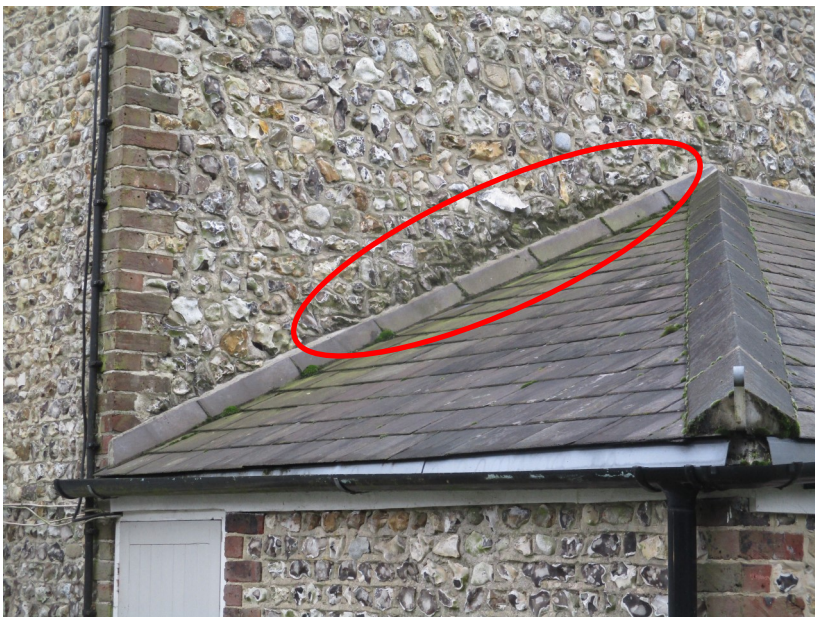
**Fig 2:**

North elevation, east side; showing biological growth affecting façade masonry at the abutment with the single storey roof

*If the single storey structure on the north side is to be retained, allowance should be made for re-detailing the abutment of the roof coverings with the façade with, say, an extended fillet or slate/lead flashing to protect the elevation masonry from water penetration. H+R assume that roof coverings are to be overhauled and roof drainage systems replaced on proposed refurbishment. The roof drainage system should be adequately maintained pending refurbishment to ensure that water from roof structures is drained clear of masonry at all times, especially around the base of the building*

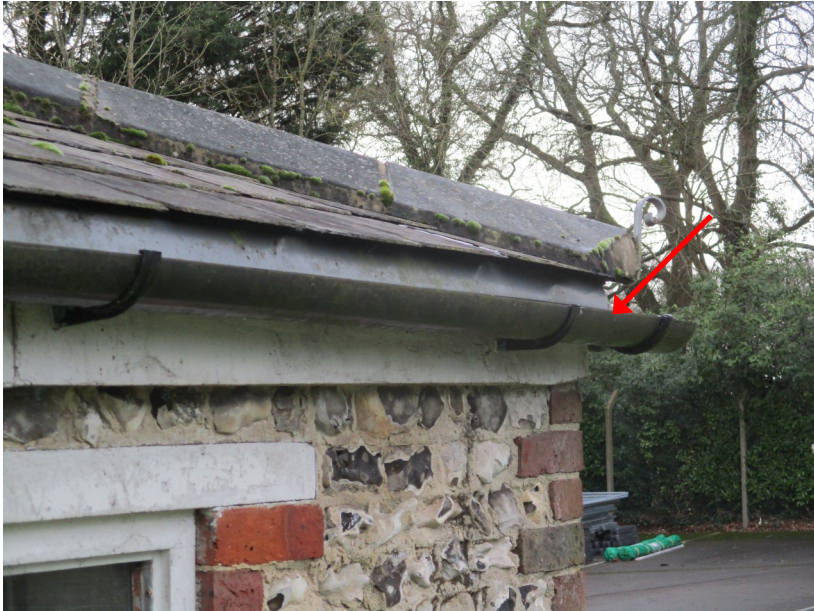
**Fig 3:**

- 1 Roof coverings and drainage: No rainwater goods were fixed against the north elevation. The 'Dutch' gable drained onto the roof coverings of the single storey secondary structure beneath. The abutments of the roof coverings of this structure were detailed with slates bedded in mortar. The roof coverings and adjacent north elevation were subject to significant biological growth where water had splashed back onto the façade from the eaves, notably on the east side. The single storey structure was covered with fibre cement slates with concrete ridge fittings, which were generally intact and free of defects allowing water penetration to the structure. The gutter below the north hip pitch of the single storey structure deflected at the west end, which may allow water to pond, overflow and drain over structures beneath

North elevation, north-west corner of single storey extension; showing deflected rainwater downpipe that may allow water to overflow and drain over structures beneath

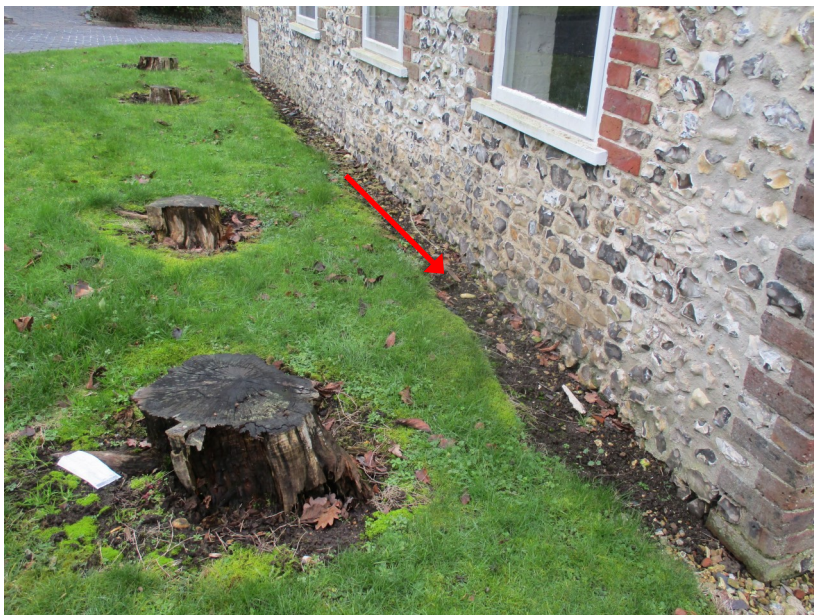
**Fig 4:**

- 3 External ground levels and drainage: Fall of ground was generally from north to south, draining ground and surface water towards the base of the structure. The single storey extension to the north was detailed with a trench at the base of the wall, back-filled with soil and chippings. This did not appear to be a fully detailed French drain and would not have significantly reduced the risk of damp penetration. No physical horizontal damp-proof course was identified

North elevation, base of single storey extension wall; showing 'drainage' trench with soil and chippings back-fill

*Subject to the general specification for refurbishment, consideration should be given to creating a fully detailed French drain, with a 'geo drain' perforated pipe at the base discharging to existing ground and surface drainage systems or to a new soakaway, as directed by the building service engineer*

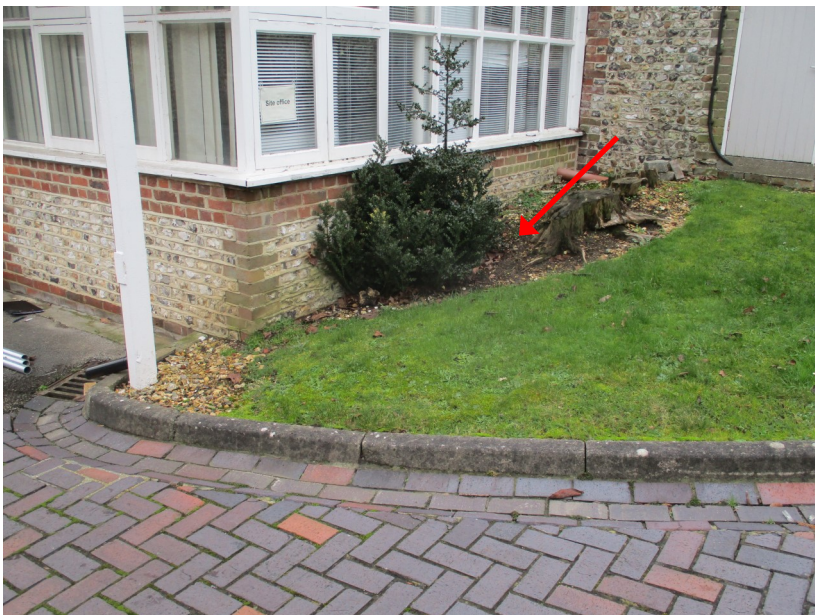
**Fig 6:**

- 3 External ground levels and drainage: Tarmacadam hardstanding was in contact with the elevation across the full width of the structure, isolated from the façade by a strip of insitu concrete, typically 200mm wide. Fall of ground was generally from north to south, parallel to the façade. No evidence of significant ponding was identified but water from the south extension gable appeared to splash back onto the elevation, providing the conditions for biological growth at low level. A slate DPC was identified close to ground level on the east side of the extension. It was assumed to continue throughout the dwarf walls below façade glazing, in which case the DPC would have been extensively bridged by ground levels on the north side, increasing the risk of damp penetration to the interior

East elevation, north side of single store extension; showing assumed position of horizontal damp-proof course bridged by a raised external ground level, increasing the risk of water penetration to the interior

*On future refurbishment consideration should be given to a general reduction in external ground levels to a minimum 150mm below any horizontal damp proof courses included in the structures and perhaps 200mm below internal floor level where no DPC had been installed. No chemical injected remedial DPCs or internal applications of waterproofing cementitious render are required or recommended. See 3.3 below*

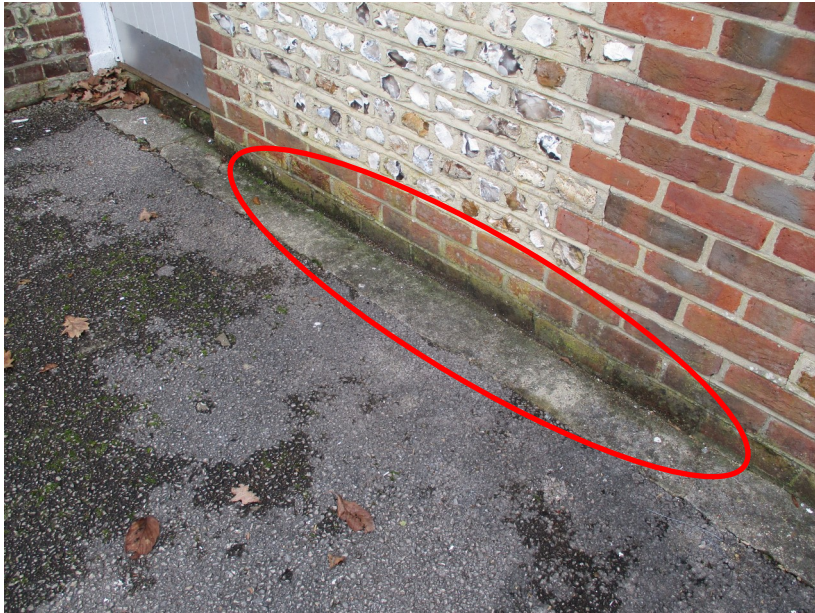
**Fig 7:**

East elevation, south side of single store extension; showing biological growth on brickwork at low level, where water splashed back onto the façade from hardstanding

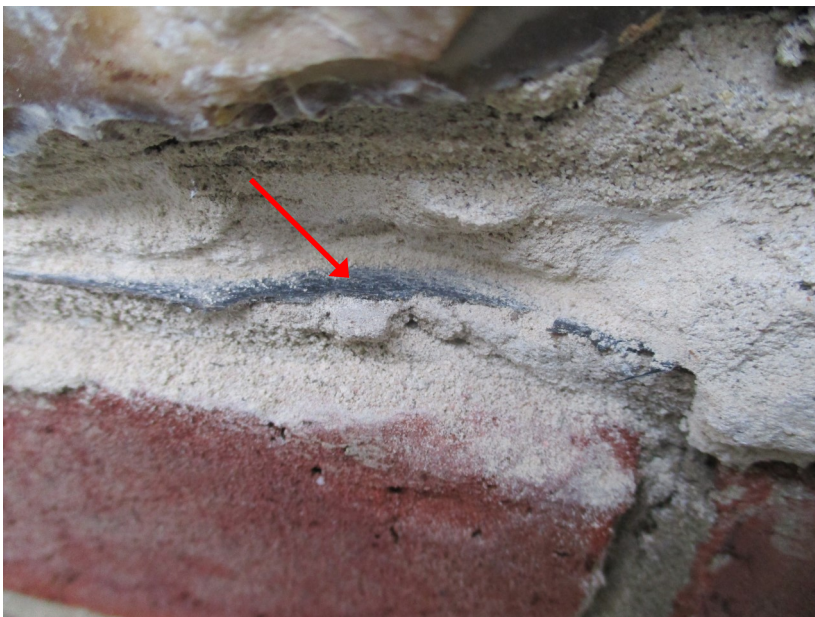
**Fig 8:**

East elevation, east side of single storey extension; showing flexible plastic dpc installed typically 2 no. brick courses above external ground level, but bridged by soil on the north side of the extension

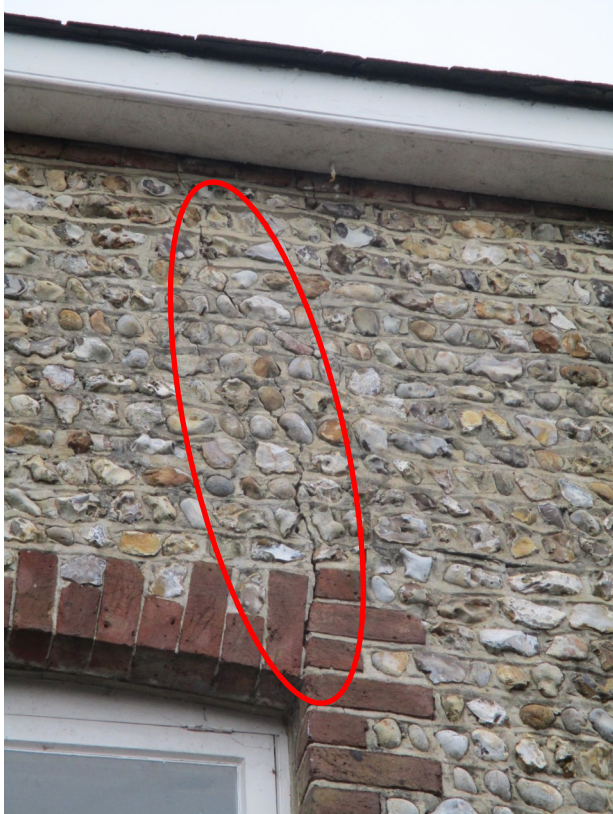
**Fig 9:**

South elevation, upper east side of first floor window opening; showing vertical crack in masonry which was likely to allow water penetration to the structure

*Allowance should be made for detailed inspection of façade masonry and provisional allowance made for specialist repair to open joints and cracks in a suitable flexible lime mortar, gauged to match the existing material. The Structural Engineer should be invited to comment on the more significant cracks, generally towards the centre of the façade at high and low level*

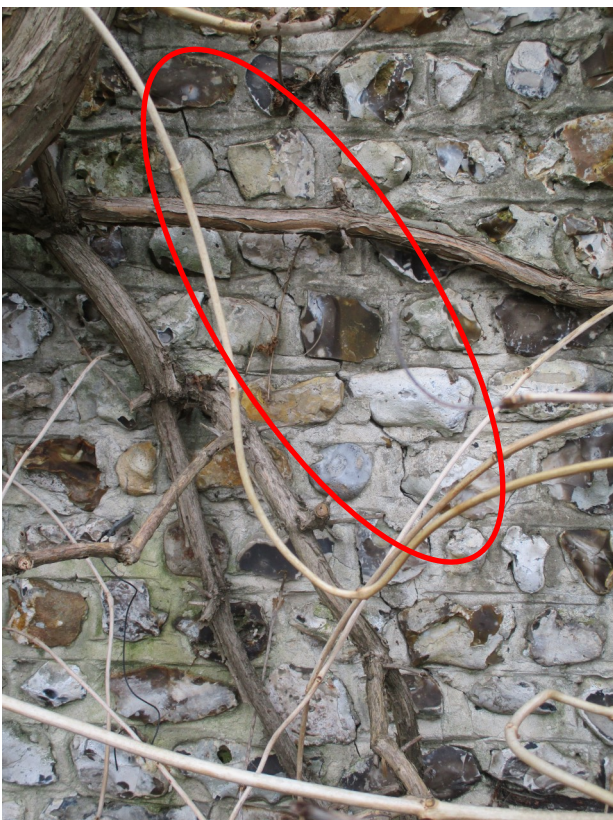
**Fig 10:**

- 2 Façade masonry: The coursed flint façade finish and pointing were in generally good condition. Some hairline cracks had formed in isolated locations, including a diagonal crack on the west side centred approximately 4m above ground level, which may allow water to drain into the structure and track through the interface between the flint external finishes and the brick structure behind. A similar diagonal crack was noted at low level at the centre of the elevation where a vine was fixed against the façade on trainer wires. The south elevation had significant exposure to wind driven rain from the south and would also have been subject to cyclical thermal movement due to solar radiation associated with the southerly orientation. This would tend to reduce the service life of pointing and increase the maintenance requirement

South elevation, central section; showing diagonal crack in masonry which was liable to allow water penetration where there was exposure to rain driven by prevailing winds from the south

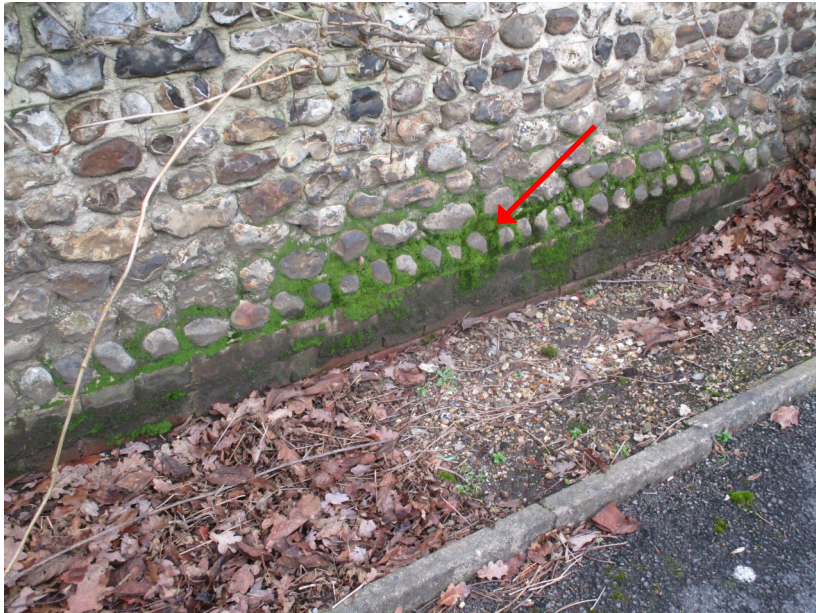
**Fig 11:**

- 1 Roof coverings and drainage: No rainwater goods were fixed against the elevation. The Dutch gable verges and eaves were not detailed with gutters allowing drainage water to splash back onto the façade from compacted soil at the base of the façade

South elevation, east side; showing damp affected brickwork at low level and biological growth on the façade, where water splashed back onto the structure from the Dutch gable eaves above

*No urgent remedial works are required. Subject to the general specification for refurbishment, consideration should be given to adding a gutter to the central horizontal eaves of the Dutch gable hip pitch and to re-profiling the verges of the east and west roof pitches to reduce the amount of water draining from the exposed edges of the slate roof coverings*

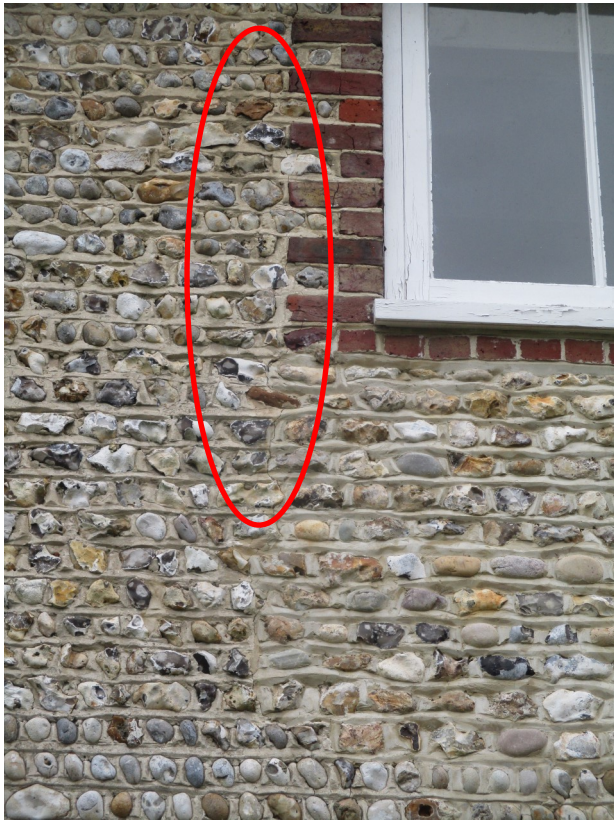
**Fig 13:**

- 2 Façade masonry: Coursed flint façade finishes and pointing were generally in good condition but a number of shrinkage cracks and hairline cracks in mortar were identified that might allow water penetration to the structure where there was exposure to rain driven by prevailing winds from the south and west. Defects were focused on the north side of the north window openings, which were separated by brick embellishments from an area of façade flint which appeared to have been replaced on a previous refurbishment. Cracks were consistent with thermal expansion and contraction of the façade in relation to the structures beneath, consistent with significant exposure to solar radiation

West elevation, north end; showing cracks formed around brick embellishments to window openings and at the junction between retained façade finishes and patch repairs, increasing the risk of water penetration to the structure

*Allowance should be made for detailed inspection of elevation masonry and for patch repairs to pointing as required in a suitable lime mortar mix*

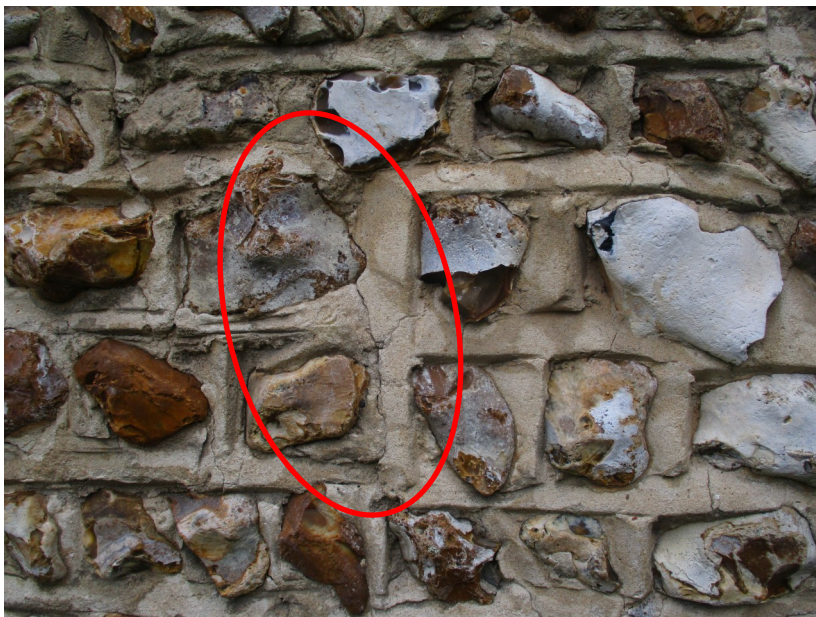
**Fig 14:**

West elevation, central section; showing typical hairline cracking of mortar between coursed flint or finishes where there was exposure to intermittent solar radiation from the west

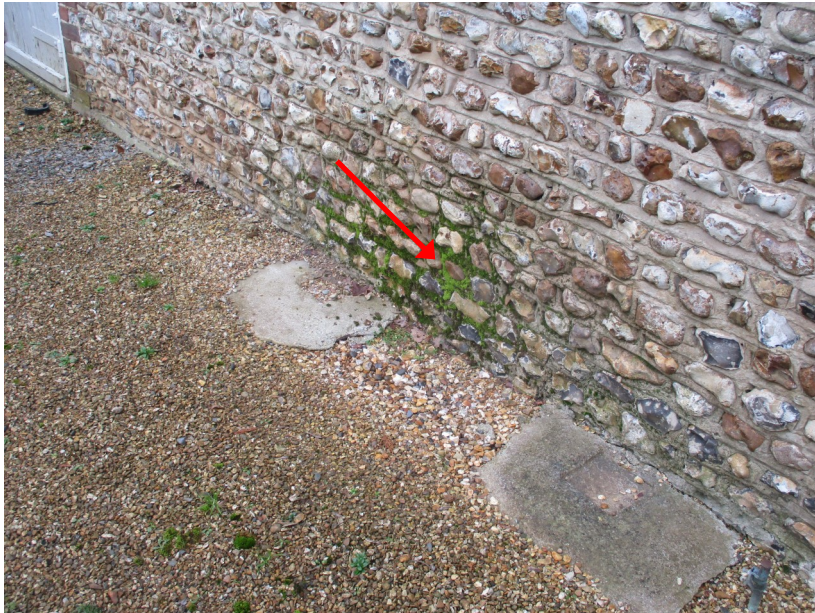
**Fig 15:**

- 1 Roof coverings and drainage: Slate roof coverings and rolled lead sheet flashings showed significant weathering, consistent with the exposed westerly orientation. A small number of slates appeared to have lifted slightly or shifted from their original positions which may indicate 'nail sickness' or other defects that would limit the service life of the roof coverings. The eaves gutter drained to a downpipe at the south end of the façade with an open joint approximately 3m from the north end allowing water to drain to ground level and splash back onto the façade from hardstanding. This would have significantly increased the risk of water penetration into the structure and of damage to timber and other vulnerable materials on the interior

West elevation, north end; showing biological growth on façade masonry where water splashed back onto the elevation from hardstanding at the base of the wall, due to failure or blockage of the eaves gutter above

*Allowance should be made for overhaul or replacement of the provision for roof drainage on proposed refurbishment. Consideration should be given to carrying out roof drainage calculations based on up-to-date meteorological data, to ensure that the roof drainage system has the capacity to effectively discharge surface water from roof coverings clear of the building on future occupancy. H+R can provide further advice if required*

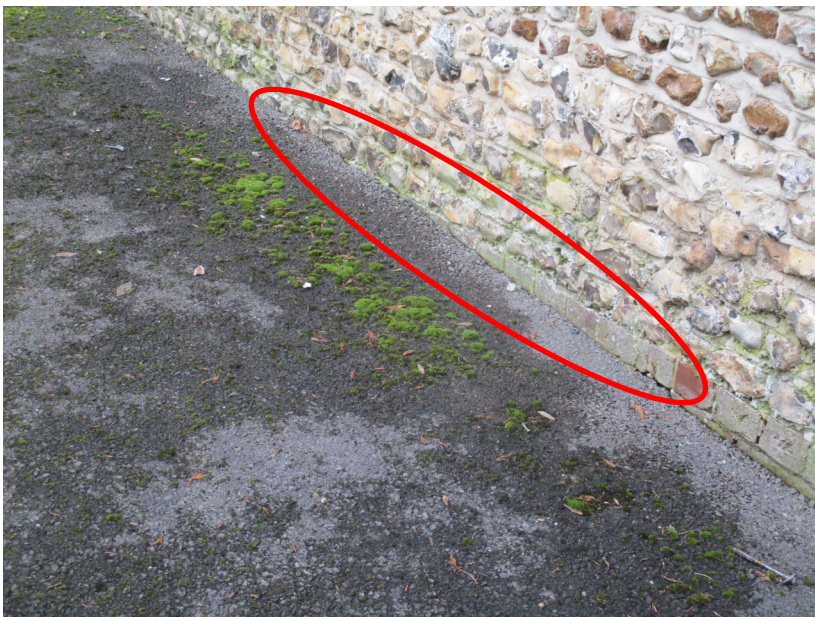
**Fig 16:**

- 3 External ground levels and drainage: Compacted soil, overlaid with chippings, was in contact with the façade at the centre and to the north. The southern section of the elevation was detailed with tarmac hardstanding in direct contact with elevation masonry, with a general fall of ground from north to south, parallel to the façade. No physical damp-proof course was identified and the structure was assumed to rely on the 2 No. courses of engineering brick exposed above ground level to provide protection against rising and penetrating damp into the masonry superstructure. However, increases in ground level over time had bridged the

upper edge of the brick courses, placing potentially saturated soil in contact with the flint façade finishes and increasing the risk of water penetration to the structure generally

West elevation, south end; showing tarmacadam hardstanding bridging the interface between engineering brick at the base of the wall and the flint elevation finishes above

*Allowance should be made for a general reduction in external ground levels to re-expose the engineering brick courses at the base of the wall and to lower ground levels to a minimum 200mm below floor level on the interior. External hard and soft landscaping should be detailed to direct ground and surface water away from the structure and consideration should be given to installing 'soft' surface finishes, such as large diameter beach cobbles forming the upper surface of a French drain, immediately at the base of the façade to reduce the 'splash back' of water from glazing, sills and the eaves onto elevation masonry*

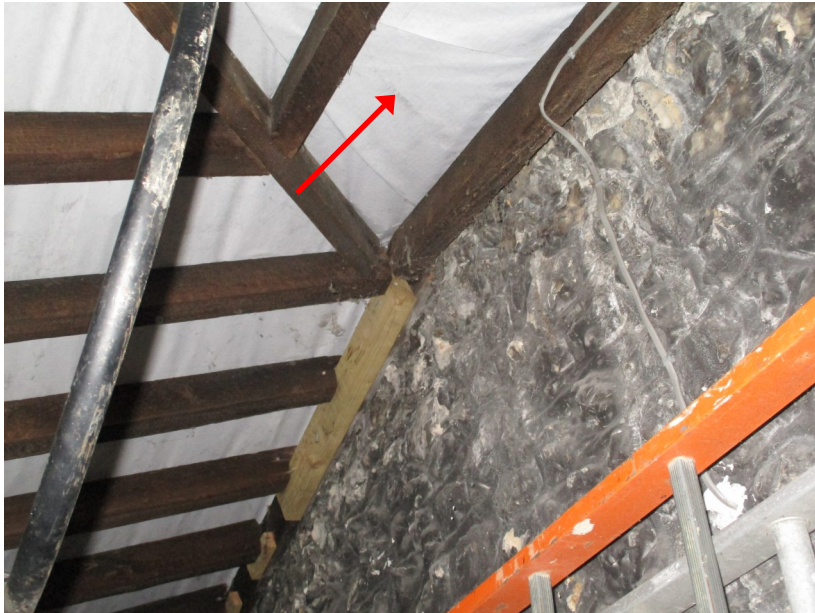
**Fig 17:**

Storage unit on north side; showing internal junction between roof surfaces and the north elevation, with 'modern' slate membranes installed on a previous refurbishment

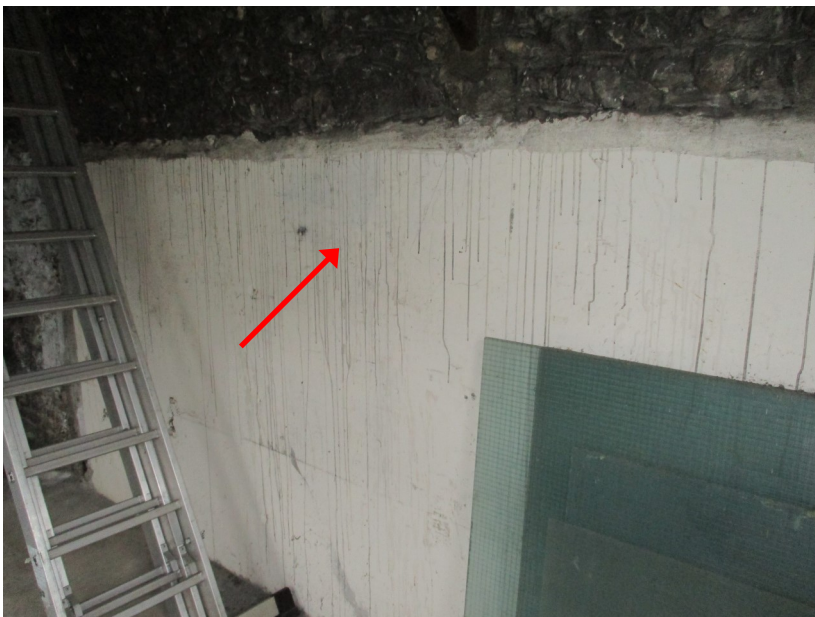
**Fig 18:**

- 1 Defects associated with damp: The previously exposed flint faced wall on the south side showed general soiling, indicating that the exposed elevations may have been cleaned on a previous refurbishment, after the extension had been constructed. A section of cementitious render extending to approximately 1.5m above floor level and covering the west half of the south wall was in fair condition and appeared well adhered. This did not appear to have been installed as a remedial damp-proofing measure. 'Streaking' on wall surfaces may indicate previous intermittent failure of the junction between the roof finishes and the north elevation, allowing surface water to drain across contaminated surfaces at high level and onto the render at the base of the wall

Storage unit on north side, west end of south wall; showing streaking on painted render surfaces at low level, consistent with water draining over soiled masonry above following the failure of the roof coverings and flashings. No evidence of recent or active water penetration was found

*No urgent remedial works are required. Roof coverings and roof drainage systems should be adequately maintained pending refurbishment, to ensure that surface water is drained clear of the structure at all times*

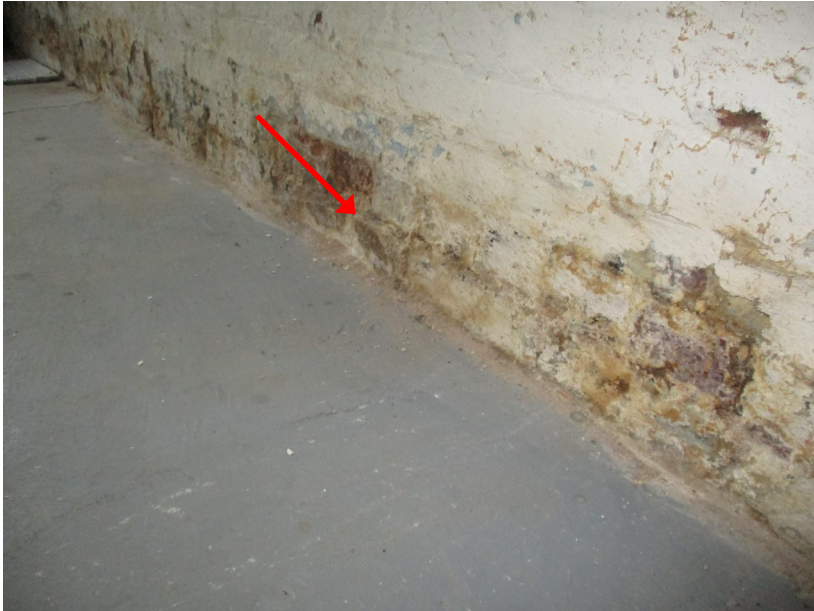
**Fig 19:**

- 1 Defects associated with damp: Paint finishes applied to the base of the south wall had failed across the full width, consistent with chronic damp conditions in masonry where water drained persistently from the exterior. Defects associated with the mobilisation and efflorescence of hygroscopic salts extending to approximately 300mm above floor level. Finishes elsewhere were in fair condition but appeared to have failed more generally to full height at the south-west corner. This part of the structure would have had the greatest exposure to rain driven by prevailing winds against the structure, reducing the service life of decorative finishes where moisture and salt transit through the structure was greatest

Storage area or garage on south side, south wall; showing general failure of decorative finishes at low level, where damp penetration to the structure was noted on the exterior

*Works described elsewhere in this report are required to improve ground drainage at the base of the south wall. Some repairs to façade masonry may be required, subject to detailed inspection. Failed internal paint finishes could be brushed off and replaced in a highly breathable and salt resistant paint type, such as limewash or 'clay' paint. These finishes should be regarded as sacrificial and will require periodic maintenance. If robust protection of internal finishes is required consideration should be given to installing independent internal wall structure, to provide a ventilated dry lining system to full height. This should be detailed to fully isolate timber, hygroscopic materials and vulnerable decorative finishes from*

*masonry vulnerable to moisture and salt transit from the exterior. H+R can provide further advice on remedial detailing if required*

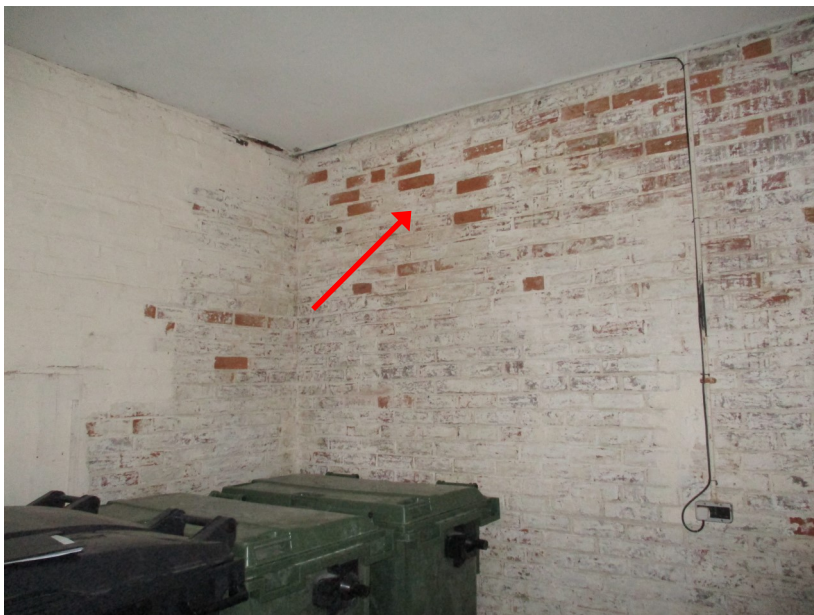
**Fig 20:**

Storage area or garage on south side, south-west corner; showing general failure of vapour permeable paint finishes where applied over bricks of variable softness. Bricks where paint had completely failed also showed significant surface erosion consistent with chronic transit of moisture and salt through the structure where there was exposure to wind driven rain on the exterior

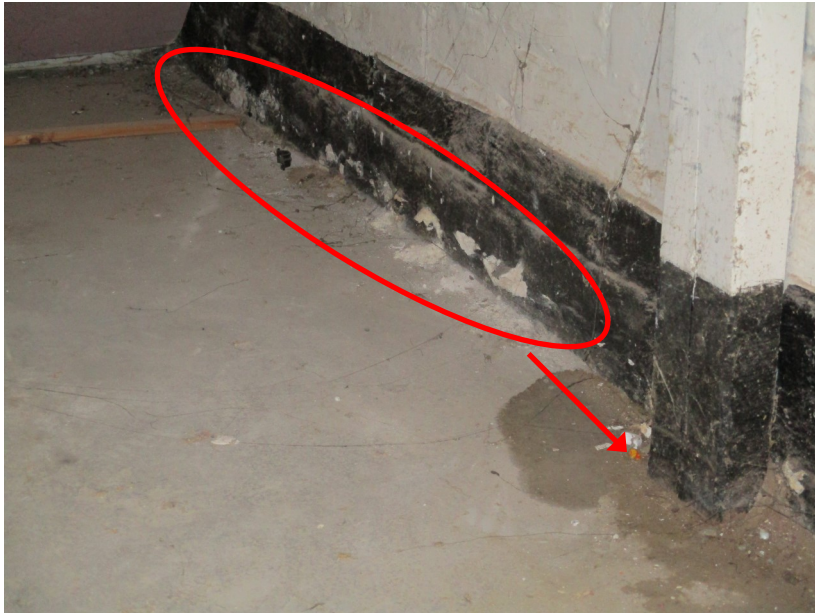
**Fig 21:**

Main central room, south side below staircase; showing salt efflorescence at the wall/floor junction consistent with moisture and salt transit from below

- 2 *Works are required to lower external ground levels generally around the structure and to improve ground drainage. Options for internal decoration on refurbishment are discussed at 3.2.2(1) above*

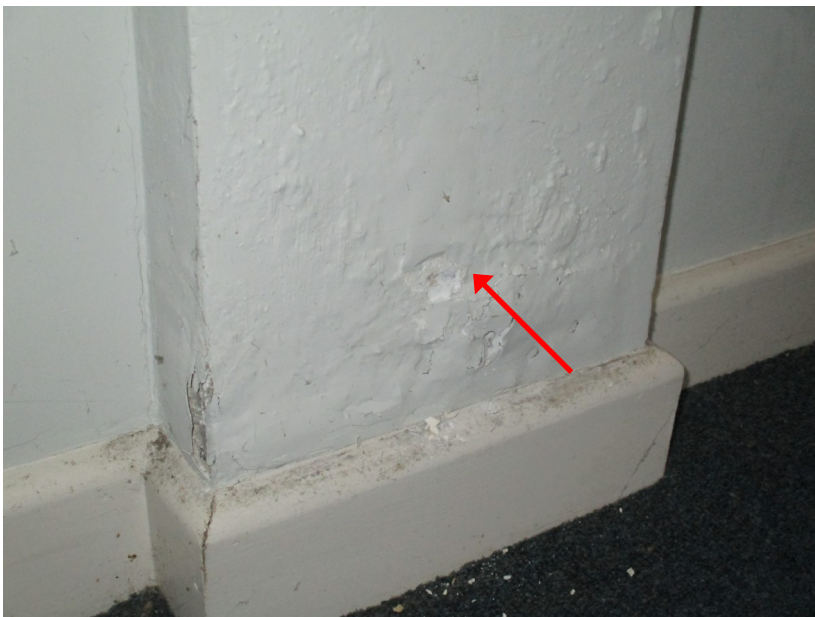
**Fig 22:**

- 1 Defects associated with damp: All external walls had been dry lined in plasterboard on a previous refurbishment, preventing detailed visual inspection from the interior. A solid masonry projection at low level on the north side of the east extension showed extensive failure of impermeable paint finishes, consistent with interstitial efflorescence of hygroscopic salts following water penetration from the exterior. External ground levels were approximately 500mm above internal floor level in this location, increasing the risk of laterally penetrating damp from below ground affecting the structure. Exposed brickwork below the staircase on the south side was in fair condition with no evidence of significant problems of water penetration. Some salt efflorescence at the wall/floor junction may indicate ground moisture penetration at the perimeters of concrete ground bearing slabs laid over horizontal damp-proof membranes on a previous refurbishment, increasing the moisture and vapour pressure at the base of a loadbearing internal wall, with no provision for horizontal damp-proofing

East extension, north side; showing salt efflorescence affecting impermeable paint finishes applied to a solid masonry structure at the base of the wall, where external ground levels were raised above internal floor level. See fig.6 above
