**ATWORTH ARBORICULTURE LTD**  
**DECAY DETECTION TESTS ON 2 OAK TREES AT WREN GROVE,**  
**HAVANT.**

Wren Grove,  
Havant,  
PO9 5FL.

Carry out Resistograph Decay detection test on main stem of 2 oak trees at the above location.

The Inspection was carried out on the 20<sup>th</sup> March 2023. The conditions were extremely wet. The Inspector was Vincent Cainey.

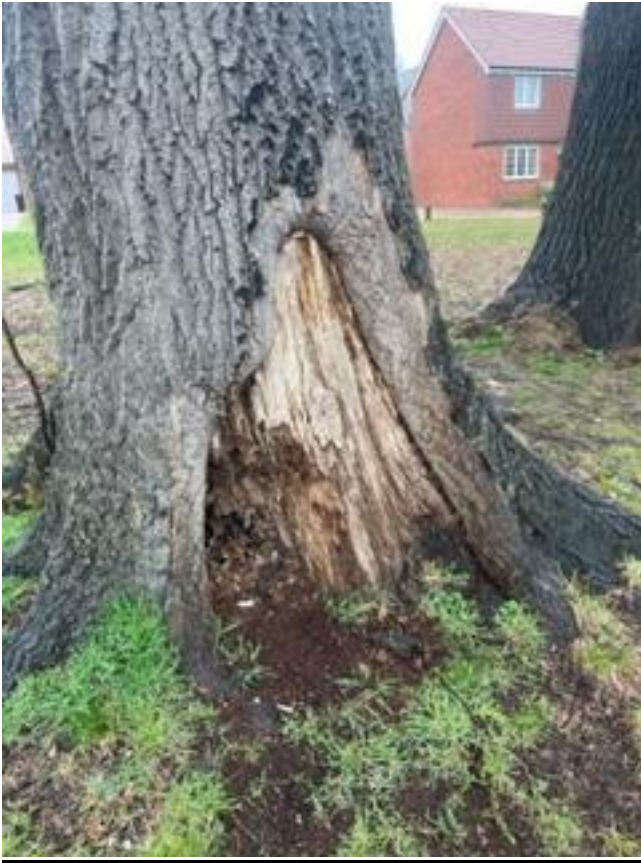
Picture 1

This tree is on a green in the middle of Wren Grove. A play area is 11m west of the tree. At base to the south and southwest is large open Cavity (Picture 1). The cavity is 110cm across, 130cm high and 40cm deep. The surface wood of the wound is soft but only on the surface and becomes hard after 1cm. On the stem at 3.5m above ground level (agl) is an old flush cut pruning wound (Picture 2), with a further wound northwest at 4.5 m agl. To the south at 5m agl is a stub where a limb has been removed. There is a little decay at this point. The crown breaks at 8m agl. A lateral limb, west at the crown break has damage on the underside. The crown has been reduced with some large limbs reduced and some stubs remain The crown is asymmetrical as T3 is 2m east.

Re-inspect in 2 years or if the tree shows significant signs of decline.

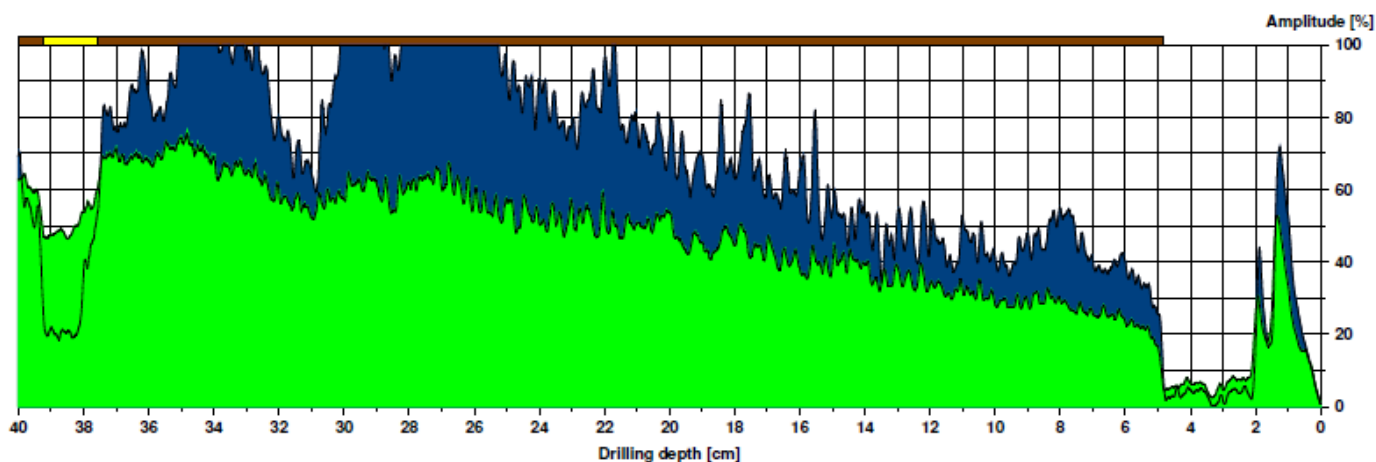
Wren Grove T2 E5M026

| <b>Direction</b> | <b>Height</b> | <b>Results</b> |
|---|---|---|
| East | 5cm | Good wood – 37cm, crack – 39, remainder good wood |

| From 4,81 cm to 37,54 cm : Good Wood |
| From 37,54 cm to 39,26 cm : Crack |
| From 39,26 cm to 40,00 cm : Good Wood |

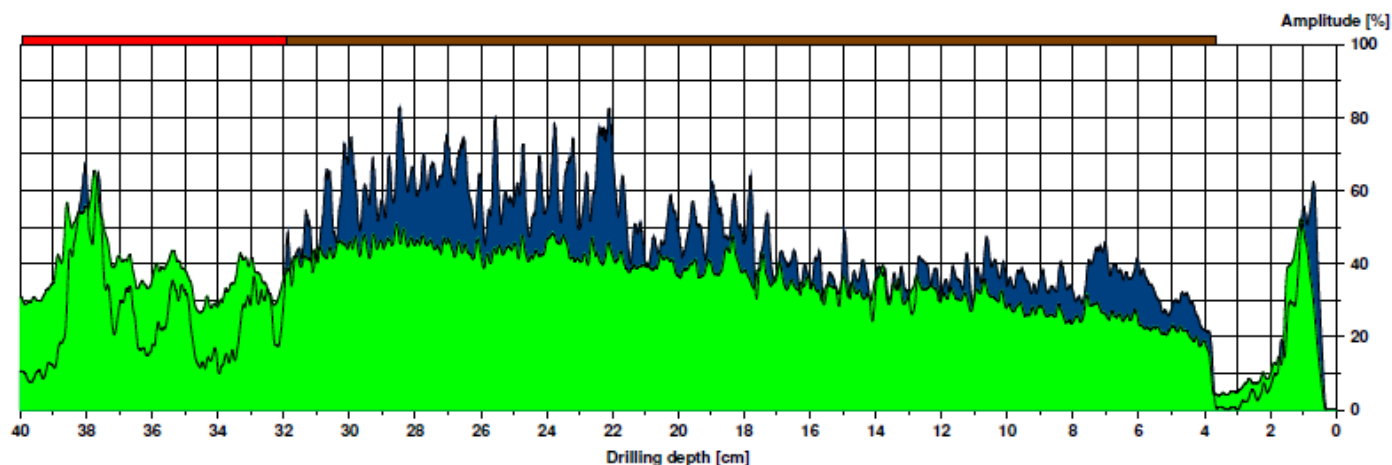
Wren Grove T2 NSM025

| <b>Direction</b> | <b>Height</b> | <b>Results</b> |
|---|---|---|
| North | 5cm | Good Wood – 32cm, remainder decay |

| From 3,65 cm to 31,89 cm : Good Wood |
| From 31,89 cm to 39,94 cm : Decay |

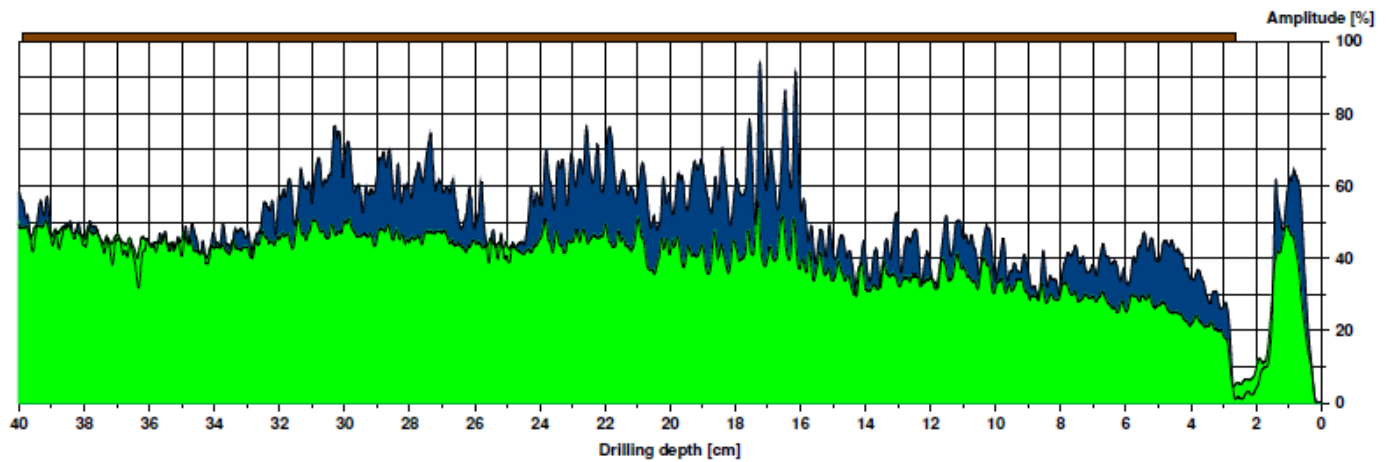
Wren Grove T2 NW5M024

| <b>Direction</b> | <b>Height</b> | <b>Results</b> |
|---|---|---|
| Northwest | 5cm | All good wood |

From 2,65 cm to 39,90 cm : Good Wood

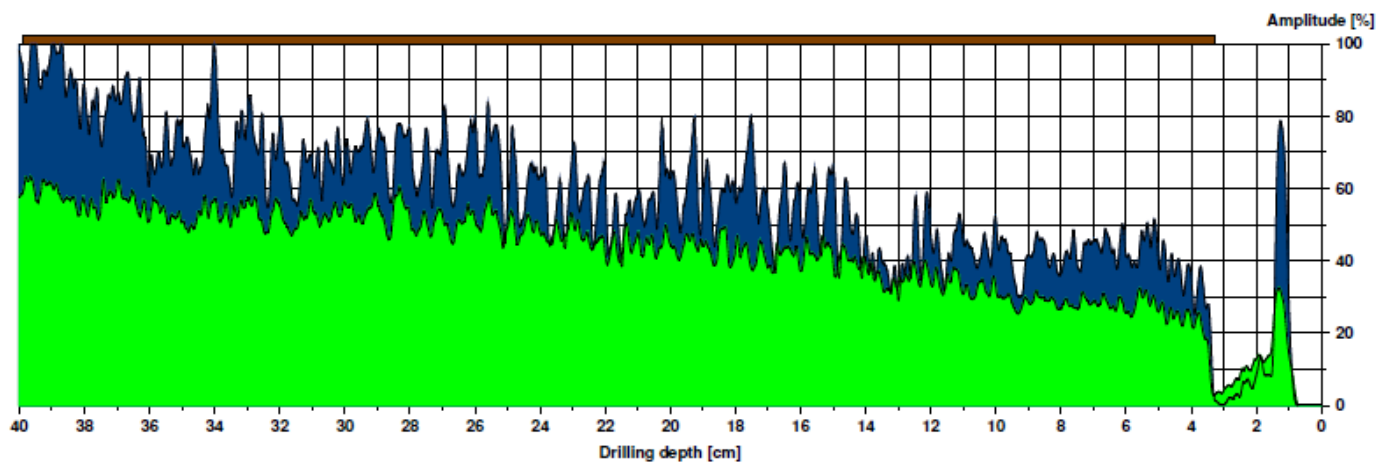
Wren Grove T2 SW15M023

| <b>Direction</b> | <b>Height</b> | <b>Results</b> |
|---|---|---|
| Southwest | 0cm | All good wood |

From 3,26 cm to 39,87 cm : Good Wood

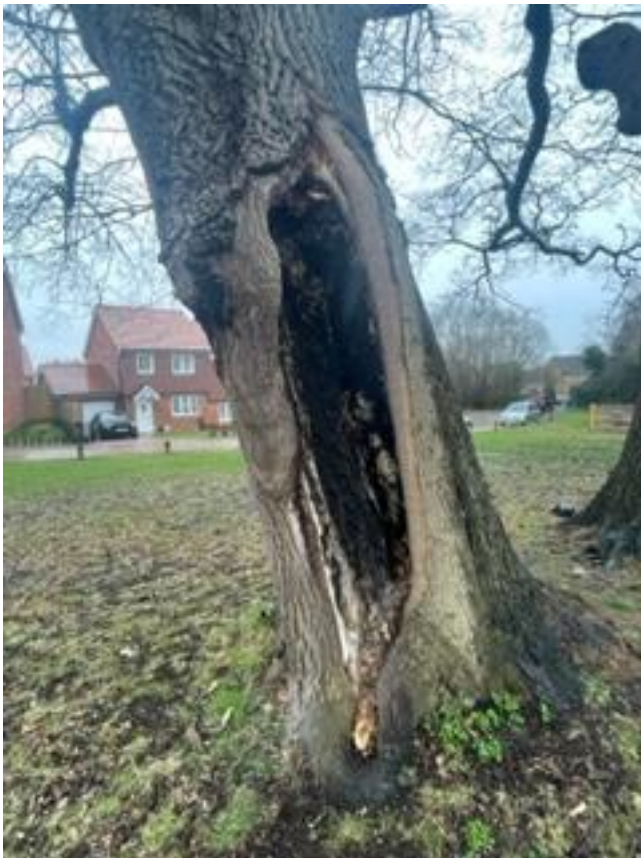
Picture 3

This tree is 2m east of T2. The road is 15m east, 12m north and 15m south. On the north side of the stem from ground level to 2.5m agl is a large open cavity (Picture 3), which is 50cm wide and up to 60cm deep. At some stage there has been a fire in the cavity. At the base of the calls are remnants of old fungal brackets that have been knocked off. To the east at ground level is an area of bark damage. The stem leans to the east. There are lots of old pruning wounds around the crown break at 5m agl, one more recent limb removed north at 5m agl. To the east and south are 2 large lateral limbs that are over 10m long. More limbs have been removed northeast at 9m agl. and central at 12m agl. On the southeast ascending stem at 14m agl is a bracket fungus, possibly inonotus (Picture 4). The crown has been reduced with some old stubs where branches have snapped off.

The tree should be felled as soon as practically possible. This work should be done by a fully qualified and insured tree surgeon working to BS3998 (2010), Tree work.

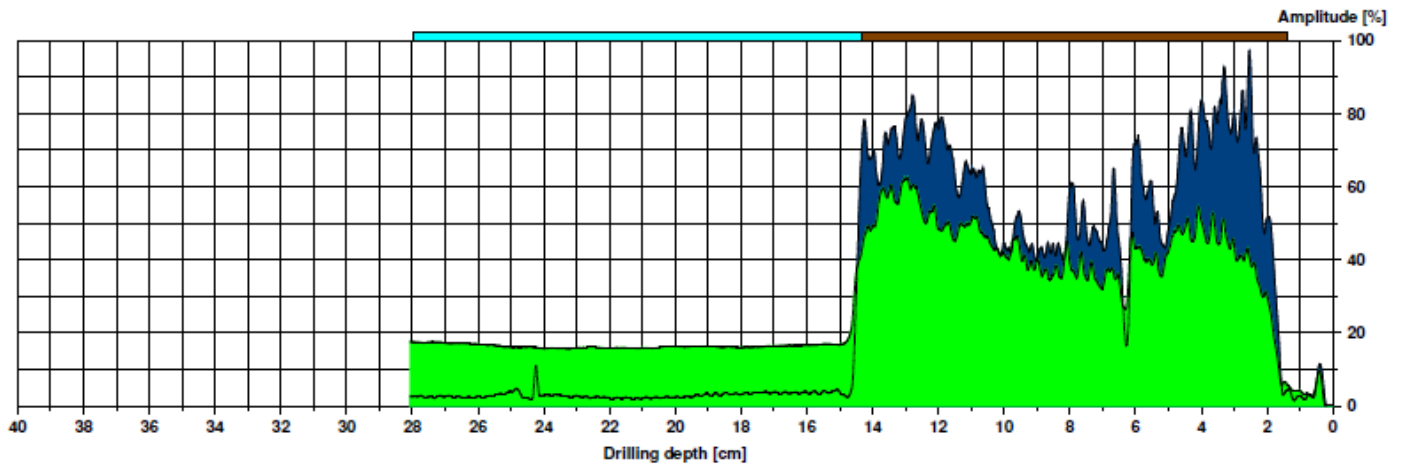
Wren Grove T3 ESM031

| Direction | Height | Results |
|---|---|---|
| East | 5cm | Good wood – 14cm, remainder cavity |

From 1,39 cm to 14,31 cm : Good Wood  
 From 14,31 cm to 27,95 cm : Cavity

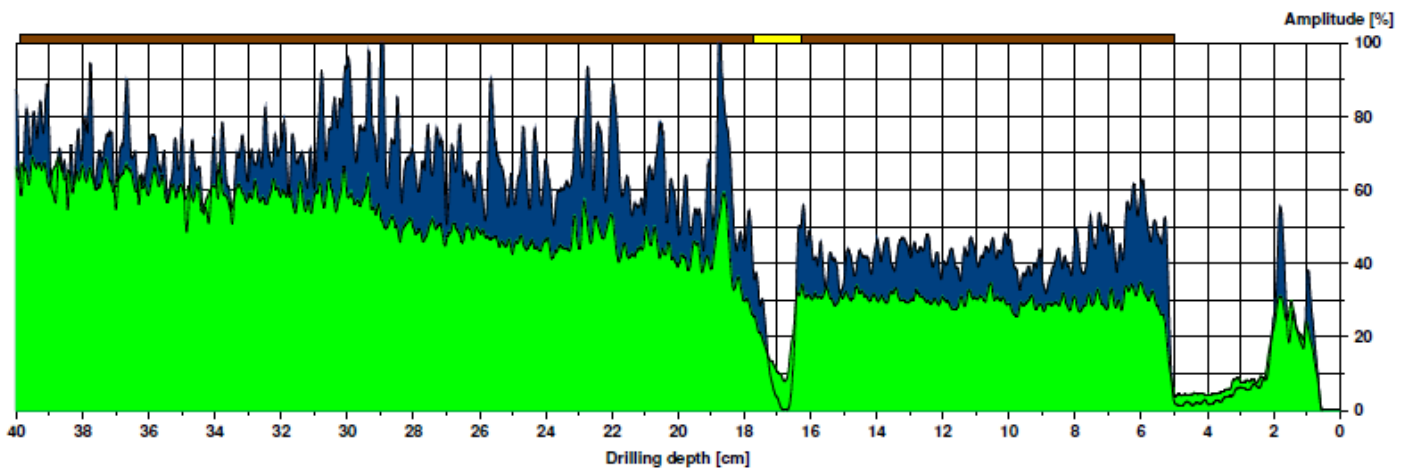
Wren Grove T3 E60M030

| Direction | Height | Results |
|---|---|---|
| East | 60cm | Crack 16 - 17cm, remainder good wood |

From 4,98 cm to 16,28 cm : Good Wood  
 From 16,28 cm to 17,71 cm : Crack  
 From 17,71 cm to 39,87 cm : Good Wood

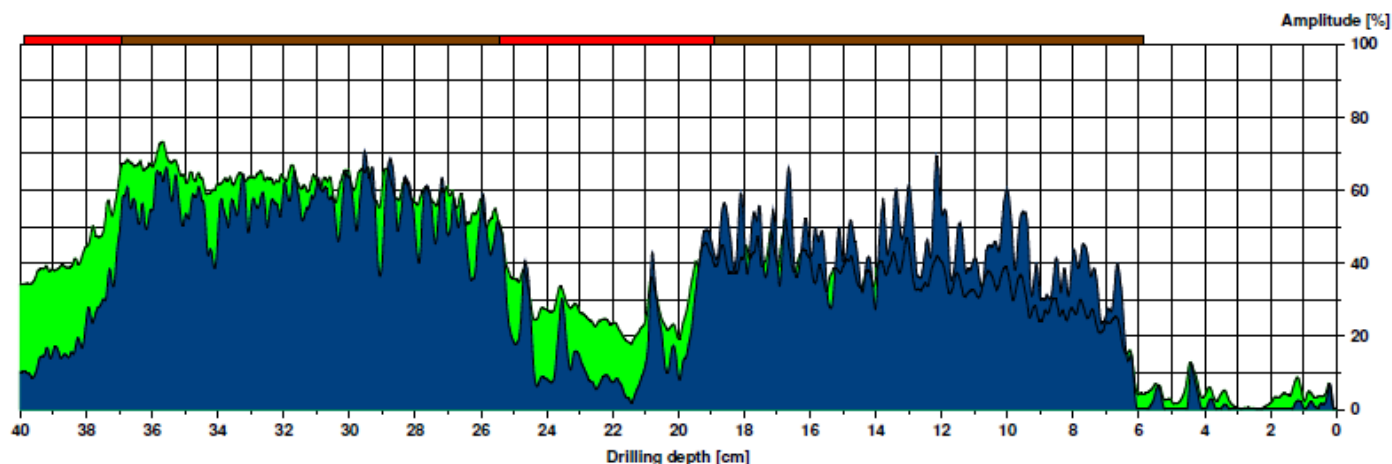
Wren Grove T3 N30M033

| Direction | Height | Results |
|---|---|---|
| North | 30cm | Good wood – 19cm, decay -26cm, good wood – 37cm, remainder decay |

| From | 5,85 cm to | 18,93 cm | : Good Wood |
| From | 18,93 cm to | 25,43 cm | : Decay |
| From | 25,43 cm to | 36,90 cm | : Good Wood |
| From | 36,90 cm to | 39,90 cm | : Decay |

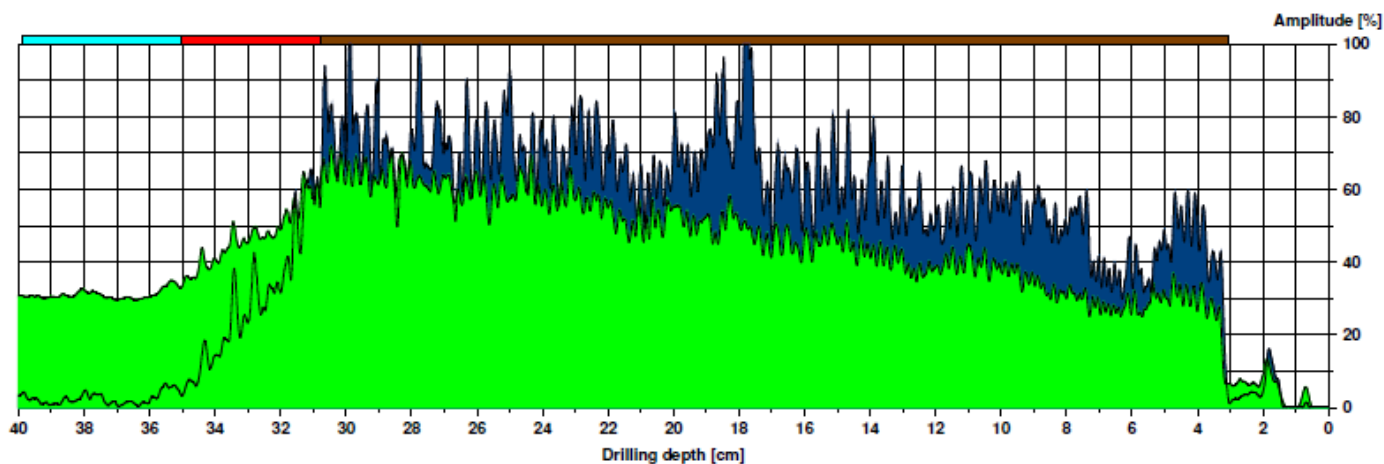
Wren Grove T3 NW 60cmM027

| Direction | Height | Results |
|---|---|---|
| Northwest | 60cm | Good – 31cm, decay – 35cm, remainder cavity |

| From | 3,07 cm to | 30,79 cm | : Good Wood |
| From | 30,79 cm to | 35,02 cm | : Decay |
| From | 35,02 cm to | 39,90 cm | : Cavity |

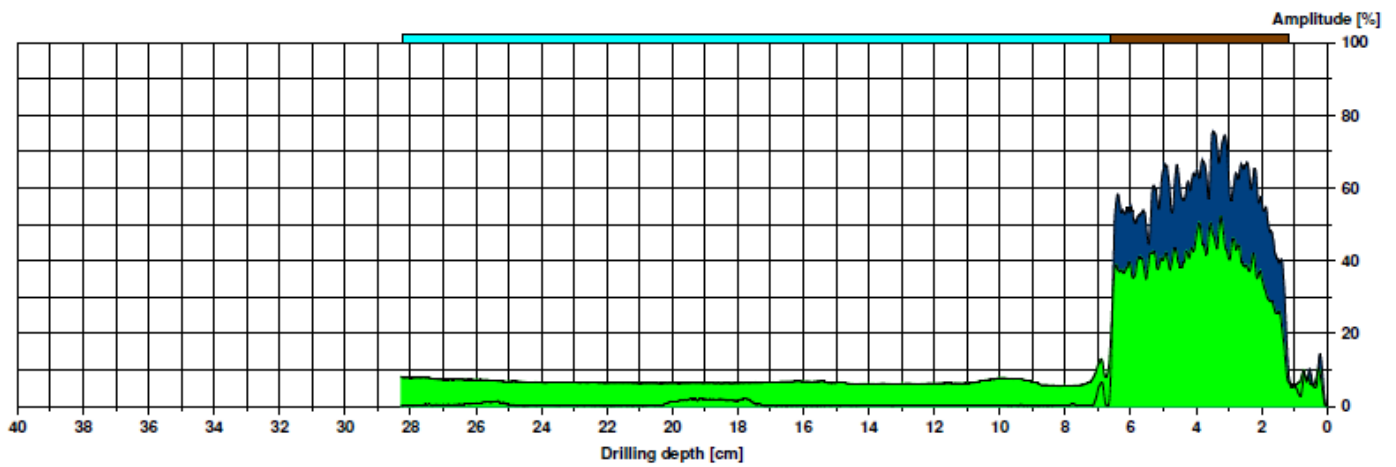
Wren Grove T3 NW10M034

| Direction | Height | Results |
|---|---|---|
| Northwest | 10cm | Good – 6cm, remainder cavity |

From 1,20 cm to 6,62 cm : Good Wood  
 From 6,62 cm to 28,24 cm : Cavity

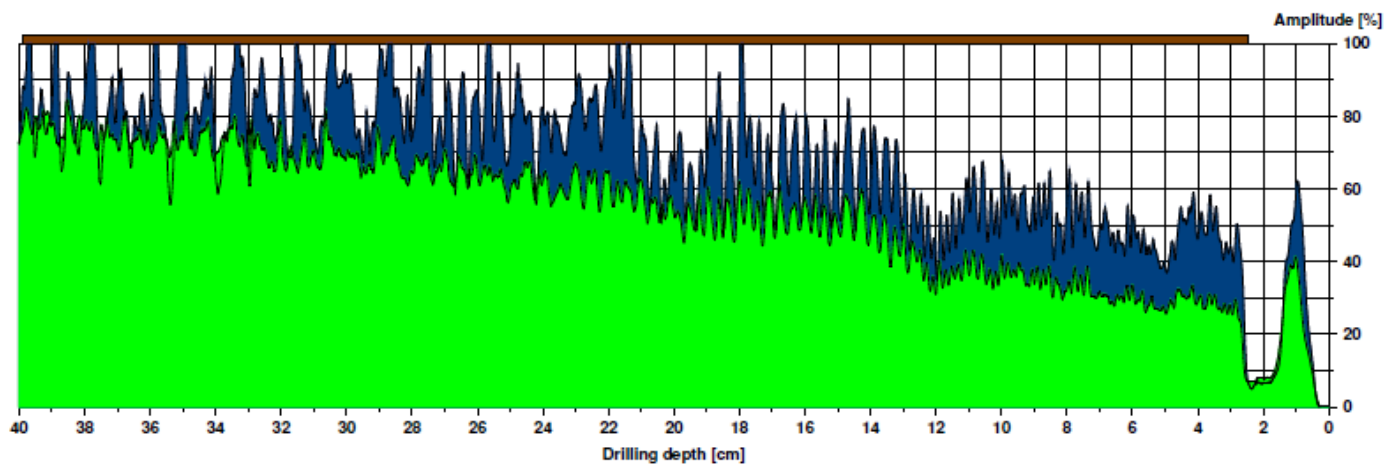
Wren Grove T3 S60M029

| Direction | Height | Results |
|---|---|---|
| South | 60cm | All good wood |

From 2,46 cm to 39,90 cm : Good Wood

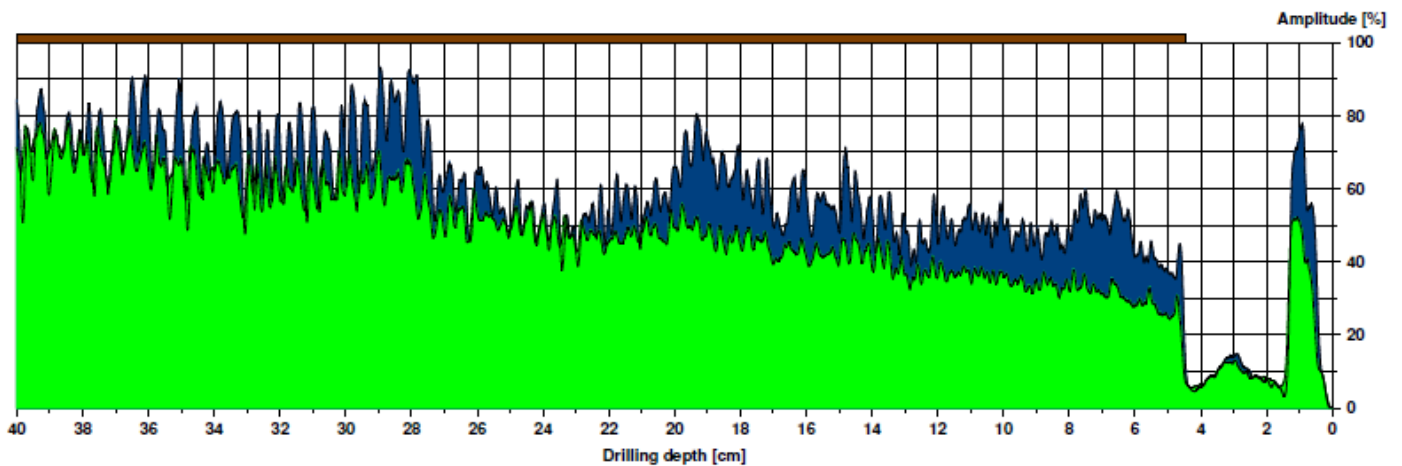
Wren Grove T3 SW5M032

| Direction | Height | Results |
|---|---|---|
| Southwest | 5cm | All good wood |

From 4,46 cm to 39,97 cm : Good Wood

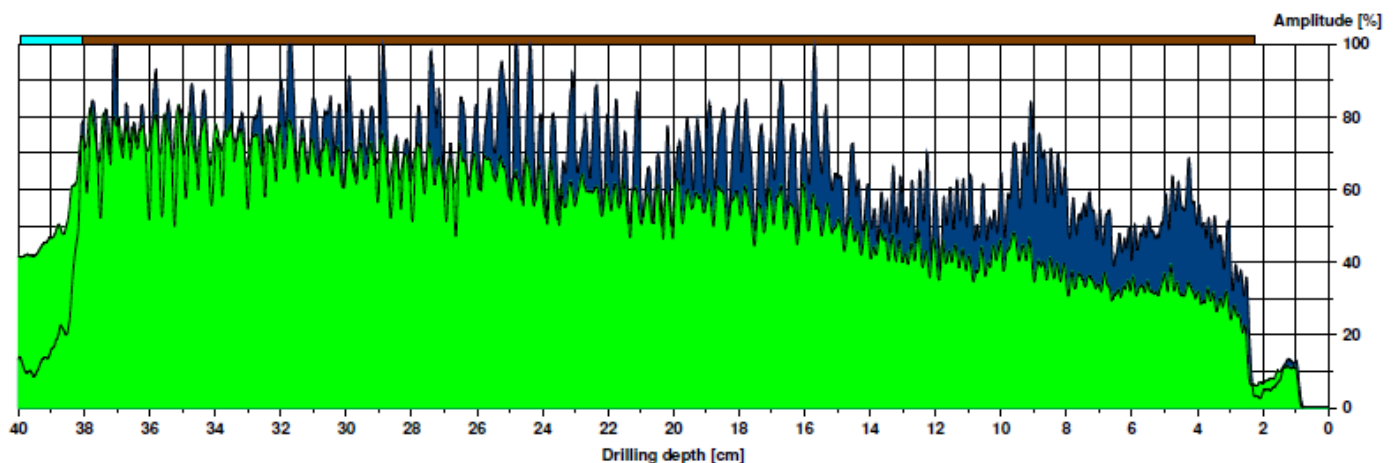
Wren Grove T3 W60M028

| Direction | Height | Results |
|---|---|---|
| West | 60cm | Good wood – 38cm, remainder cavity |

From 2,26 cm to 38,06 cm : Good Wood  
From 38,06 cm to 39,94 cm : Cavity
