# Hutton + Rostron Environmental Investigations Limited

## Southleigh Park, Stables: Investigation of masonry damp and damp-proof courses

Site note C3 for 18 January 2021, job No. 152.09.

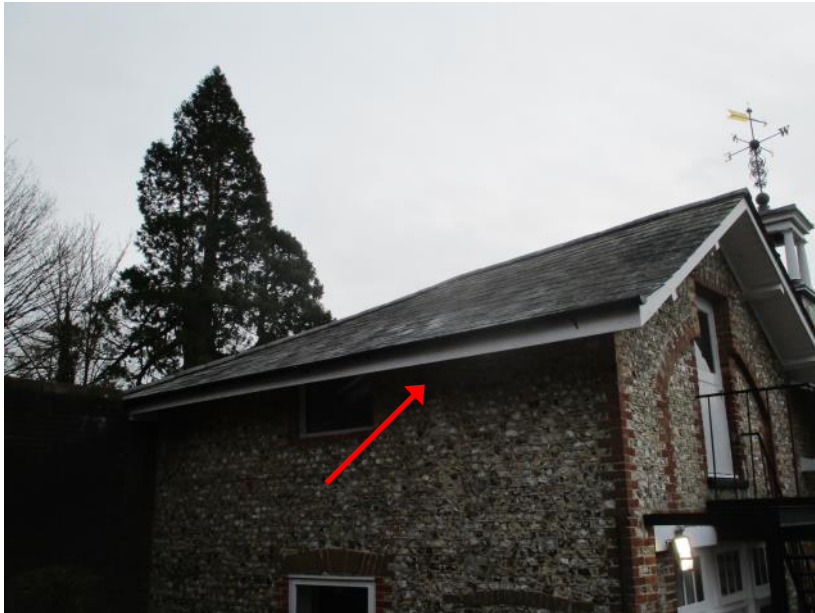
**Fig 1:**

North elevation, view from north-west;  
showing general arrangement of roof  
coverings and deep eaves

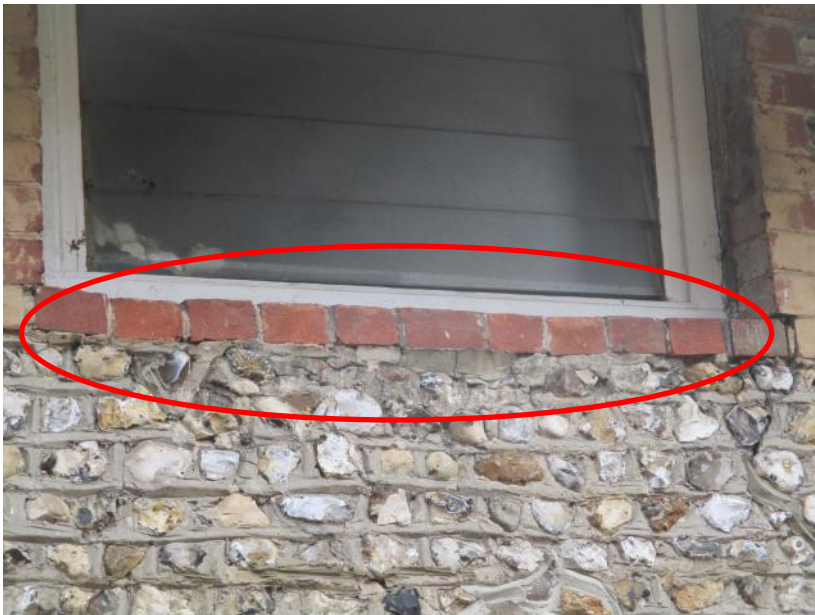
**Fig 2:**

- 2 Masonry: The façade was from coursed flints set into weather struck pointing. Pointing had failed around the flat brick sill to the first floor window but the extent to which this increased the risk of water penetration into the structure was mitigated by the sheltered northerly orientation. Elsewhere a number of shrinkage cracks around flints indicated that the façade had been patch repaired in a cementitious mortar in isolated areas on previous refurbishment. This may allow surface water to drain into the structure but restrict drying, increasing the risk of residual moisture accumulating in the masonry of the façade and of damp penetration to the interior

North elevation, first floor window;  
showing damaged pointing around a  
flat brick sill that may be allowing water  
to drain into the structures beneath  
window opening

*Allowance should be made for replacing the sill to the first floor window in a fired clay or masonry sill that it is assigned to throw surface water clear of the structures beneath. Façade pointing should be inspected in detail when safe and convenient access is available and allowance made for cutting out and replacing any detached or loose render in a lime mortar mix, gauged to match the original materials. Consideration should be given to cutting out all cementitious pointing from the façade and replacing in a suitable lime mortar mix. H+R can advise further on conservation repairs if required*

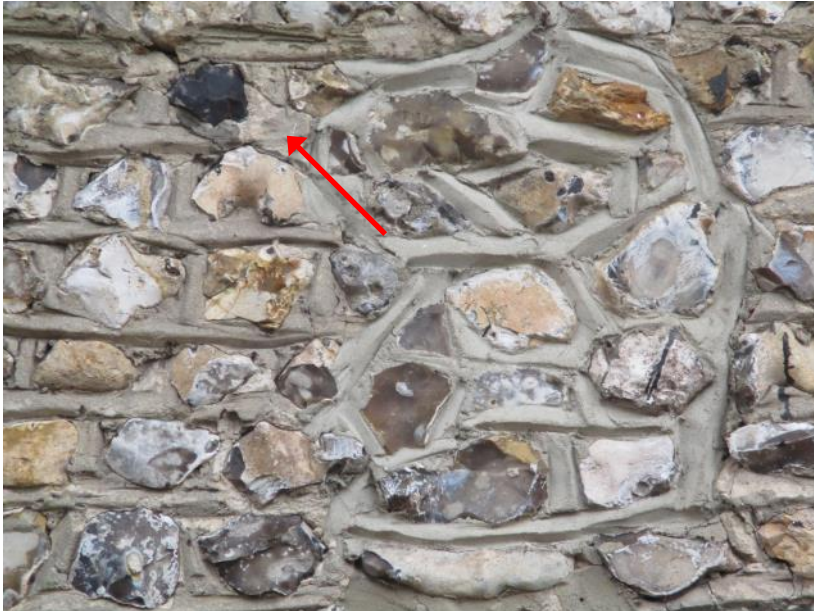
**Fig 3:**

North elevation, central section; showing typical cementitious patch repair to lime mortar pointing. Note shrinkage cracks around flints which may allow surface water to drain into the structure

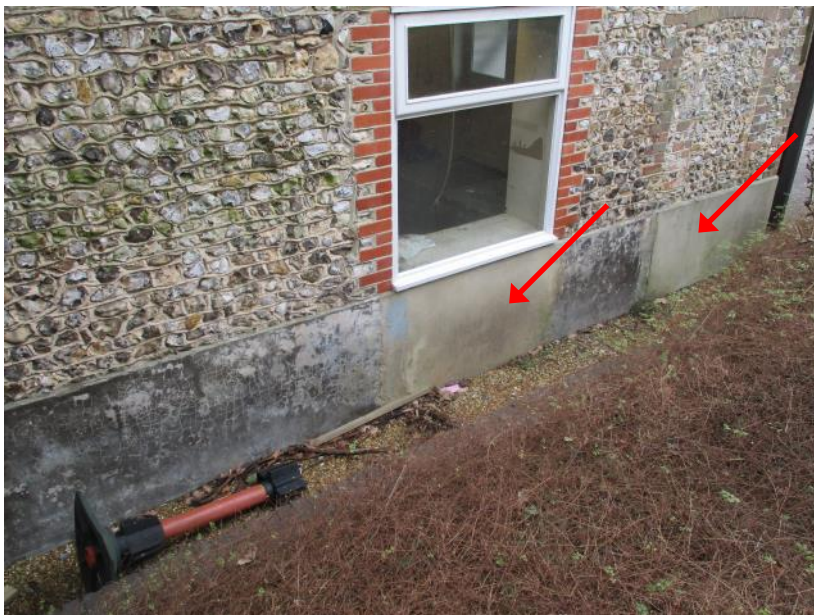
**Fig 4:**

- 3 Render: A render panel approximately 30mm thick had been applied to the base of the wall extending to approximately 700mm above external ground level. Patch repairs had been made in a cementitious mortar below the central ground floor window and a blind window opening towards the west end of the elevation. Vertical cracks had formed between the repaired material and retained render on the west side, which may have allowed surface water to drain into the structures behind

North elevation; showing patch repairs to the render skirting at the base of the wall, possibly where door openings had been closed off or reduced on previous refurbishment

*Allowance should be made for specialist repair to cracks in the render panel at the base of the wall if this is to be retained on proposed refurbishment*

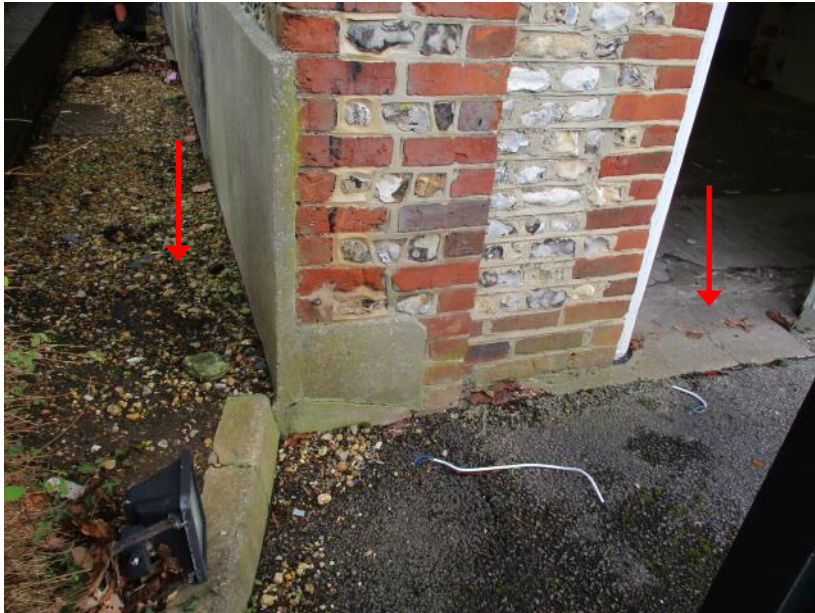
**Fig 5:**

North elevation, west end; showing external ground levels approximately 150mm above finished floor level on the interior across the full width of the façade

*On future refurbishment consideration should be given to a general reduction in external ground levels to a minimum 150mm below any horizontal damp proof courses included in the structures and perhaps 200mm below internal floor level where no DPC had been installed. No chemical injected remedial DPCs or internal applications of waterproofing cementitious render are required or recommended.*

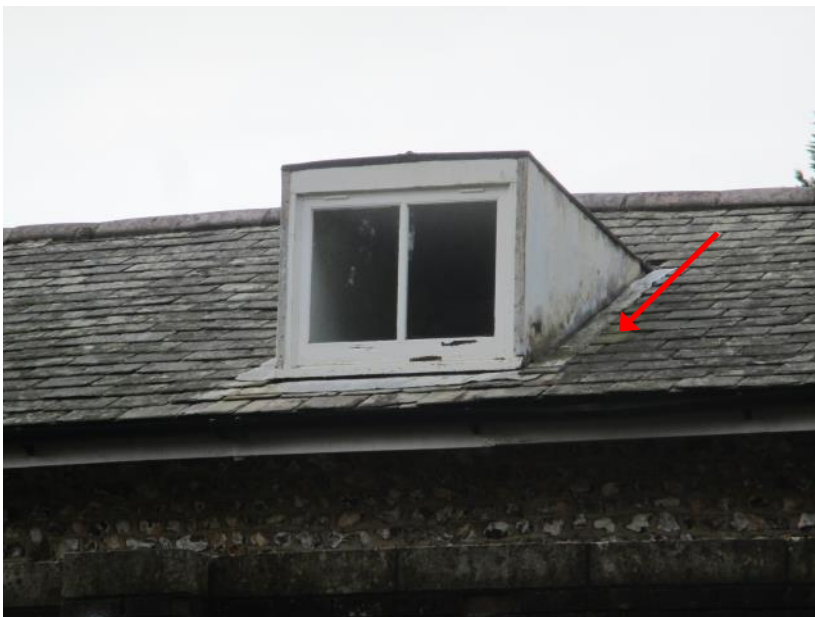
**Fig 6:**

North wing, east elevation; showing general condition of roof coverings and sheet lead flashings around the central dormer

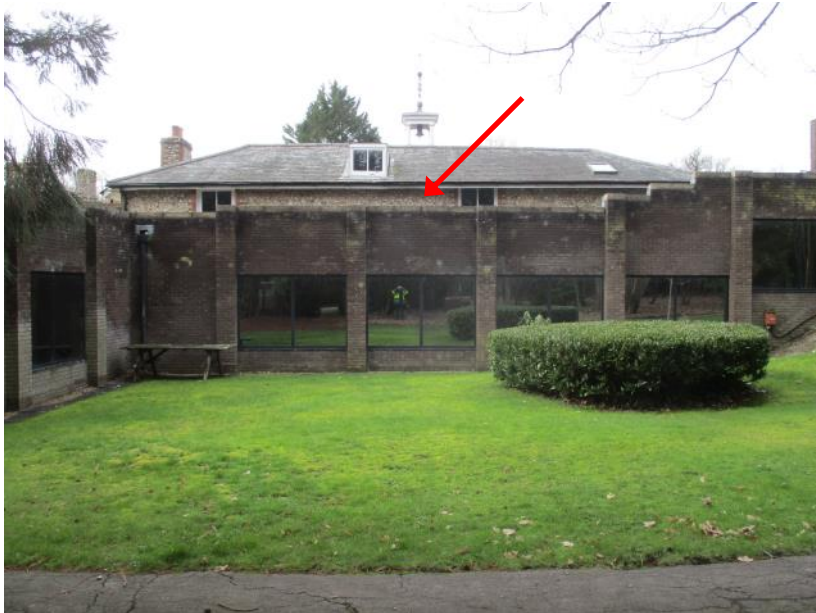
**Fig 7:**

- 2 Façade: Approximately 1.5m of elevation masonry was exposed below the eaves, above the flat roof of the extension installed across the full width of the elevation on a previous refurbishment. Flint masonry, laid in courses and brick embellishments to window reveals at first floor level were in good condition, consistent with the sheltered easterly orientation

North wing, east elevation; showing general arrangement of façade, with approximately 1.5m of elevation masonry exposed above a flat roofed extension extending across the full width of the building, which H+R understand is scheduled for demolition on proposed refurbishment

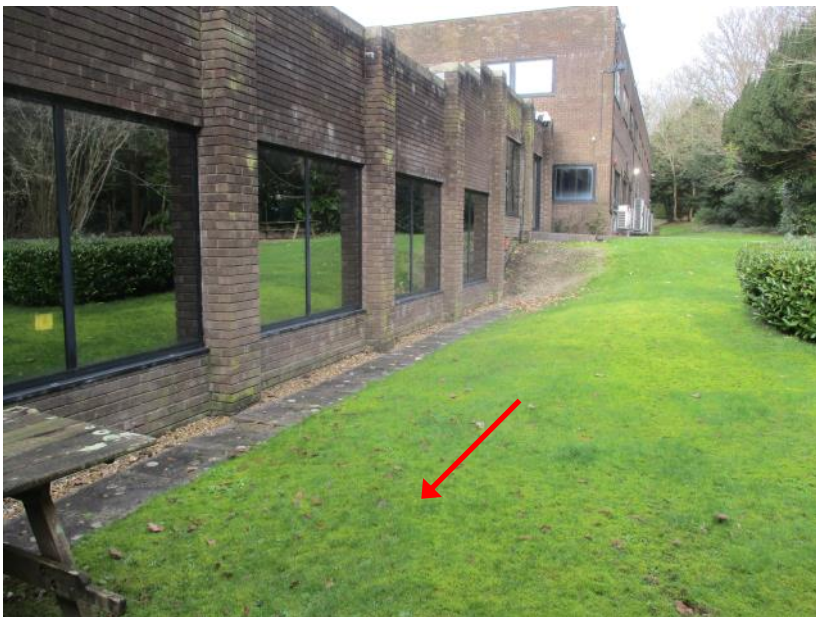
**Fig 8:**

North wing, east elevation; showing general fall of ground from north to south, with extensive moss growth on turf indicating saturation of soil in contact with the single storey extension at time of survey

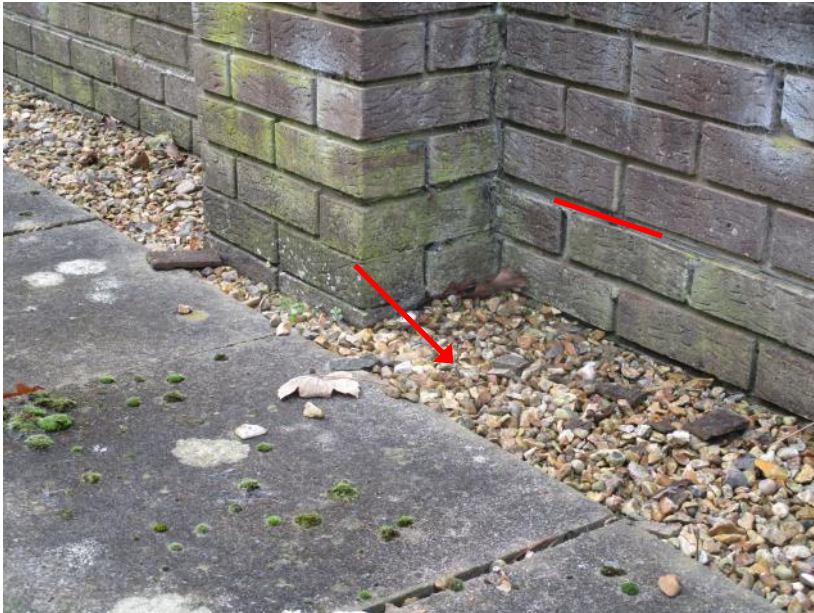
**Fig 9:**

North wing, east elevation of single storey extension; showing drainage trench detail at base of wall and physical horizontal damp-proof course 2 no. brick courses above external ground level

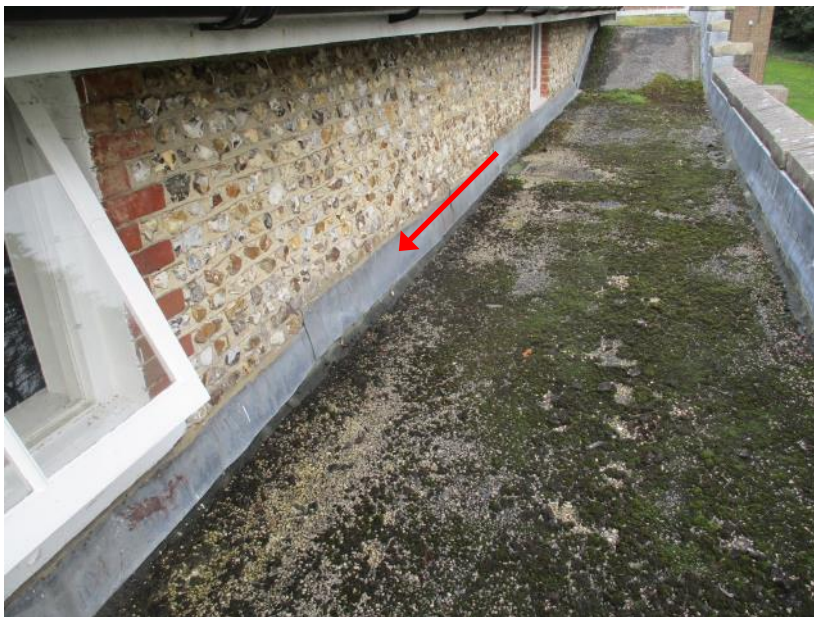
**Fig 10:**

North wing, east elevation; showing generally good condition of sheet lead cover flashings to the asphalt upstand at the abutment between the single storey extension and the east elevation

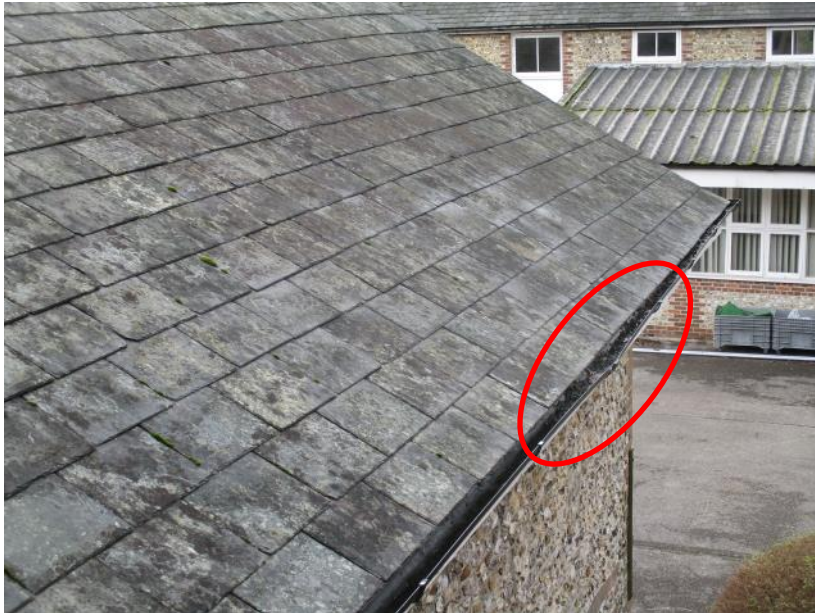
**Fig 11:**

- 1 Roof coverings appeared to be from natural slates on preliminary inspection from ground level. Slates and ridge fittings were generally intact and appeared in good condition. The eaves gutter was laid to fall from west to east, draining onto the flat roof of the extension from on the east side of the elevation. The eaves were relatively deep, extending approximately 600mm from the façade. No defects allowing surface water to drain over structures below the eaves were identified but a deflection in the gutter, approximately 3m from the west end, may have allowed water to overflow onto the ground at the base of the structure in the past

North elevation; showing general condition of slate roof coverings and eaves gutter at time of survey. Partial obstruction of the gutter was allowing water to drain clear of the eaves but the depth of the eave projection protected the façade from surface water

*H+R assume that roof coverings are to be overhauled and roof drainage systems replaced on proposed refurbishment. The roof drainage system should be adequately maintained pending refurbishment to ensure that water from roof structures is drained clear of masonry at all times, especially around the base of the building*

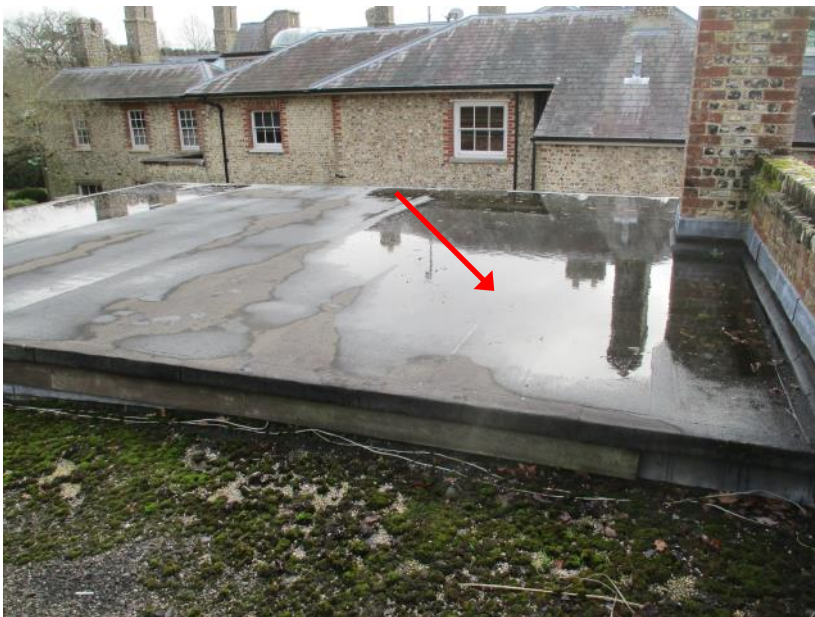
**Fig 12:**

- 1 Roof coverings and drainage: Roof coverings above the façade were in a mixture of asphalt and mineral felt, laid over flat roof structures. Extensive ponding was noted to the east of the upstand wall and chimneystack, dividing the south-east extension from the single storey corner building to the south-west. This may have allowed surface water to drain into internal loadbearing masonry, increasing the risk of damage to decorative finishes and of decay in structural timber elements in contact with damp affected masonry at roof level and below

Extension to south-east; showing flat roof coverings subject to extensive ponding, increasing the risk of water penetration to the structures below

*H+R assume that roof structures are to be overhauled on proposed refurbishment and roof coverings and drainage provision replaced. Allowance should be made for routine inspection and repair of the roof coverings and drainage pending refurbishment, to prevent further water penetration to the roof structures or interiors*

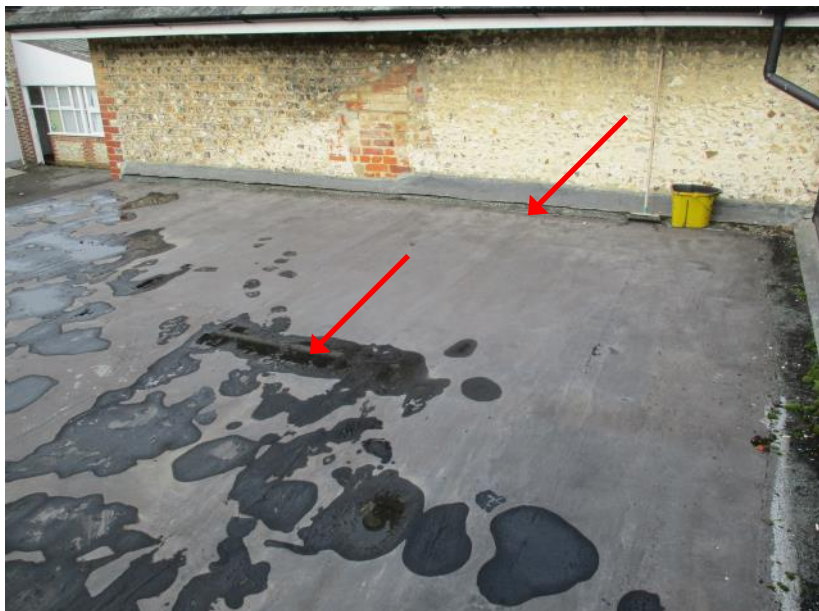
**Fig 13:**

South elevation, west end; showing generally serviceable condition of asphalt roof coverings, with isolated blistering and progressive failure of protective paint coatings. Note mineral felt patch repairs at the roof perimeter. Defects at the edge of the roof may have allowed surface water to drain into the structures below in the past

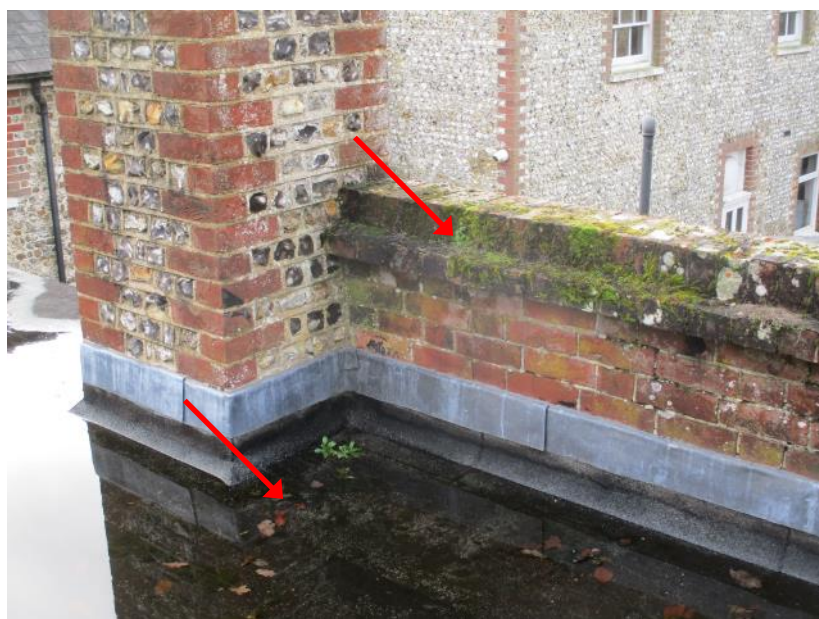
**Fig 14:**

Roof above south elevation, central section; showing standing water adjacent to an upstand dividing wall which was subject to extensive biological growth, indicating intermittent saturation and an increased risk of water penetration into the structures beneath

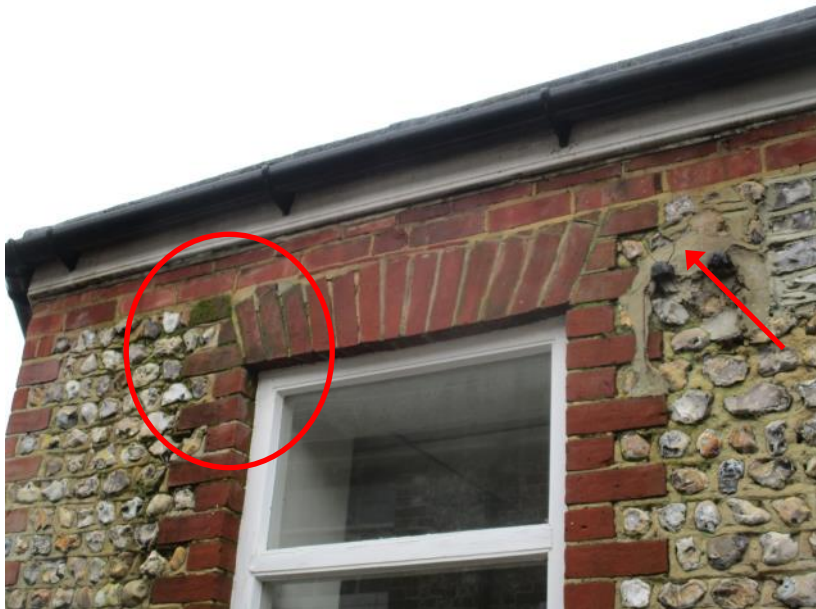
**Fig 15:**

South elevation, west end; showing biological growth affecting brickwork adjacent to a window opening, consistent with intermittent failure of the provision for roof drainage above. Note also cementitious repair to masonry and pointing, where an item of architectural ironmongery had been removed on previous refurbishment. Cracks and open joints in this location were likely to be allowing water penetration where the roof drainage system above was vulnerable to overflow

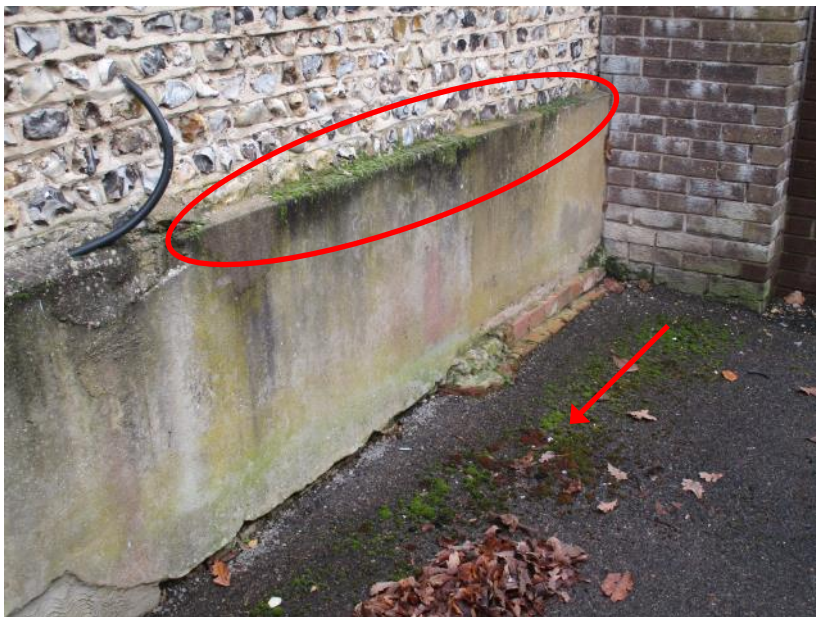
**Fig 16:**

South elevation, east end; showing biological growth on the upper surface of the render skirting at the base of the wall and moss growth on hardstanding close to the façade, indicating persistently damp conditions consistent with intermittent failure of the provision for roof drainage

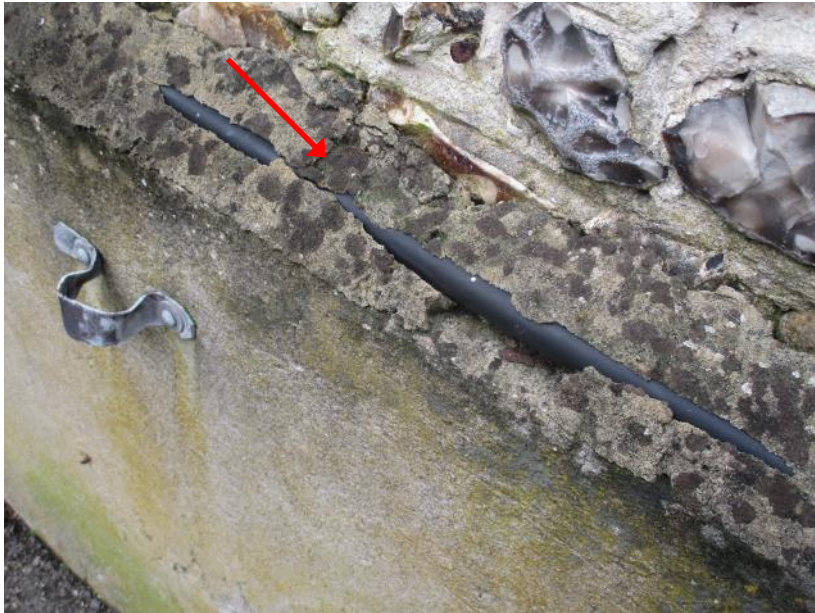
**Fig 17:**

South elevation, central section;  
showing typical failure of cementitious  
fillet applied above the render skirting,  
to cover a power cable

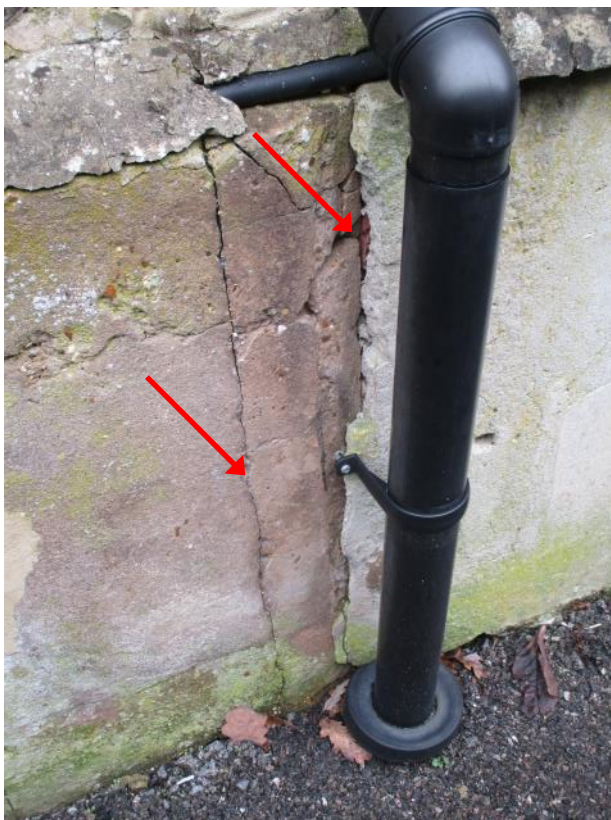
**Fig 18:**

- 3 Render: A render skirting, projecting approximately 60mm from the façade, was installed across the full width of the elevation, following the fall of ground at the lower edge and with the upper edge between 400 and 600mm above external ground level. Render appeared to have been extensively patch repaired or replaced on previous refurbishments and significant vertical cracks had formed in 2 No. locations; approximately 1.5m to the west of the 45° return corner and beneath the rainwater downpipe at the centre of the elevation. Render surfaces were subject to extensive biological growth on the upper surfaces, where these did not shed water effectively away from the façade and at low level, where render was in direct contact with tarmacadam hardstanding, allowing water draining from the eaves to splash back onto the façade at low level. A mortar fillet had been applied to the upper surface of the skirting across the majority of the elevation, where a power cable had been covered over. This fillet showed widespread failure and detachment, allowing surface water to drain into the head of the render skirting and to pass through open joints at the interface between the skirting and the elevation masonry

South elevation, central section;  
showing vertical open joints in the  
render skirting, likely to allow water  
penetration into the structure should  
the provision for roof drainage fail  
locally

*Allowance should be made for complete removal of the existing render skirting and for replacement in new materials as directed by the Architect. Render replacement should be undertaken in conjunction with modifications to external ground levels and landscaping, to ensure effective drainage at the junction between the external ground and the façade and to prevent water 'wicking' up through the skirting render or the interface between the render and the brickwork behind*

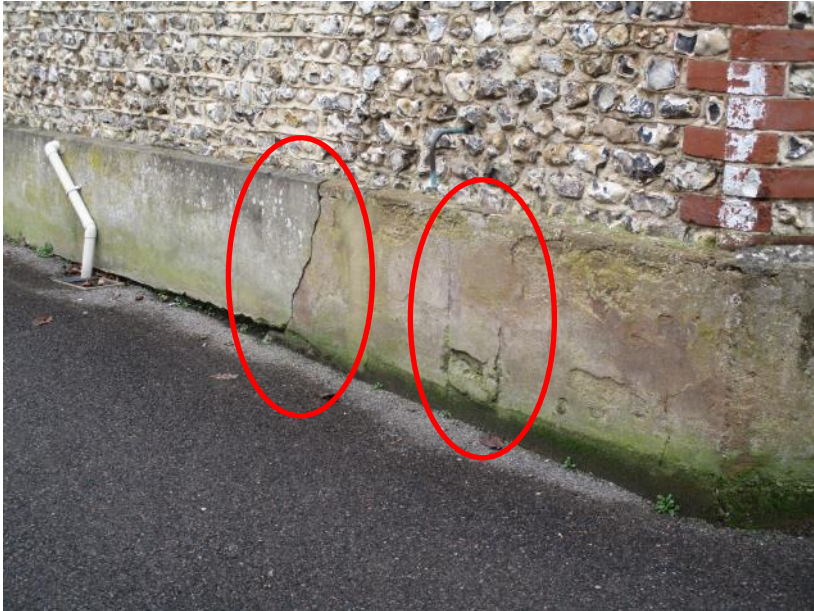
**Fig 19:**

South elevation, angled return on west side; showing surface weathering and cracks in the render skirting at the base of the wall

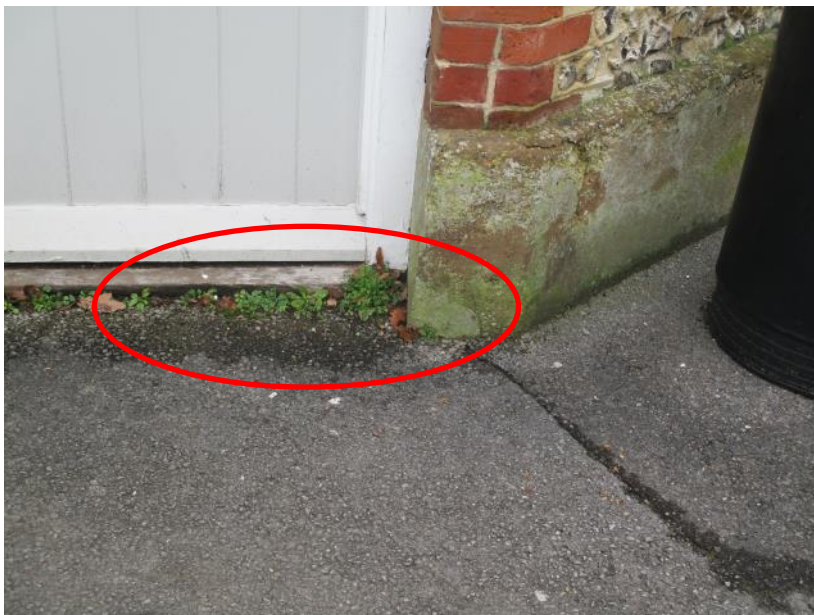
**Fig 20:**

South elevation, west end; showing external ground levels rising to be roughly equivalent to floor level on the interior, increasing the risk of surface water draining into masonry structures locally

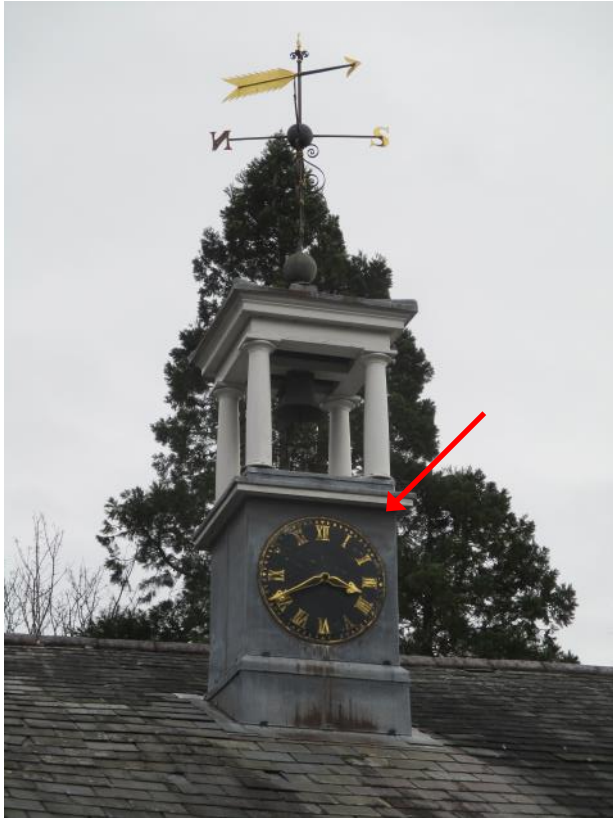
**Fig 21:**

- 2 Clock tower: The lead sheathed timber structure including a weathervane, bell and clock, was in fair condition and flashings at the interface between the structure and the roof pitch did not appear to be approaching the end of their service lives. H+R assume that the structure is to be retained on proposed refurbishment. No defects allowing water penetration into masonry structures were identified on preliminary inspection from ground level

West elevation; showing generally good condition of clock, bell and weathervane turret at the centre of the façade

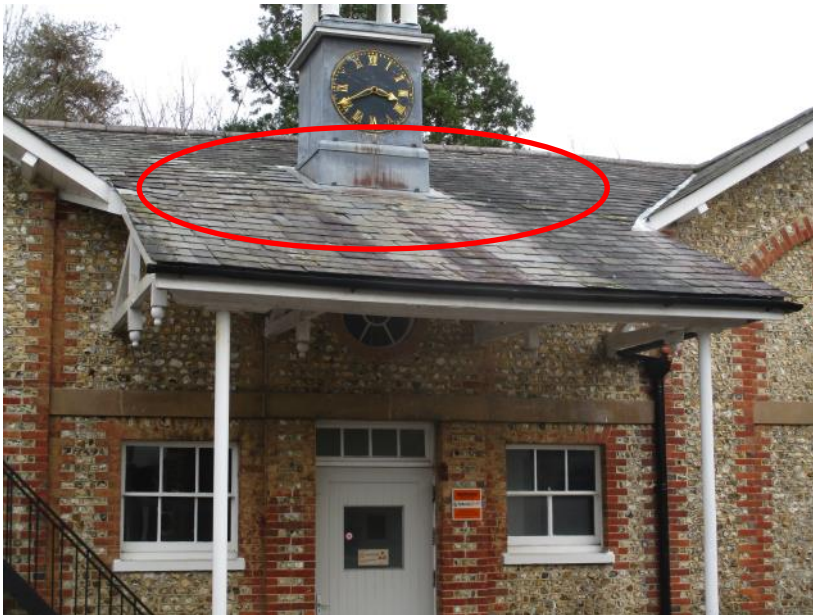
**Fig 22:**

refurbishment. Damaged slates may have been allowing water penetration to roof structures, where there was significant exposure to rain driven by prevailing winds from the west. The gutter below the central canopy drained to a downpipe on the north side of the south gable and from there to hardstanding at the base of the wall

West elevation; showing general condition of slate roof coverings with a number of slipped slates increasing the risk of water penetration to the structure

*H+R assume that the roof coverings are to be extensively overhauled or replaced on proposed refurbishment and that the roof drainage system will be reinstated in new materials. The design of a roof drainage system should be based on up-to-date meteorological data and roof drainage calculations should be undertaken to ensure that the system has adequate capacity to discharge surface water clear of the structure at all times after refurbishment. H+R can provide further advice if required*

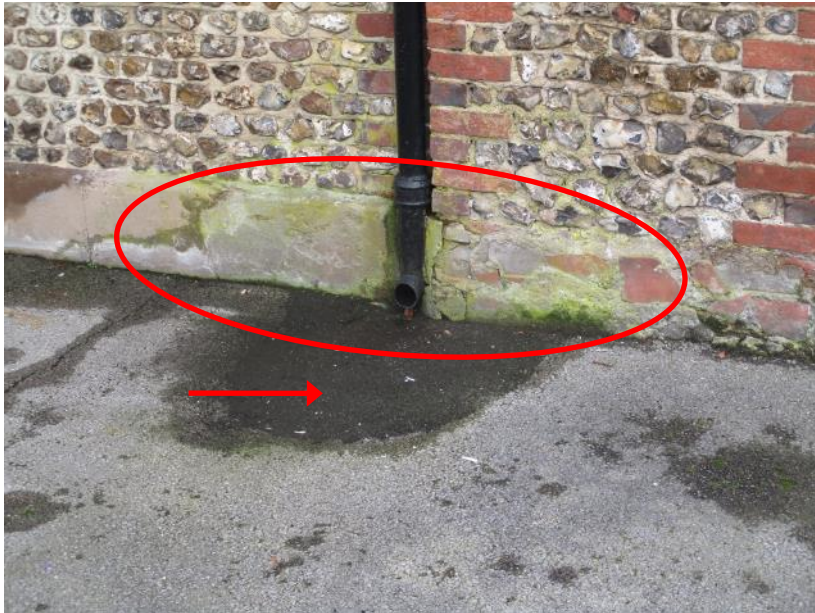
**Fig 23:**

Defects associated with water penetration to masonry from the exterior were limited to some isolated paint failures on the west side, at the base of the access stair to the first floor. A rainwater downpipe on the exterior had been identified as being vulnerable to blockage and overflow, which was likely to have allowed water to drain intermittently into the base of the masonry external wall. Water was also liable to pond on external hardstanding in contact with the façade in this location. See 3.1.4(4) above and figs.23 and 27 at Attachment A

West elevation, north side of south gable; showing generally damp conditions and weather damage to masonry and render skirtings, where a rainwater downpipe was vulnerable to blockage and overflow. Note evidence of water ponding in contact with the structure on hardstanding at the base of the façade

*Subject to the general specification for refurbishment, allowance should be made for removing residual render skirting from the base of the wall, followed by making good or replacement of damaged masonry blocks and reinstatement of the render skirting in new materials, generally to match the existing and as directed by the Architect*

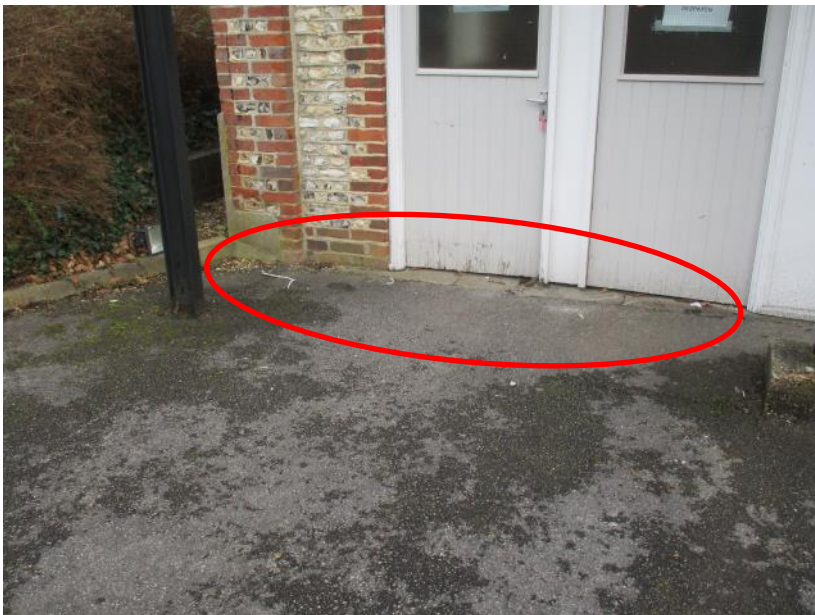
**Fig 24:**

- 4 External ground levels, drainage and dpc: Tarmacadam hardstanding was in contact with the façade across its full width, laid to fall generally from north-east to south-west, away from the masonry and foundations of the structure. Ground levels rose generally towards the north to a level above internal floor finishes, directing surface water into masonry at the base of the façade. The north door opening appeared to have been reduced in size on a previous refurbishment, with isolated sections of horizontal damp-proof membrane installed in bed joints 2 No. brick course above external ground level. A depression in the tarmacadam surface at the base of the downpipe on the north side of the south gable was allowing water to pond in contact with the structure and façade masonry at the base of the wall was subject to widespread biological growth. The render plinth at the base of the façade was extensively weathered and had partially fallen away to the south of the downpipe, where there was also significant exposure to wind driven rain in the location to which surface water would have tended to drain

West elevation, north end; showing ground levels rising above finished floor level on the interior, increasing the risk of water penetration to the structure

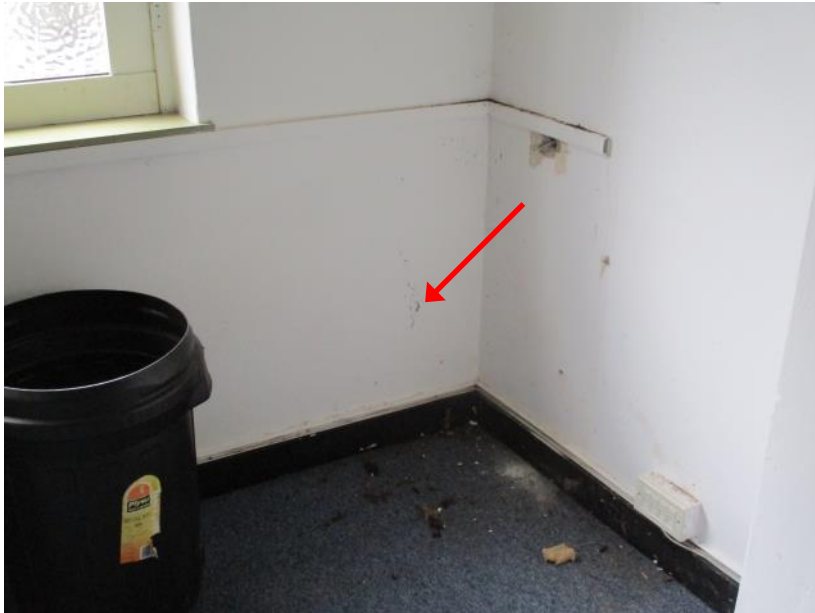
Interior, west room on south side; showing section of external wall masonry found to be dry, with a residual moisture content below 2 per cent on analysis of samples. This was despite a rainwater downpipe that was vulnerable to blockage and overflow being installed locally on the exterior

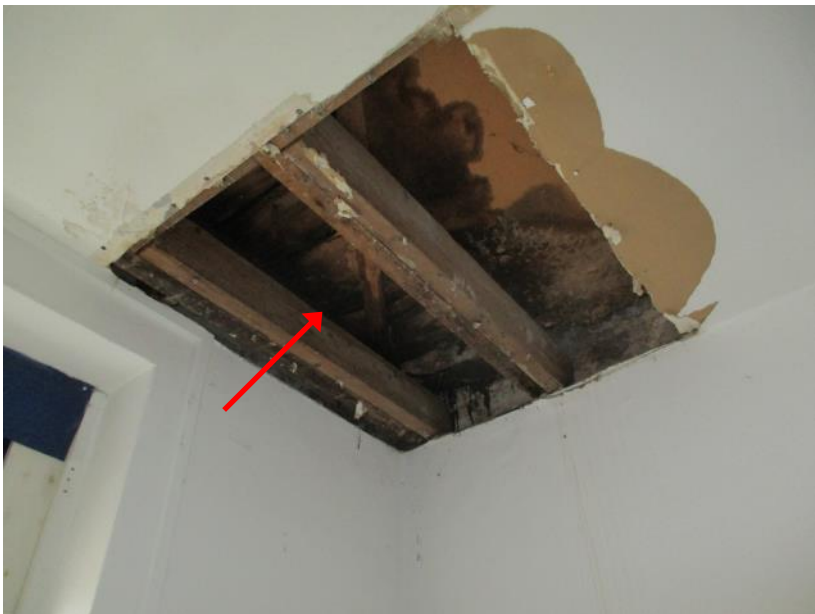
**Fig 26:**

Ground floor, west room on south side, south-west corner; showing failure of ceiling finishes and evidence of extensive water penetration to the timber roof structure, where water was identified as ponding on roof surfaces above. See fig.12

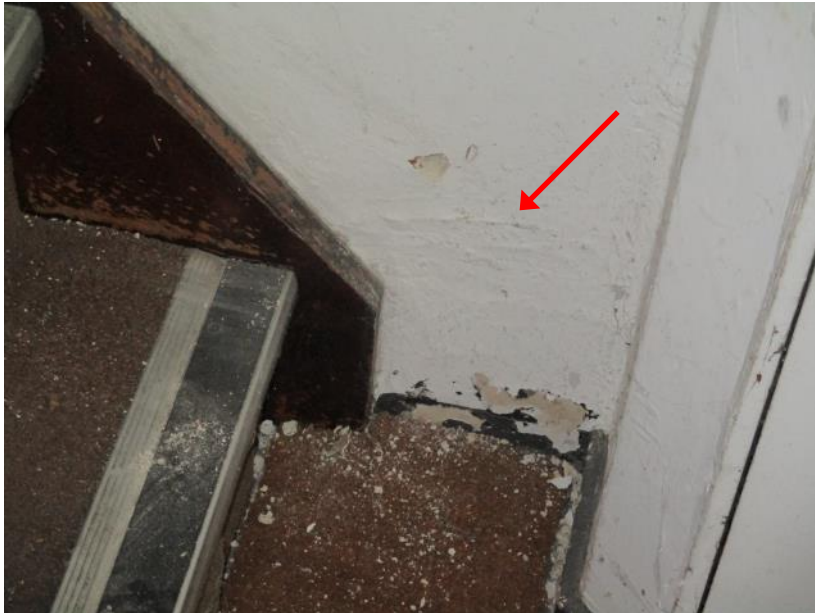
**Fig 27:**

Ground floor, base of west staircase; showing blistering and detachment of internal paint finishes, where a rainwater downpipe had been identified as vulnerable to blockage and overflow on the exterior. A masonry sample from this location was classified as saturated, with an available moisture content above 8 per cent
