# Hutton + Rostron Environmental Investigations Limited

## Southleigh Park, Stables: Investigation of masonry damp and damp-proof courses

Site note C3 for 18 January 2021, job No. 152.09.

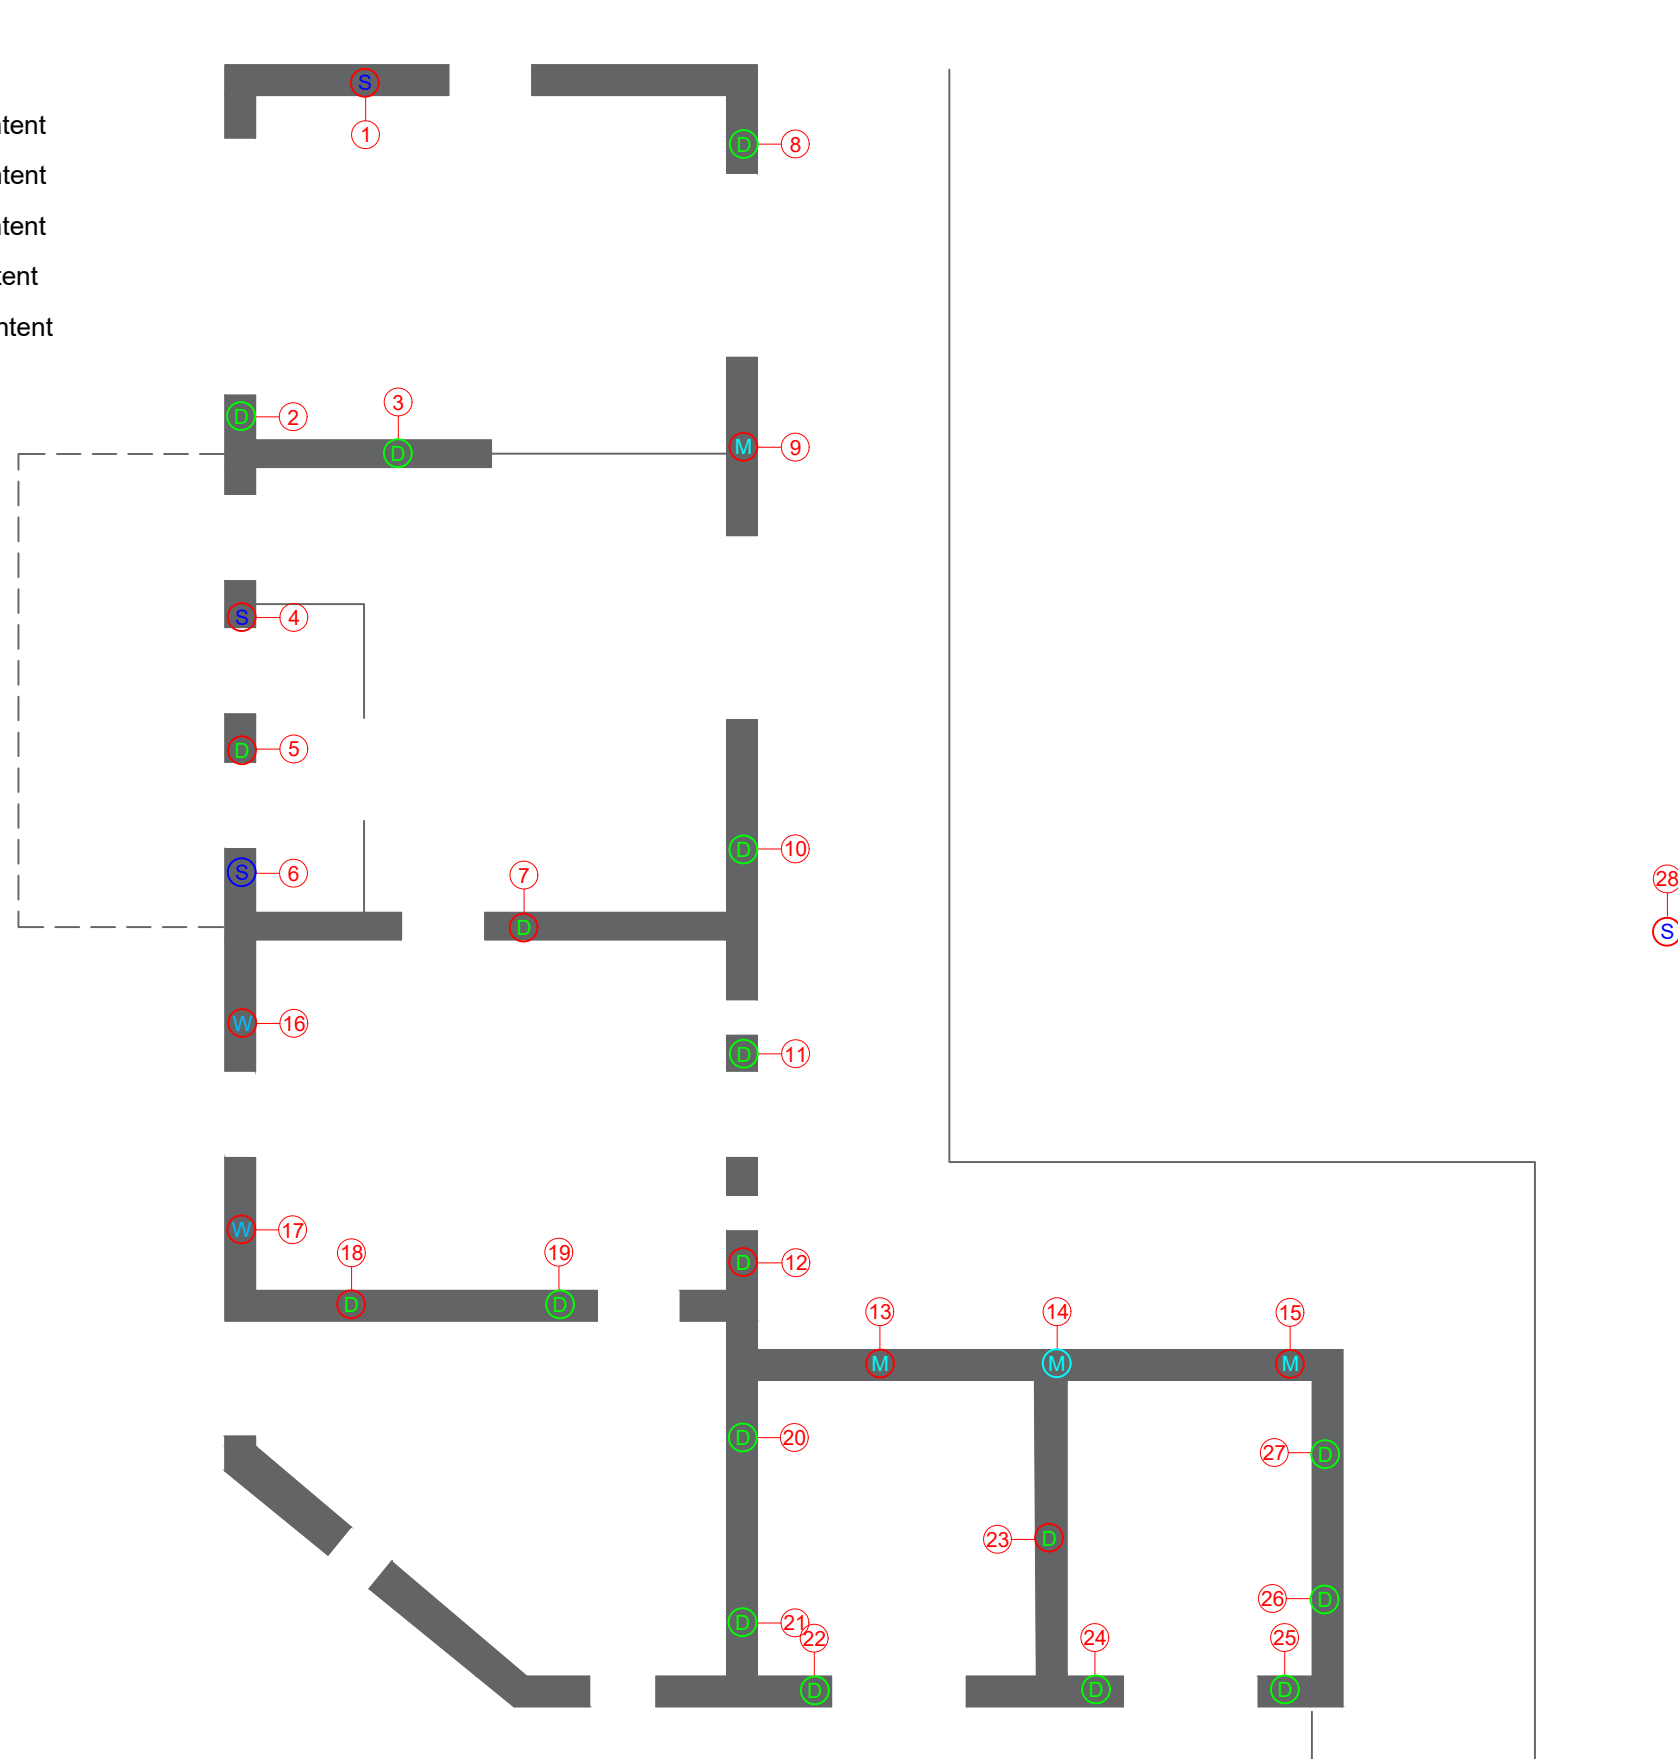
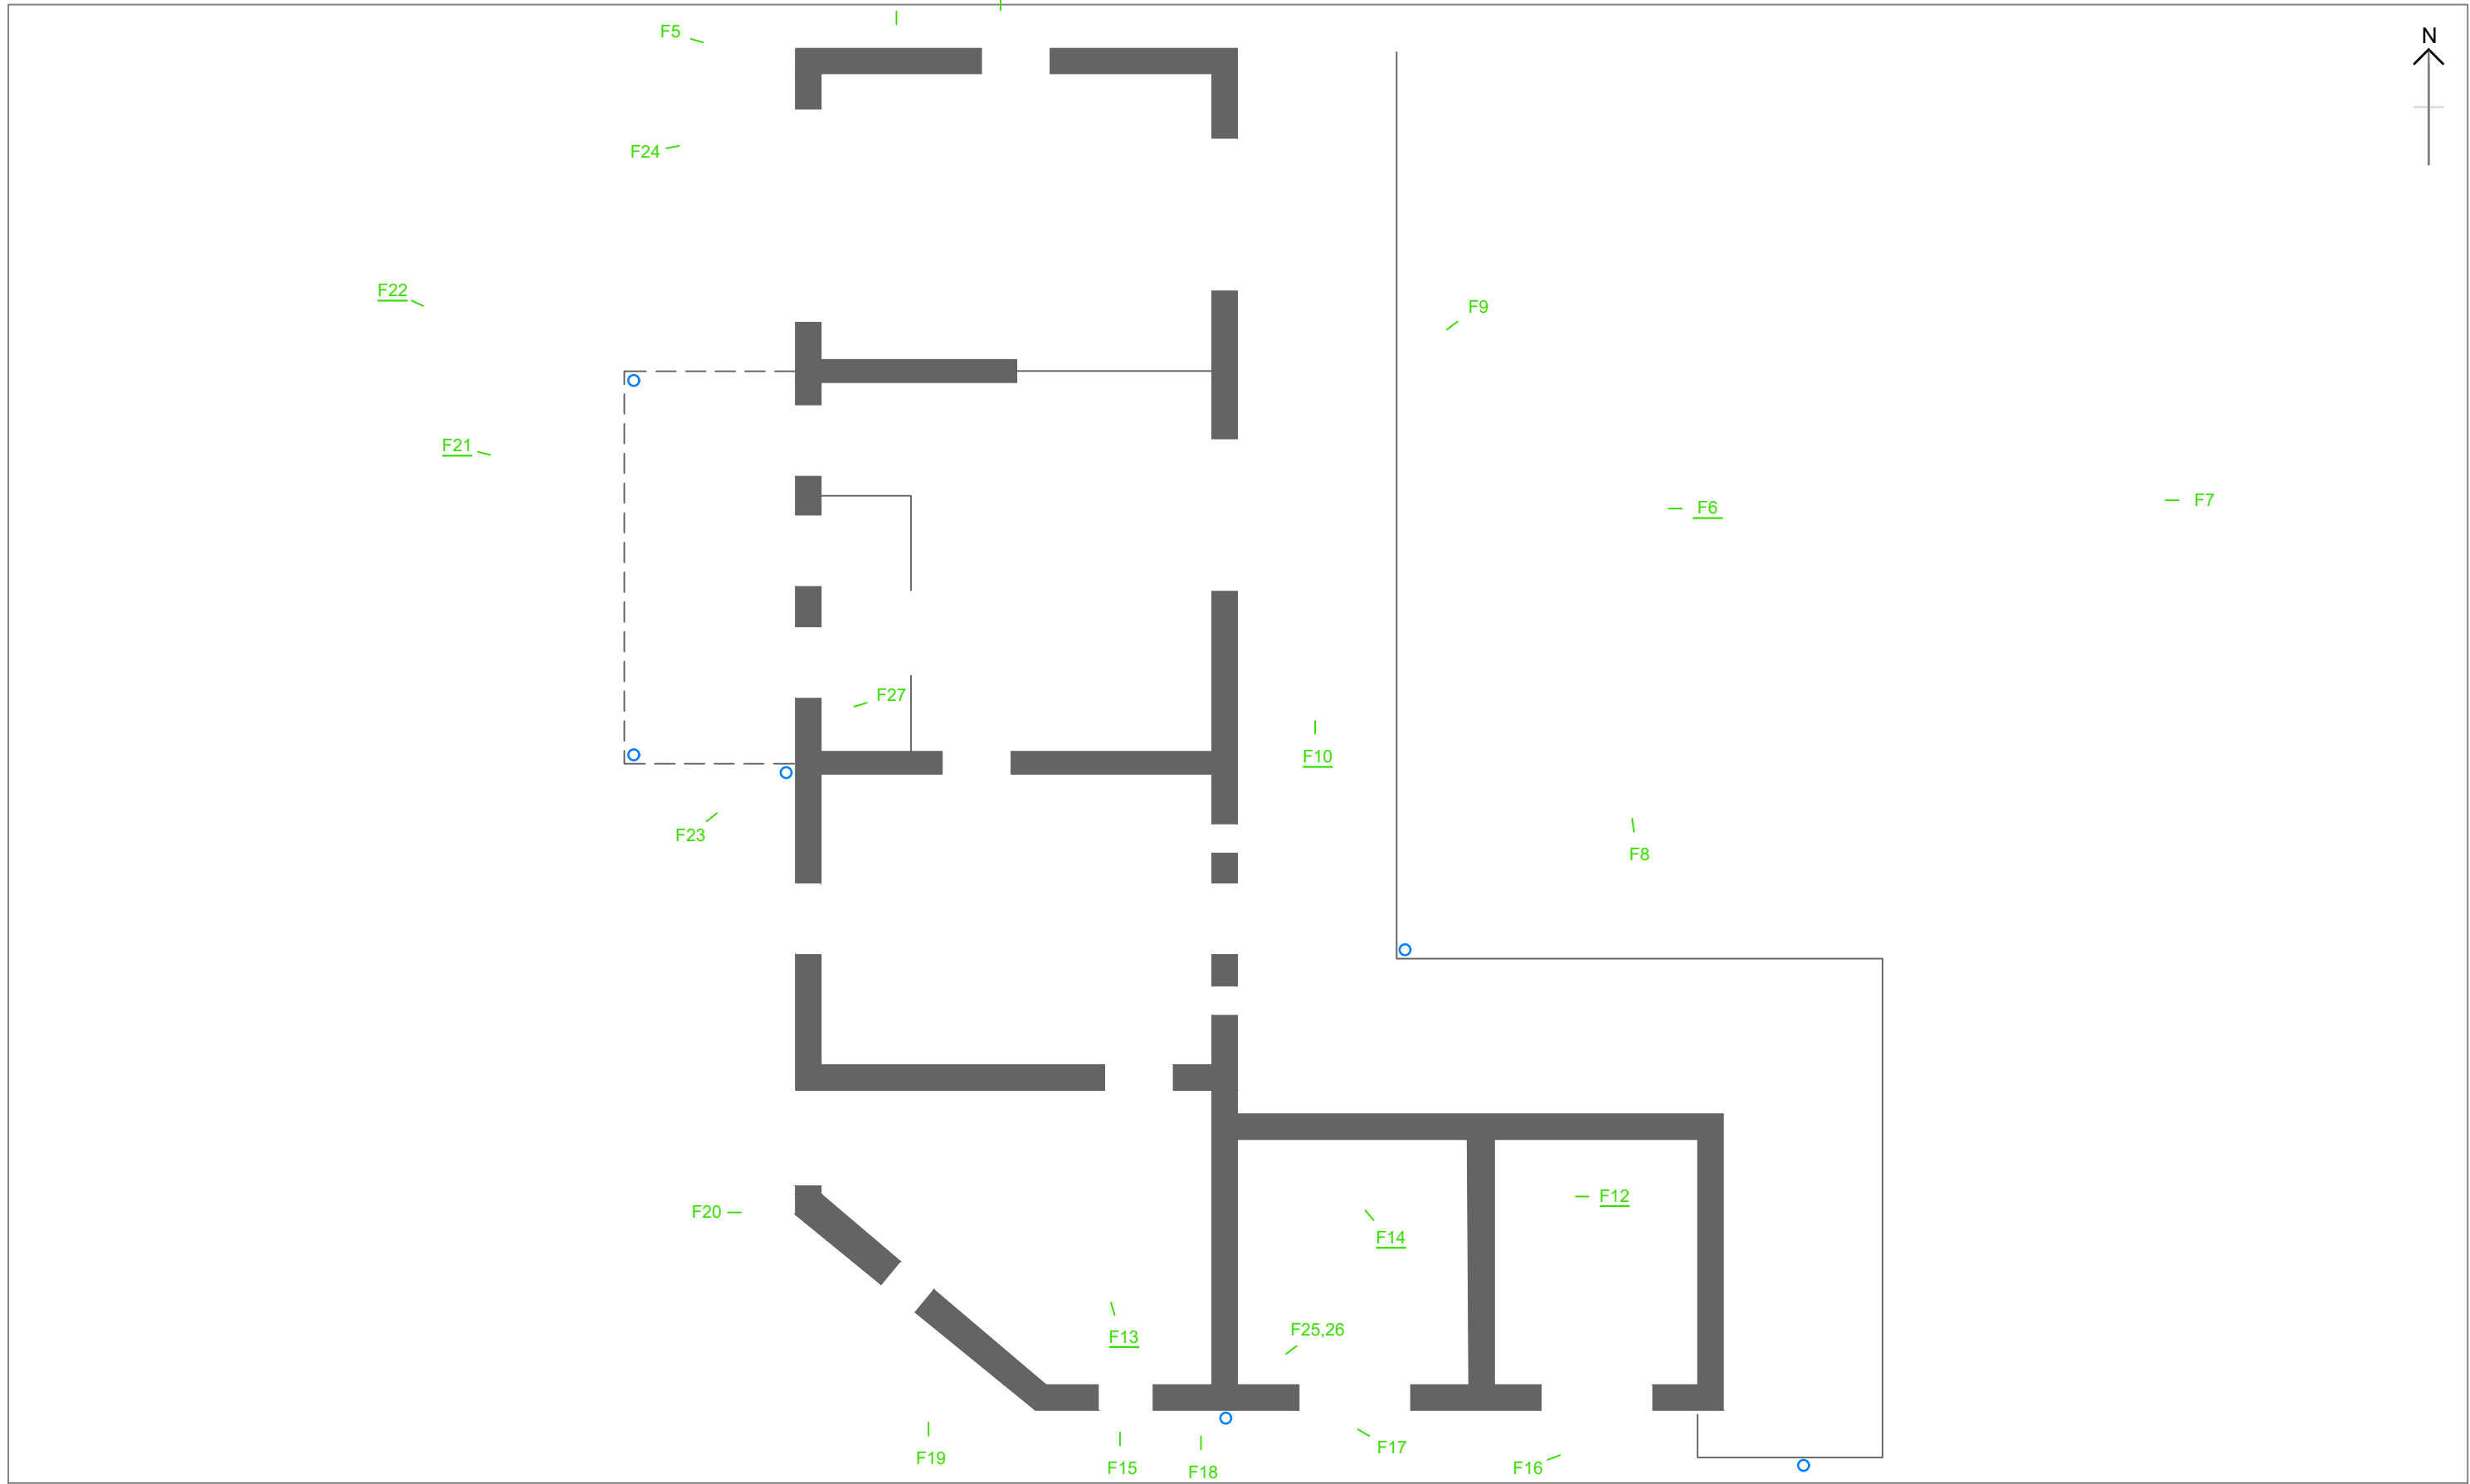
**Southleigh Park, Stables - Ground Floor**  
Masonry damp and DPC investigation  
18 January 2021

- 1 West side: 4 no samples from the base of the west external wall were classified as either wet or saturated, with available moisture contents above 5 per cent. Falls in hard landscaped surfaces were draining water into the masonry at internal floor level and defects in the provision for roof drainage were allowing water to pond intermittently in contact with the structure in this location

- 2 North side: An isolated sample from the base of the north external wall was classified as saturated, with an available moisture content above 8 per cent. The eaves guttering in this location on the exterior was allowing intermittent escape of water, which splashed back onto the wall from the compacted ground beneath

- 3 East side: 3 No. samples from the north side of the east wing and an isolated sample towards the north end of the east wall were classified as moist, with available moisture contents between 2 and 5 per cent. All these samples were taken from the wall separating the two storey structure from the corridor extension

*Chemical injected or other remedial damp-proof courses are not required. The application of waterproofing render or cementitious slurries to the interior is not recommended and may cause damage to the structure and actually promote decay on future occupancy. See below*

*Works described elsewhere in this report are required to improve ground drainage at the bases of all external walls, especially on the east and west sides. Some repairs to façade masonry may be required, subject to detailed inspection. Failed internal paint finishes could be brushed off and replaced in a highly breathable and salt resistant paint type, such as limewash or 'clay' paint. These finishes should be regarded as sacrificial and will require periodic maintenance. If robust protection of internal finishes is required consideration should be given to installing independent internal wall structures, to provide a ventilated dry lining system to a minimum 1.0m above internal floor or external ground level or to full height, as directed by the Architect. This should be detailed to fully isolate timber, hygroscopic materials and vulnerable decorative finishes from masonry vulnerable to moisture and salt transit from the exterior or from the ground. H+R can provide further advice on remedial detailing when required*
