## BS 5837:2012 Arboricultural Impact Assessment

**SITE: Robin Gardens, Waterloooville. PO8 9XE.**

**Site visit carried out by Stuart Campbell**

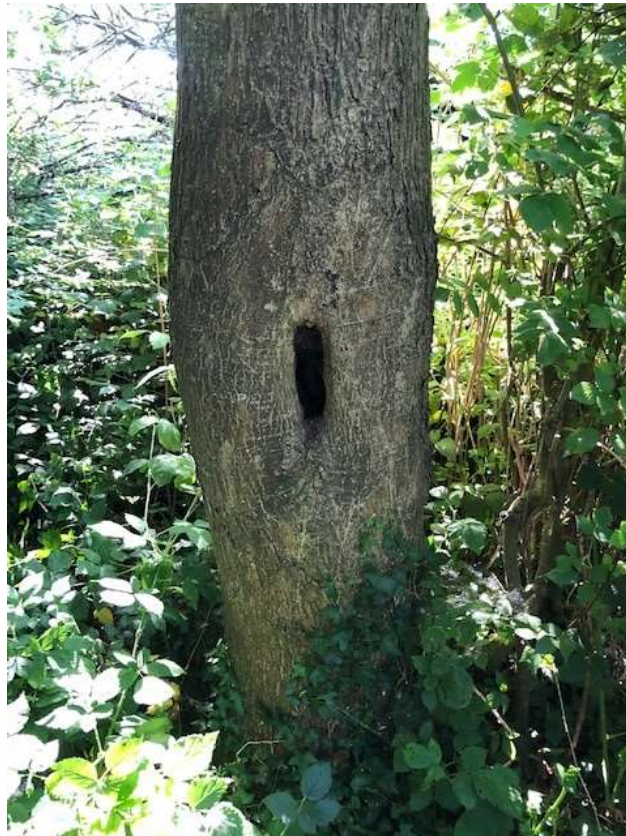
- 4.6 Trees on the schedule consisting predominantly of common ash ( *Fraxinus excelsior* ) are generally of upright habit with suppressed crowns and minor deadwood throughout.
- 4.7 Trees 13,14,37 & 39 (Common ash) all require further investigation to ascertain the extent of decay within their main stems

Photo 2. Common ash tree (14) cavity 1m above ground level west side of main stem.

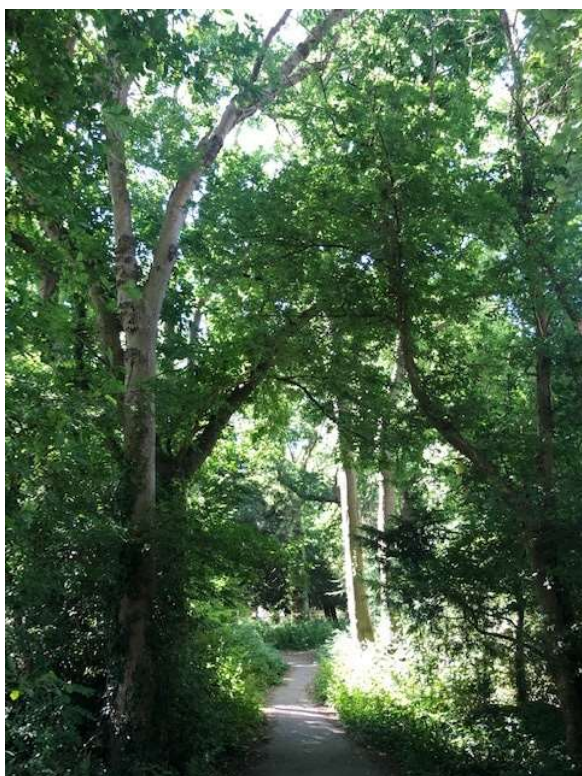
Photo 3. Mix of ash, oak and yew.

4.10 A mature mixed woodland to the north-west of Robin Gardens consisting predominantly of ash (*Fraxinus excelsior*), oak (*Quercus robur*) and yew (*Taxus baccata*) with an understorey of hawthorn (*Crataegus monogyna*), hazel (*Corylus avellana*) and field maple (*Acer campestre*)

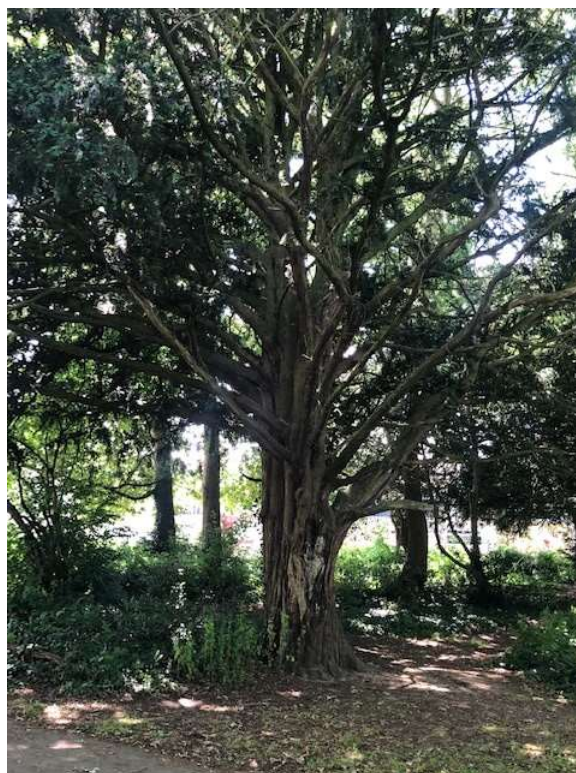
Photo 4. Yew tree (27) Wounding to main stem

4.11 Many of the maturing yews had suffered wounding to their lower stems and had minor deadwood throughout their canopies.

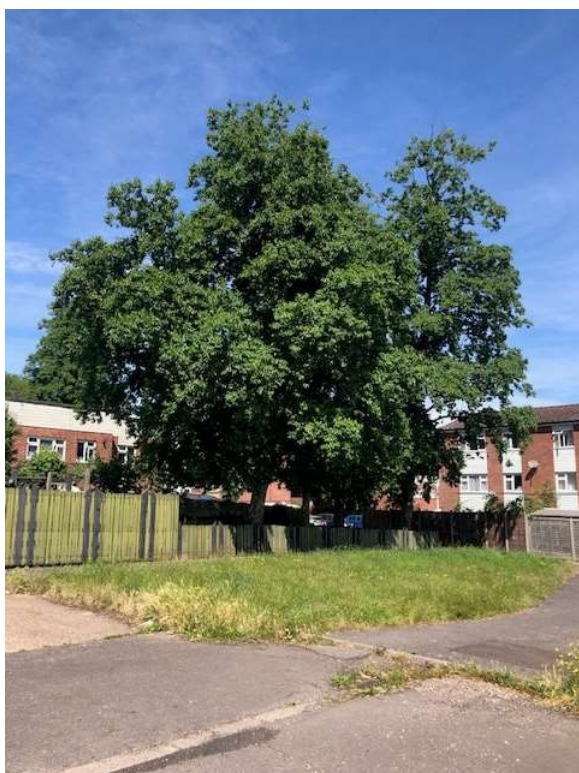
4.12 Five large, mature and significant alders (*Alnus glutinosa*) are highly visible within communal gardens located off Robin Gardens. Minor defects were identified but were deserving of high quality rating.

Photo 5. Group of 4 alders (73,74,75 & 76)

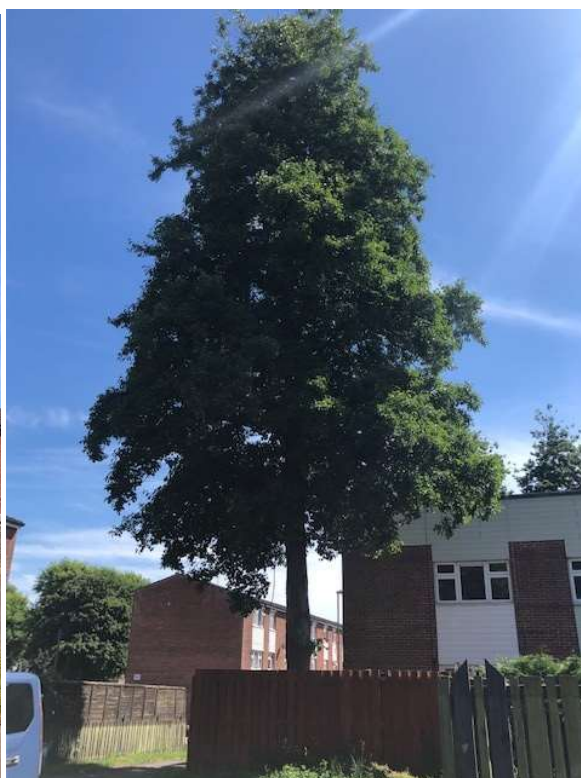
Photo 6. Alder (72) Unable to access in garden.

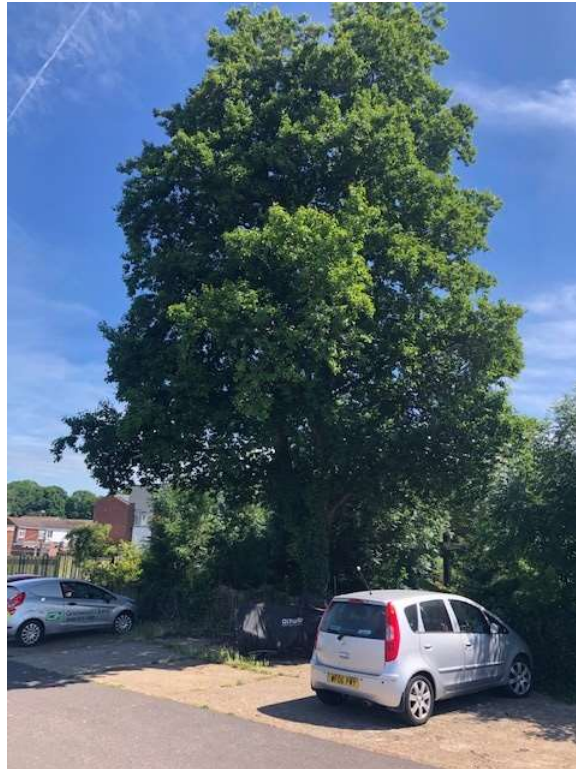
4.16 Tree 77, common alder (*Alnus glutinosa*) standalone tree growing true to form displaying good shape and habit.

Photo 7. Common alder tree 77.

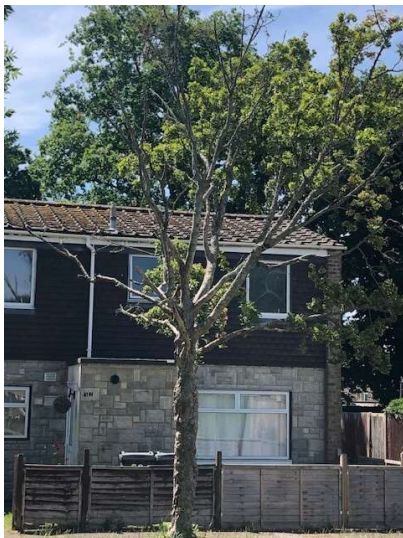
4.18 There are 7 trees which are *in such a condition that they cannot realistically be retained as living trees.*

Photo 8. Tree 79 – Field maple

4.19 I have recommended for those trees to felled.

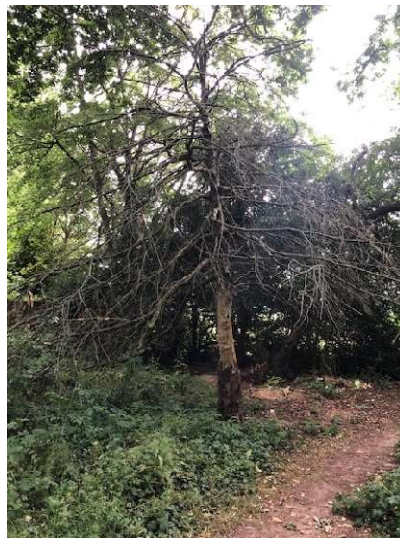
Photo 9. Tree 58 - Yew
