**VERIFICATION REPORT**

**PLOTS 129-135 & 141-144**

**WOODCROFT FARM, WOODCROFT LANE,**

**VISTRY SOUTHERN**

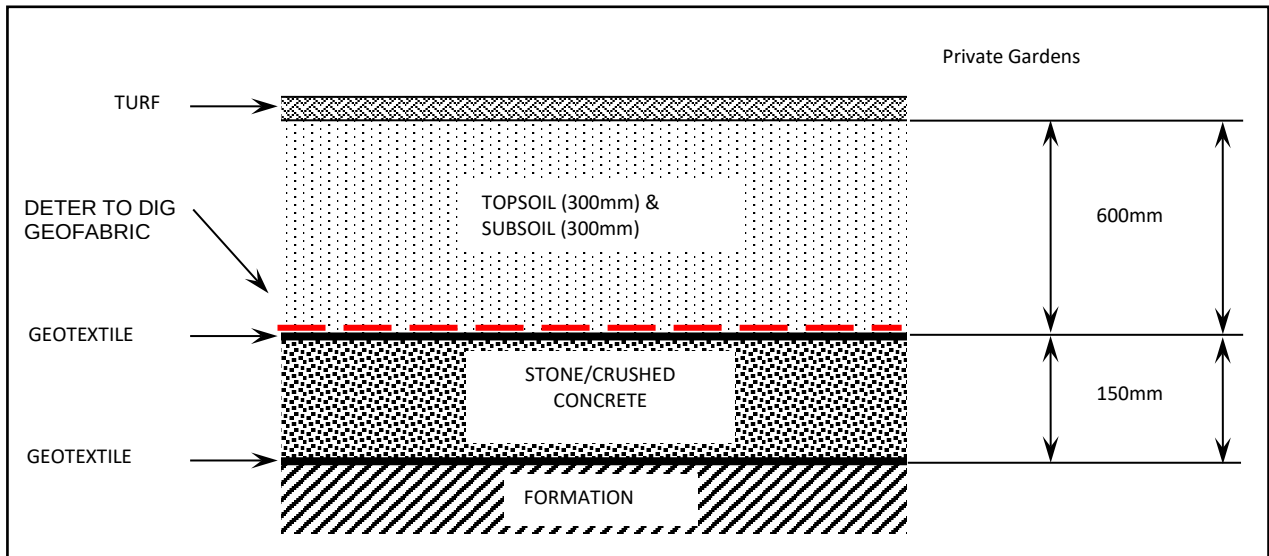
An example of the recommended cover system for use in private gardens where Made Ground remain in-situ is provided below:

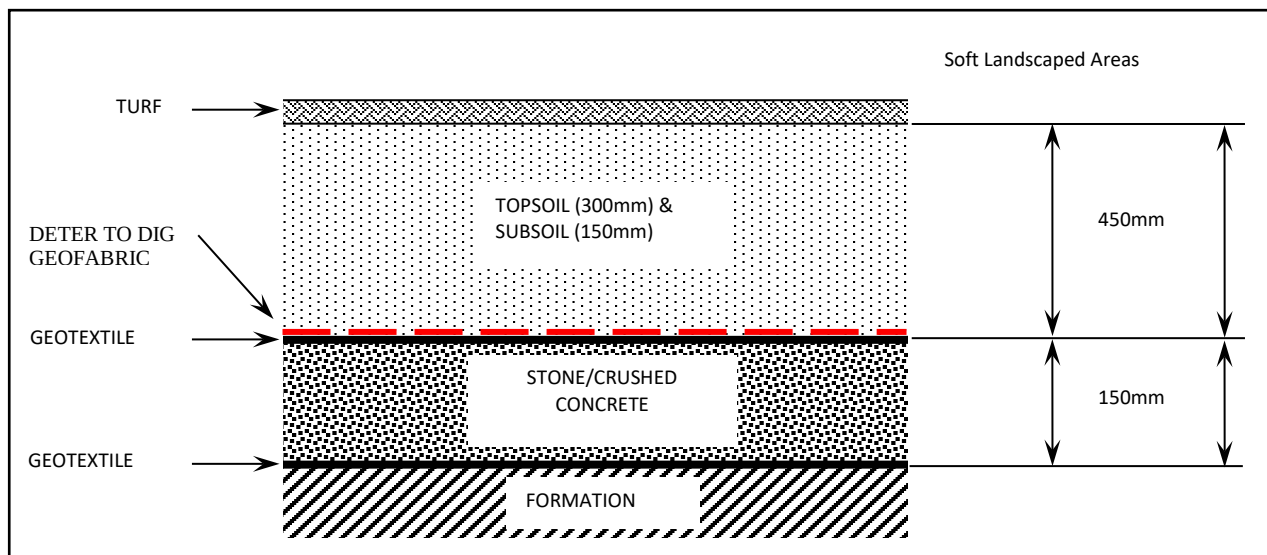
An example of the recommended cover system for use in areas of communal soft landscaping where Made Ground was to remain in-situ is provided below:

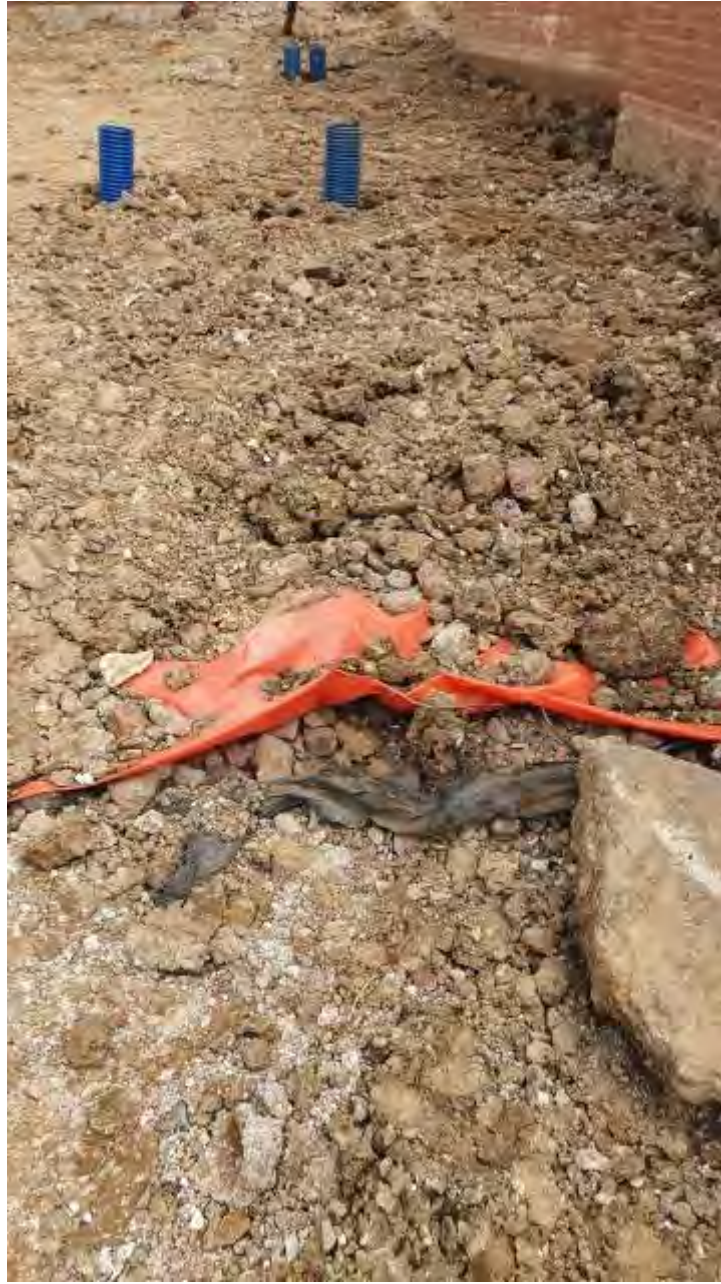
Plate 1 – View of membranes beneath subsoil installed within Plot 129

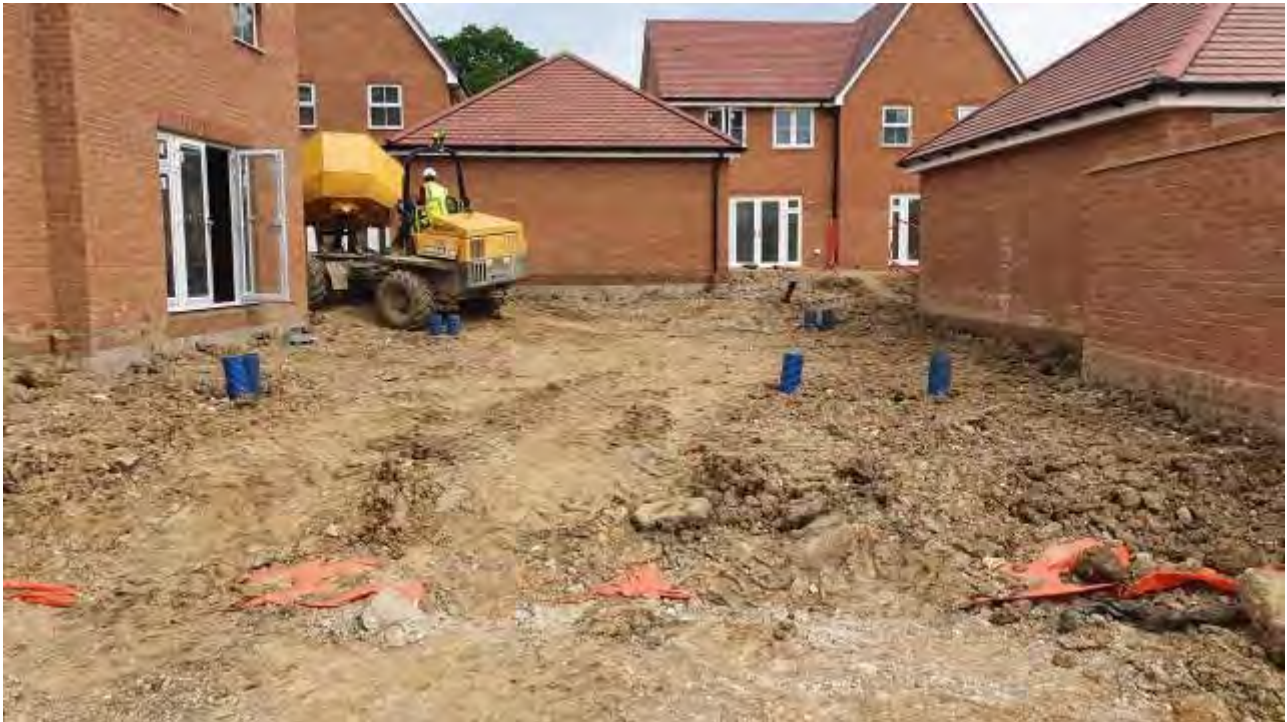
Plate 2 – View of subsoil installed within Plot 129-130

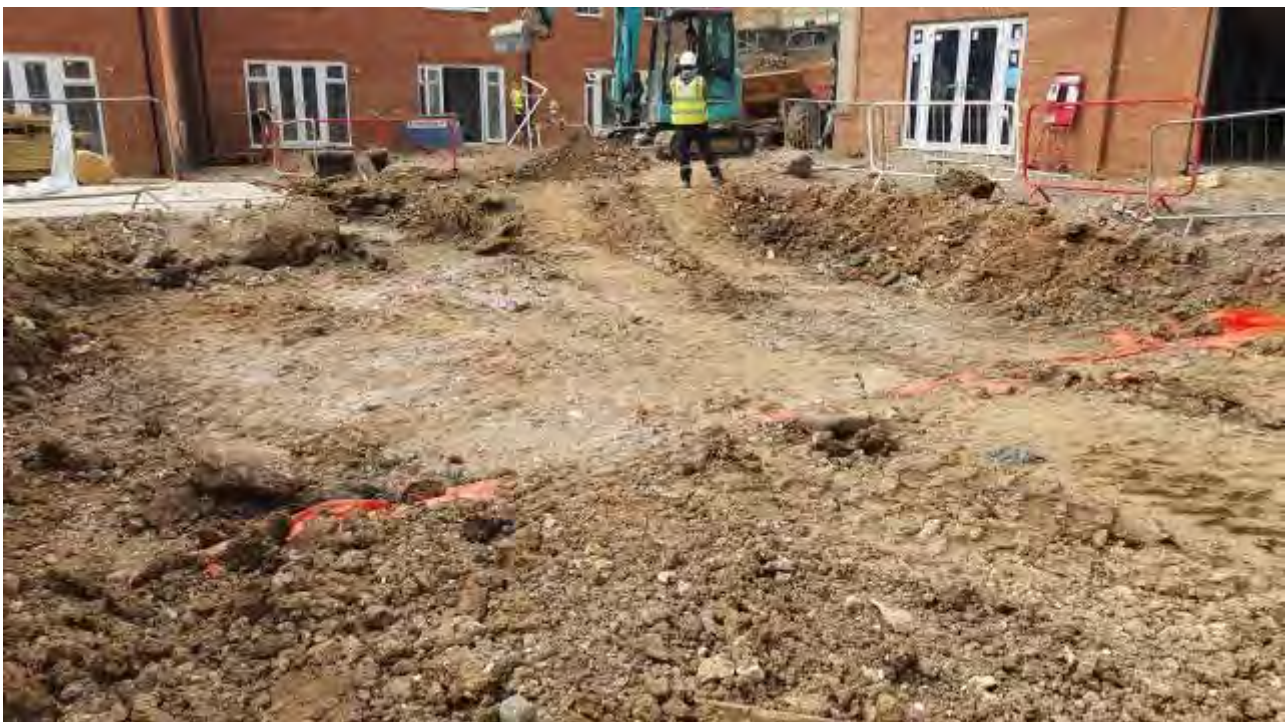
Plate 3 – Reduced dig undertaken in Plots 131-132

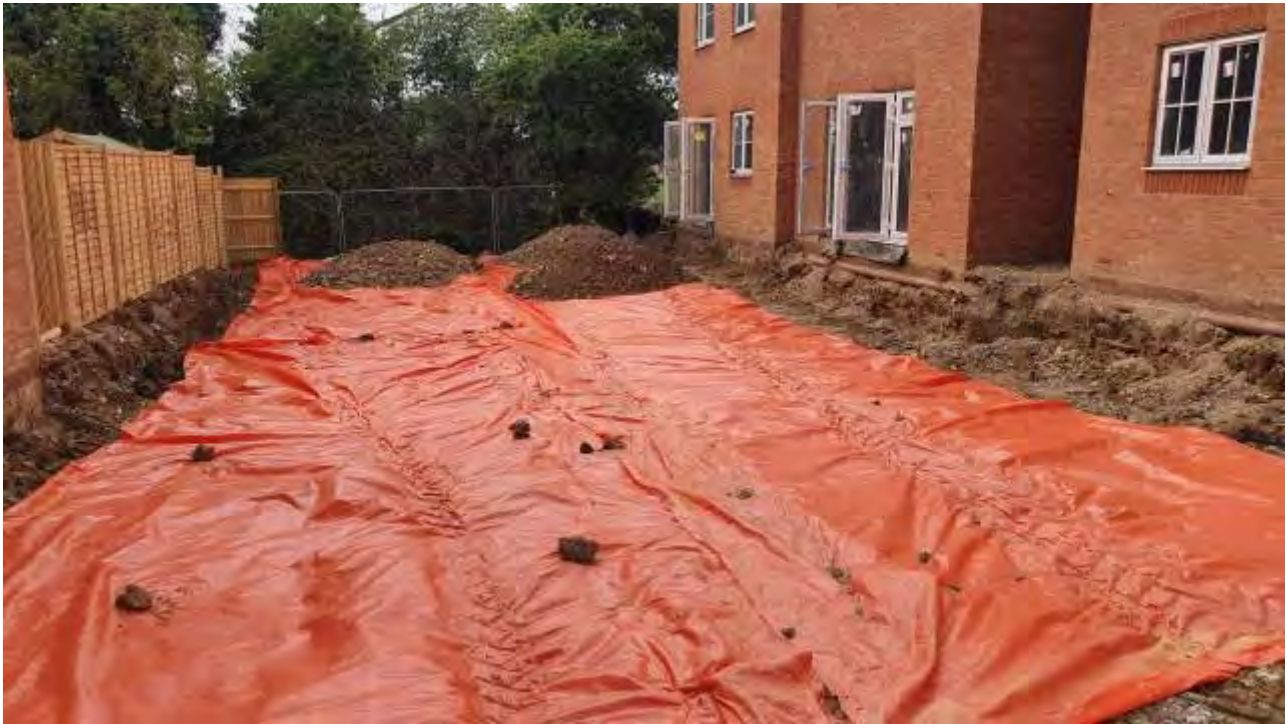
Plate 4 – View of membrane installed above crushed concrete layer across Plots 141-144
