## **TREE SURVEY AT PARK LANE BRIDLEWAY WATERLOOVILLE**

**Prepared for:  
David Wilson Homes Southern  
Norgate House  
Tealgate  
Charnham Park  
Hungerford  
RG17 0YT**

**24 January 2023**

**Ref: PB/VTa-23/01.04**

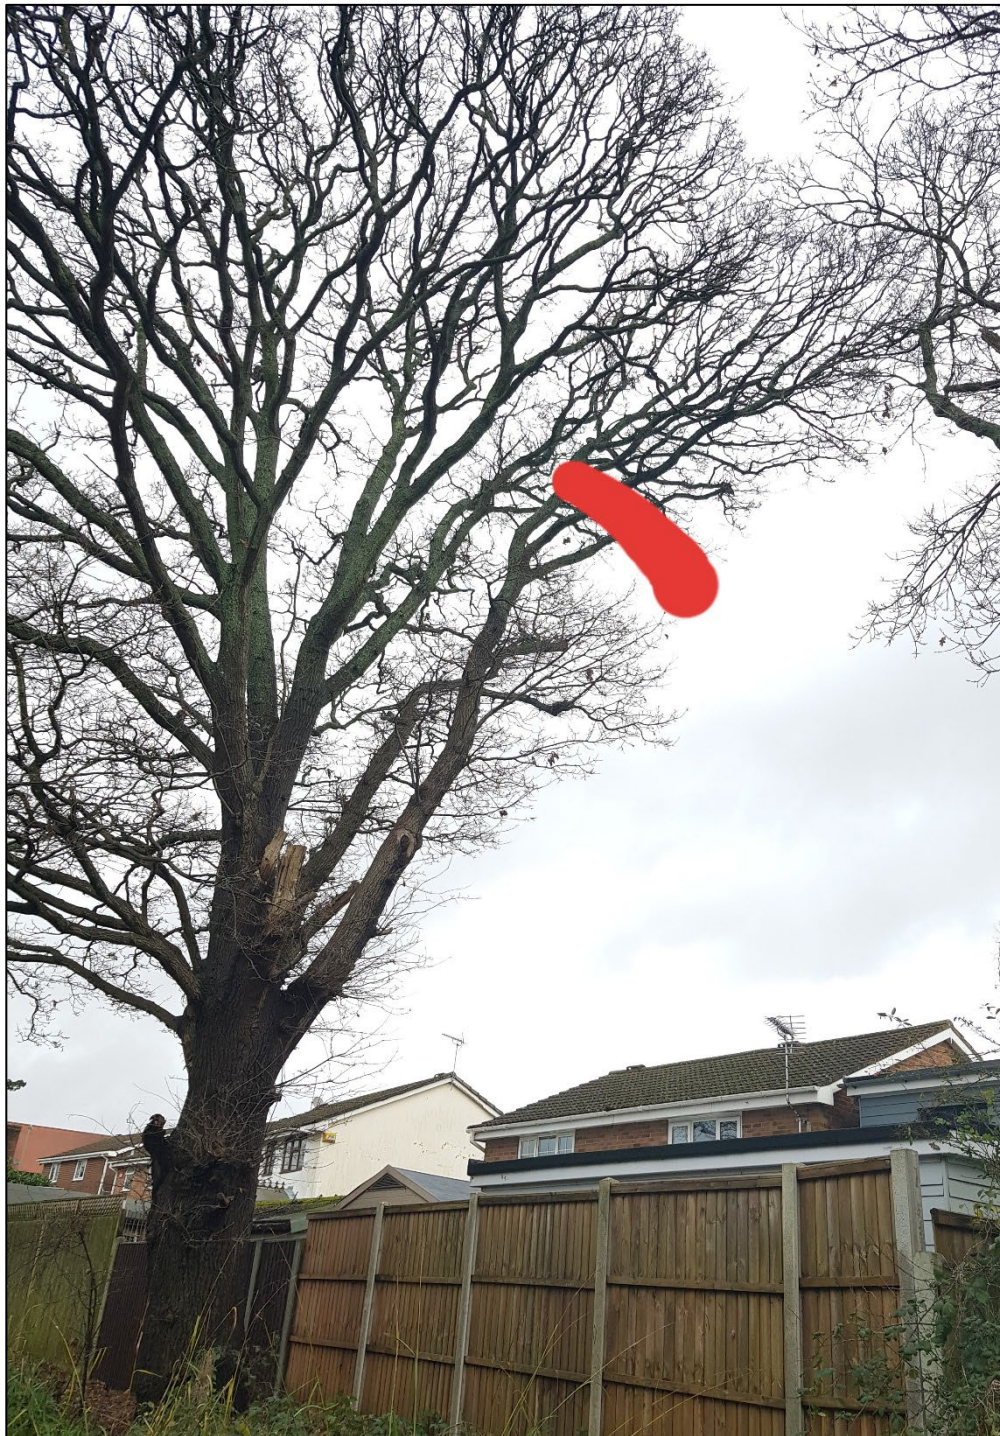
| Tree No | Species | Height (m) | Av. crown spread Radius (m) | Condition/Observations | Recommendations | Work Priority | Next Inspection |
|---|---|---|---|---|---|---|---|
| 8 | English oak | 21.5 | 8.5 | Single stem. Mature tree. Spreading branches, fair form and condition. Previous crown lifting with dead stub wounds, and width reduction on east side of canopy. Minor deadwood <40mm diam. Lower over extended limb southeast has pruning wound 5.5m AGL with decay. | Prune back over extended limb on southeast side to 17m AGL, +/- 1m. (See Appendix 3 photo 1) | 12 months | Summer 2024 |

Photo 1: T8 –. Indicative pruning back of over extended limb

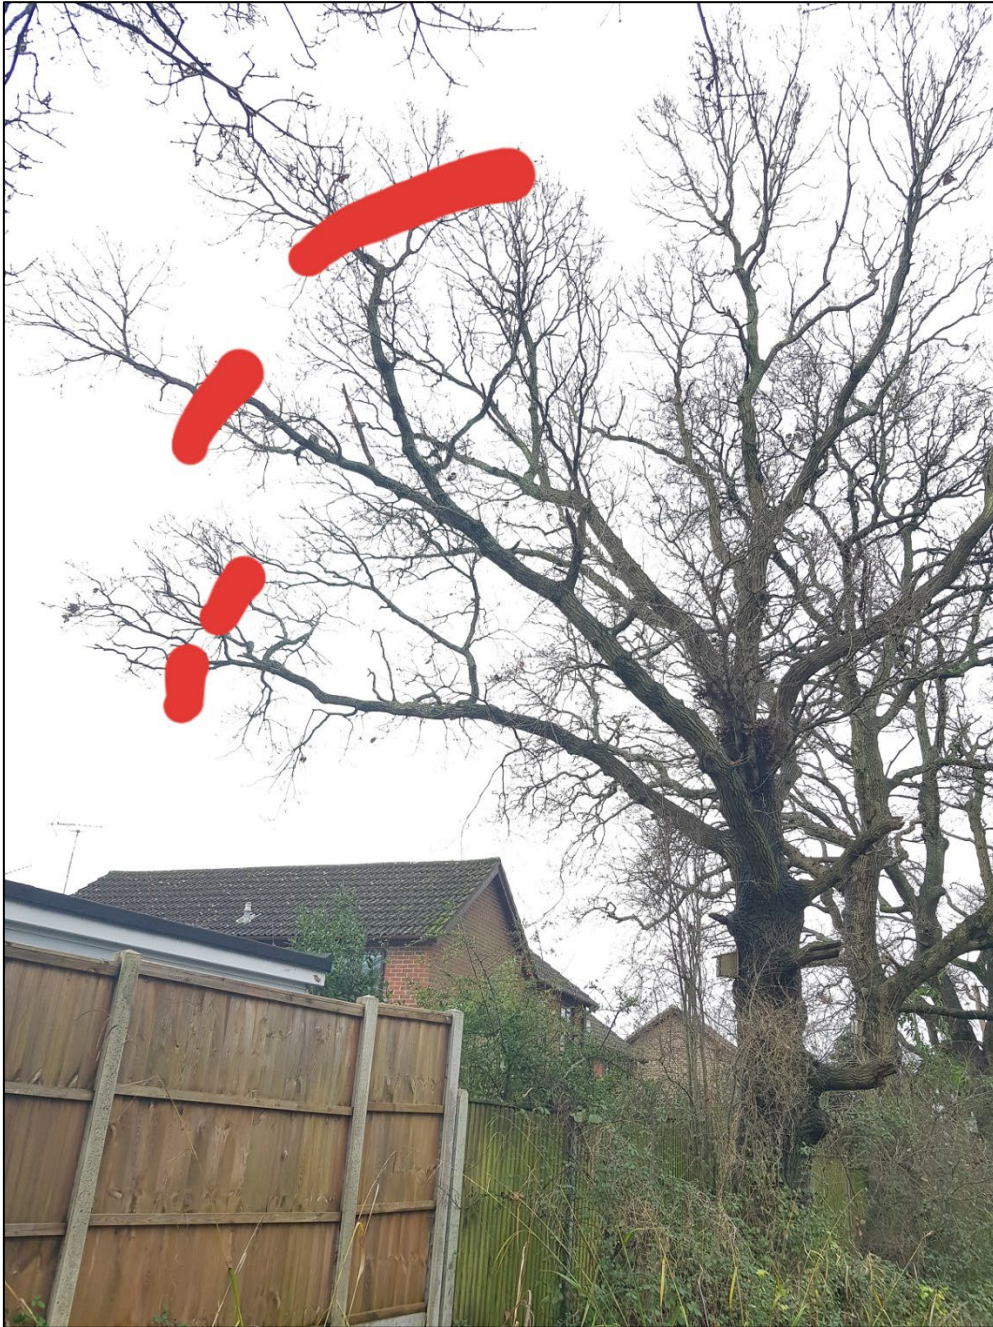
| Tree No | Species | Height (m) | Av. crown spread Radius (m) | Condition/Observations | Recommendations | Work Priority | Next Inspection |
|---|---|---|---|---|---|---|---|
| 9 | English oak | 18.5 | 8.5 | Single stem. Mature tree. Spreading branches, poor form, fair condition. Asymmetric canopy biased to east Previous crown lifting with dead stub wounds. Minor dieback, deadwood <40mm diam. Lower limbs, northeast and east, are over extended. | Prune back over-extended limbs on northeast and east side to 6.5m, +/- 1m. (See Appendix 3 photo 2) | 12 months | Summer 2024 |

Photo 2: T9 – Indicative pruning back of over extended limbs

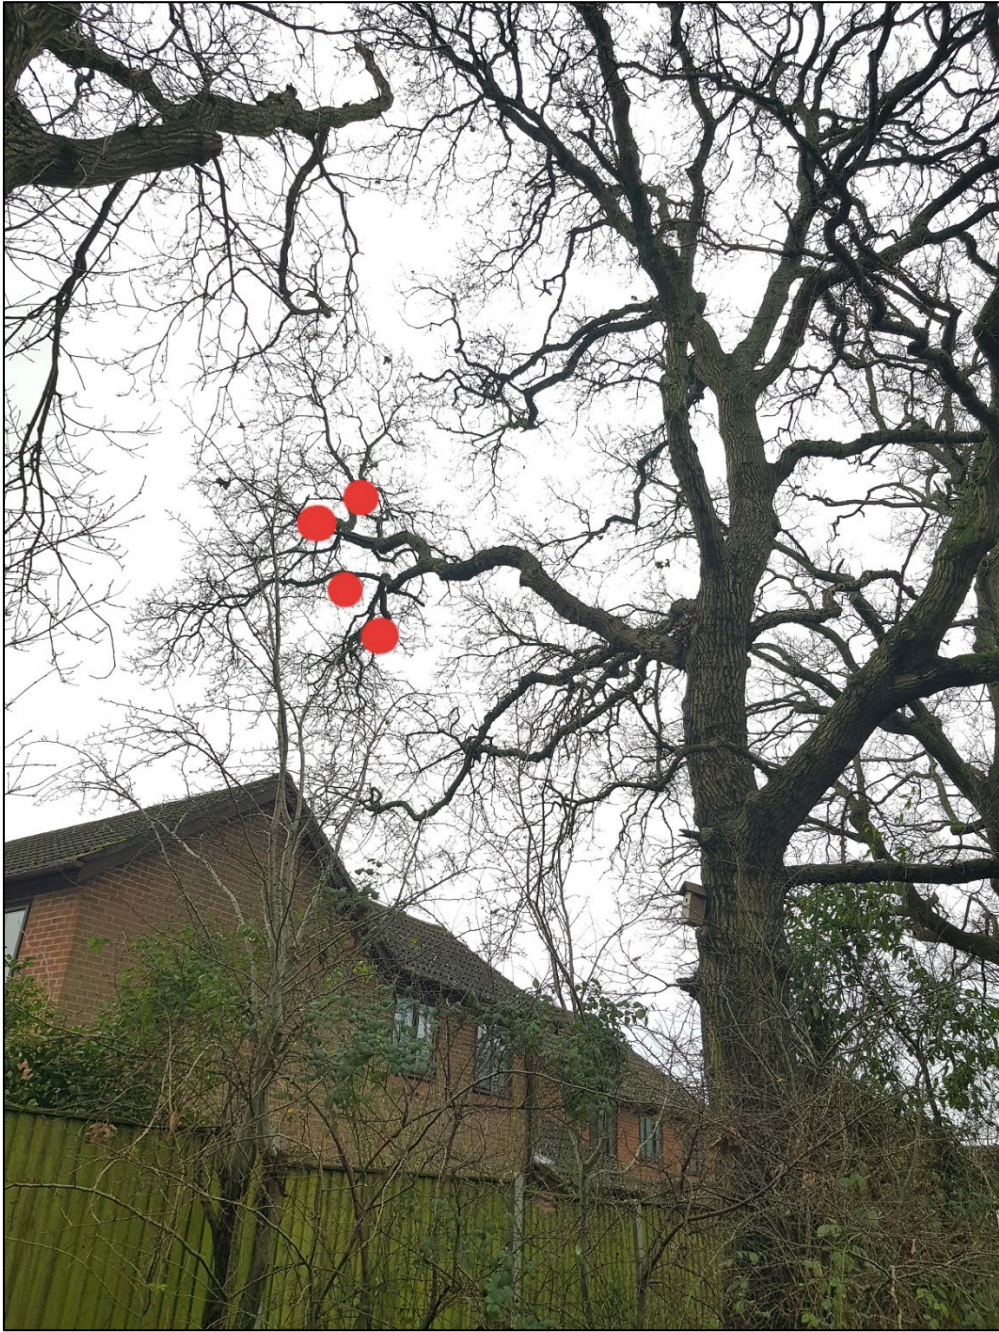
| Tree No | Species | Height (m) | Av. crown spread Radius (m) | Condition/Observations | Recommendations | Work Priority | Next Inspection |
|---|---|---|---|---|---|---|---|
| 10 | English oak | 18.5 | 8 | Single stem. Mature tree. Spreading branches, poor form, fair condition. Asymmetric canopy biased to east Previous crown lifting with dead stub wounds. Minor dieback in canopy, deadwood <40mm diam. Lower over extended limb, east side, over-hanging gable end | Prune back over-extended limb on east side to 5.5m, +/- 1m. (See Appendix 3 photo 3) | 12 months | Summer 2024 |

Photo 3: T10 – Indicative pruning back of over extended limb on east side

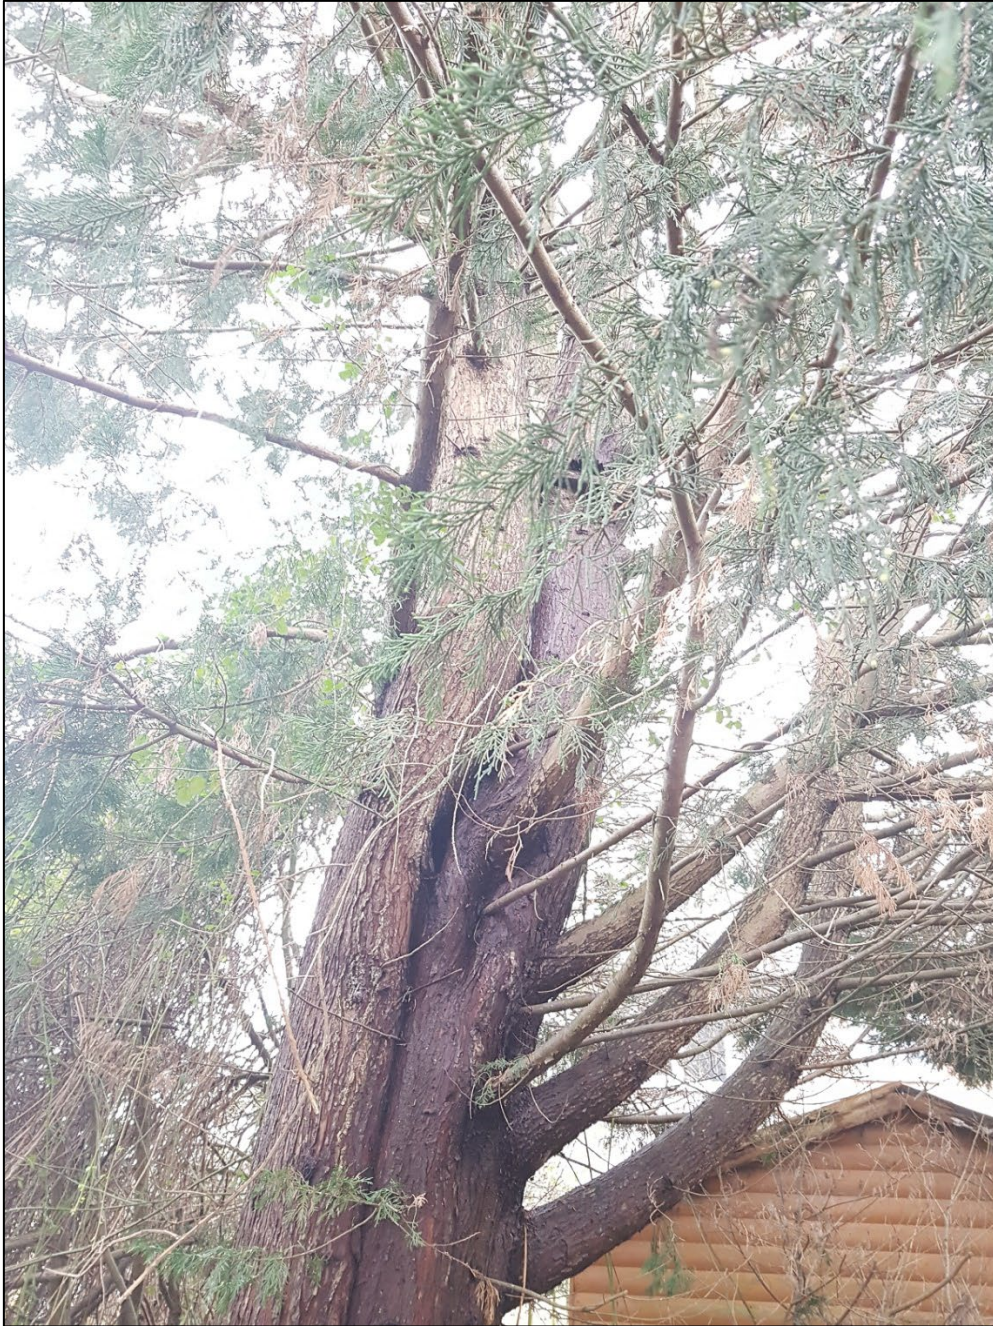
| Tree No | Species | Height (m) | Av. crown spread Radius (m) | Condition/Observations | Recommendations | Work Priority | Next Inspection |
|---|---|---|---|---|---|---|---|
| 20 | Monterey cypress | 15.5 | 4.5 | Co-dominant stems from included unions, 1.5-3m AGL. Large inclusion with vertical crack splitting open; likely to fail. (See Appendix 3 photo 4)<br>[Query ownership; on garden boundary] | Fell | 3 months | n/a |

Photo 4: T20 –Included union with splitting vertical crack

- 5.1.1 A complete list of tree work recommendations is included in the tree schedule at Appendix 2, with those trees requiring attention within three months of the date of this report highlighted in red.
- 5.1.2 One tree, T20 a Monterey cypress, with a large inclusion with a vertical crack splitting open, with a high likelihood of failure, is recommended for felling within 3 months. The tree is located on the boundary between a private house and an estate path, and therefore exact ownership needs to be verified.
- 5.1.3 Two mature English oak trees, T22 and T23, are recommended for maintenance pruning. The pruning of T22 should be undertaken below the previous cutting heads. This work is shown indicatively in Appendix 3 on photographs 5 and 6.

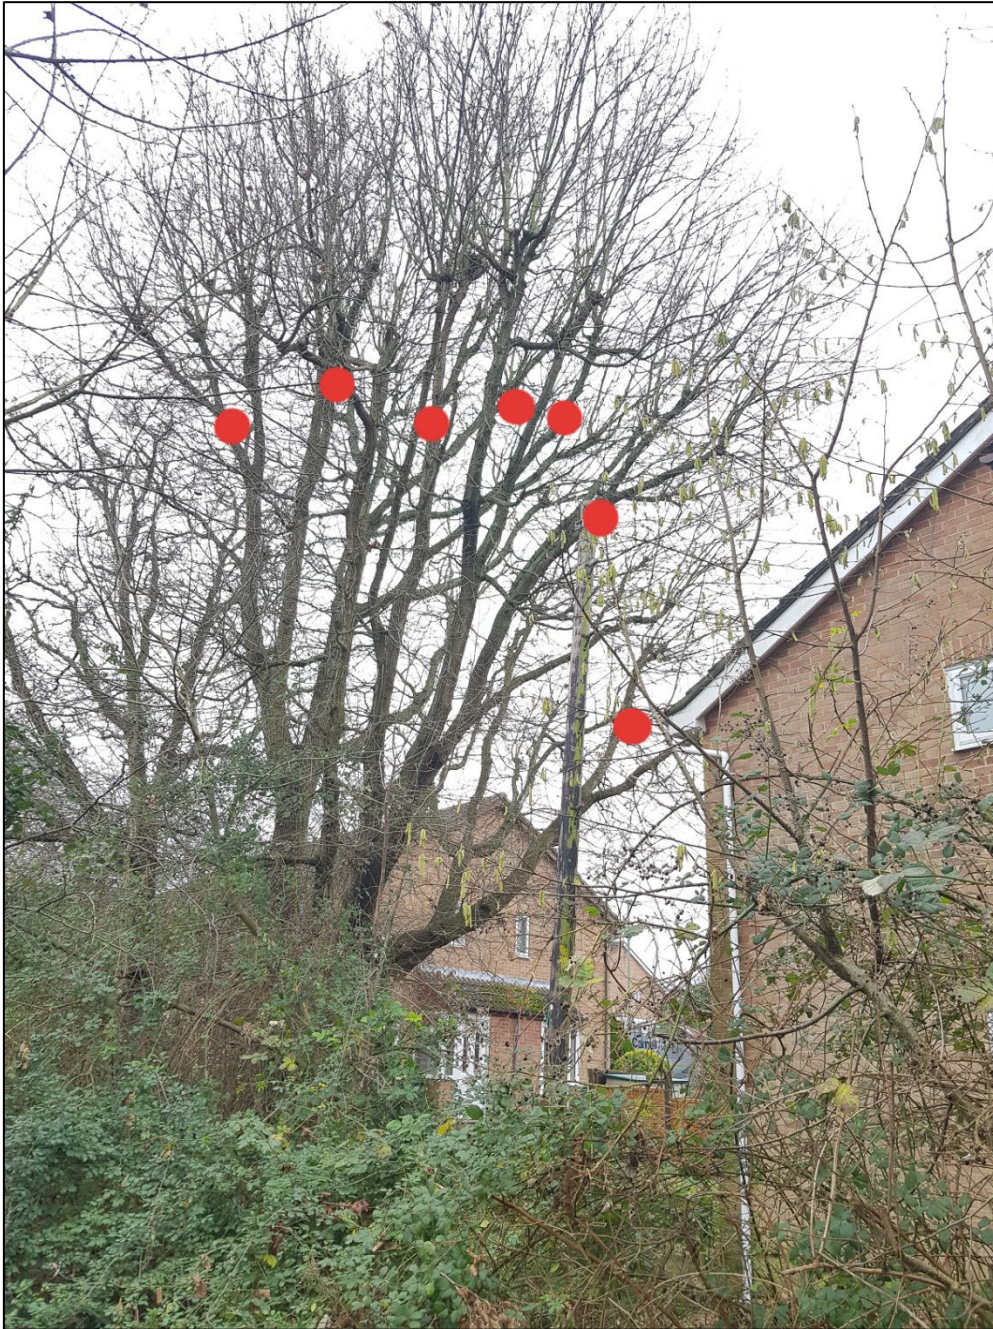
| Tree No | Species | Height (m) | Av. crown spread Radius (m) | Condition/Observations | Recommendations | Work Priority | Next Inspection |
|---|---|---|---|---|---|---|---|
| 22 | English oak | 22 | 8 | Co-dominant stems from ground level, with major bifurcations on northern stem at 2.2-2.5 & 4.5m AGL; this half of the tree has asymmetric canopy and stem is leaning towards the house (No 37) to the northwest, and overhanging the property. Previous crown reduction with vigorous secondary regrowth | Maintenance pruning to reduce height to 13-15m AGL, cutting about 1-1.5m below previous pruning heads. (See Appendix 3 photos 5 and 6) | 3 months | Summer 2024 |

Photo 5: T22 – Maintenance pruning to reduce height to 13-15m AGL, cutting about 1-1.5m below previous pruning heads.

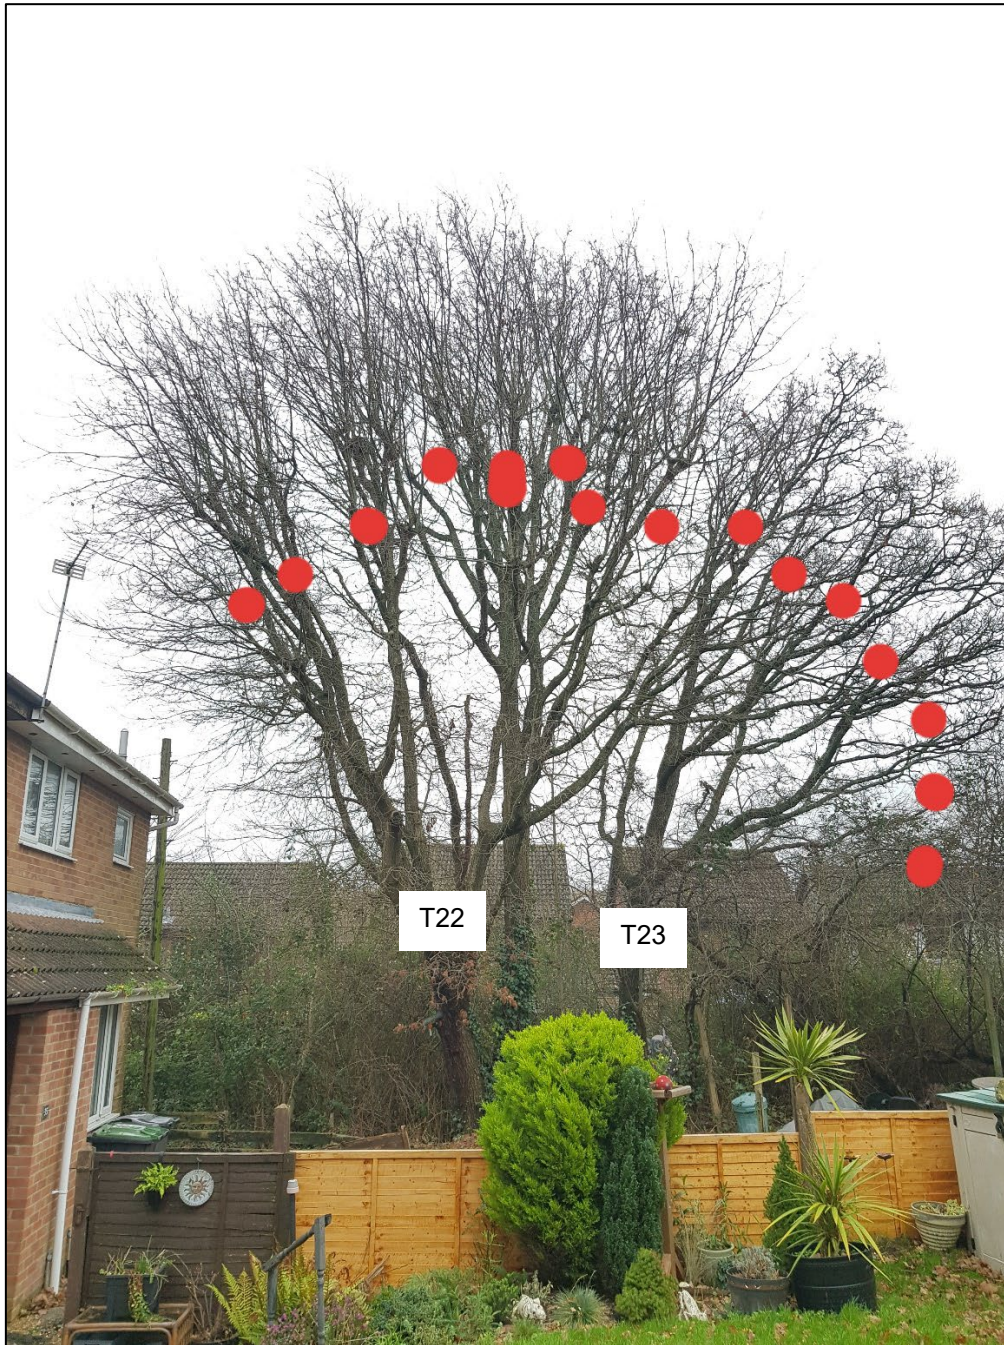
Photo 6:

| Tree No | Species | Height (m) | Av. crown spread Radius (m) | Condition/Observations | Recommendations | Work Priority | Next Inspection |
|---|---|---|---|---|---|---|---|
| 23 | English oak | 17.5 | 7 | Single stem. Co-dominant stems from unions 4.3m AGL. Asymmetric canopy biased to south over garden | Maintenance pruning to reduce height to 11-13m and reduce width on southwest sector to 5m +/- 0.5m. (See Appendix 3 photo 6) | 3 months | Summer 2024 |

Left on photo; T22 – Maintenance pruning to reduce height to 13-15m AGL, cutting about 1-1.5m below previous pruning heads.

Right on photo; T23 – Maintenance pruning to reduce height to 11-13m and reduce width on southwest sector to 5m +/- 0.5m
