***Project ref:TV230111***

10<sup>th</sup> January 2023

# ***CCTV Survey Report***

**SITE: 109 Fortunes Way**

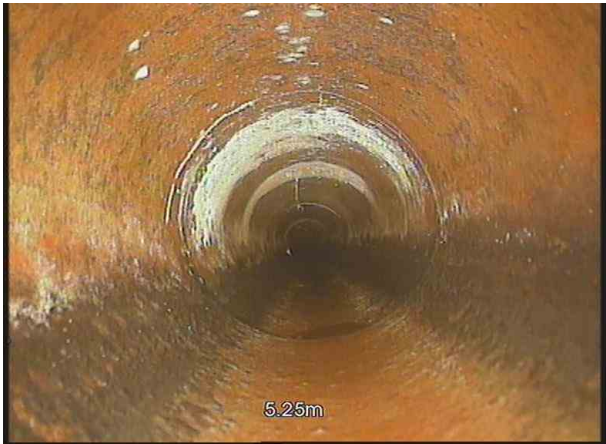
001.jpg, 00:00:41, 5.25 m  
Crack, circumferential at joint from 9 o'clock to 2 o'clock

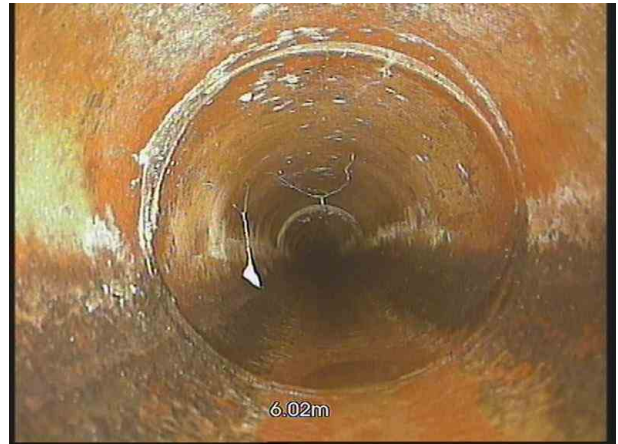
002.jpg, 00:00:50, 6.02 m  
Crack, circumferential at joint from 1 o'clock to 3 o'clock

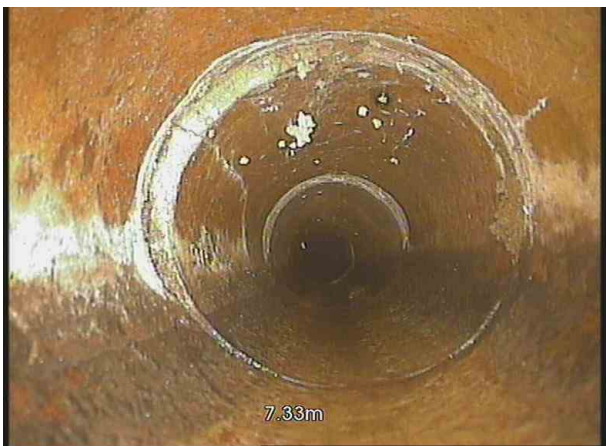
003.jpg, 00:01:05, 7.30 m  
Crack, circumferential at joint from 8 o'clock to 12 o'clock

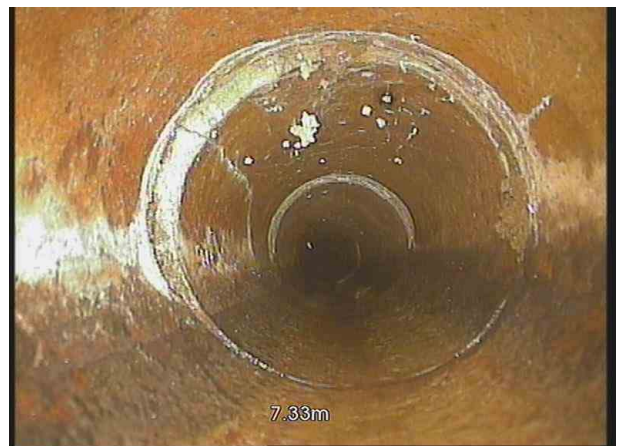
004.jpg, 00:01:07, 7.33 m  
Fracture, longitudinal at joint at 10 o'clock

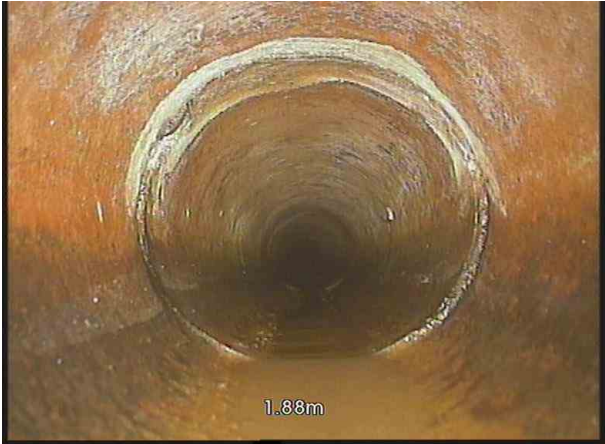
Crack, circumferential at joint from 10 o'clock to 2 o'clock

006.jpg, 00:00:21, 1.88 m  
Crack, circumferential at joint from 10 o'clock to 2 o'clock
