**Tree condition assessment**  
**at**  
**37 Horndean Road, Emsworth, GU10 7PU**  
**for**  
**G Duke**

**sapling arboriculture ltd**

Reference: J1323  
December 2020

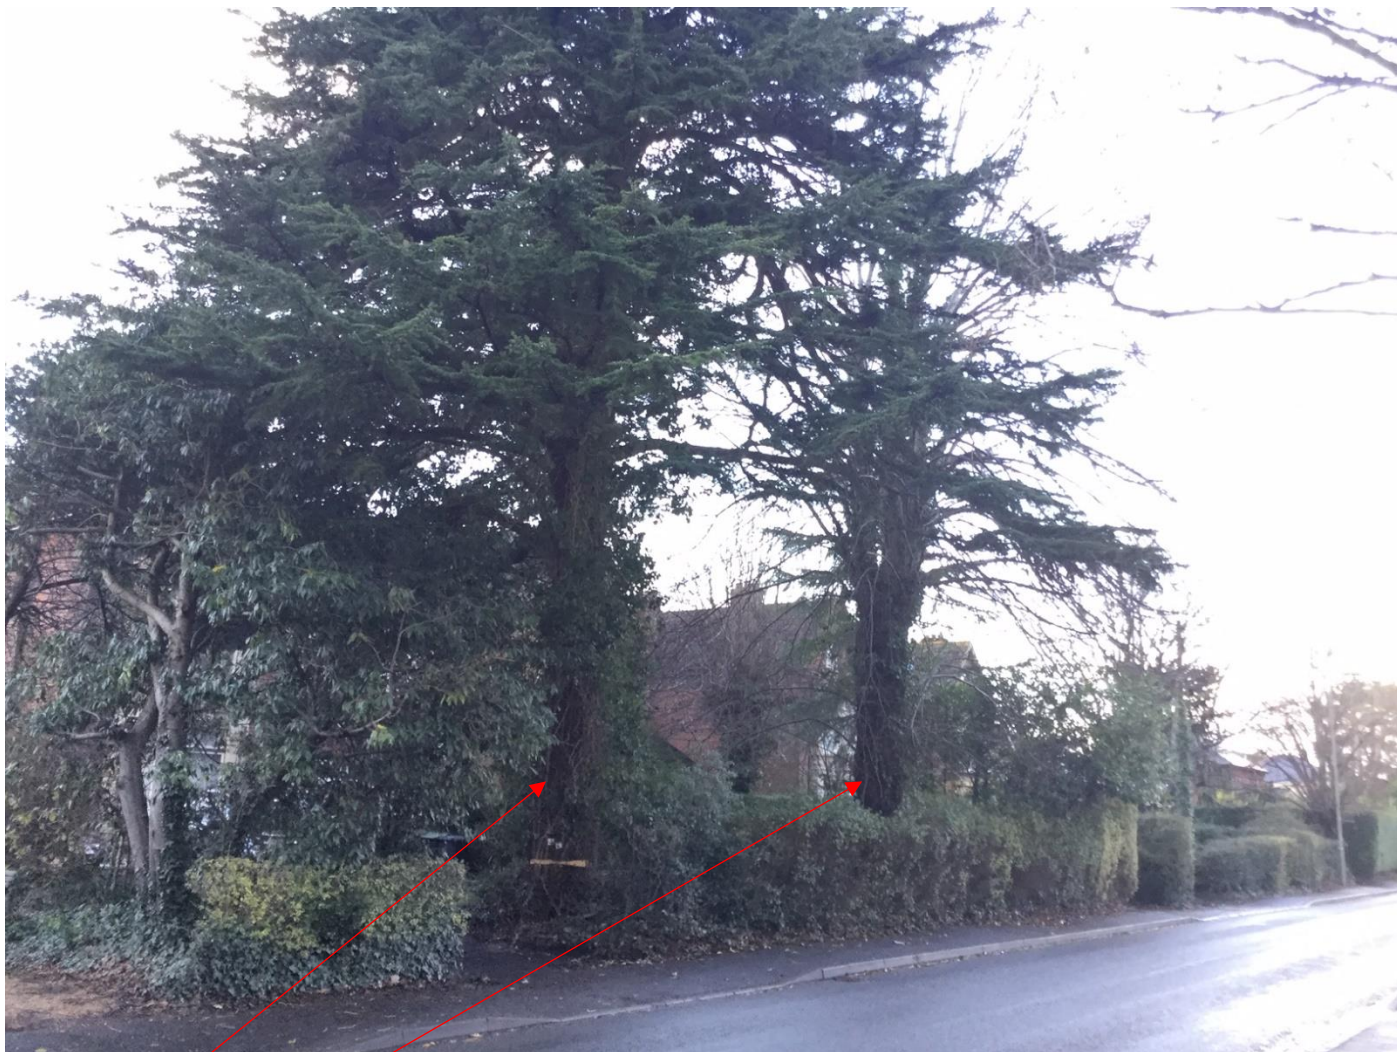
SAL1 T1 cedar and T2 lime.

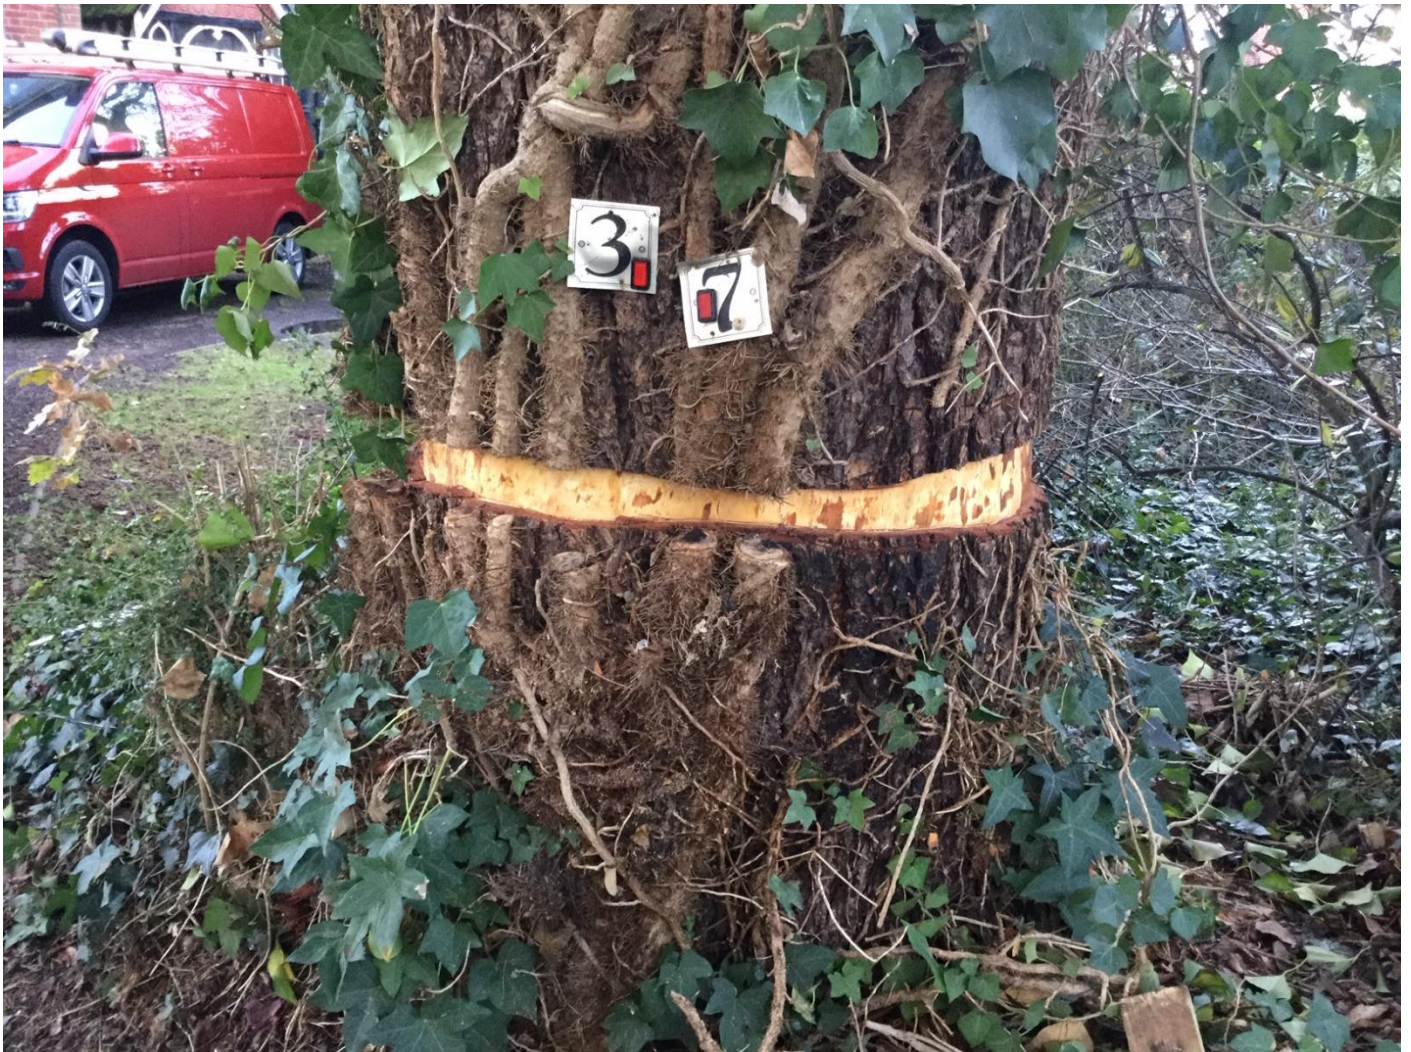
| Designation | Reference number | Species | Height (m) | Age class | Physiological condition | Structural condition | Condition notes | Condition related tree works | Priority |
|---|---|---|---|---|---|---|---|---|---|
| T | 1 | Cedar <i>Cedrus libani</i> var <i>deodar</i> | 16 | Mature | Good | Fair | Previously crown reduced. Series of typical branch failures and mid lateral branch splits. Moderate (25 to 100mm diameter) deadwood and hanging branches throughout. Ivy partly obscures survey. Ivy cut at 1m and includes removal of bark. Access immediately adjacent to base of the tree. Canopy spread N5, E8, S8, W8. | Remove deadwood more than 25mm diameter. Remove hanging and broken branches. Tip reduction of overlong lateral branches to create a canopy spread 7m horizontal radius. Crown lift to 5m above existing ground level. Reassess tree vitality in June 2021. | Moderate |

The removal of the bark may have an impact upon the vitality of the trees. At this point it is not clear whether the trees will recover or not. It is necessary to review the vitality of the trees in June 2021 when the influence of the bark removal will become more clear due to the active growing season, unlike the current dormant period.

SAL2 Ivy and bark removed at c1m on T1 cedar with the cut into the sapwood being c2mm wide and c2 to 3mm depth.

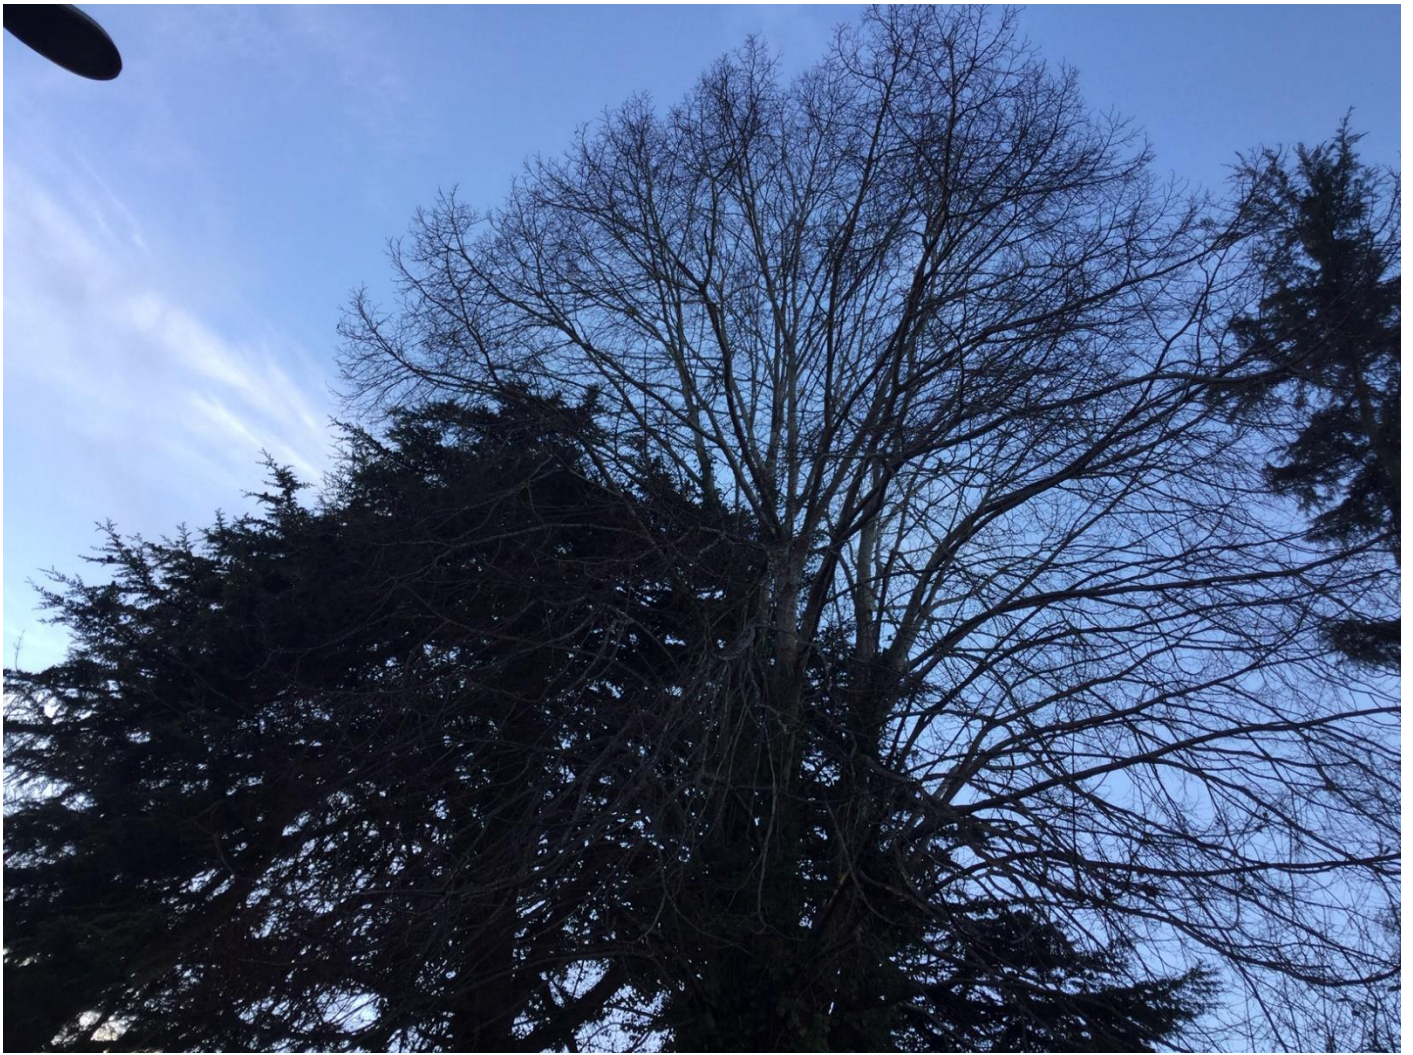
SAL3 T1 cedar and T2 lime vitality good on both trees shown by density of foliage on the cedar and twig density on the lime.

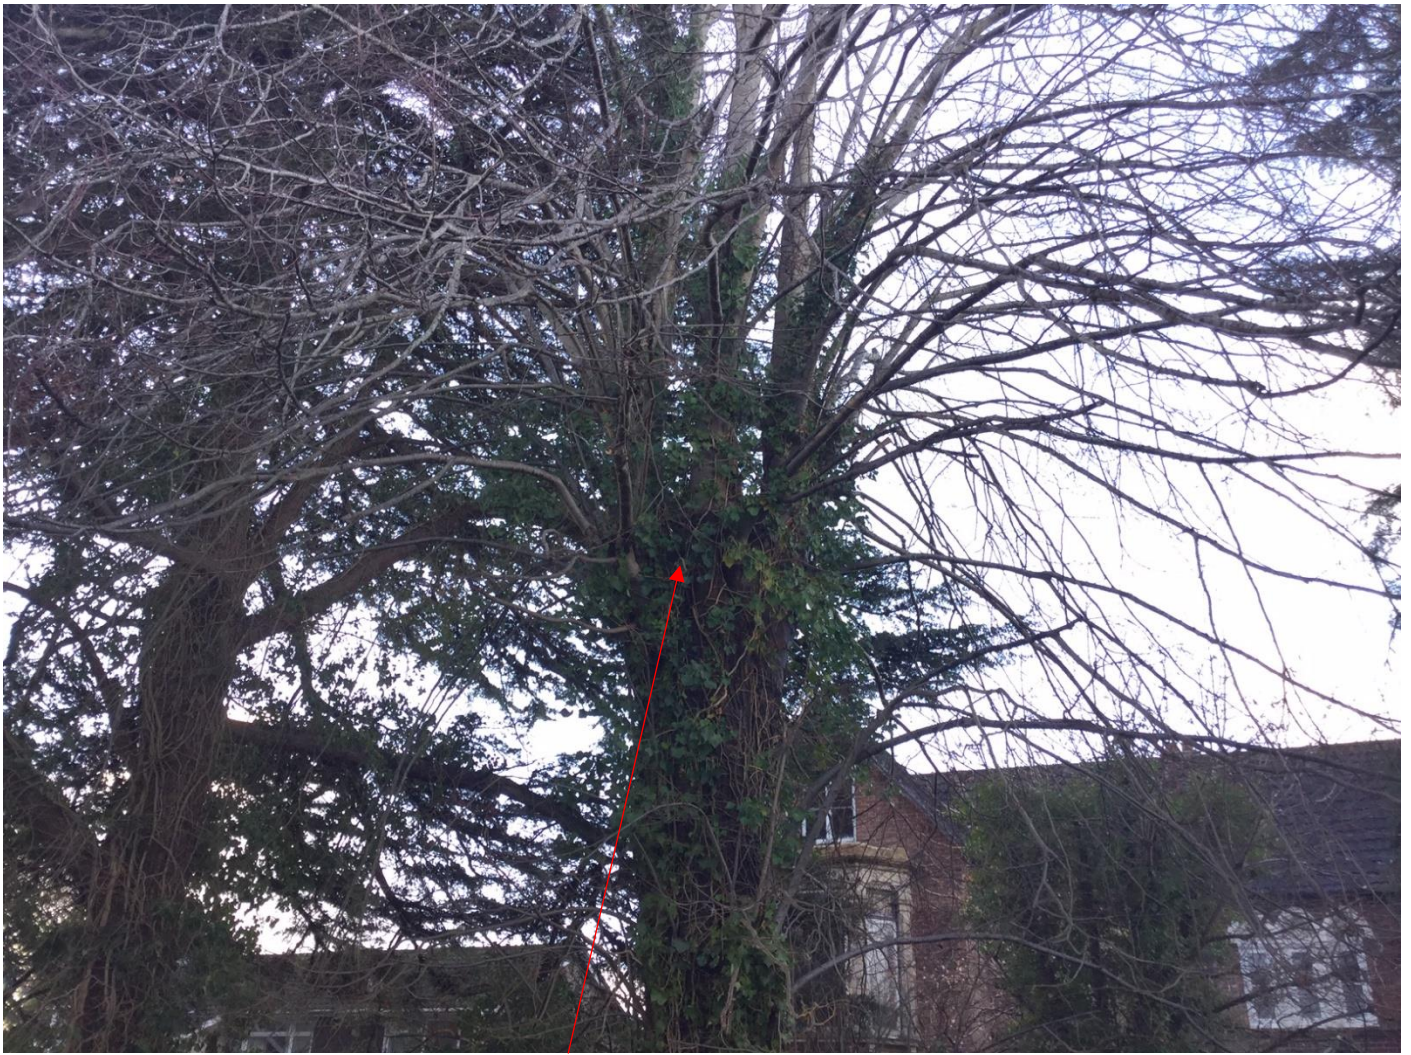
SAL4 T2 lime with previous topping point and subsequent mature regrowth.

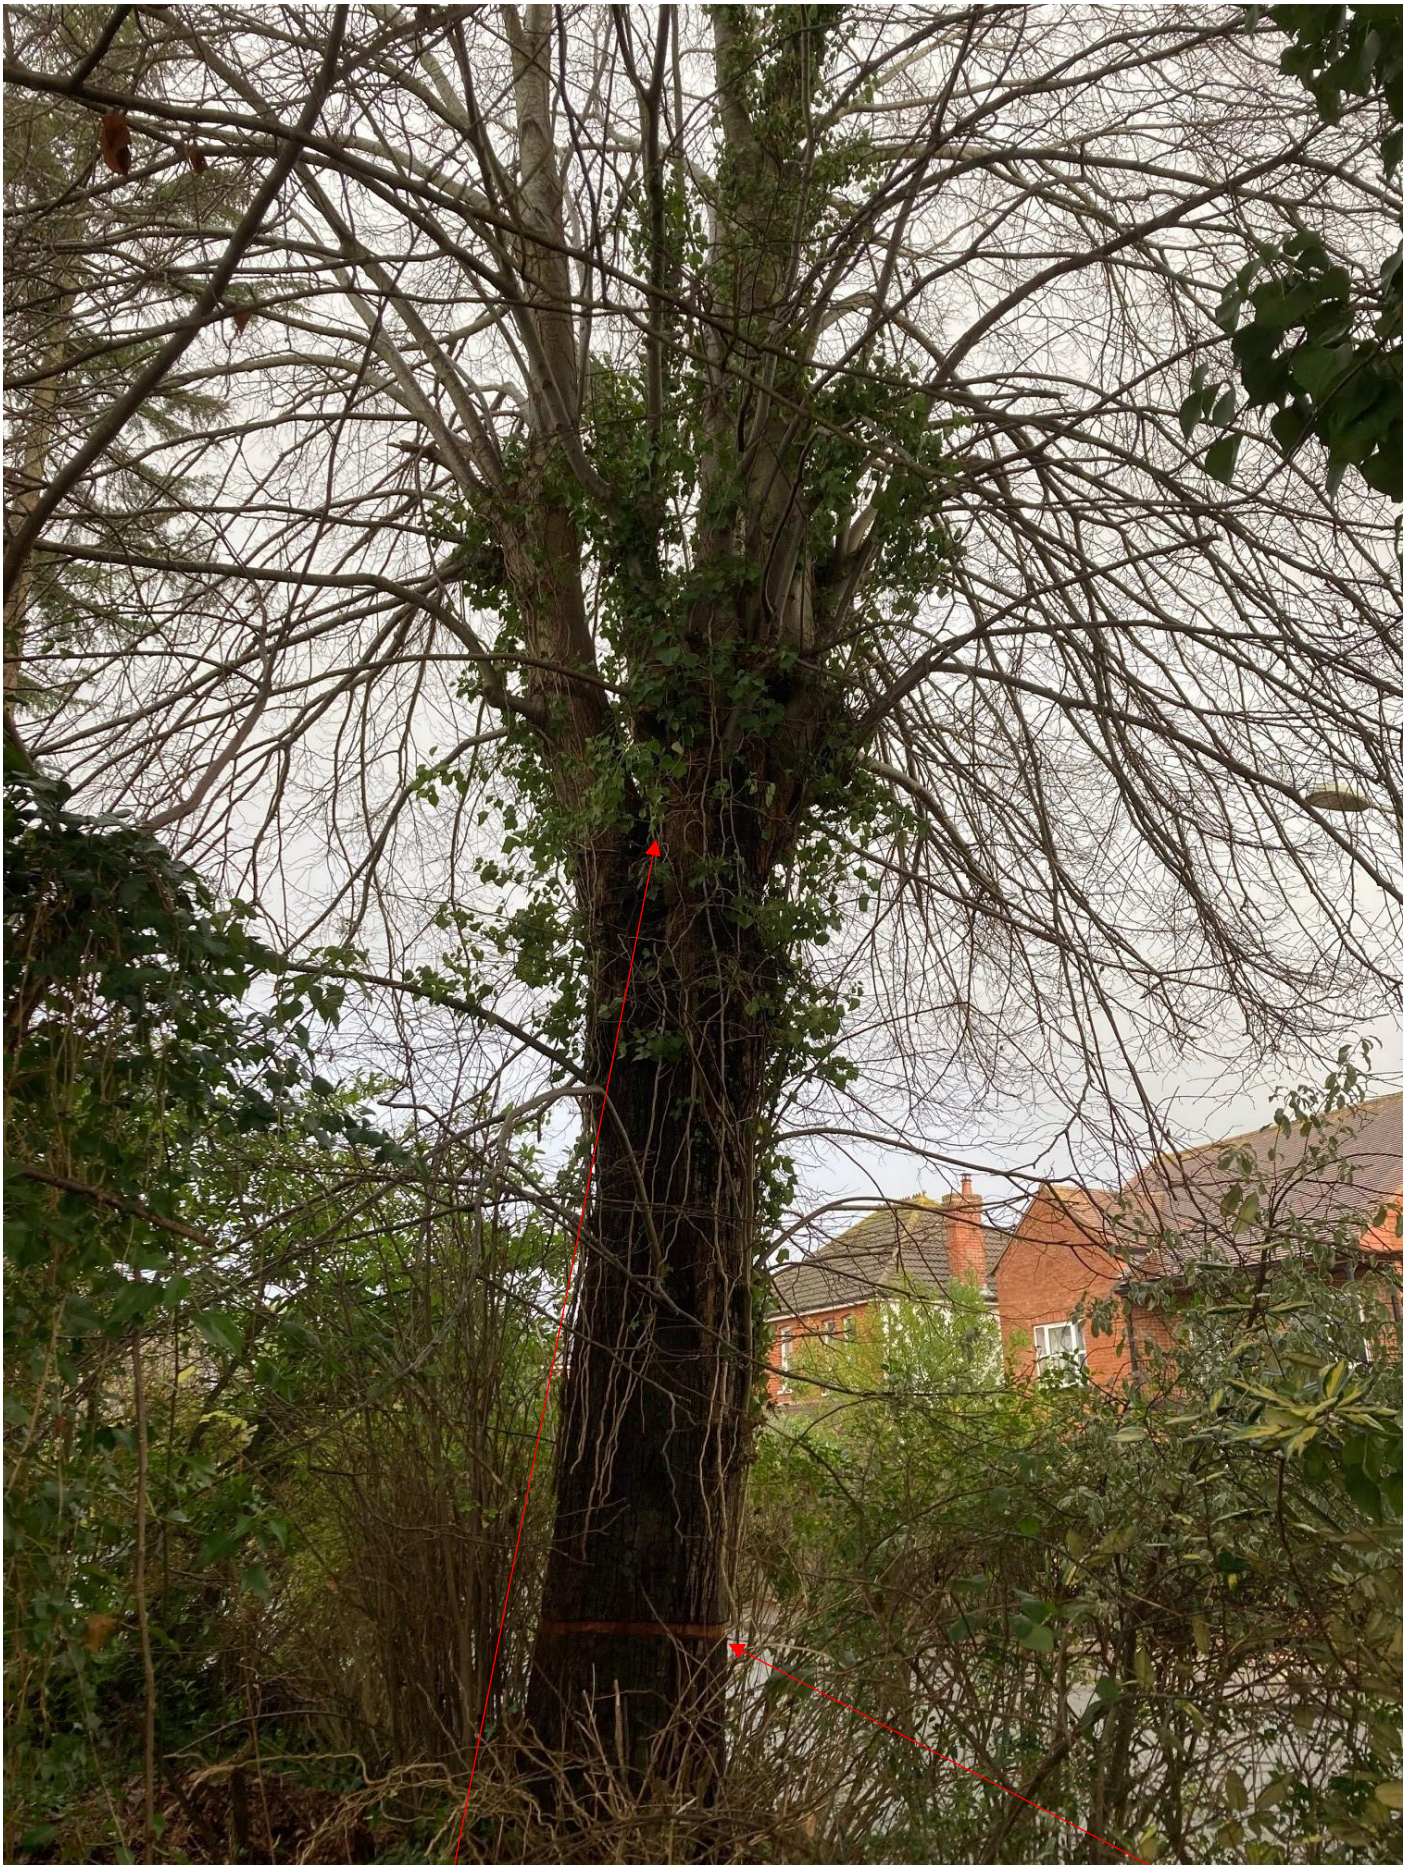
SAL5 T2 lime with previous topping point and subsequent mature regrowth. Ivy and bark removal.

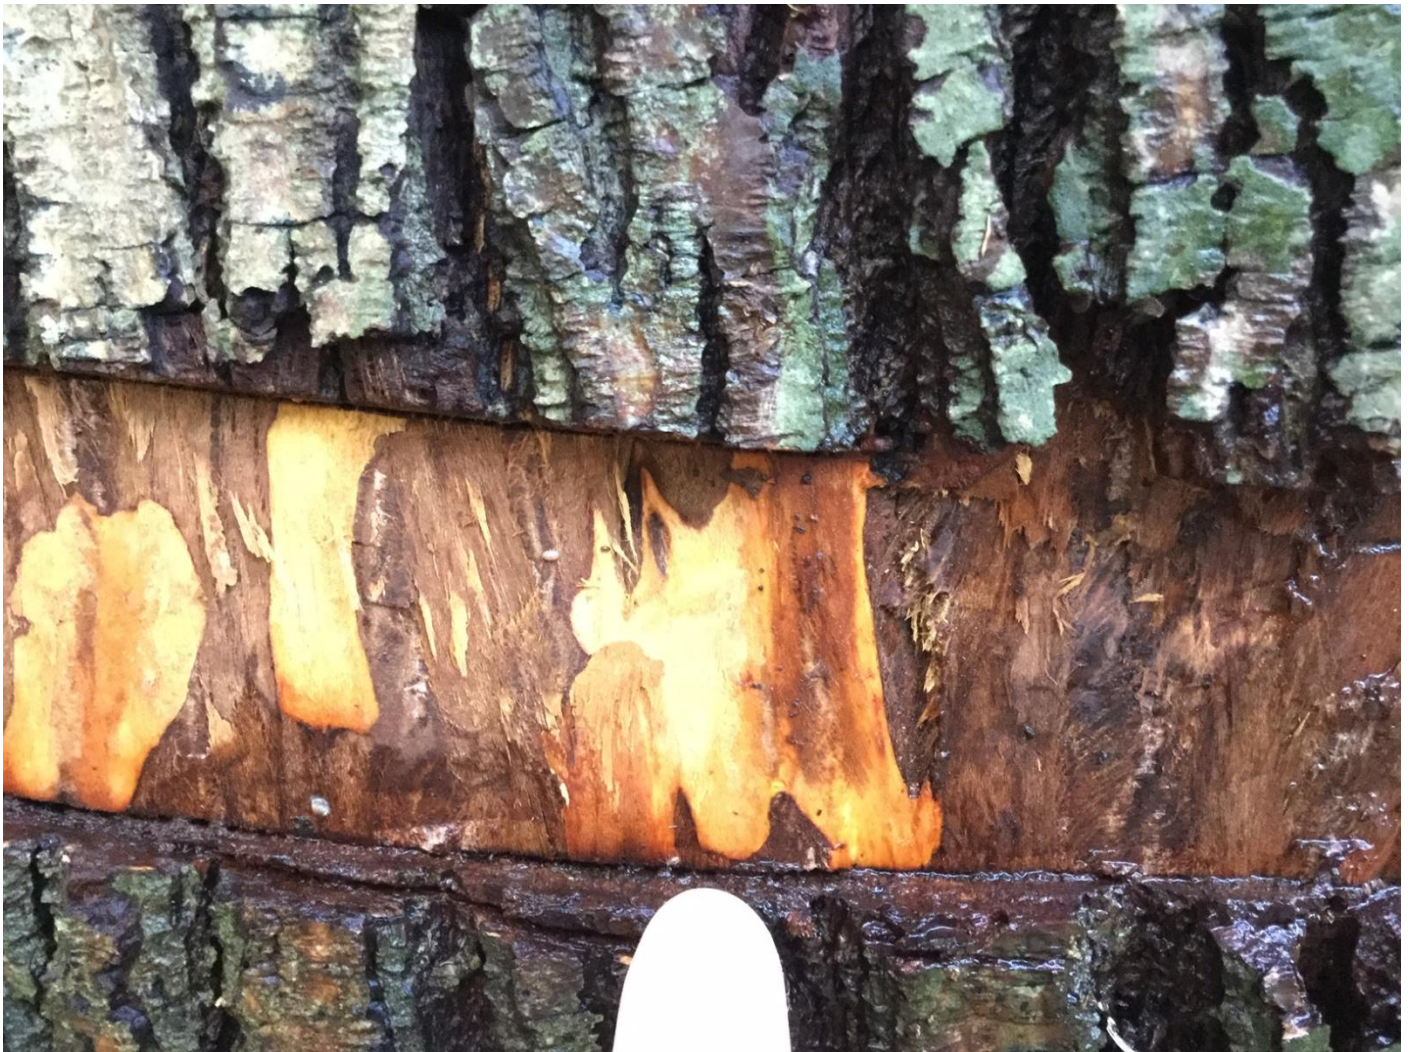
| Designation | Reference number | Species | Height (m) | Age class | Physiological condition | Structural condition | Condition notes | Condition related tree works | Priority |
|---|---|---|---|---|---|---|---|---|---|
| T | 2 | Lime <i>Tilia x europaea</i> | 17 | Mature | Good | Fair | Previously topped at c5m with mature regrowth. Ivy partly obscures survey. Ivy cut at 1m and includes removal of bark. Epicormic growth at base and impedes survey. Canopy spread N7, E6, S5, W6. | Crown lift to 5m above ground level. Remove epicormic growth on the lower stem on an annual basis to allow survey. Reassess tree vitality in June 2021. | Low |

SAL6 Ivy and bark removed at c1m on T2 lime with the cut into the sapwood being c2mm wide and c2 to 3mm depth.
