2<sup>nd</sup> November 2018

Our ref: GE17736/GR02/181102

**RE: Manor Farm, Lower Road, Bedhampton**

Further to your instruction, we write to present the results of the supplementary ground investigation and in-situ testing undertaken to assess the potential for use of borehole soakaways as part of a drainage solution for storm water discharge from the proposed development.

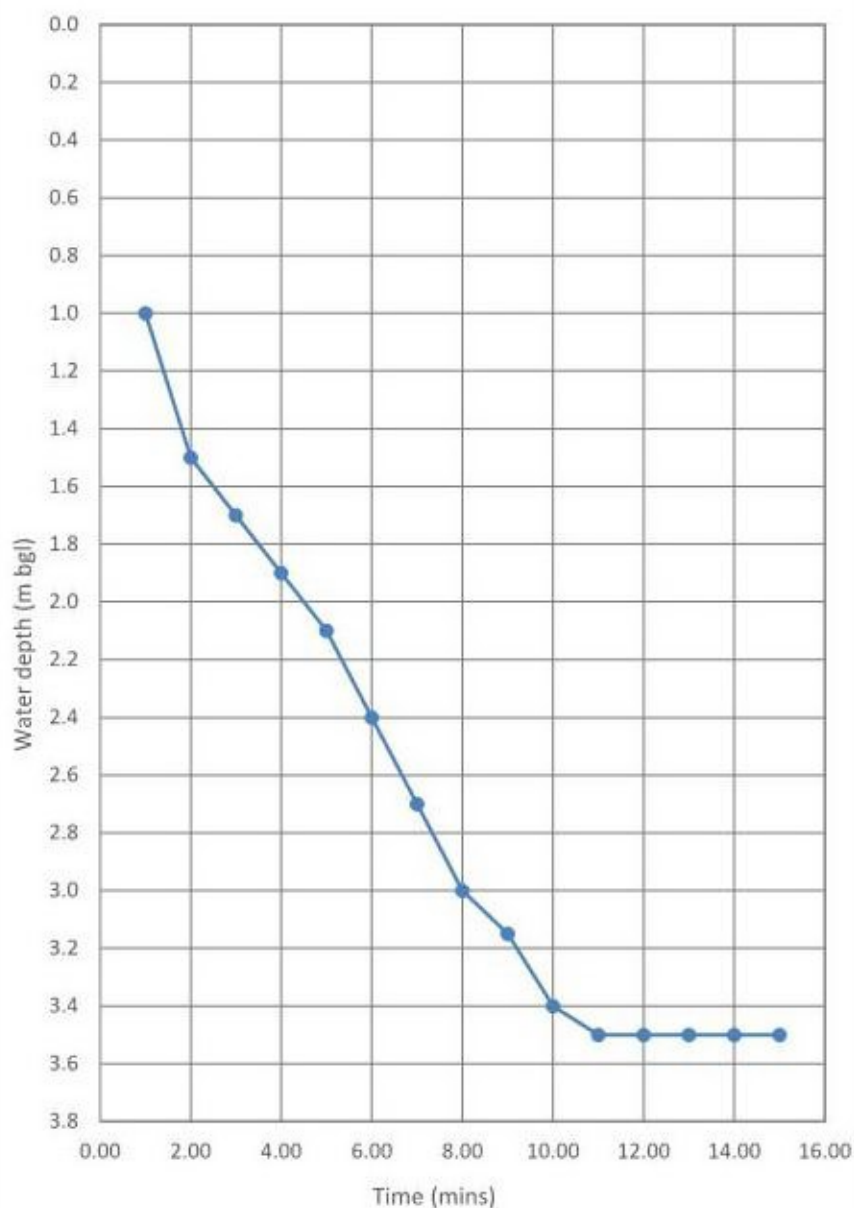
| Borehole | Test location depth | Infiltration rate (m/s) |
|---|---|---|
| BH101 | 14-15m bgl | $1.63 \times 10^{-4}$ |

The falling head tests at depth within both boreholes were undertaken below the depth at which water ingress occurred, i.e. the tests were surcharging groundwater. Whilst a potentially suitable infiltration rate has been derived for the falling head tests at depth, direct discharge of storm water into groundwater is not normally acceptable. As such, consultation with the EA and Portsmouth Water should be sought at the earliest opportunity.

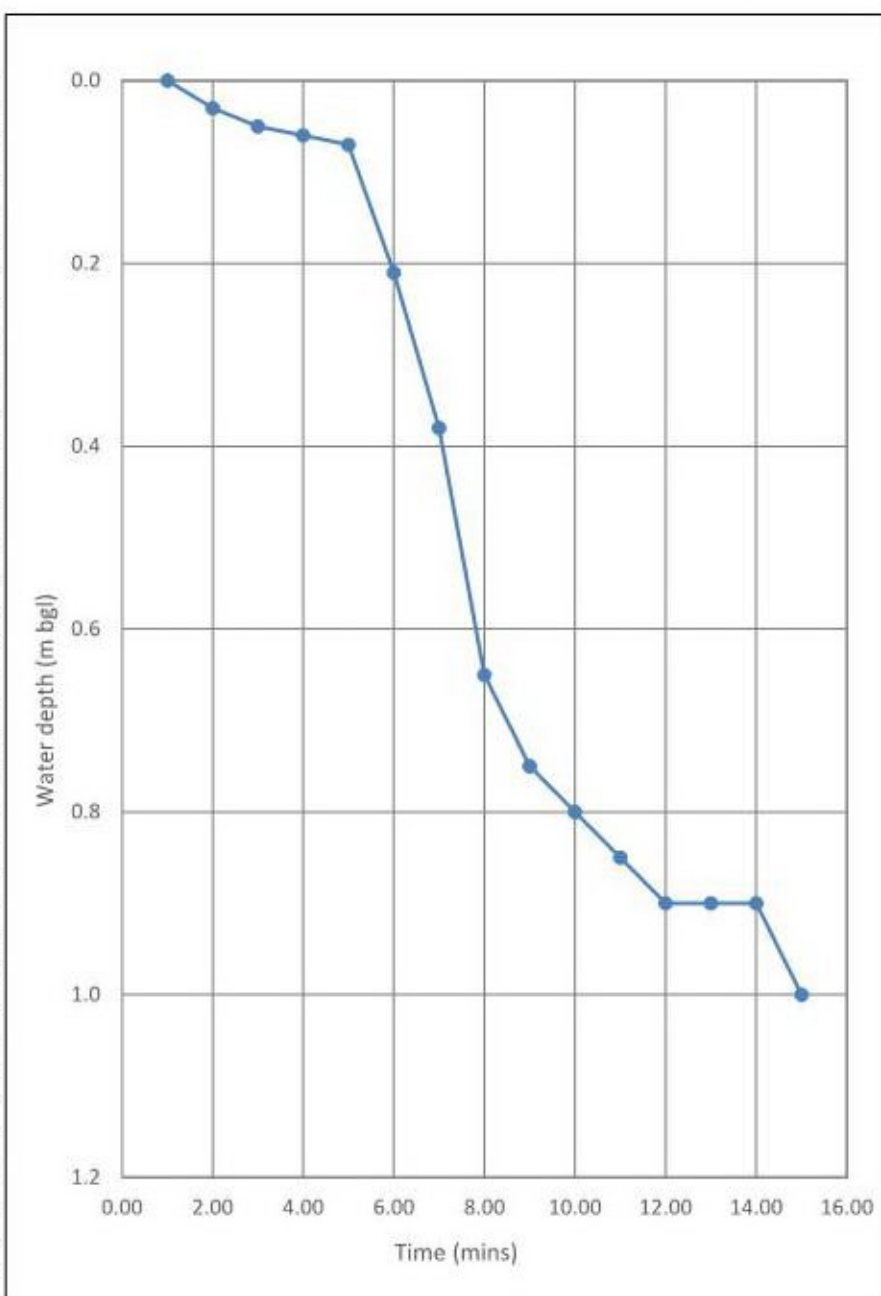
| Borehole | Test location depth | Infiltration rate (m/s) |
|---|---|---|
| BH102 | 3-5m bgl | $1.00 \times 10^{-5}$ |

Whilst an infiltration rate of  $1.0 \times 10^{-5}$  m/s was derived from the shallower falling head test undertaken in BH102, it should be noted that trial pit soakage testing in similar ground conditions, a similar test depth range and in the same area of the site was unsuccessful and thus the rate of infiltration would appear not to be uniform and consistent.

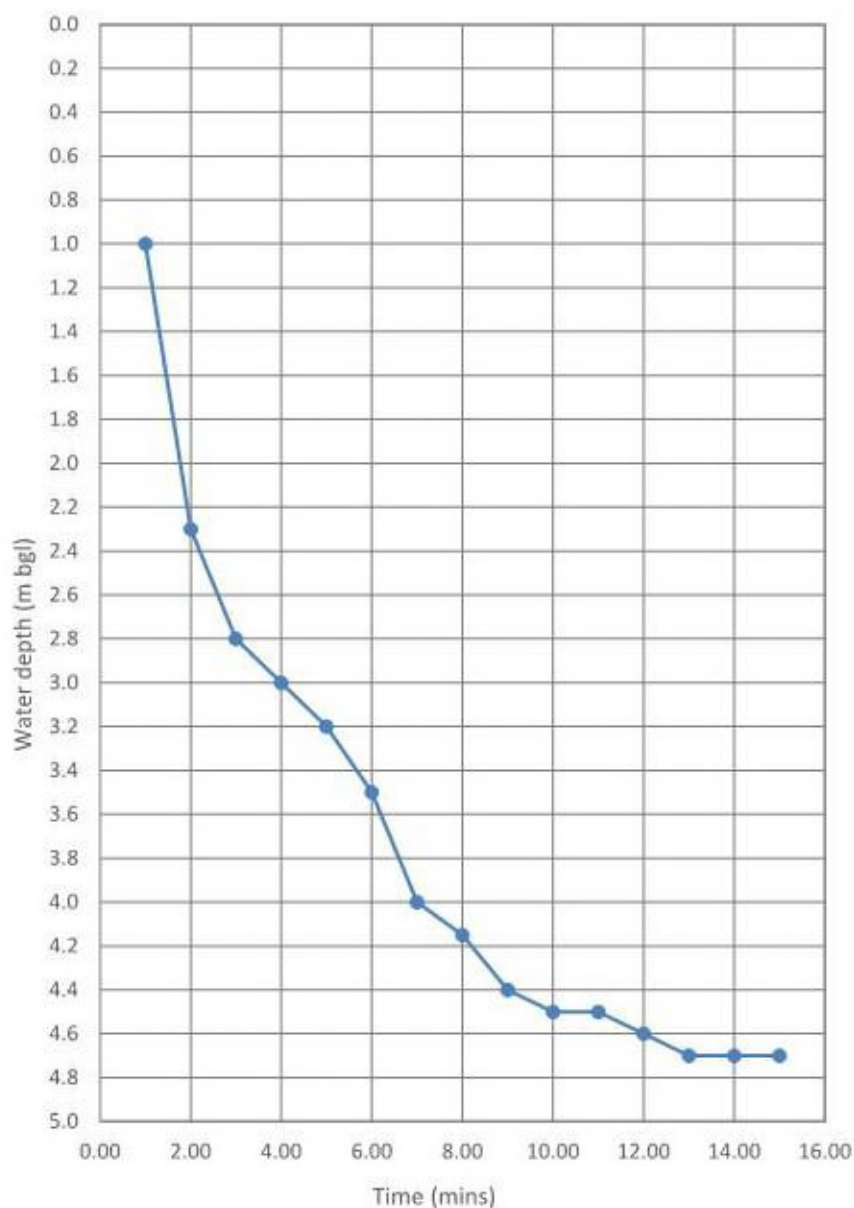
| Borehole | Test location depth | Infiltration rate (m/s) |
|---|---|---|
| BH102 | 14-15m bgl | $1.37 \times 10^{-4}$ |
