# Aerial Tree Report

Prepared on the 22<sup>nd</sup> January 2021 for

Mark Tuson  
4 South Road  
Hayling Island  
PO11 9AE

## Climbing Inspection Form

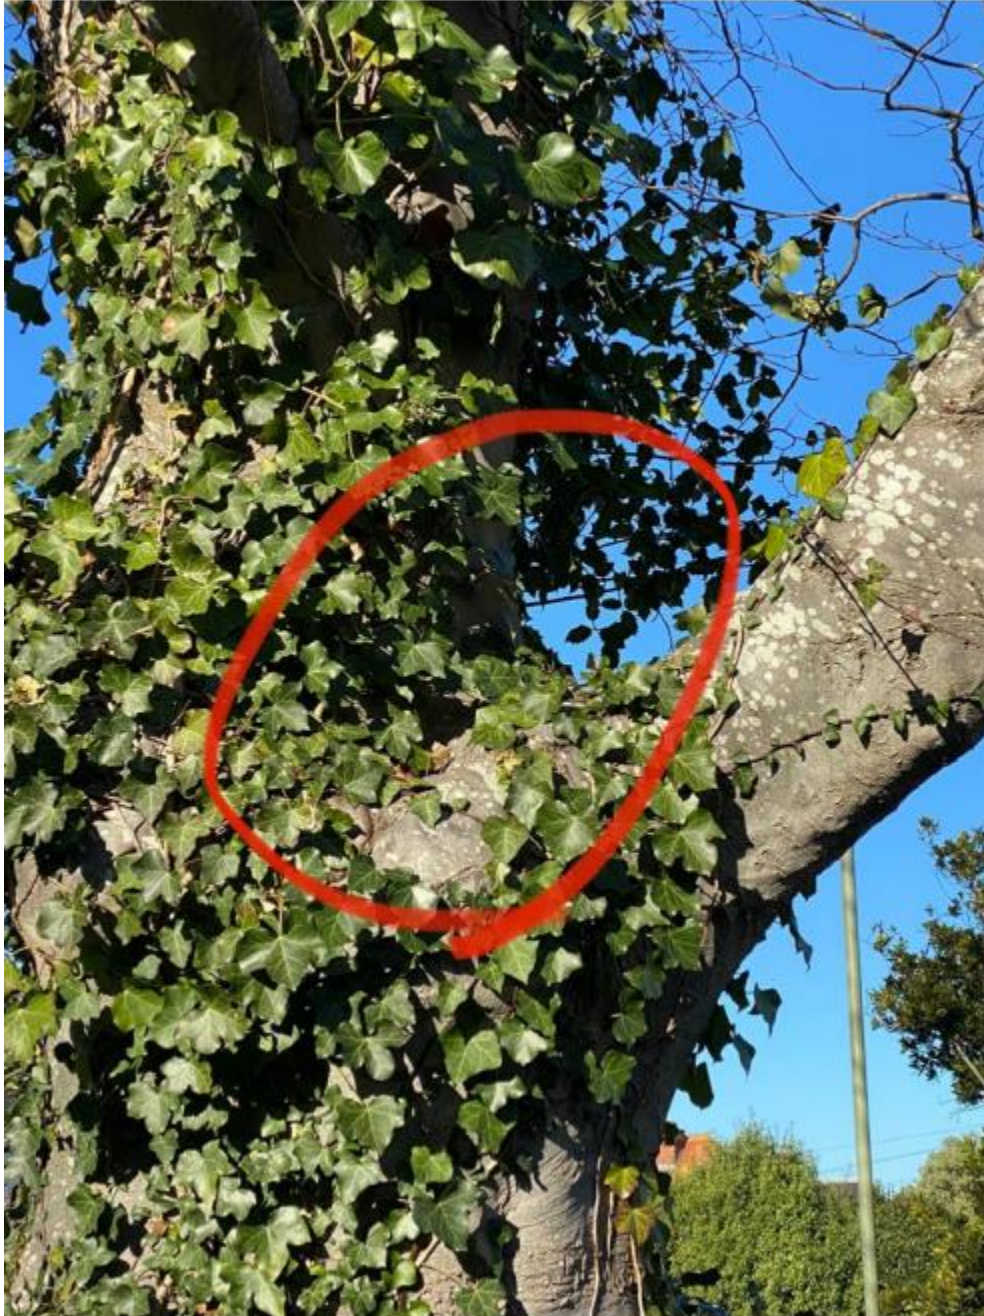
### Appendix 1

- At approximately 2.5m high, there is a cavity from either a past pruning wound or snapped limb. Sufficient reaction wood has formed around this. (Ref Appendix 1)

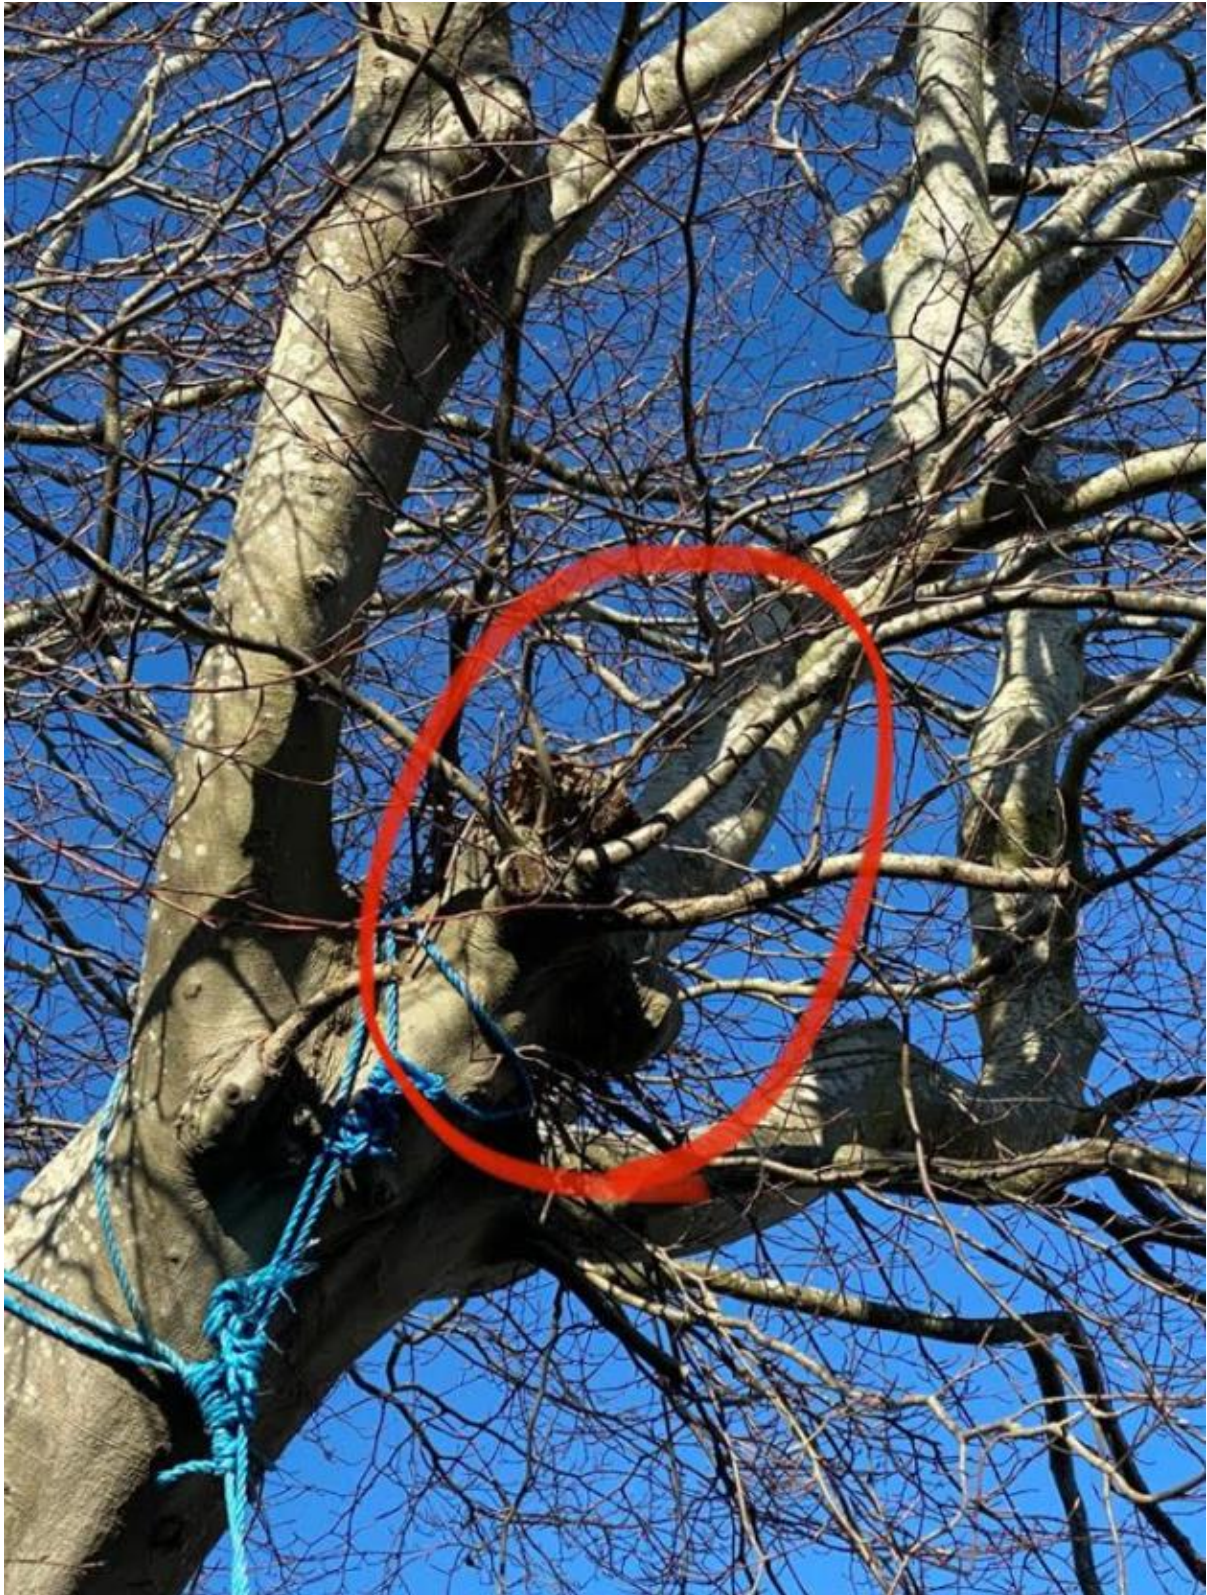
## Appendix 2

- Throughout the canopy there are epicormic shoots that have formed from old pruning wounds. Nothing out of the normal. (Ref Appendix 2)
- Excessive ivy surrounds lower stem and mid canopy. (Ref Appendix 3)

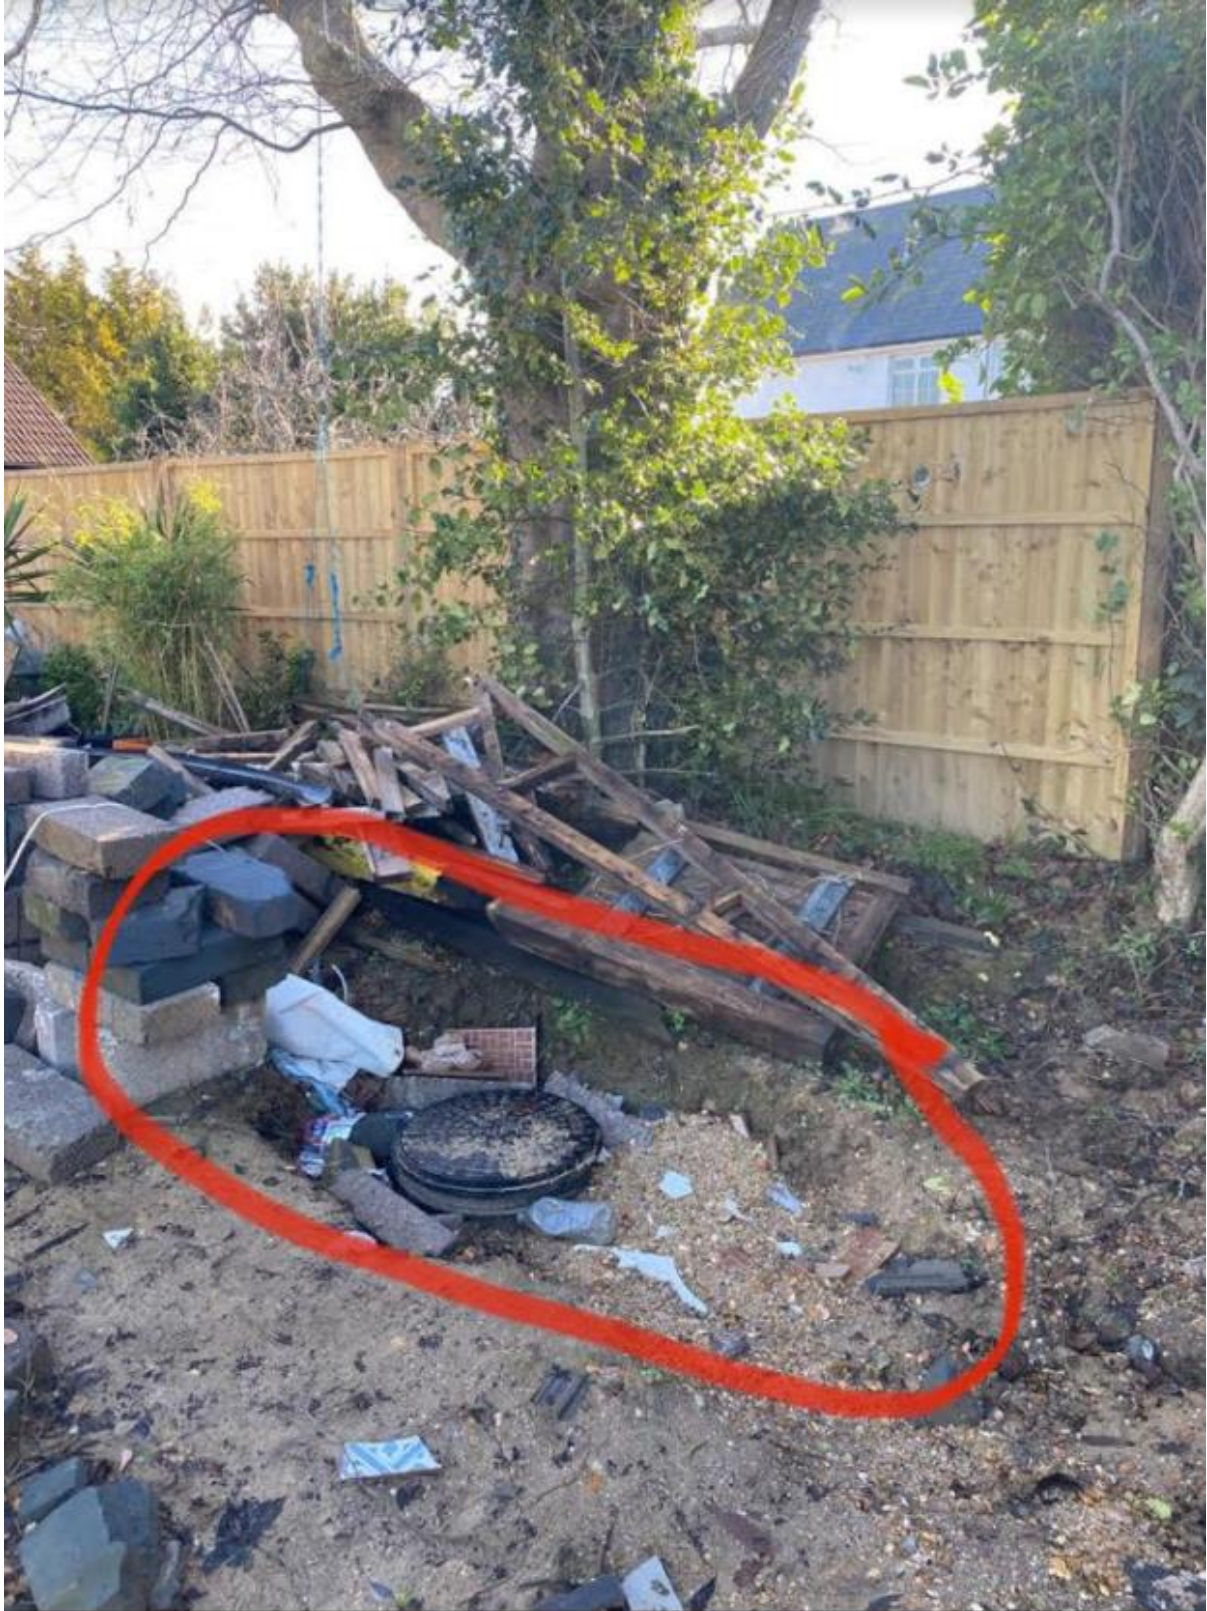
## Appendix 4

- Root intrusion, upon looking from the road across neighbouring property it would seem that foundation works have entered into the root zone for drainage works. (Ref Appendix 4)

I would suggest that the following is commenced, drop crotch lateral limbs on the east face to give appropriate clearance for the BT line. It has been mentioned that a dwelling may be placed beneath the canopy of T1. If this were to happen providing the height does not exceed 2.4m and the foundations are not intrusive within the root plate then this would not have a detrimental effect on the tree.

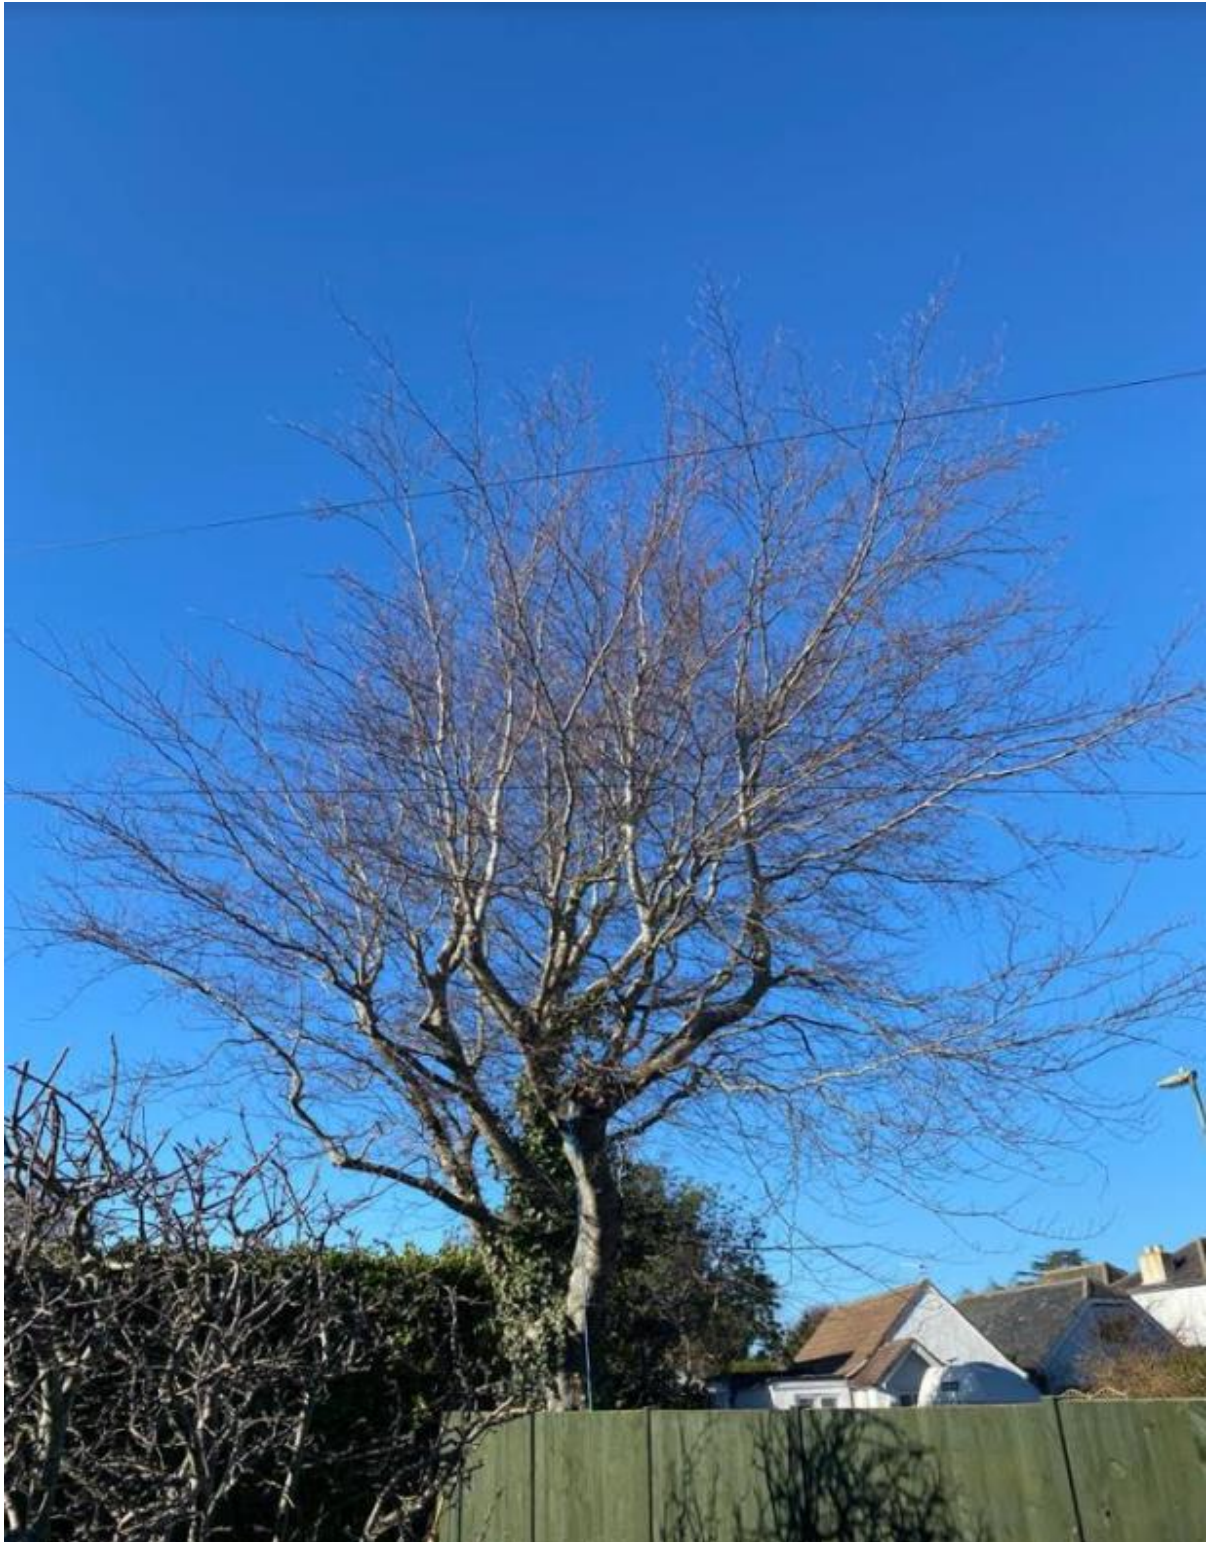
## Appendix 5

- Canopy condition seems to be dense with a full canopy of buds and plenty of low lateral growth. (Ref Appendix 5)
- Canopy on the east face seems to be entering the vicinity zone of the BT line. (Ref Appendix 6)
