OAK FRAMED BAY WINDOW

THE MANOR. PO9 3JT

FRAME AS EXISTING

AH. BOCC LTD.  
 14/05/2019  
 THE MANOR, POBSI  
 FRAME AS REPAIRED

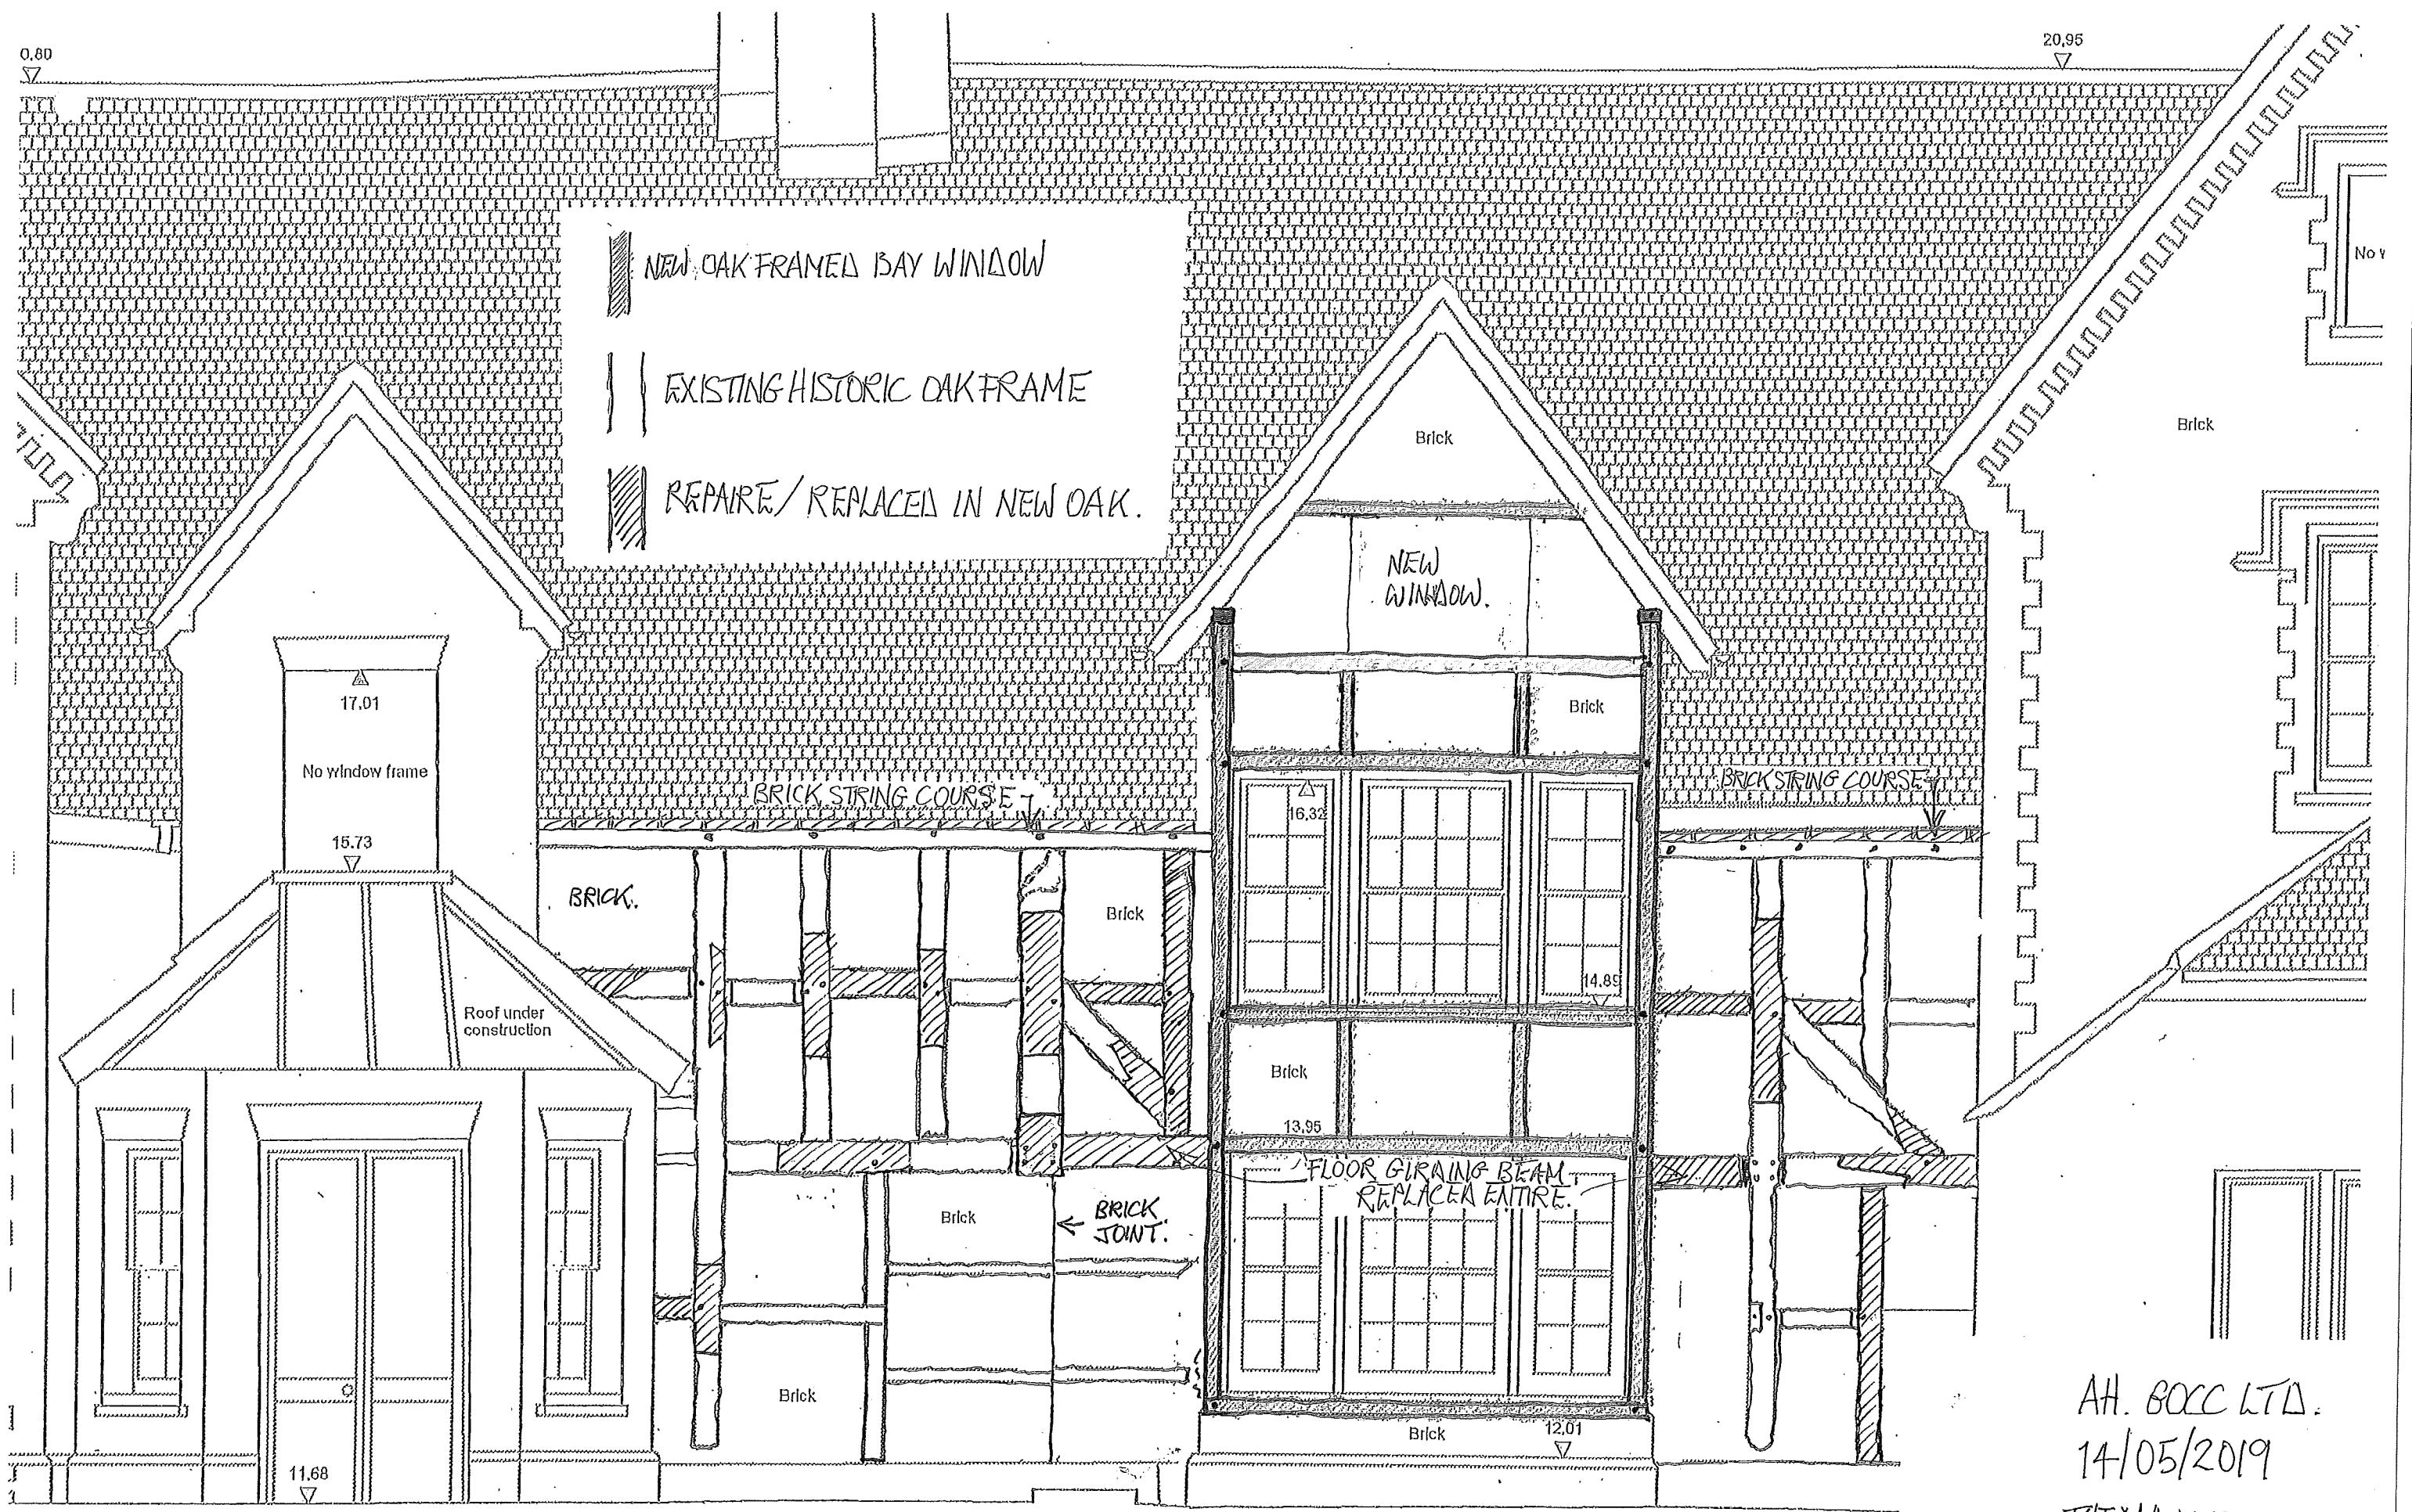
EXISTING HISTORIC OAK FRAME

BAY INDICATES AREAS OF DECAY.

No window frame

FLOOR GIRING BEAM  
BADLY DECAYED.

REPAIR/REPLACED IN NEW OAK.

NEW WINDOW.  
94X145.
