SHEET 6  
Photographic Record / Inventory:  
Ground Floor: G6, 7, 8, 9, 10

January 2020

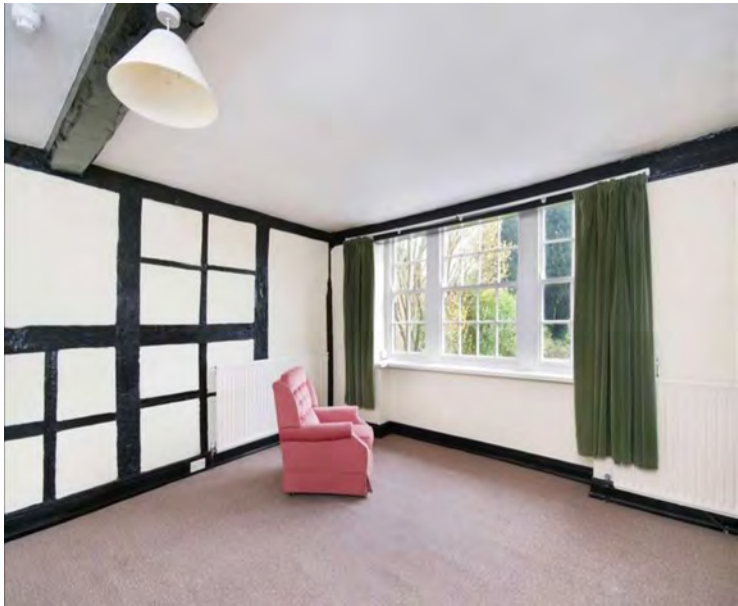
Before: Modern finishes to walls and ceilings with spine beam, side girt, cross beam, box frame visible.

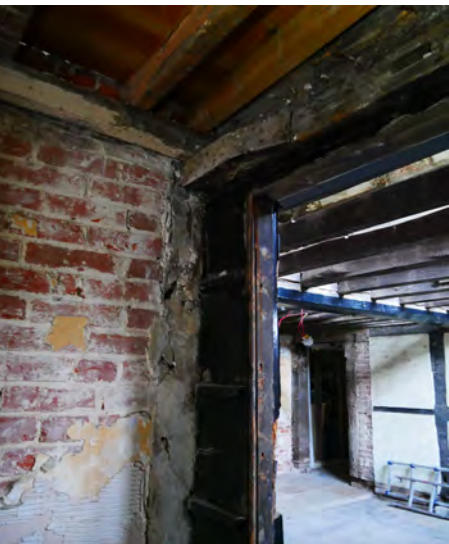
19. G6 - Inner hallway - baffle entry from west. The nib was added to narrow the doorway. A narrow timber has been added below the cross beam. Ceiling was intended to be concealed.

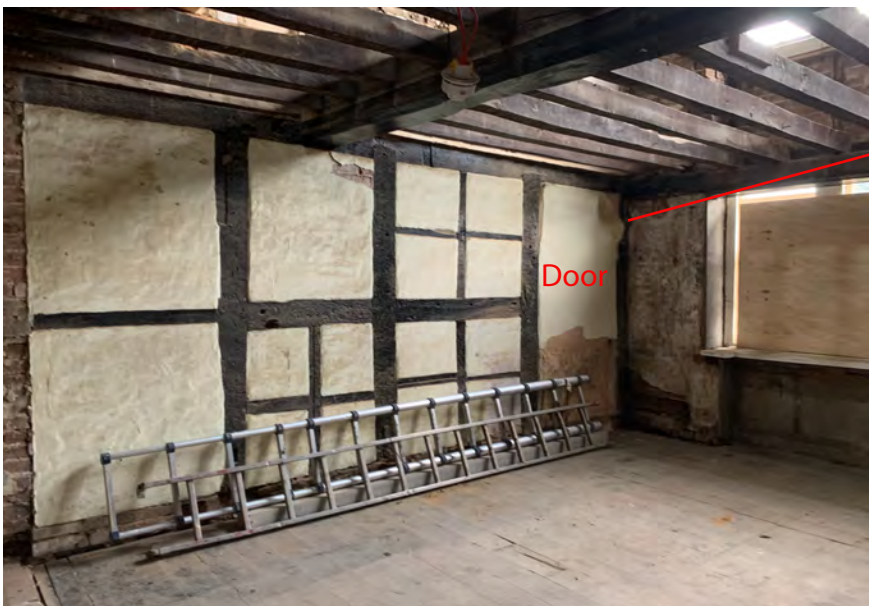
20. G7 - another former baffle entry. Blocked up and may have accommodated a stair/ladder to the first floor. This was used as an ensuite with tiled walls and floor and sanitary fittings.

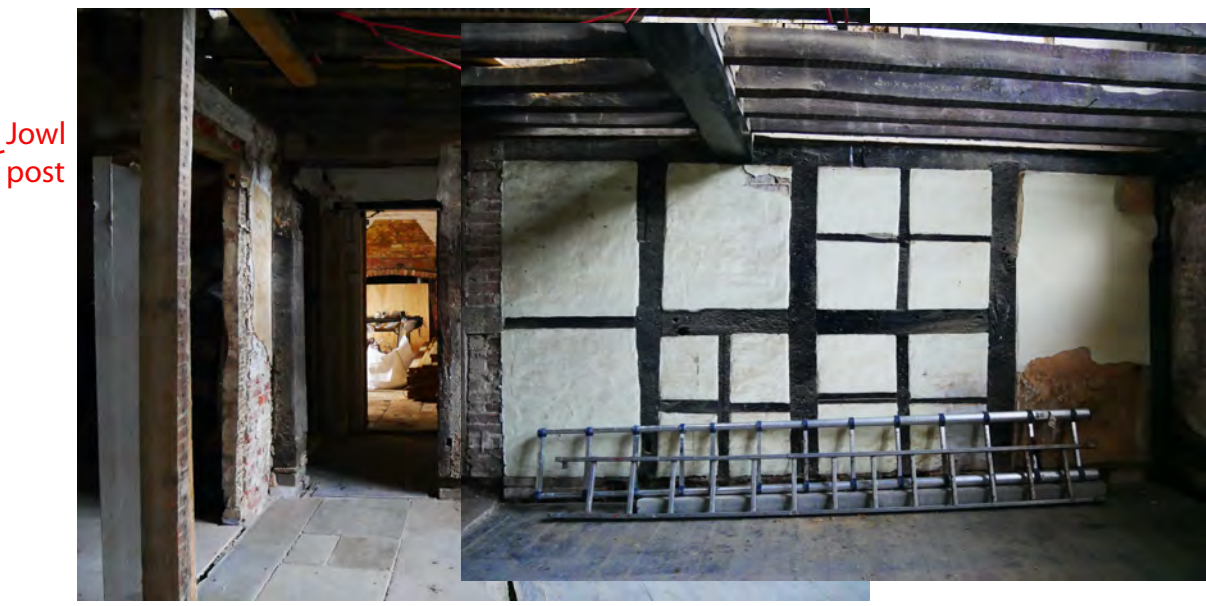
21. As per the former state but walls exposed, former door revealed and modern ceiling covering removed revealing joists.

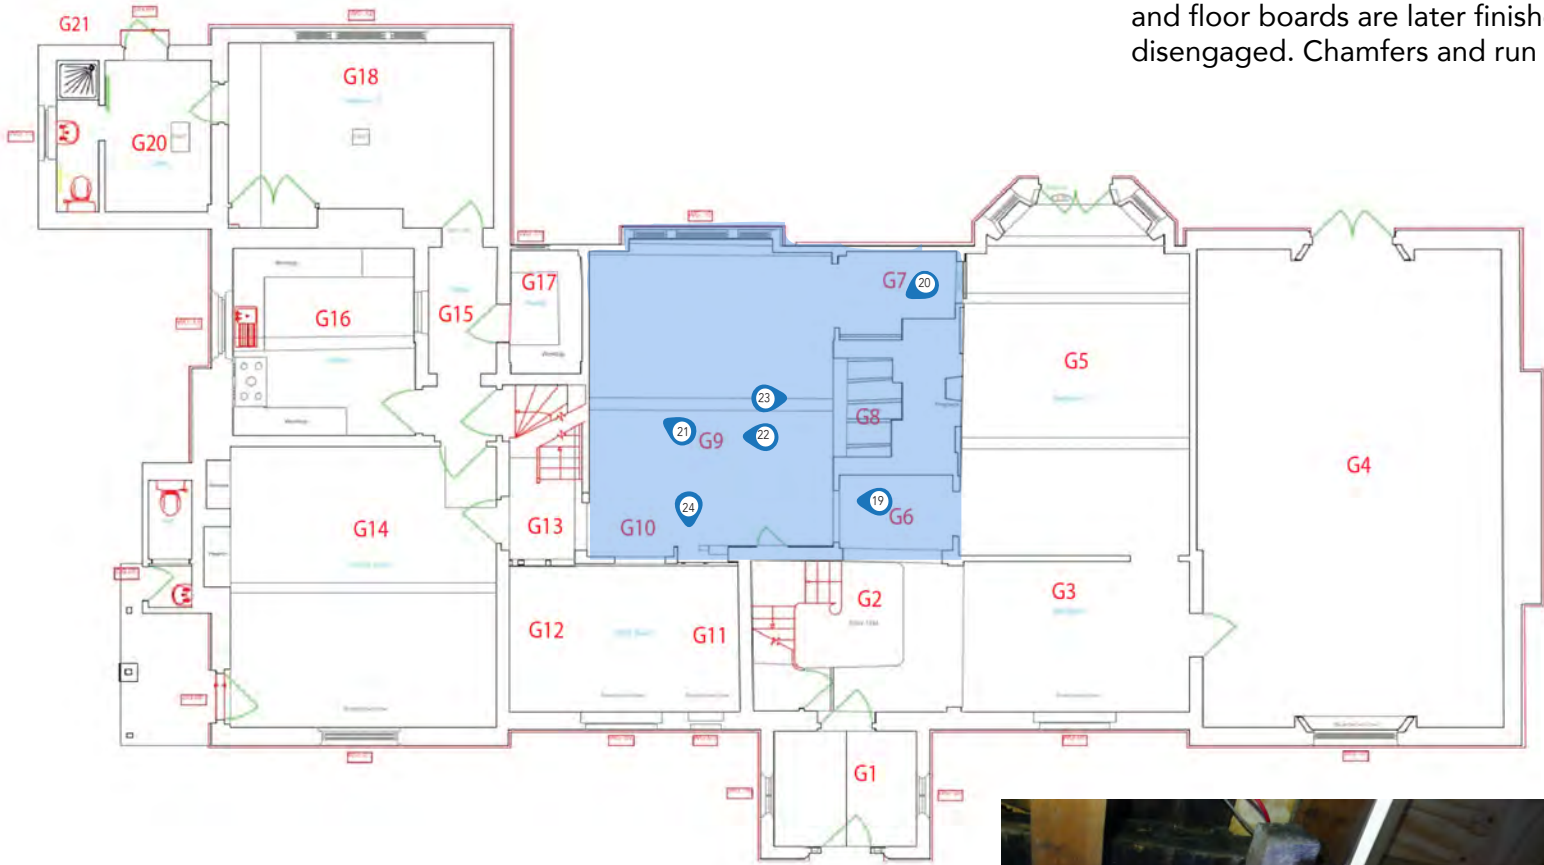
22. The central bay includes G9 and 10. There appears to have been doors on each side, that to west side altered, to the east blocked up. Evidence of fixed furniture to box frame. Wattle & daub was replaced with brick infill panels. Floor raised. Flags and floor boards are later finishes. Inner wall of G10 - side girt has racked and disengaged. Chamfers and run through stops to spine beam.

Refer to Dwg MHB-02A & 05A and repairs indicated by The Green Oak Carpentry Co.

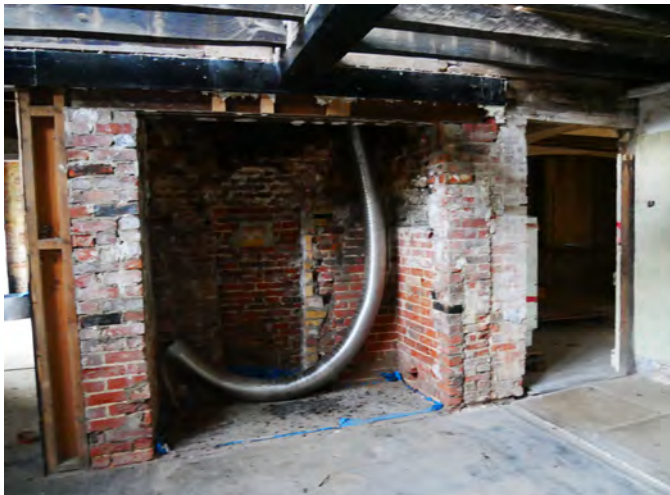
23. Used as an ensuite, tiled with wc & handbasin. Now removed & reveals past alterations to the brickwork, posts and an introduced steel RSJ. The Crossbeam above the door shows the original height of the room.

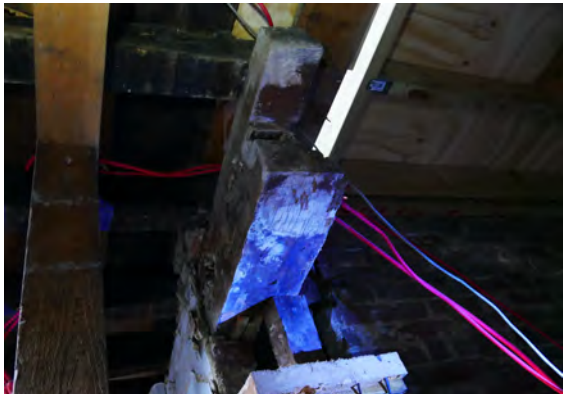
24. Disengaged side girt of the original 3-bay timber frame. Intruded into with formation of doors to G11 & G12 as well as west extension.
