Before: Dining Room

Current (2018/19):

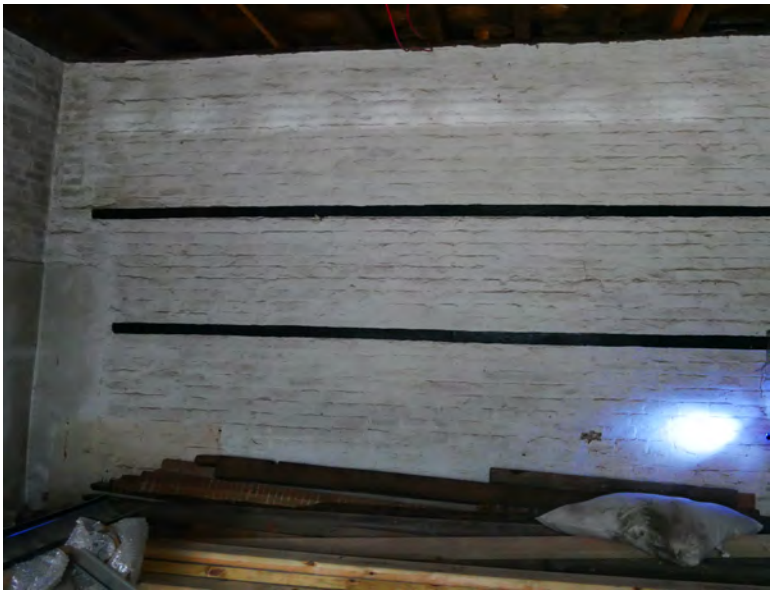
32. Inner face of south wall reveals a former door opening to G12 and a cambered arch to the door to G13. Bolts for new Floor to G11/12 noted.

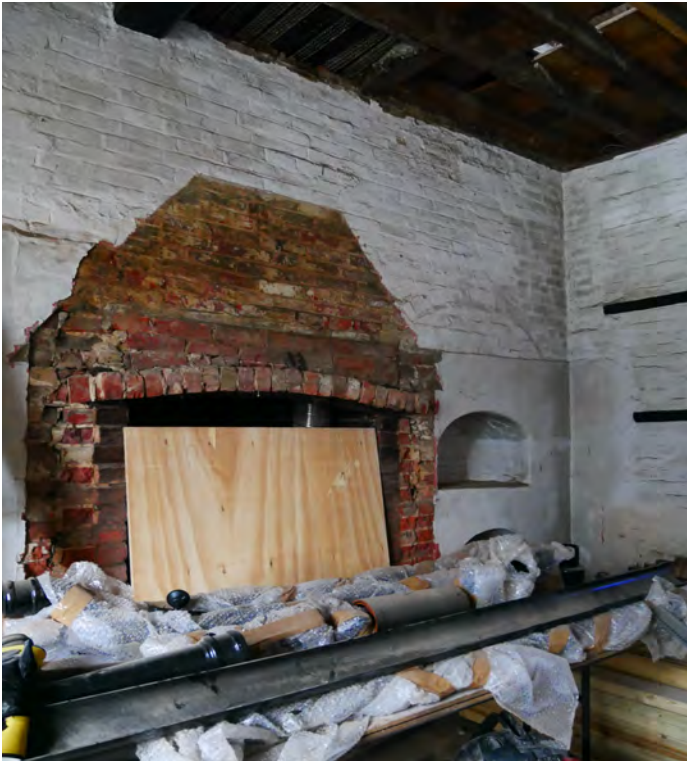
33. Inner face of east wall is more rudimentary in construction with timber.

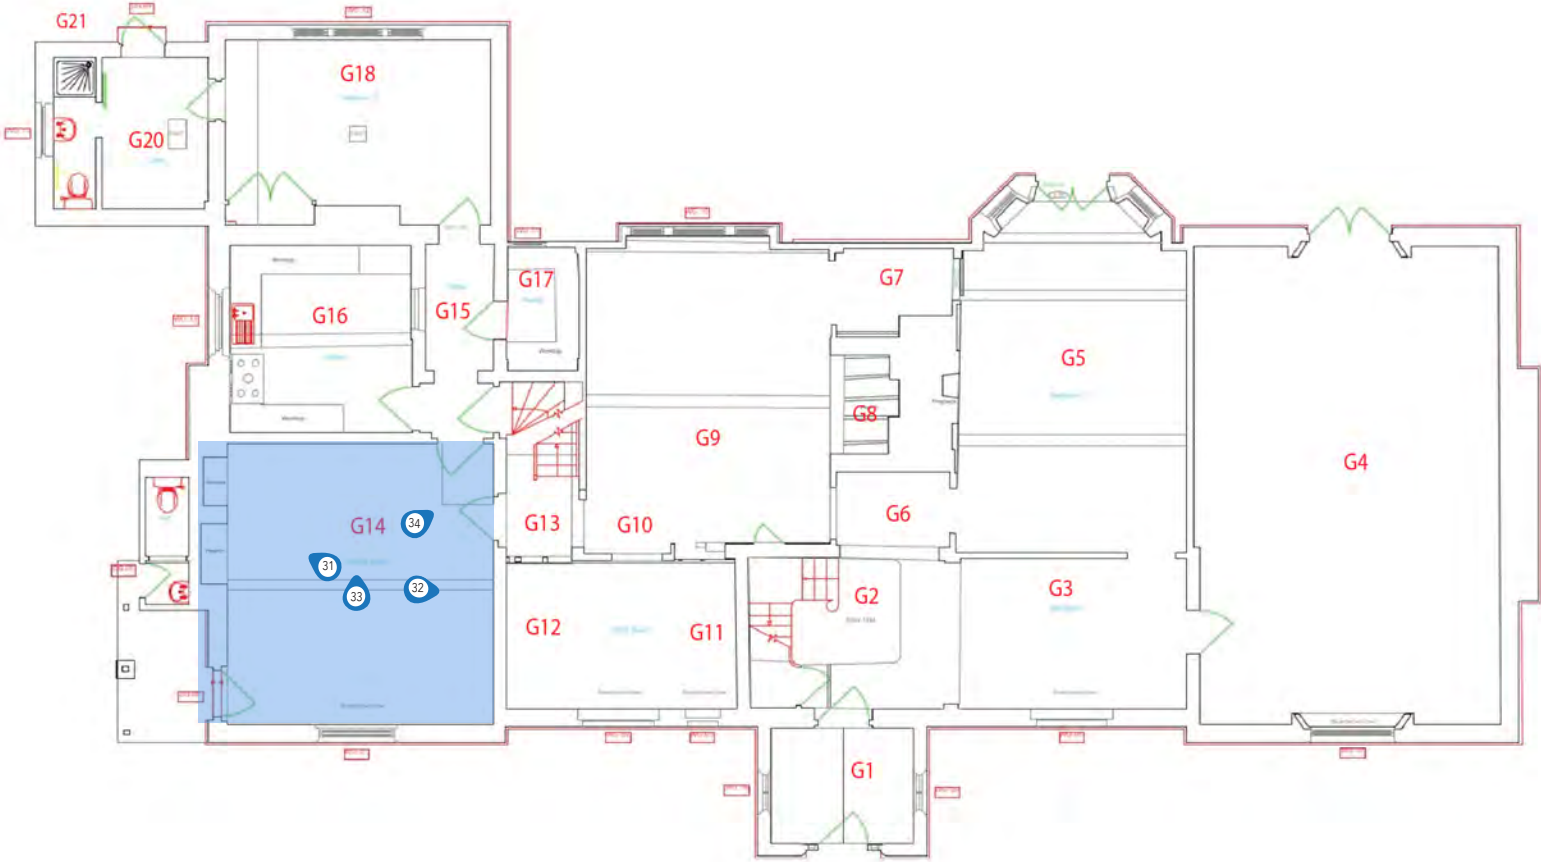
31. Inner north wall exposing brickwork to fireplace, higher arch to side indicating a possible doorway. Predominantly stretcher bond which could relate to the addition of the first cross wing. East and west walls are Flemish bond.

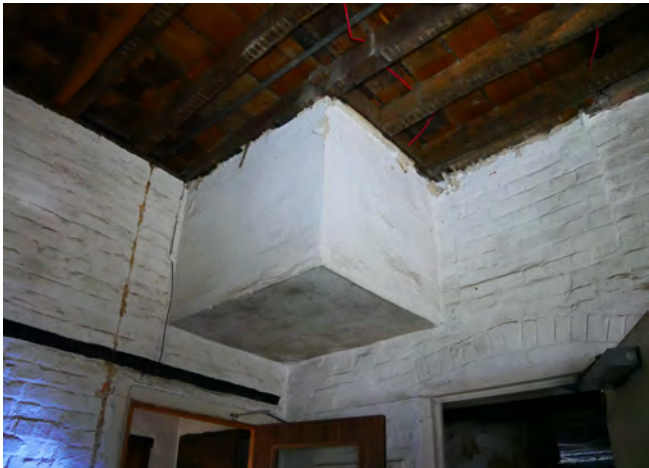
34. The bulkhead for the introduction staircase to the SW corner.
