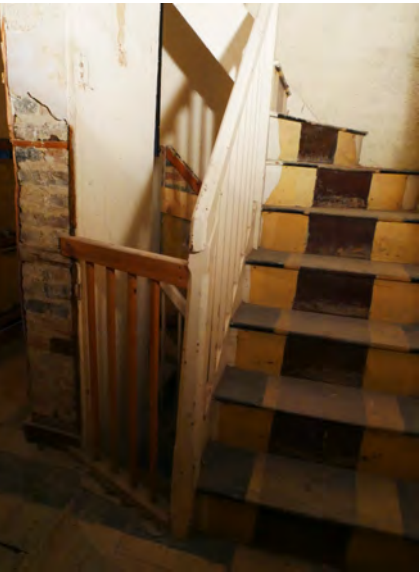
Before: No images available of this area. Both are within the 'ghost' northern bay. Evidence of fire damage, timber reuse and extensive re-working of this area coinciding with north cross wing. .  
Current (2018/19):

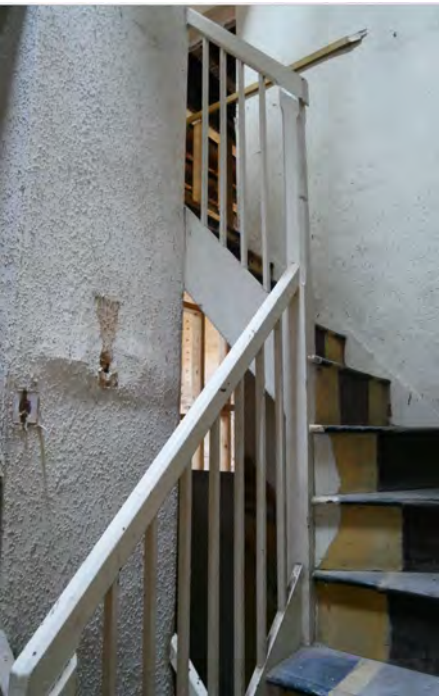
82. FF14 secondary Victorian stairs rising off landing. 1st flight rises from ground floor. Side landing also served FF17 but stairs removed.

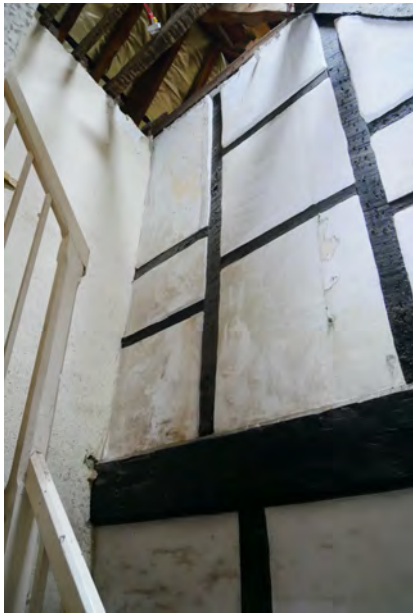
83. Flight continuing to attic above.

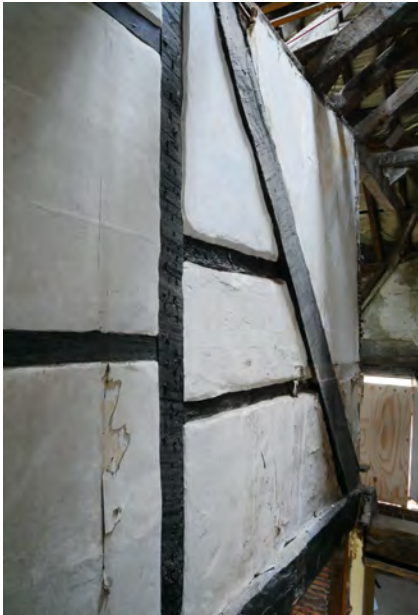
84. Cross beam & box frame rising up the stairwell wall. This would have been internal to the north 'ghost' bay.

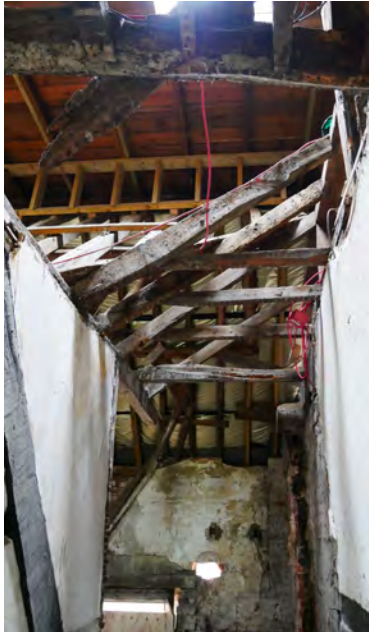
86. Evidence of missing rail. Underside of cross beam above shows position of former door to north bay.

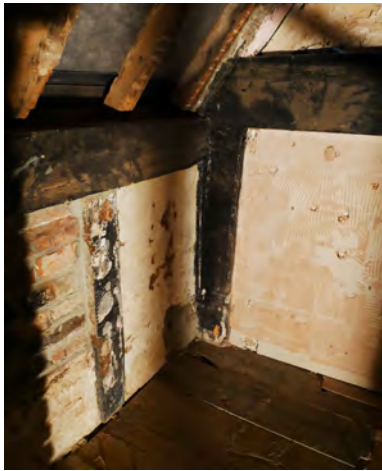
90. SE crnr of FF17 with cross beam, wall plate & possible former window.

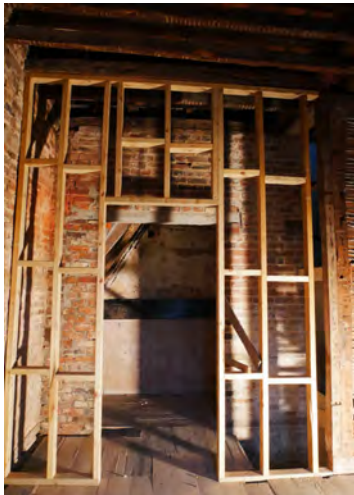
89. Partitioning in FF16 with FF17 used as an ensuite. Note the concrete RSJ. At a higher floor level than photo 88.
