# Drainage Report

Site  
**Staunton Country Park farm**

## Staunton Country Park - CCTV Survey Report : 13/11/19

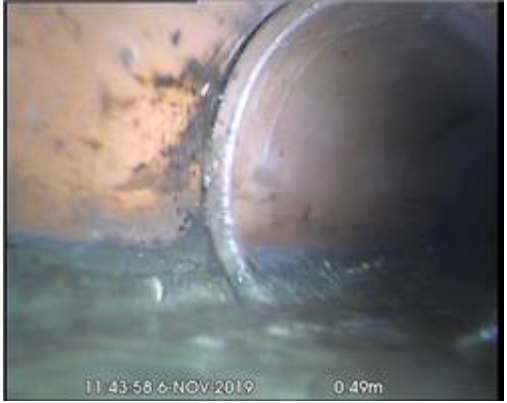
| Position | Code | Description | CD | Pic | Video Ref | |
|---|---|---|---|---|---|--|
| 00.49m | OJM | Open joint medium | | 1_2 | 0:00:21 | |

| Pos | Video Ref | Code | Description | Image |
|---|---|---|---|---|
| 00.49m | 0:00:21 | OJM | Open joint medium - Severity 3 | Image Provided - Ref: 1_2<br> |

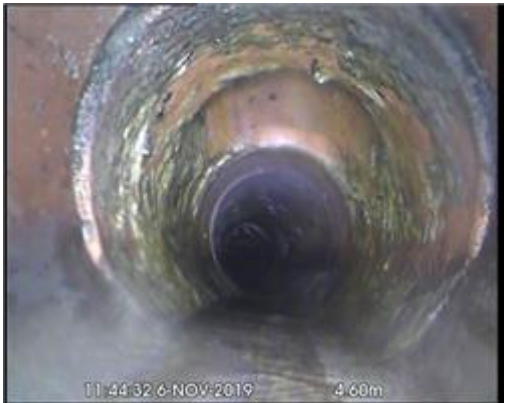
| Pos | Video Ref | Code | Description | Image |
|---|---|---|---|---|
| 04.60m | 0:00:55 | JN | Junction at 12 o'clock: 100mm Diameter | Image Provided - Ref: 1_3<br> |

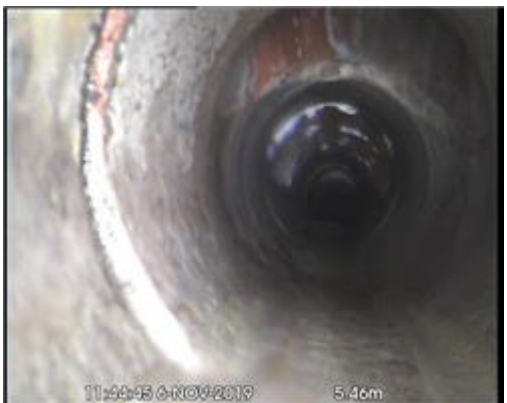
| Pos | Video Ref | Code | Description | Image |
|---|---|---|---|---|
| 05.46m | 0:01:08 | JN | Junction at 12 o'clock: 100mm Diameter | Image Provided - Ref: 1_4<br> |

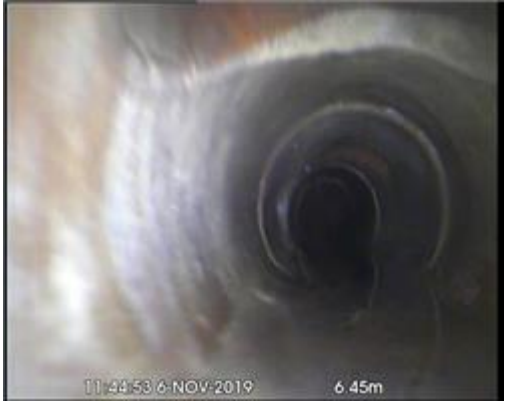
| Pos | Video Ref | Code | Description | Image |
|---|---|---|---|---|
| 06.45m | 0:01:16 | JN | Junction at 12 o'clock: 100mm Diameter | Image Provided - Ref: 1_5<br> |

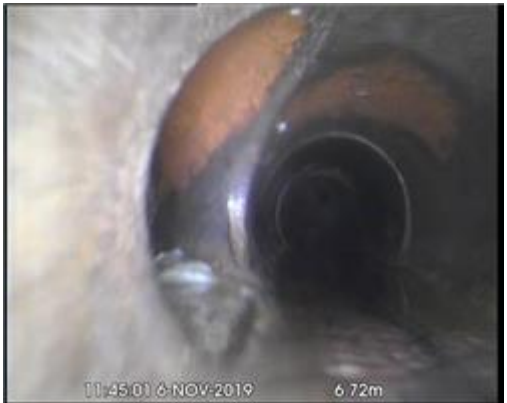
| Pos | Video Ref | Code | Description | Image |
|---|---|---|---|---|
| 06.72m | 0:01:24 | JN | Junction at 09 o'clock: 100mm Diameter | Image Provided - Ref: 1_6<br> |

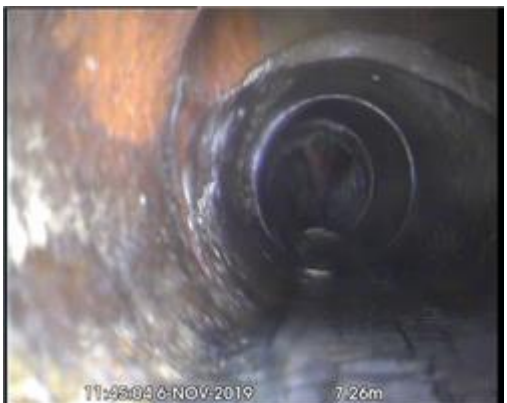
| Pos | Video Ref | Code | Description | Image |
|---|---|---|---|---|
| 07.26m | 0:01:27 | JN | Junction at 12 o'clock: 100mm Diameter | Image Provided - Ref: 1_7<br> |

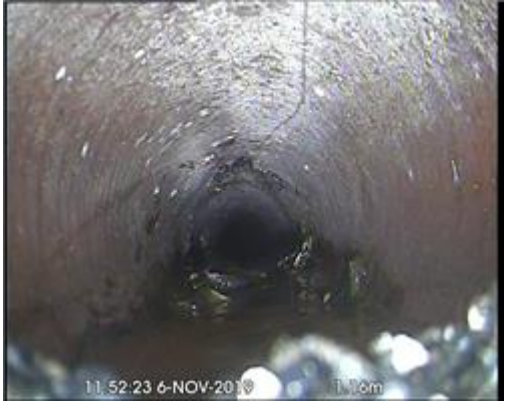
| Position | Code | Description | CD | Pic | Video Ref | |
|---|---|---|---|---|---|--|
| 01.16m | CL | Crack, longitudinal 12 | | 2_2 | 0:00:22 | |

| Pos | Video Ref | Code | Description | Image |
|---|---|---|---|---|
| 01.16m | 0:00:22 | CL | Crack, longitudinal at 12 o'clock - Severity 1 | Image Provided - Ref: 2_2<br> |

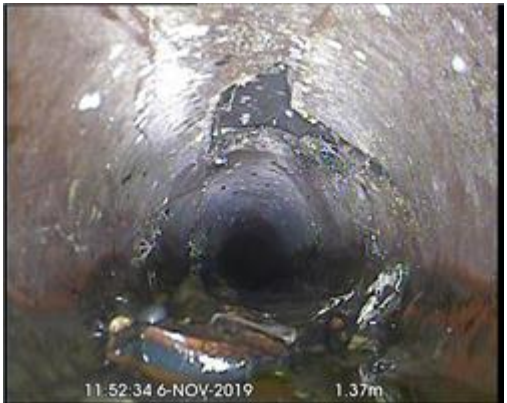
| Position | Code | Description | CD | Pic | Video Ref | |
|---|---|---|---|---|---|--|
| 01.37m | H | Hole in drain/sewer 12 | | 2_3 | 0:00:33 | |

| Pos | Video Ref | Code | Description | Image |
|---|---|---|---|---|
| 01.37m | 0:00:33 | H | Hole in drain/sewer at 12 o'clock - Severity 4 | Image Provided - Ref: 2_3<br> |

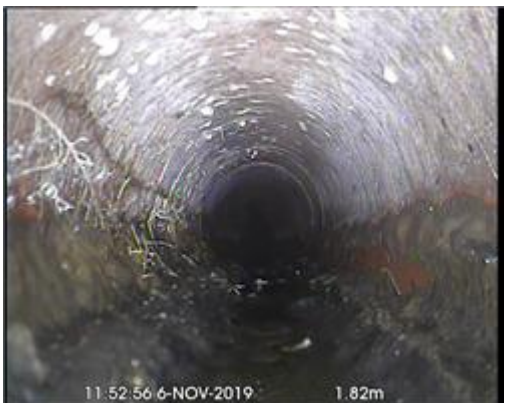
| Position | Code | Description | CD | Pic | Video Ref | |
|---|---|---|---|---|---|--|
| 01.82m | R | Roots | | 2_4 | 0:00:55 | |

| Pos | Video Ref | Code | Description | Image |
|---|---|---|---|---|
| 01.82m | 0:00:55 | R | Roots - Severity 3 | Image Provided - Ref: 2_4<br> |

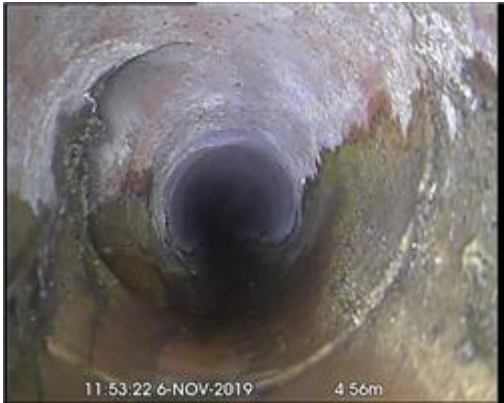
| Pos | Video Ref | Code | Description | Image |
|---|---|---|---|---|
| 04.56m | 0:01:20 | JN | Junction at 09 o'clock: 100mm Diameter<br>root ingress from junction | <p>Image Provided - Ref: 2_5</p> |

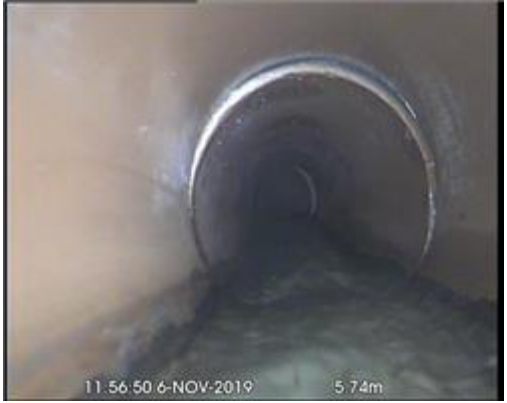
| Position | Code | Description | CD | Pic | Video Ref |
|---|---|---|---|---|---|
| 05.74m | JDM | Joint displaced medium | | 3_2 | 0:00:46 |

| Pos | Video Ref | Code | Description | Image |
|---|---|---|---|---|
| 05.74m | 0:00:46 | JDM | Joint displaced medium - Severity 3 | <p>Image Provided - Ref: 3_2</p> |

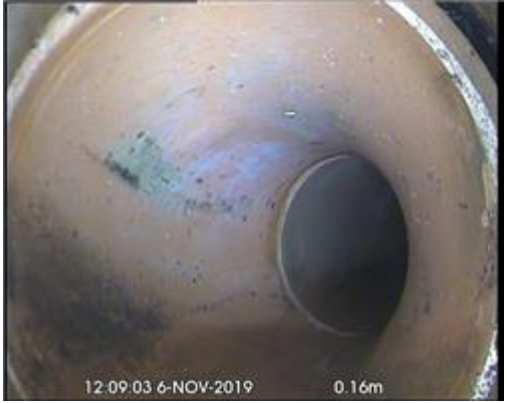
| Position | Code | Description | CD | Pic | Video Ref | |
|---|---|---|---|---|---|--|
| 00.16m | OJM | Open joint medium | | 4_2 | 0:00:12 | |

| Pos | Video Ref | Code | Description | Image |
|---|---|---|---|---|
| 00.16m | 0:00:12 | OJM | Open joint medium - Severity 3 | Image Provided - Ref: 4_2<br> |

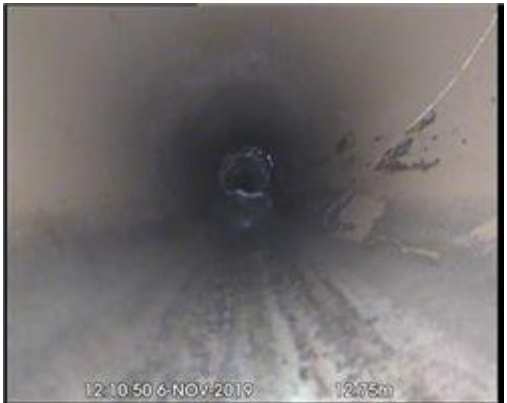
| Position | Code | Description | CD | Pic | Video Ref | |
|---|---|---|---|---|---|--|
| 12.75m | CL | Crack, longitudinal 03 | | 4_3 | 0:01:59 | |

| Pos | Video Ref | Code | Description | Image |
|---|---|---|---|---|
| 12.75m | 0:01:59 | CL | Crack, longitudinal at 03 o'clock - Severity 1 | Image Provided - Ref: 4_3<br> |

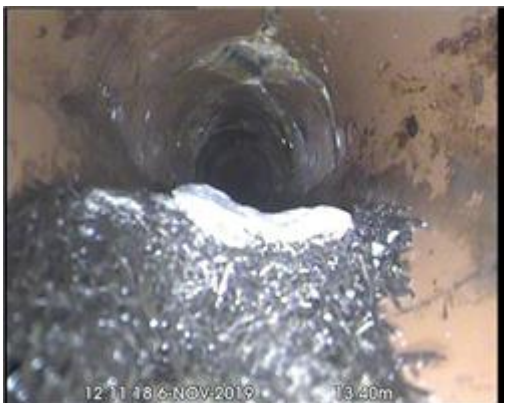
| Position | Code | Description | CD | Pic | Video Ref | |
|---|---|---|---|---|---|--|
| 13.40m | H | Hole in drain/sewer 12 | | 4_4 | 0:02:27 | |

| Pos | Video Ref | Code | Description | Image |
|---|---|---|---|---|
| 13.40m | 0:02:27 | H | Hole in drain/sewer at 12 o'clock - Severity 4<br>root ingress present at this point | Image Provided - Ref: 4_4<br> |

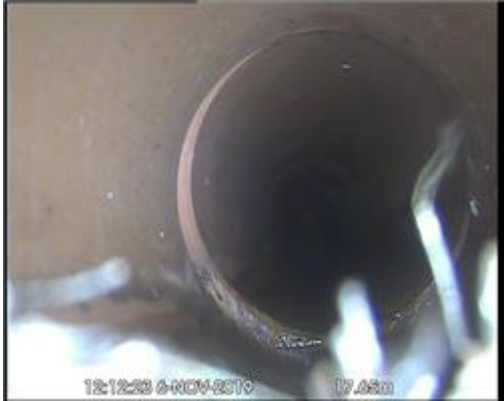
| Position | Code | Description | CD | Pic | Video Ref | |
|---|---|---|---|---|---|--|
| 17.65m | JDM | Joint displaced medium | | 4_5 | 0:03:32 | |

| Pos | Video Ref | Code | Description | Image |
|---|---|---|---|---|
| 17.65m | 0:03:32 | JDM | Joint displaced medium - Severity 3 | Image Provided - Ref: 4_5<br> |

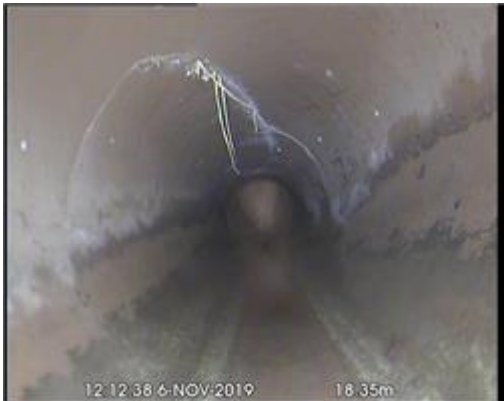
| Position | Code | Description | CD | Pic | Video Ref | |
|---|---|---|---|---|---|--|
| 18.35m | CL | Crack, longitudinal 12 | | 4_6 | 0:03:47 | |

| Pos | Video Ref | Code | Description | Image |
|---|---|---|---|---|
| 18.35m | 0:03:47 | CL | Crack, longitudinal at 12 o'clock - Severity 1 | Image Provided - Ref: 4_6<br> |
