**Tree Report**  
**200 Seafront, Hayling Island**

**1.1 Test date:** 21st April 2020 by Mr. Kim Gifford, undertaken in the area of test and at the time of inspection.

**1.6 Holm Oak (Quercus ilex) front garden 200 Seafront, Hayling.**  
**Test undertaken in fine weather conditions.**

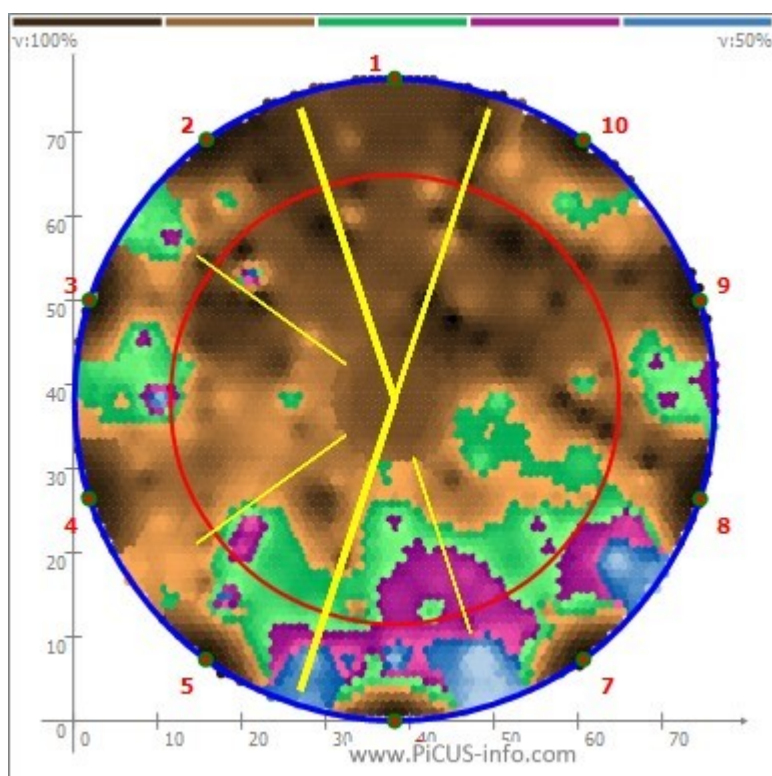
**Test 1 @ level: 30cms approximately from ground level.**

The measuring point readings give evidence of medium sound velocities overall in the area of test representation showing as altered timber. The tomographic image shown above has a percentage amount of altered/ decayed timber (detailed on the top graph bar of the image). With reference to the 'colour chart see figure 2', the slower sonic speed of sound is represented by three bands of data representation blue/violet/white being the slowest altered/decayed timber, green being faster not altered timber, brown being fast sonic-speeds solid timber.

The yellow lines are indicators of possible internal cracking or splitting timber in the area of test.

The resulting Holm Oak Picus test of acceptable limits in relation the remaining timber. This ratio called a 'trunk ratio' TR (*reference Claus Mattheck*) has been calculated to be a guideline in terms of stability and rigidity of cylindrical structure. Although a debated theory in arboriculture in general terms the TR of 30% is an average.

**The existing crown needs to be severely cut back from the footpath and the overextended branches reduced on the northeast side. The Picus testing shows the stressed areas in the trunk at 30cms from ground level.**

**It is appropriate to recommend that the Holm Oak is removed entirely and mitigated with a new semimature transplant. I would recommend a Fastigate Oak (Quercus robur Fastigate).**

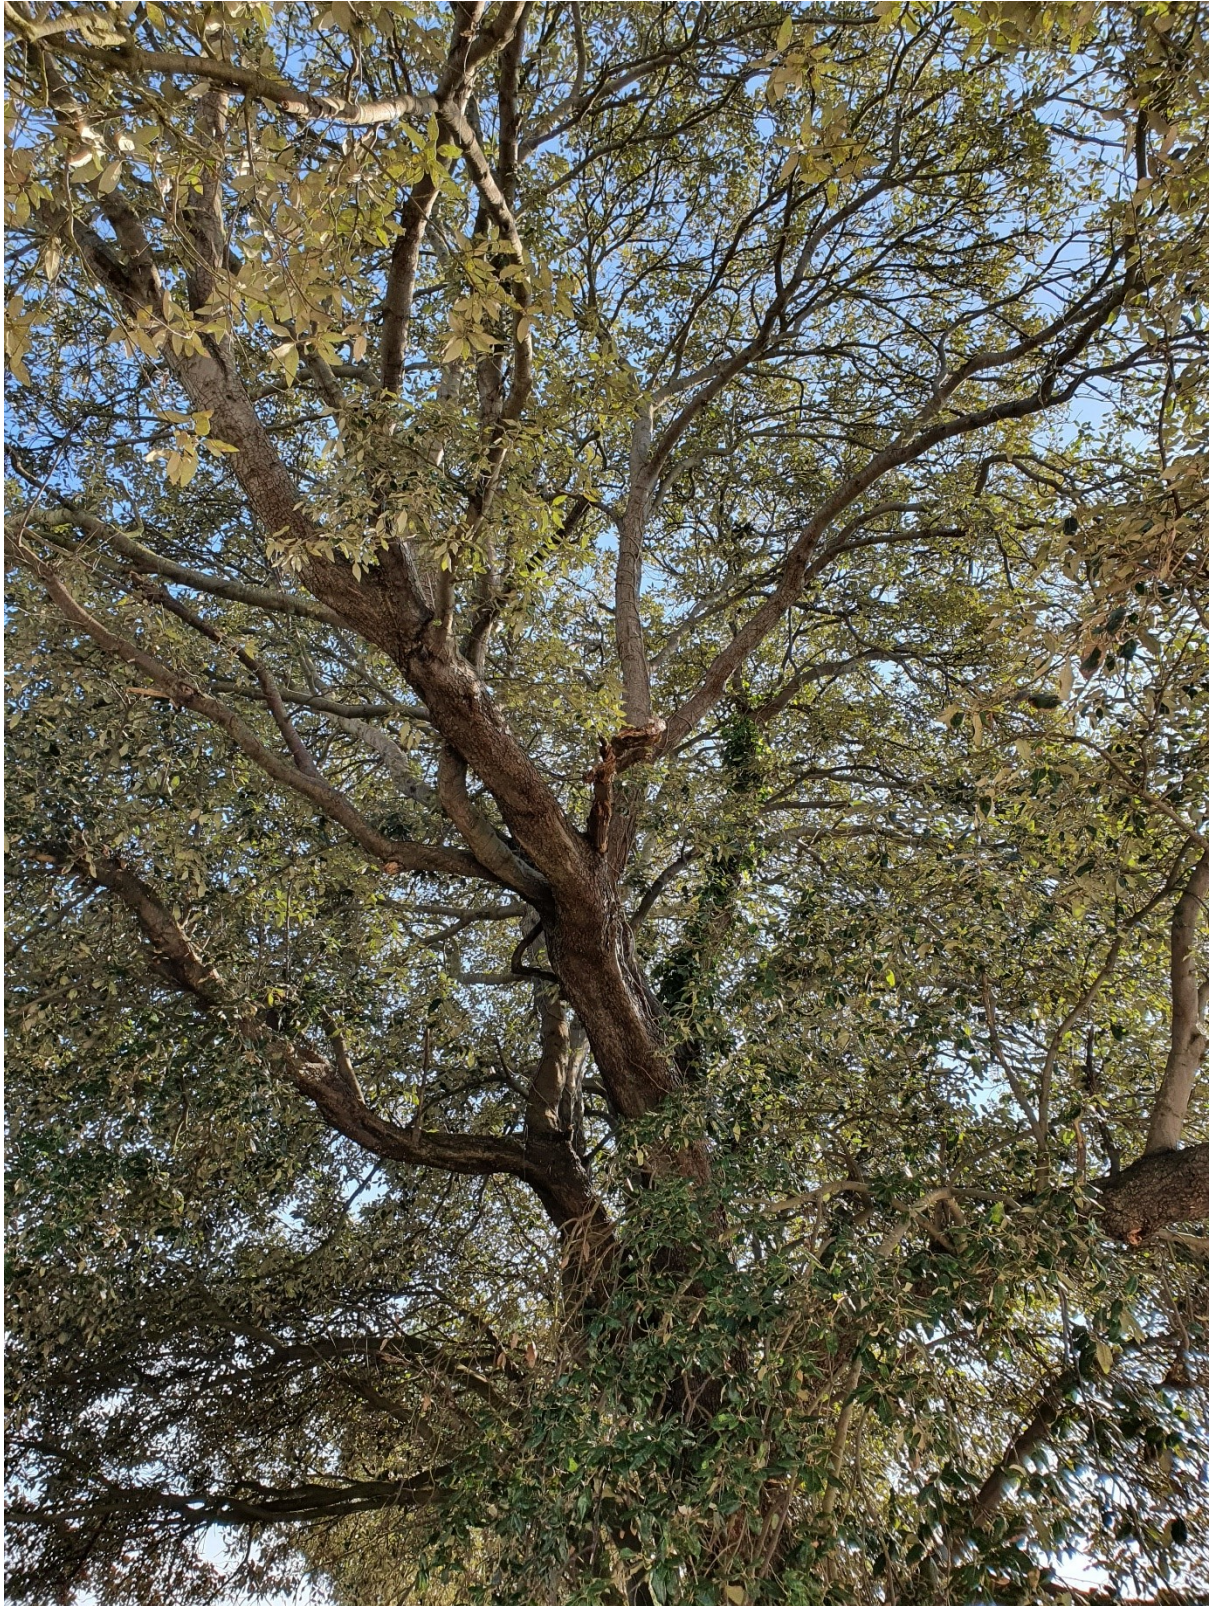
*Figure Holm Oak Crown*

**General description:** Wind shaped crown form leaning predominately from the south west winds on the seafront. Evidence of previous severe 'topping' of major leader and lateral branches in the distant past. Low limbs on the roadside cut back and regrown over the footpath with poor branch attachments.

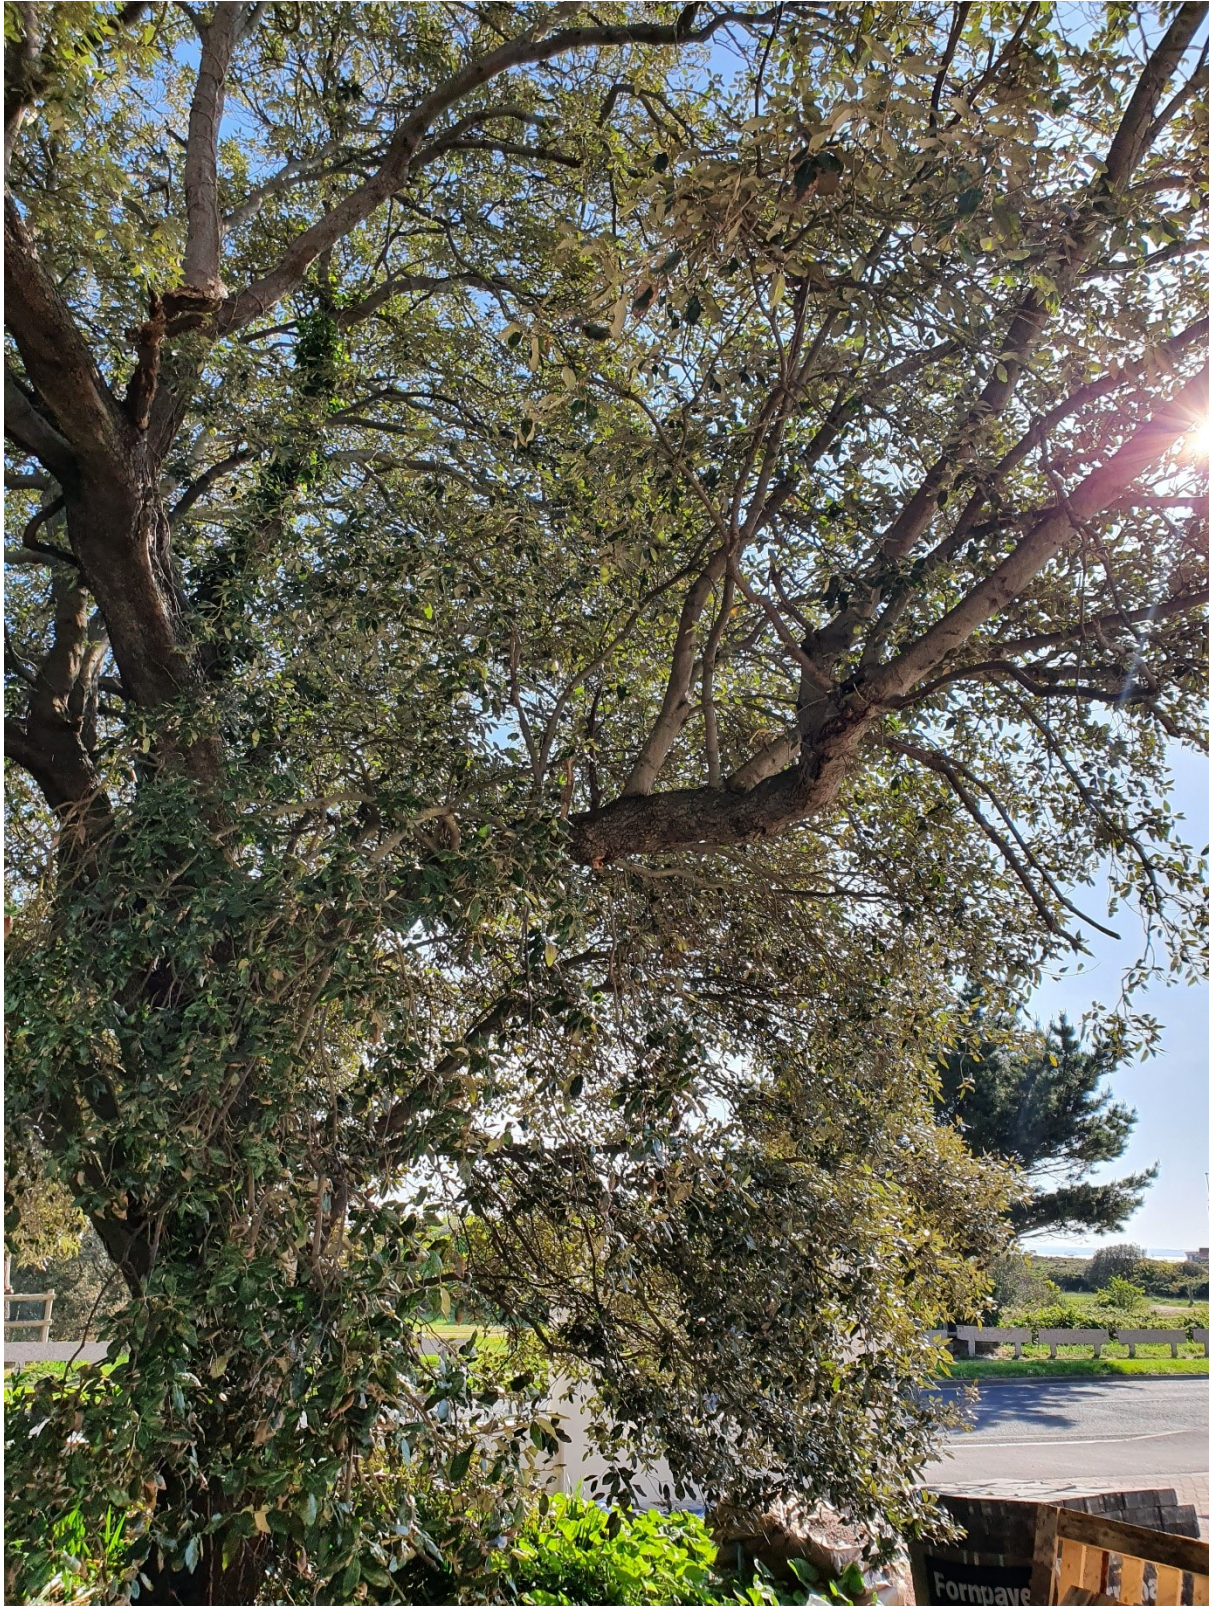
**Upper Crown:** occluding wounds evidence of spiral twisting and wind torsion wounds. Long overextended branches on the north east side.

*Figure Overextended branches*

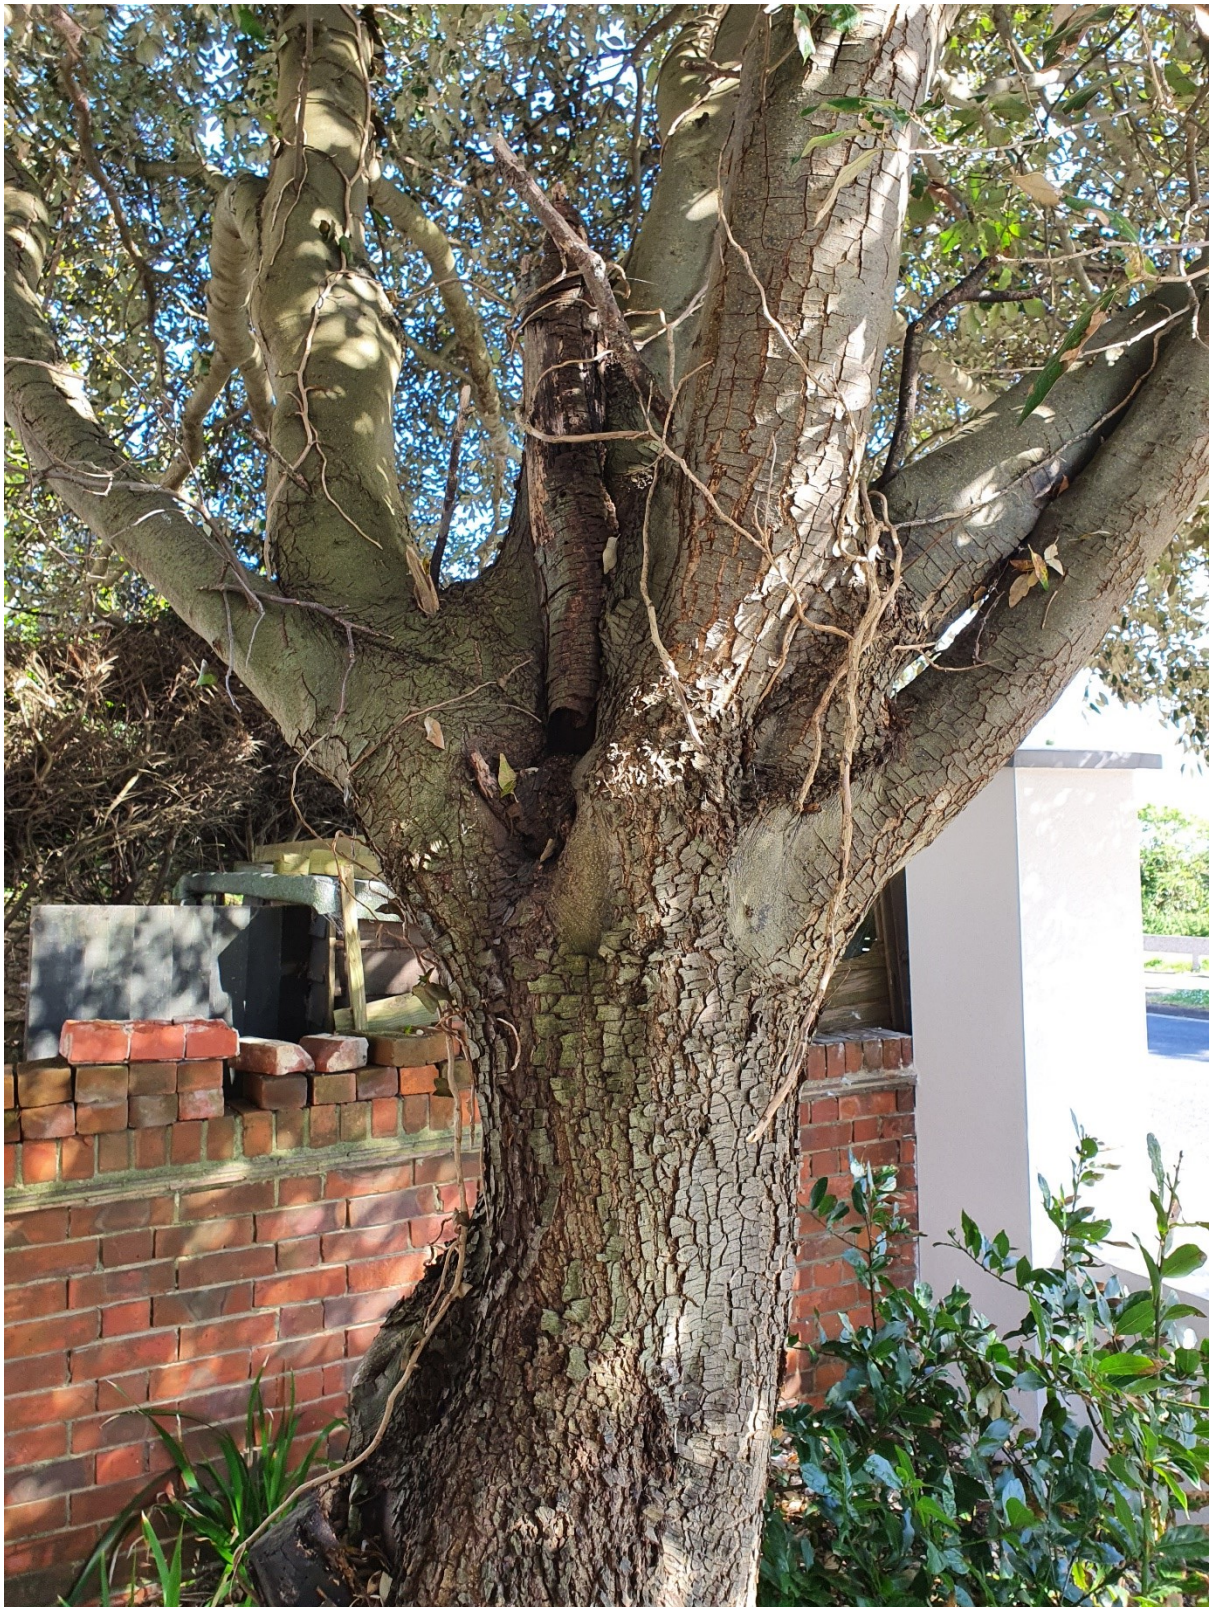
**Trunk condition:** main union, occlusions on stem occluding and occluded poor pruning wounds from old cuts/dead limbs throughout. Many old wounds close together from regular cutting back and branch removal.

*Figure main unions poor attachments*
