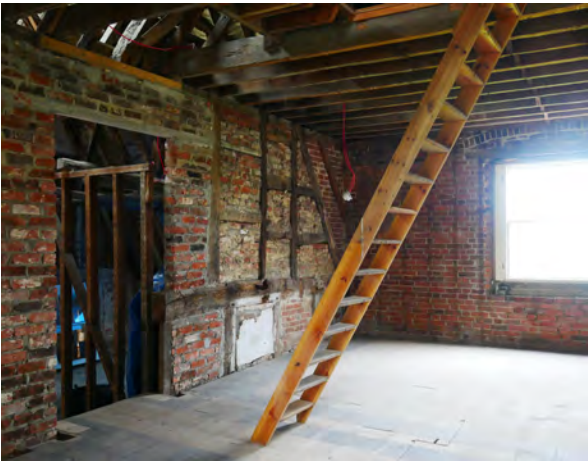
68. Victorian southern cross-wing. The NE corner of room shows the original external southern wall of the three-bay building. The original end wallplate has been served losing the west side. Evidence of a former windows. Brick infills not maintained properly. Evidence of 2 stages of change to the roof.

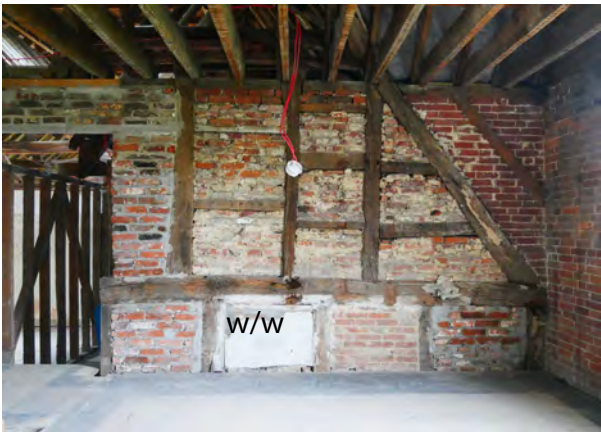
69. View of southern end bay

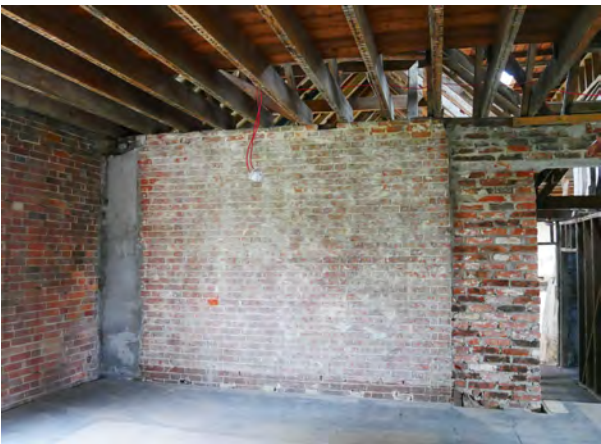
70. FF6 north wall, built after FF5. The rafters are of the Victorian period and a late construction.

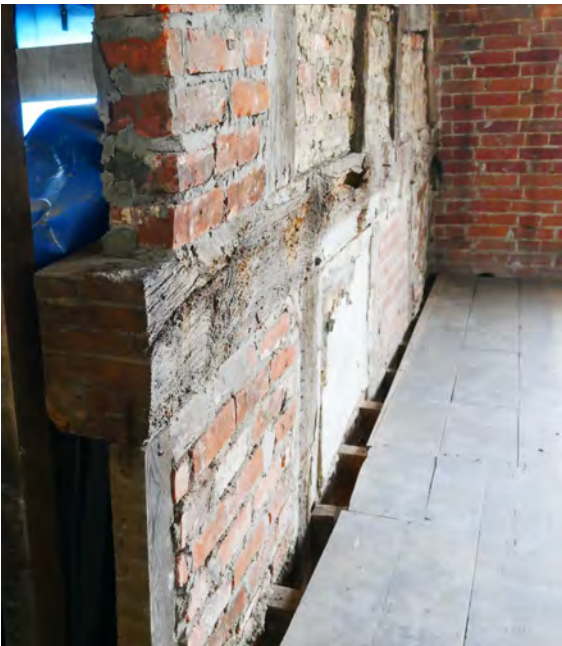
71. Truncated end wallplate for new opening. Infill panels would have had wattle and daub but have been replaced with brick.

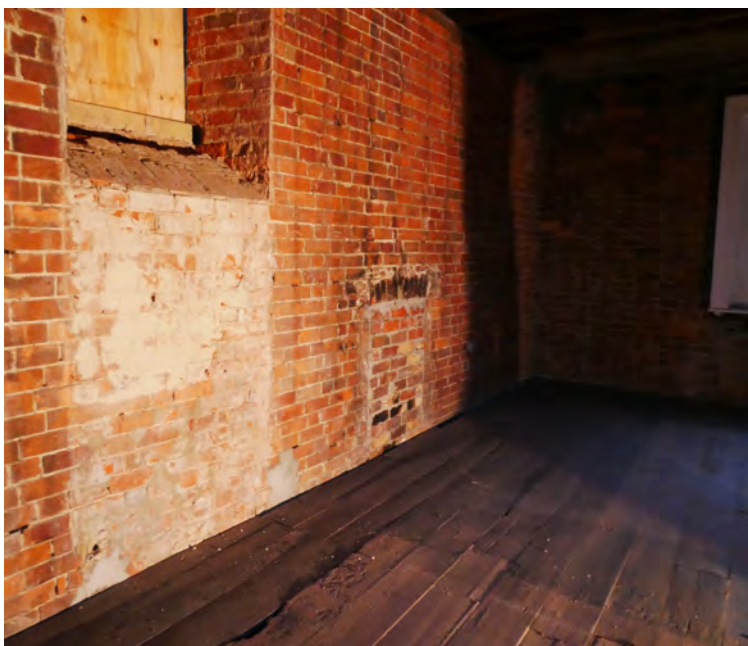
72. South wall with small window to east of former fireplace.

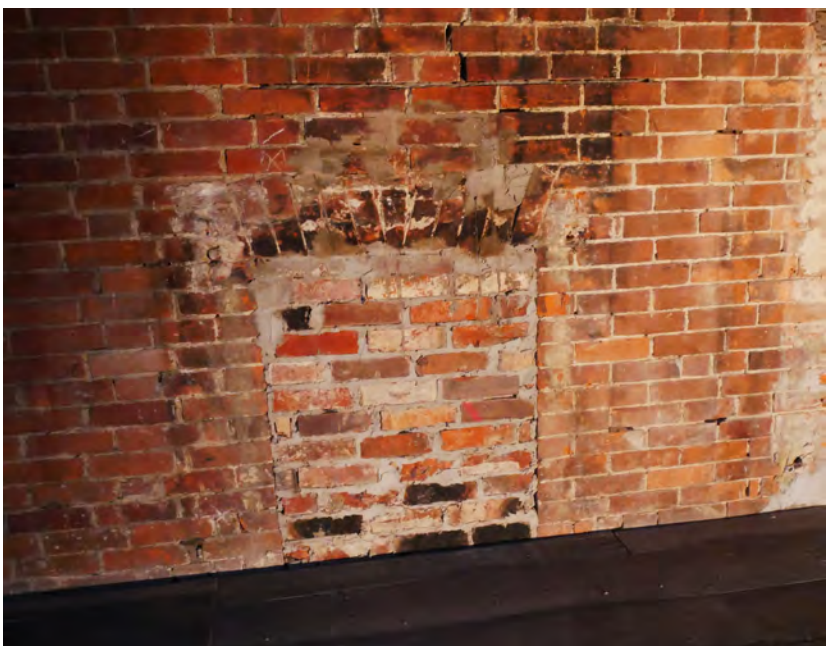
73. Cental fireplace indicates that this space was originally one room.

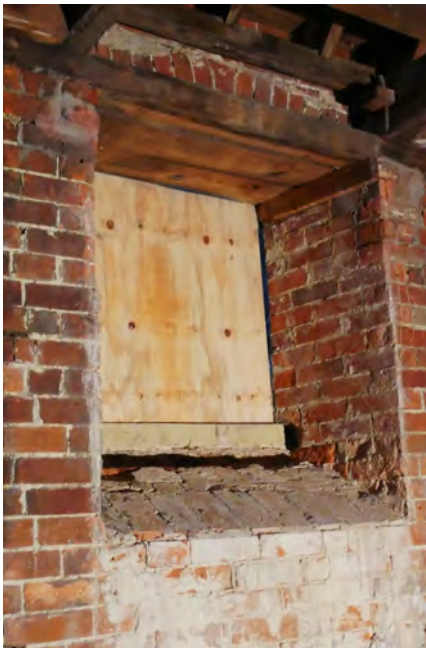
74. Small window to south gable of Victorian cross-wing.

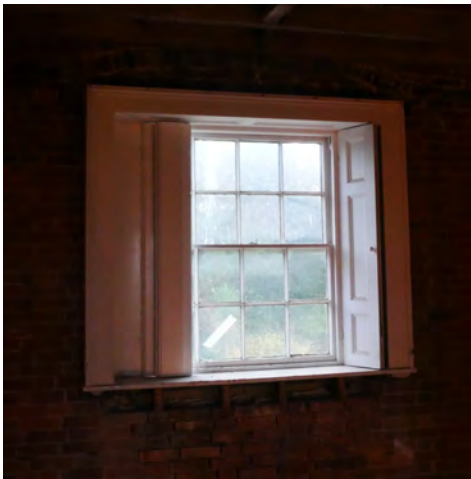
75. Original west facing window with shutters.
