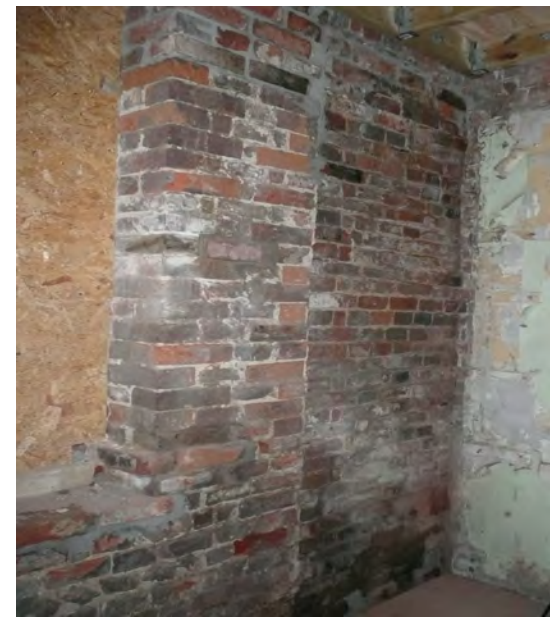
25. SW corner of G11, previously a wc. This was an extension to the north of the main entrance and west of central bay. The floor was been lowered in the past, revealing the cambered arch to the basement. The ceiling had been lower, cutting across the main windows. Now raised. Evidence of a former bay window can be said, a door at half landing height and a later small window.

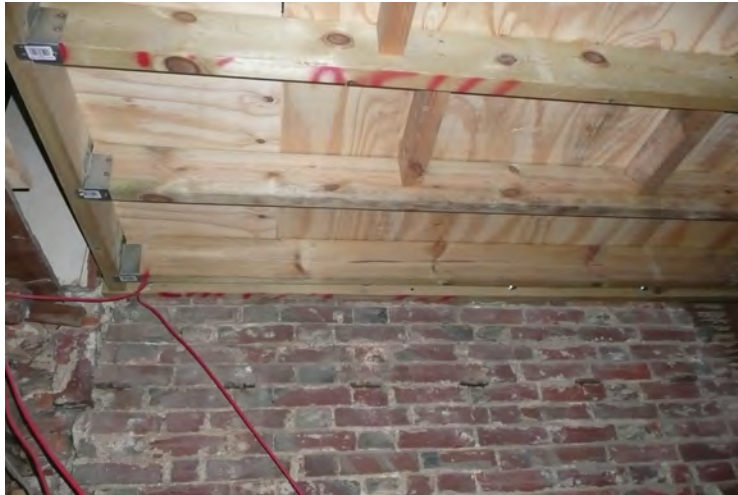
26. NW corner of G12. Previously partitioned off G11 as a utility room. Evidence of a former bay window clearly noted. Plaster had been applied direct to brickwork.

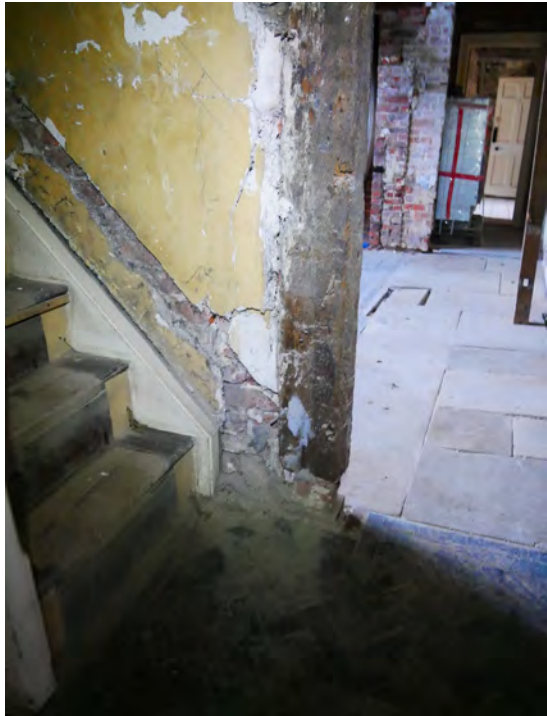
27. New floor inserted at higher level. Accepted that reversal would be harmful to historic fabric.

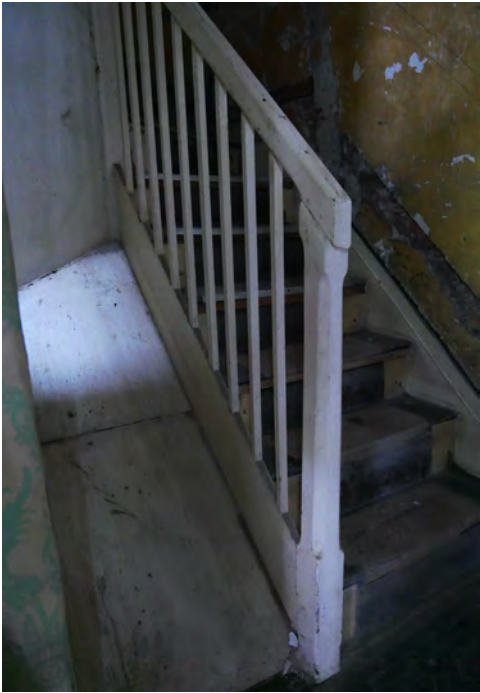
28.Edge of G13 Stair with post to door leading into G10. Evidence of wattle and daub to rear of wall of G9. The base post has eroded at the base requiring brick underbuilding.

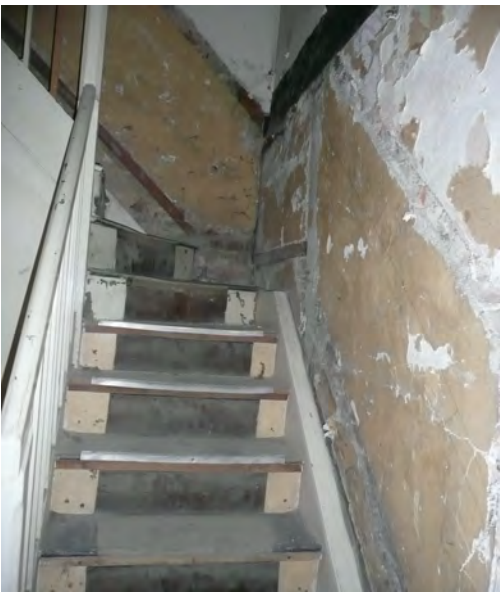
29. Newel Post, baluster and spindels of staircase, late Victorian.
