BASEMENT PHOTOGRAPHS

| <div>Check all dimensions on site prior to commencement of work.<br/>Do not scale from this drawing except for planning purposes.</div> <div>This drawing is the © copyright of<br/><b>Jane Jones-Warner Associates</b></div> <div>This drawing has been produced for [Client Name] for the project [Project Name] and is submitted as part of the [Project Workstage] and is not intended for use by any other person or for any other purpose.</div> | Revisions | | | | <div><b>JANE JONES-WARNER ASSOCIATES</b></div> <div>Unit 78<br/>Chichester Enterprise Centre<br/>Terminus Road<br/>Chichester<br/>West Sussex<br/>PO19 8TX</div> <div><div>T : 01243 767151<br/>E : mail@janejoneswarner.com<br/>W: www.janejoneswarner.com</div><div><b>RIBA</b> <br/>Chartered Practice</div></div> | Project:<br>Magnolia House, Havant | |
| | Rev | Description | Date | Drawn | | Drawing Title:<br>Photographs of Basement (5) | |
| | | | | | | Drawing No:<br>692/PL 812 | Revision:<br>- |

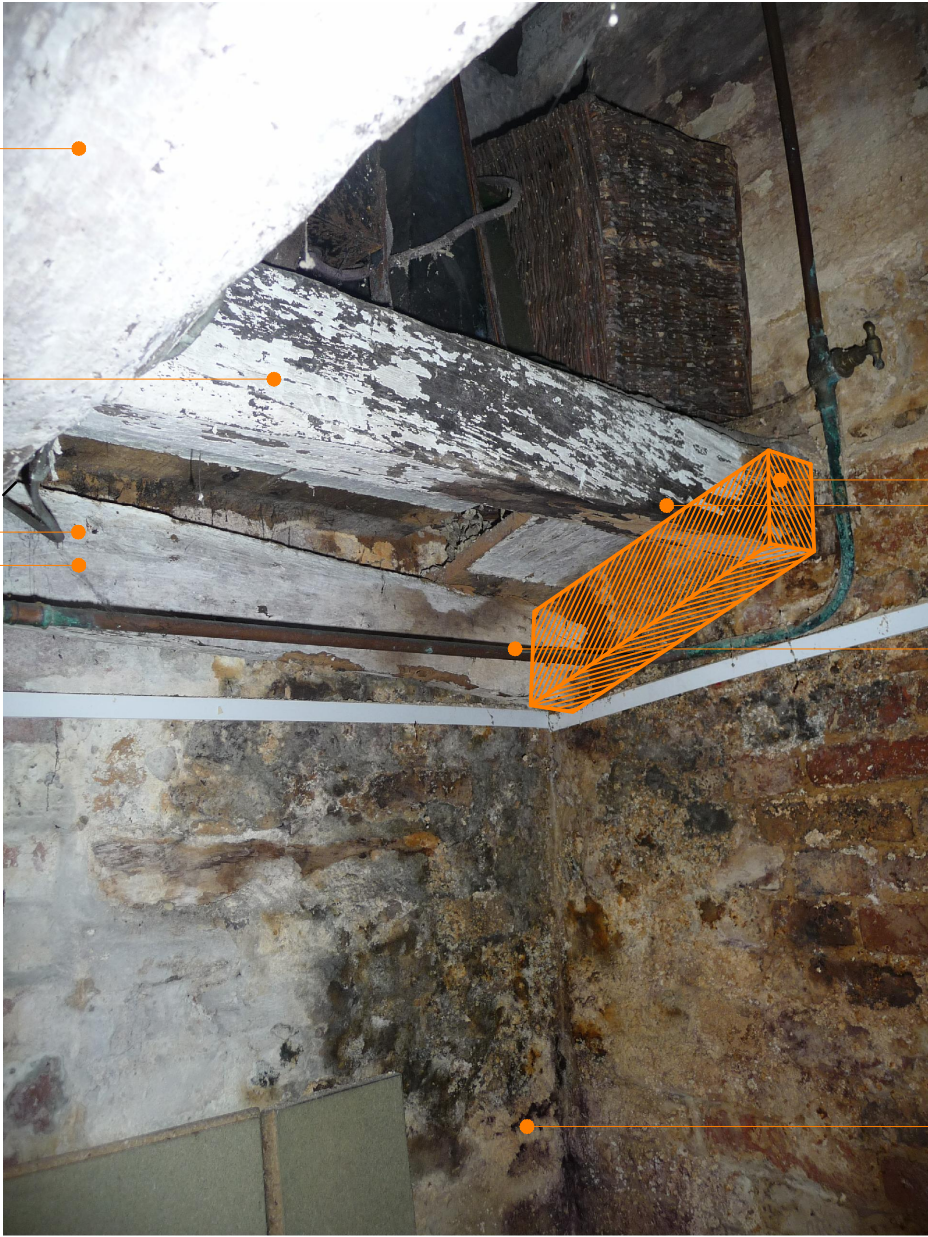
Note:  
Fragile immediately adjacent  
lathe and plaster ceiling to be  
secured with ply

Heavily decayed sections of  
timber removed and replaced

Note:  
Bottom winder of staircase is  
below this repair

Timber joist adjacent to wall  
to be wrapped in DPC

New timber wall  
plate to be wrapped  
with a DPC material

New joists hung from the  
new DPC wrapped wall plate  
bolted to the masonry in  
accordance with Structural  
Engineer's Detail F
