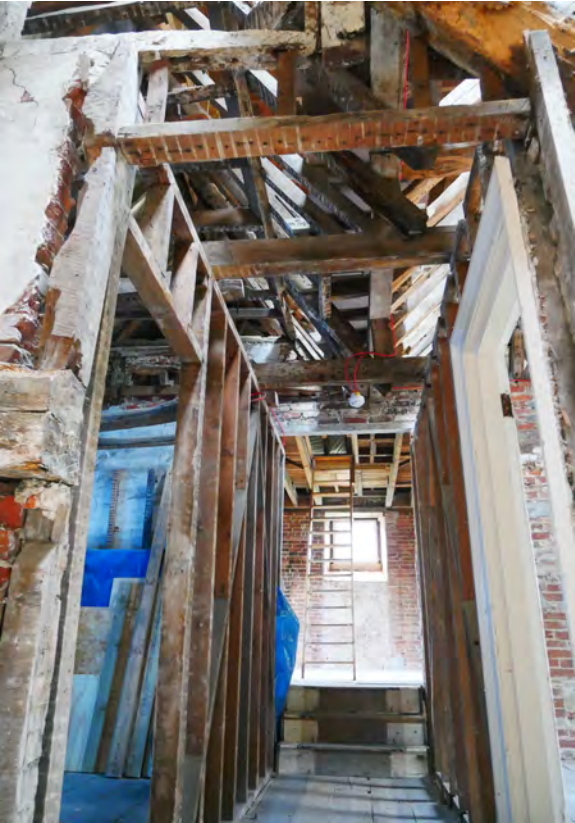
61. View from FF3 stair. This hall serves FF5, FF9 and leads to the later Victorian cross wing with attic above. Height floor to ceiling has been raised to 'fit' with the Victorian alterations.

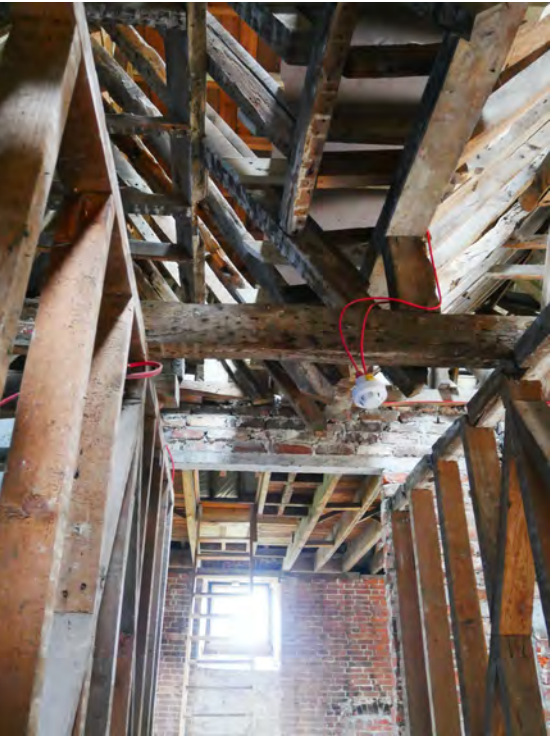
62. Valley between 2 roof above. Later partitions of each side.

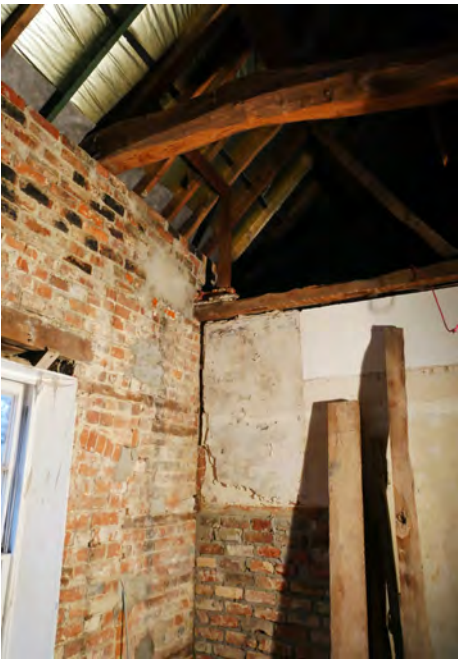
63. FF5 NW - Evidence of bay window. Note the outer west wall plate has been raised. The two walls do not match which indicates different builds.

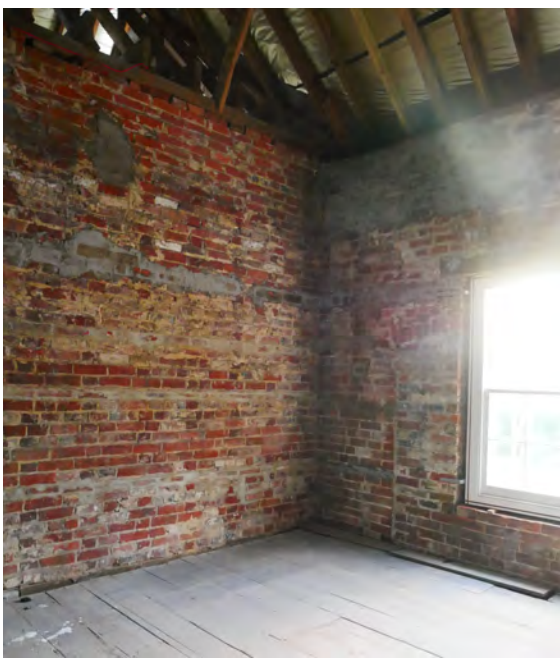
64. FF5 SW - Noteable mark/cambered brick lintel for a bay. Sth wall also shows signs of wall plate increase with later Victorian cross wing added. Evidence of old cement repairs.

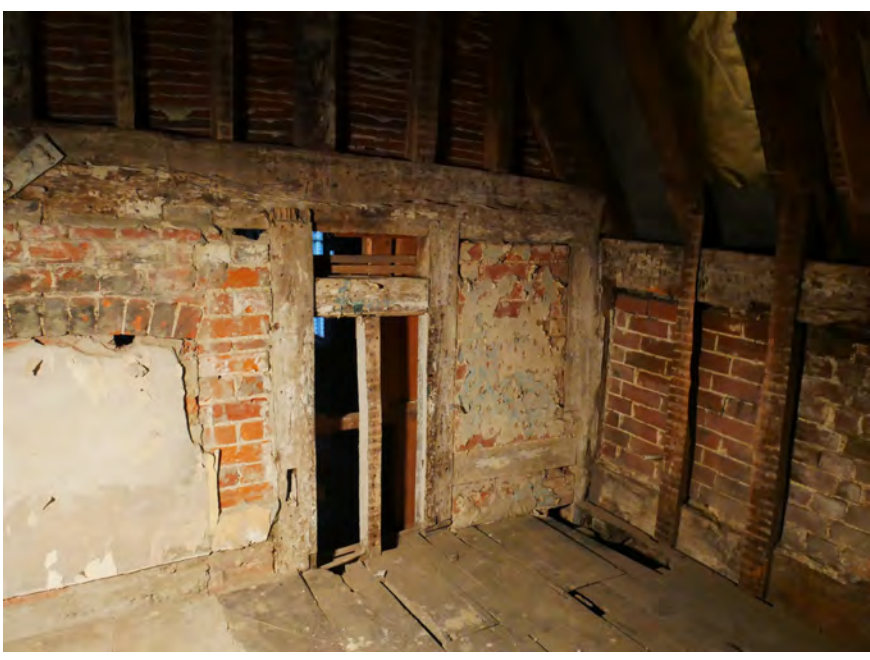
65. Nrtth & East inner walls -the south end chamber bay of the 3-bay post medieval house. The floor is notably raised. Cross beam and wall plate with jowl post to corner. Blocked up fire-place. The ceiling height had also been raised. This was covered over.

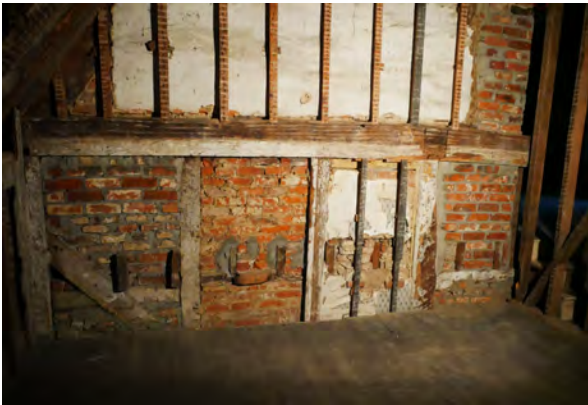
67. FF5 south. The joists of the 'new' floor can be clearly seen. End wall plate intact. Floor raised.

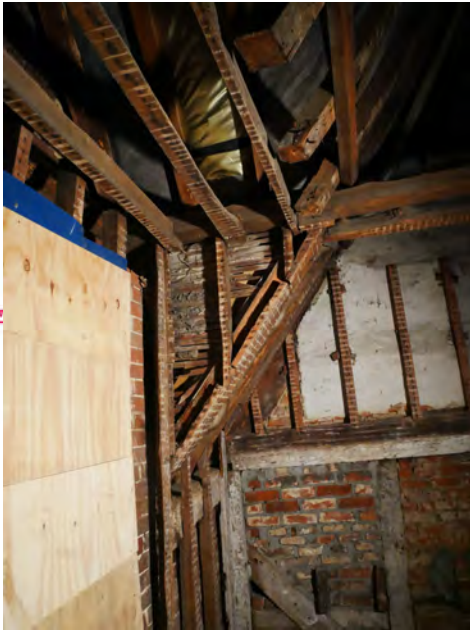
66. Raised wall. of a less substantial construction. Evidence of adaptations to roof incl. dormer introduced.
