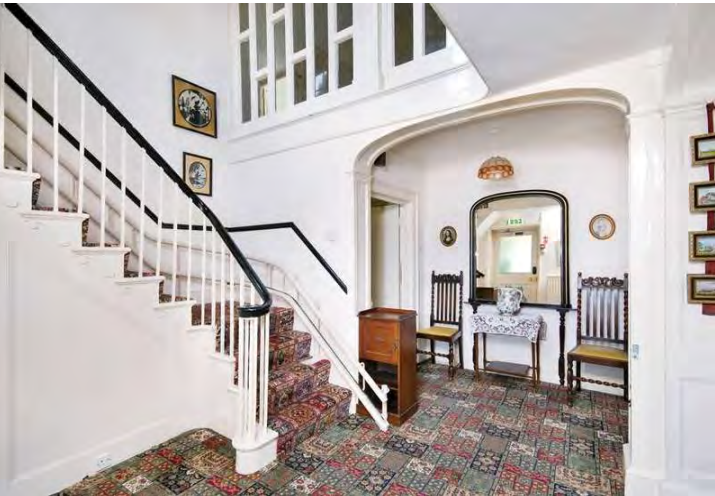
Before: Partial view to First Floor

Note the presence of a chair lift and handrail to inner wall.

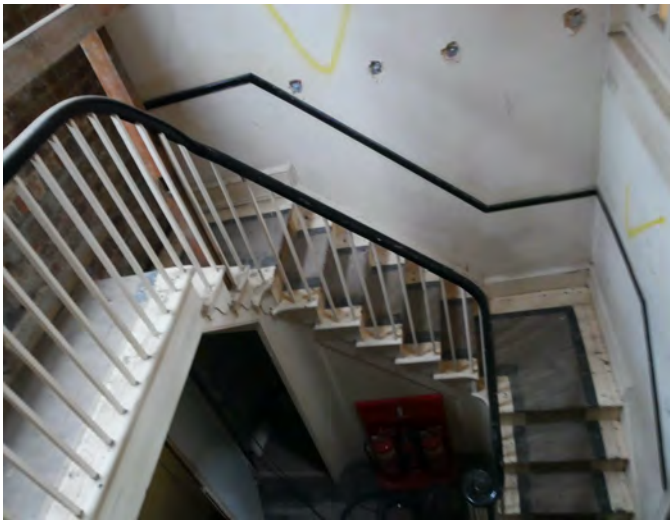
47. View of FF1 stairs and landings. The chair lift has been removed. Bolts noted through inner face of north wall. Note spindles are metal as the staircase has been altered.

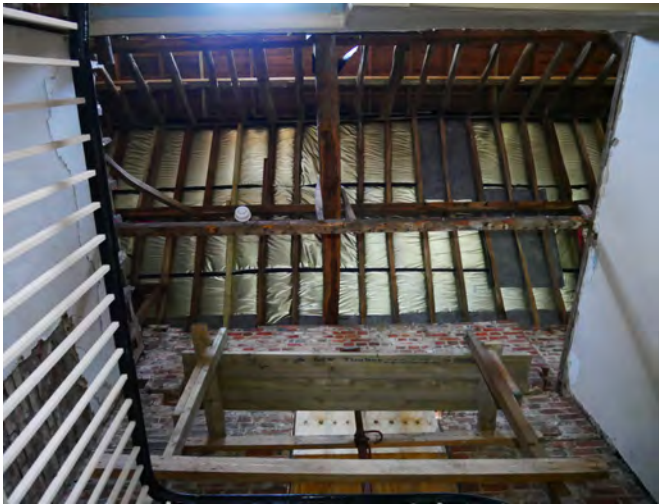
48. View up to underside of roof showing structure. The tie beam is pole stripped of bark, roughly shaped. The 'spine' is quite is lightweight and at the height of the former ceiling.

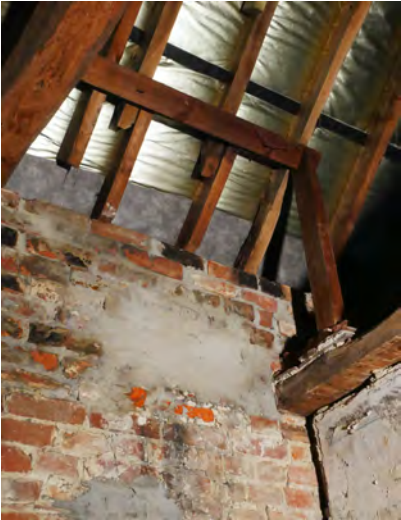
49. View of NW corner revealing parting of west face from inner north wall and raised height. Evidence of past cement repairs.

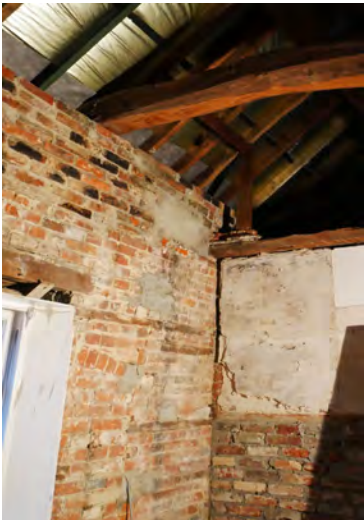
50. Similar view showing the blocked up door to FF12 and the cambered brick arch to former bay window. Again raised height evident.

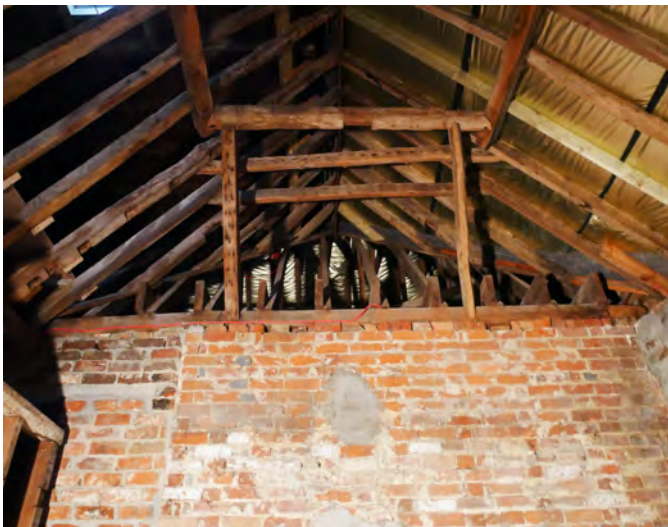
51. South inner elevation - wall plate to central chamber of 3-bay timber framed building noted with two extended areas of brickwork suggesting two phases of change and raised ceiling heights corresponding with raised floor heights to southern rooms. Note the nature of the Queen Post roof to FF5. Note the roof to the south differs over FF12 /13

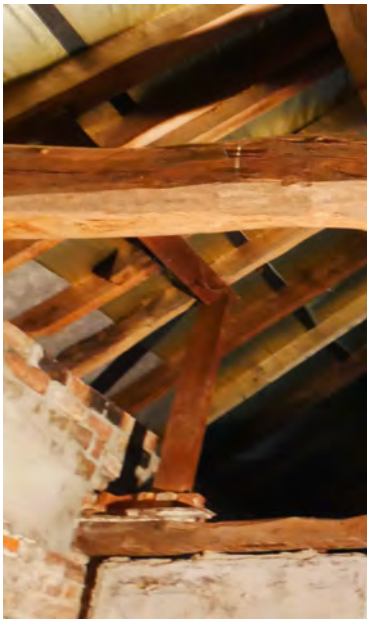
52. Later interventions to roof over wall between FF1 & FF12
