## Project-information / Inspection: 1

Project name :  
**PTA Havant Survey 2**

Date :  
**17/10/2019**

Site: **Pre Development**  
Contact Name:  
Department:  
Road: **New Lane**  
Town: **Havant**  
County: **Hampshire**  
Telephone:  
Fax:  
Mobile:  
E-mail:

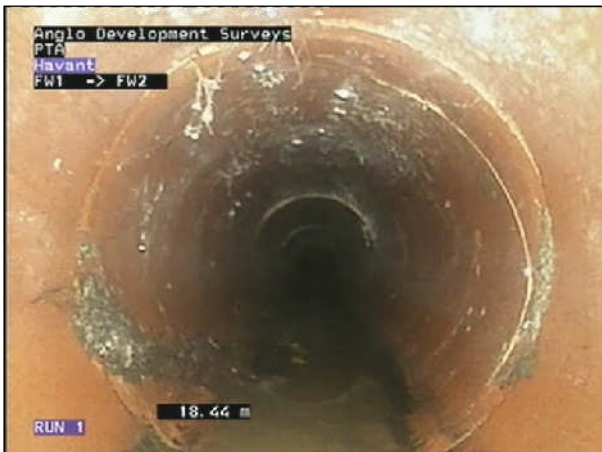
Photo: 1\_1\_5\_A.JPG  
18.4m, Crack, circumferential at joint, from 9 to 4 o'clock

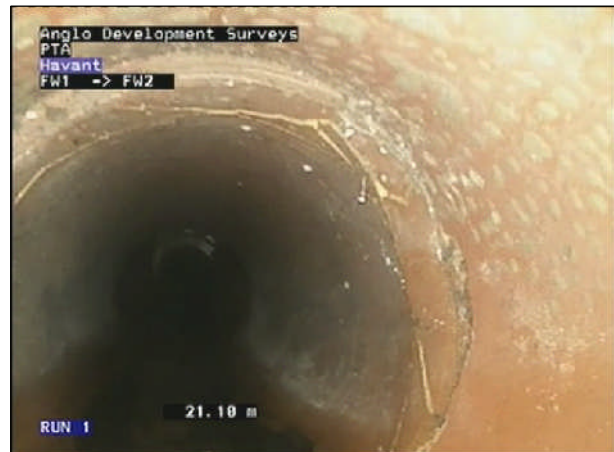
Photo: 1\_1\_7\_A.JPG  
21.1m, Cracks, multiple at joint, from 12 to 12 o'clock

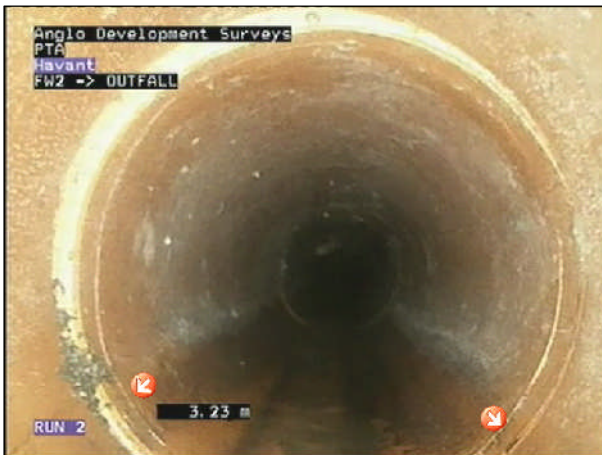
| 1:75 Position<br>Depth: 1.54 | Code | Observation | Grade |
|---|---|---|---|
| | <b>CCJ</b> | Crack, circumferential at joint, from 12 to 12 o'clock | (Struct) 2 |

Photo: 3\_3\_11\_A.JPG  
3.2m, Crack, circumferential at joint, from 12 to 12 o'clock

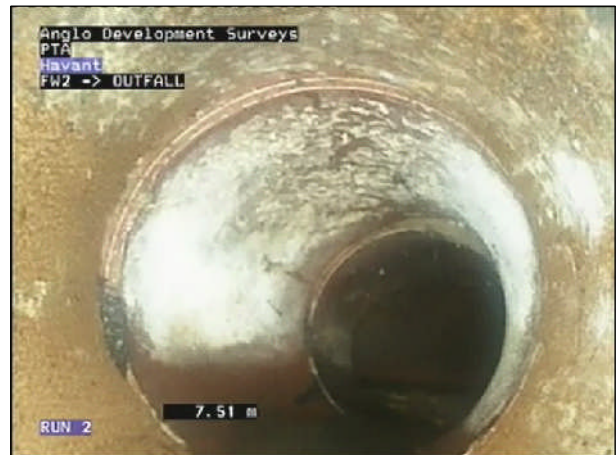
Photo: 3\_3\_12\_A.JPG  
7.5m, Line deviates right

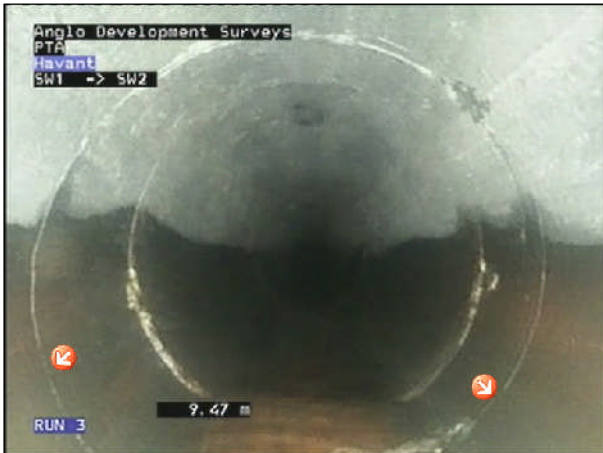
| 1:105<br>Depth: 1 | Position | Code | Observation | Grade |
|---|---|---|---|---|
| 9.40 | CC | | Crack, circumferential, from 12 to 12 o'clock | (Struct) 2 |

Photo: 4\_4\_18\_A.JPG  
9.4m, Crack, circumferential, from 12 to 12 o'clock

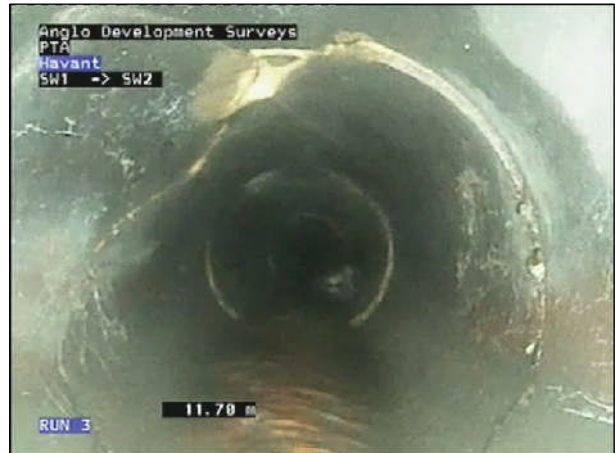
| 1:105<br>Depth: 1 | Position | Code | Observation | Grade |
|---|---|---|---|---|
| 11.70 S01 | B | | Broken pipe, from 12 to 12 o'clock, Start | (Struct) 4 |
| 13.00 F01 | B | | Broken pipe, from 12 to 12 o'clock, End | (Struct) 4 |

Photo: 4\_4\_19\_A.JPG  
11.7m, Broken pipe, from 12 to 12 o'clock, Start

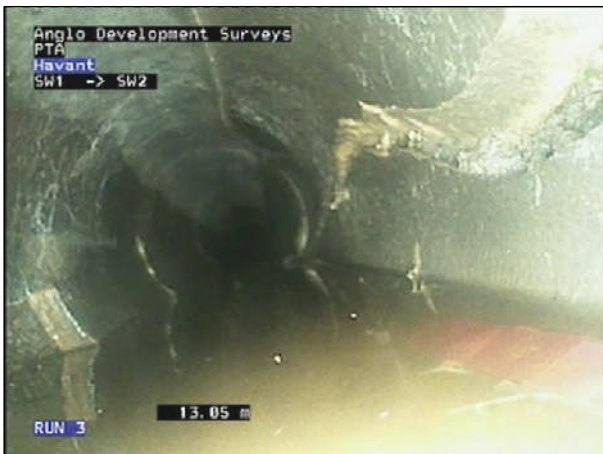
| 1:105<br>Depth: 1 | Position | Code | Observation | Grade |
|---|---|---|---|---|
| 13.00 | SA | | Survey abandoned Remarks: Camera will not pass deformed pipe | (Misc) 0 |

Photo: 4\_4\_21\_A.JPG  
13m, Survey abandoned

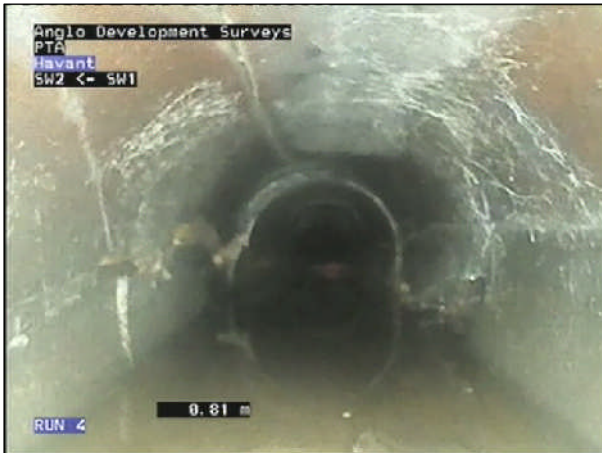
| 1:50<br>Depth: 8.75 | Position | Code | Observation | Grade |
|---|---|---|---|---|
| | | S01 | Broken pipe, from 12 to 12 o'clock, Start | (Struct) 4 |
| | | SA | Survey abandoned Remarks: Camera will not pass | (Misc) 0 |

Photo: 5\_5\_24\_A.JPG  
0.8m, Broken pipe, from 12 to 12 o'clock, Start

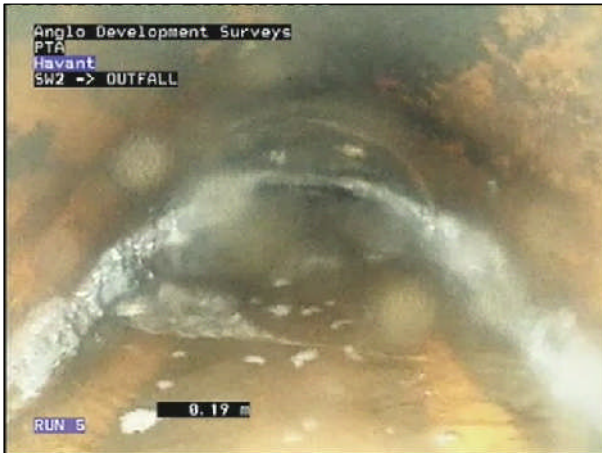
| 1:50<br>Depth: 0.88 | Position | Code | Observation | Grade |
|---|---|---|---|---|
| | 0.20 | WL | Water level, 50% of the vertical dimension | (Serv) 0 |

Photo: 6\_6\_29\_A.JPG  
0.2m, Water level, 50% of the vertical dimension

Sw2 to Outfall under water due to Ditch outlet fully charged due to heavy rain

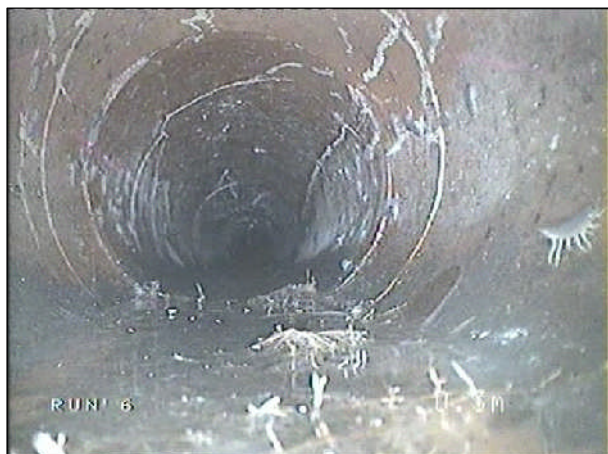
| 1:60<br>Depth: 0.98 | Position | Code | Observation | Grade | |
|---|---|---|---|---|---|
| 0.30 | S01 | FM | Fracture, multiple, from 12 to 12 o'clock, Start | (Struct) 4 | |
| 0.30 | S02 | RM | Roots, mass, 10% cross-sectional area loss, Start | (Serv) 3 | 6.8 m |

Photo: 7\_7\_35\_A.JPG  
0.3m, Fracture, multiple, from 12 to 12 o'clock, Start

Sw3 to Outfall will require remedial lining if to be utilised for future development , a budget of £1877+vat should be applied

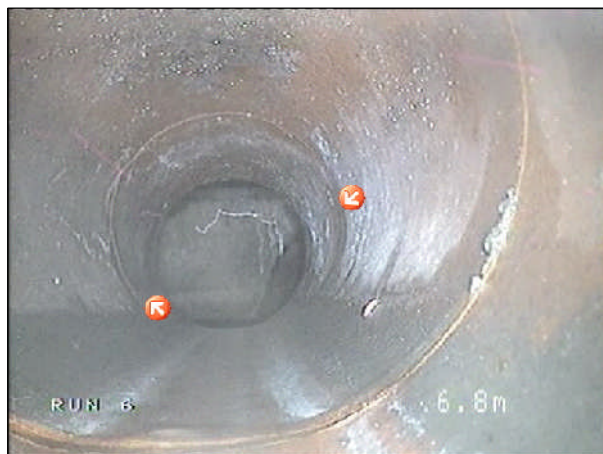
| 1:60<br>Depth: 0.98 | Position | Code | Observation | Grade | |
|---|---|---|---|---|---|
| 6.80 | CC | | Crack, circumferential, from 12 to 12 o'clock | (Struct) 2 | |

Photo: 7\_7\_39\_A.JPG  
6.8m, Crack, circumferential, from 12 to 12 o'clock

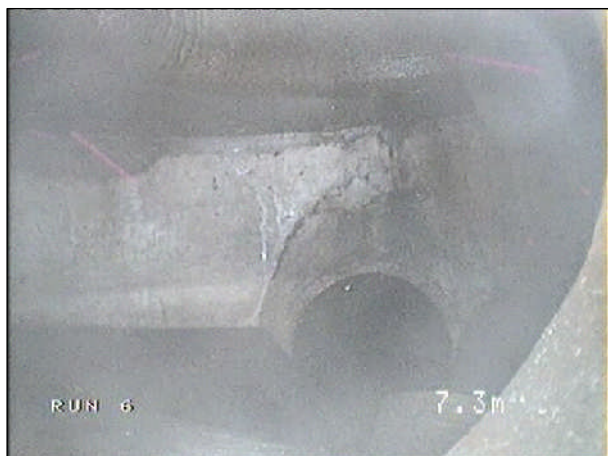
| 1:60<br>Depth: 0.98 | Position | Code | Observation | Grade | |
|---|---|---|---|---|---|
| 7.30 | MHF | | Finish node type, manhole reference number: OUTFALL Remarks: BURIED | (Constr) 0 | |

Photo: 7\_7\_41\_A.JPG  
7.3m, Finish node type, manhole reference number: OUTFALL
