SHEET 9  
Photographic Record / Inventory:  
Ground Floor: G15, 16 and 17

January 2020

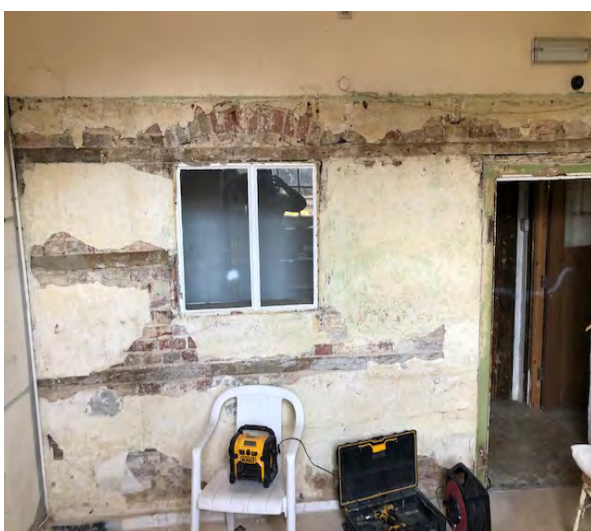
35. G16 - Kitchen. Of a similar rudimentary construction as G14 and Victorian.

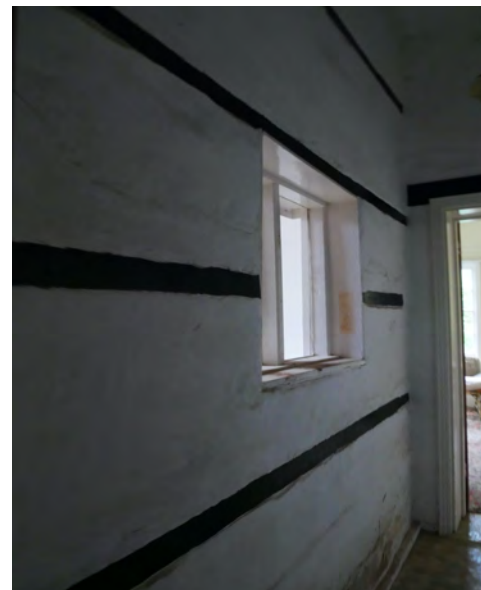
36. Inner south wall, single brick thick. Door and window to a former external passage.

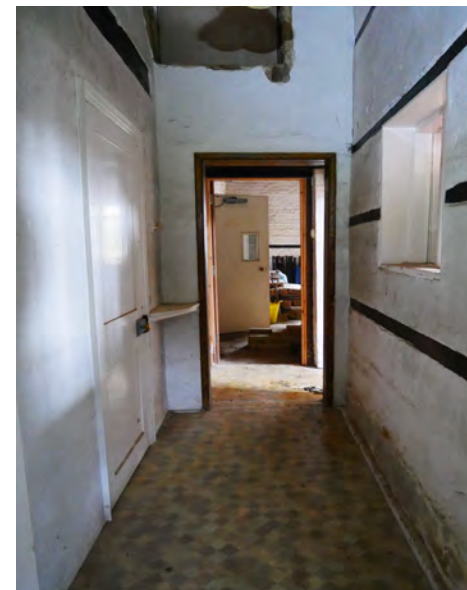
37. G15 - Former external wall to G16. Single brick thick and rudimentary dairy/agricultural form of construction.

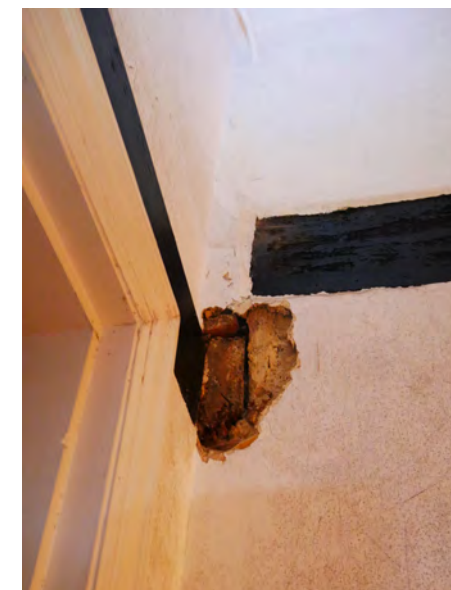
38. G15 - Looking toward G14. This is also part of the area where the lost north bay of the 3-bay timber-framed building existed.

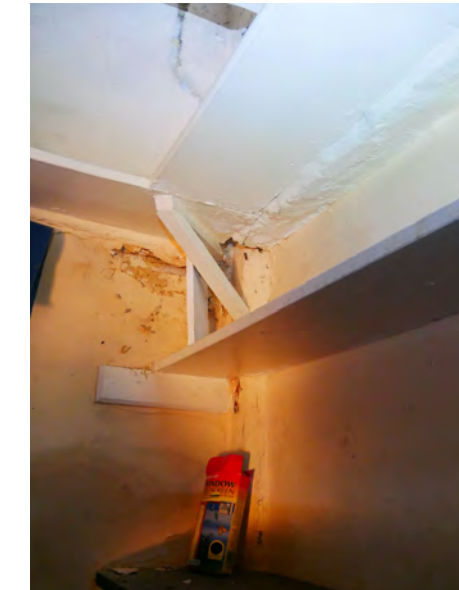
39. SE corner of G15 - evidence of side girt. The cross beam is likely to be reused from the dismantled frame.

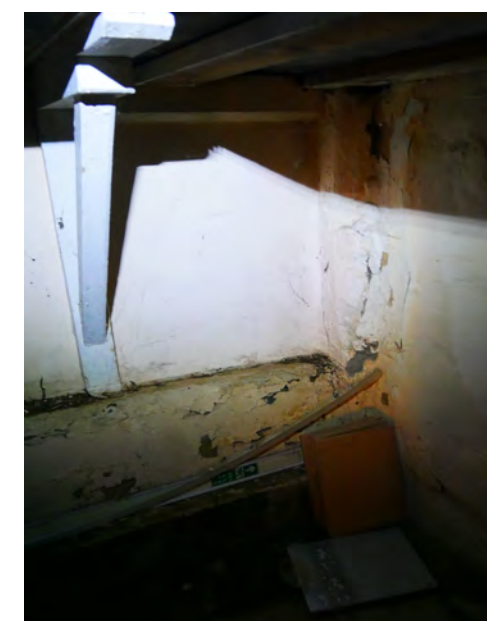
41. SE corner of G17 - the sole plate is clearly visible and is also evidence of the existence of the north bay.
