SHEET 12  
Photographic Record / Inventory:  
First Floor: FF2, FF10 & FF11

January 2020

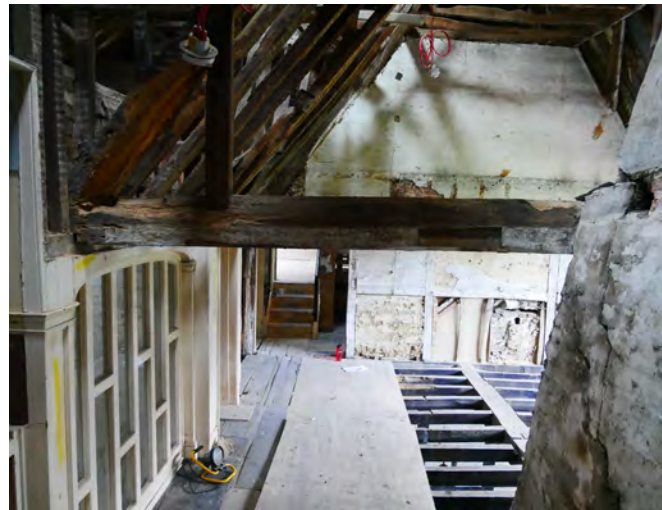
53. View from FF3 stair along sight line of former FF2 modern partition, FF1/2 screen and part of FF11. Note the cross beam has a principal rafter but no principal post. The mortice for a beam can be seen.

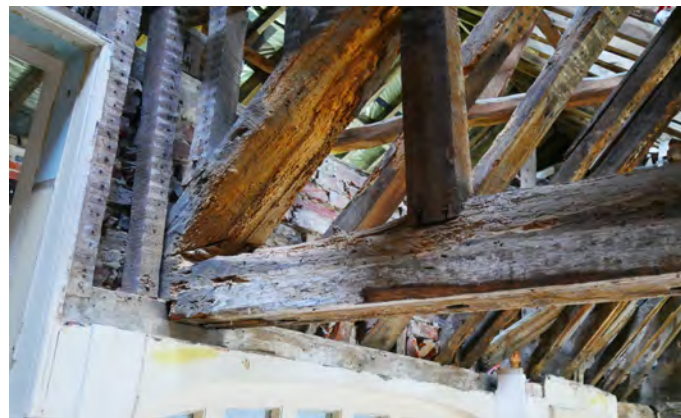
54. Closer view of the missing post. The wall plate has been altered in this area. There is evidence of a partition / door in this location.

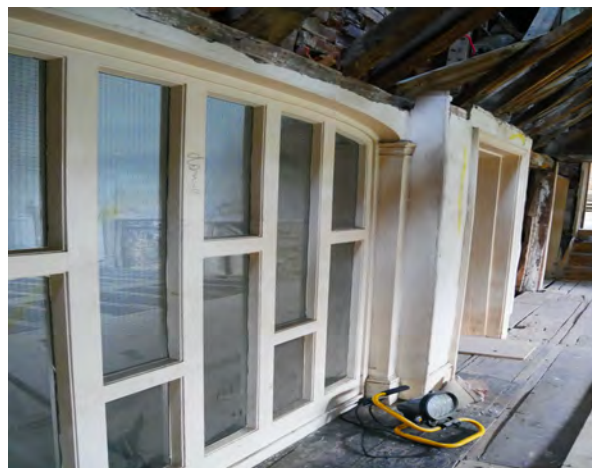
55. Brick above the wallplate relates to the roof over what became a parallel range.

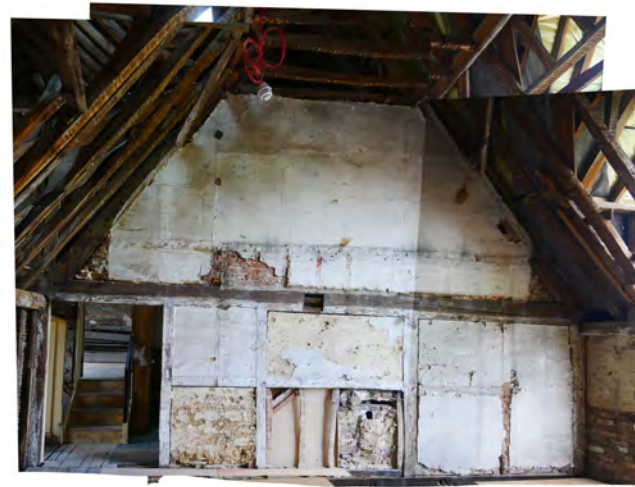
56. An amalgamated photograph showing the inner north wall plus former garret above. Evidence remains for the former spine position, the scar mark for the modern partition and two different ceiling heights. Daub panels have been repaired.

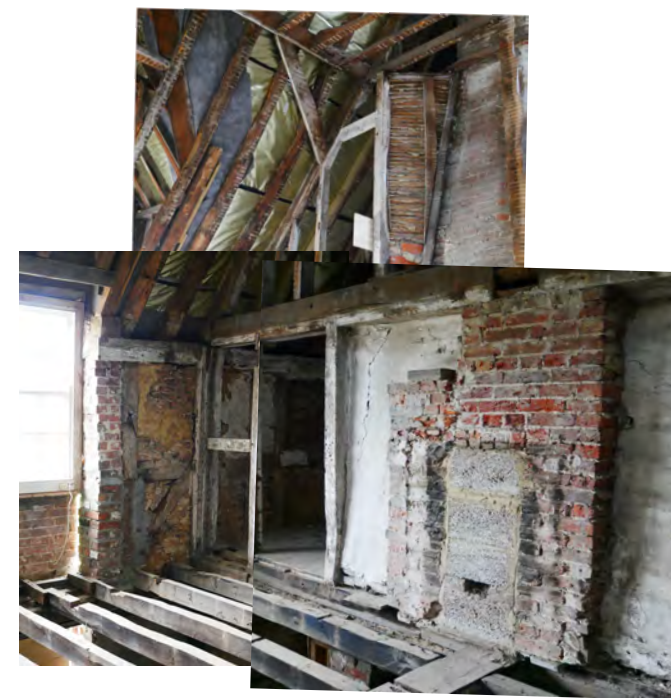
57. The East wall plate, rail and side girt was cut for the late Victorian Bay. Scar marks can be seen for the former ensuite partition. The timber in this area was disintegrating & brickwork collapsing. A former window to FF10 was also uncovered as well the doorway to the garrett above. Modern blocks to fireplace.

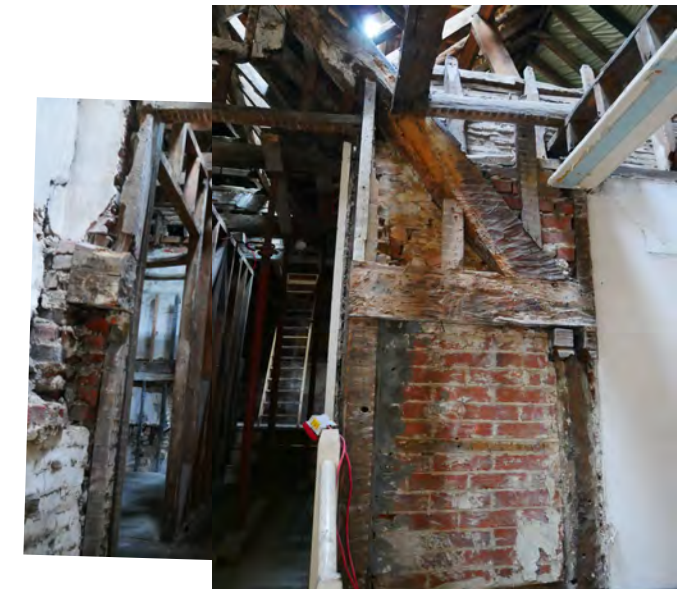
58. View to the south reveals the original wall plate, principal rafter and principal post. As the floors beyond have been raised, the door cuts through the end wall plate.

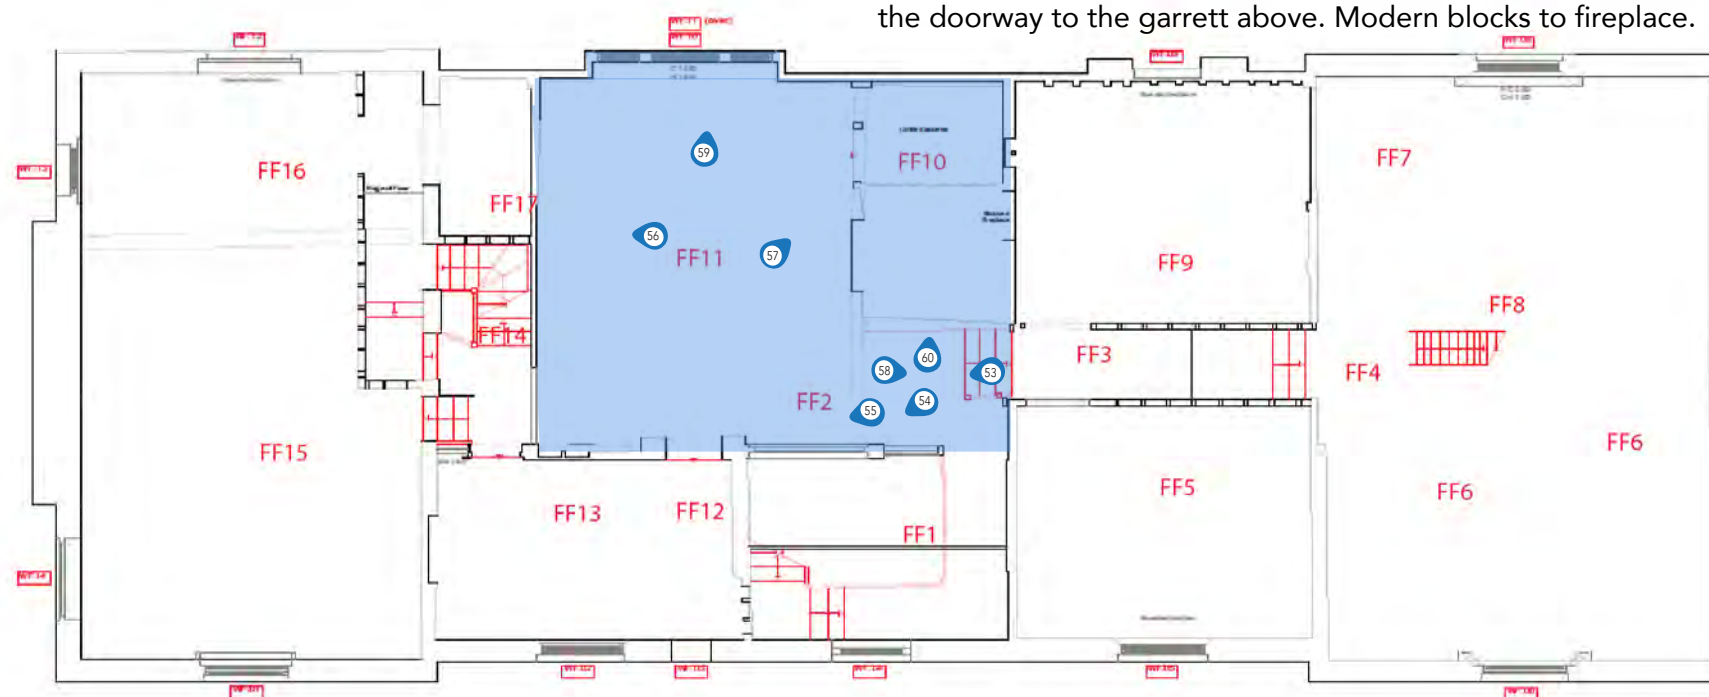
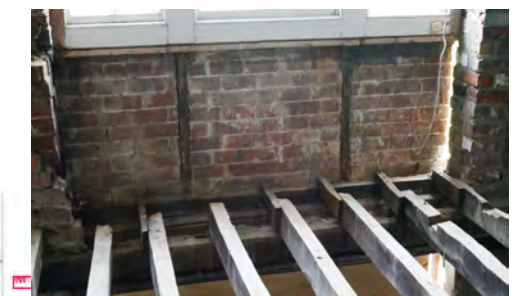
59. The Victorian bay is a mere 'bolt on', not tied in correctly to the main frame. Extensions to floor joists are the method of support. Also concealed with modern coverings.

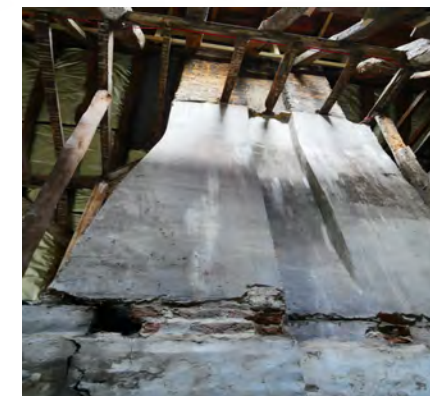
60. The original build had a stack but it has been increased in height correlating with roof changes.
