# THE MANOR HOUSE, EDWARD GARDENS, BEDHAMPTON

## PHOTOGRAPHIC RECORD OF REAR BAY TO EAST ELEVATION

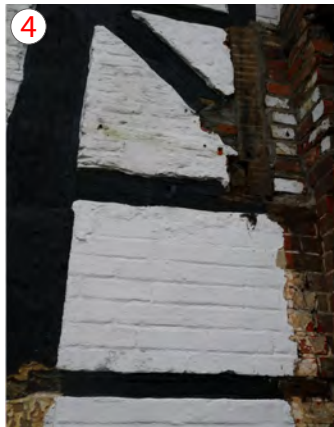
4. Focussed image of brace having rotted and void infilled with brick which had been covered over with cement render and painted black,
5. Similar to 2 but shows condition of timbers forming the bay, including outer posts, cill and head beam as well as evidence of decay to panelling to north side, concealed by black non-breathable paint.

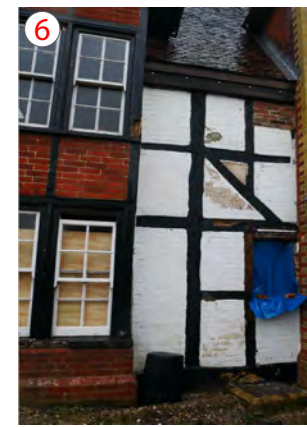
6. North side of bay with small window with no glass. Brick panels covered with white paint and timbers covered with black paint. Clear signs of decay and rot.

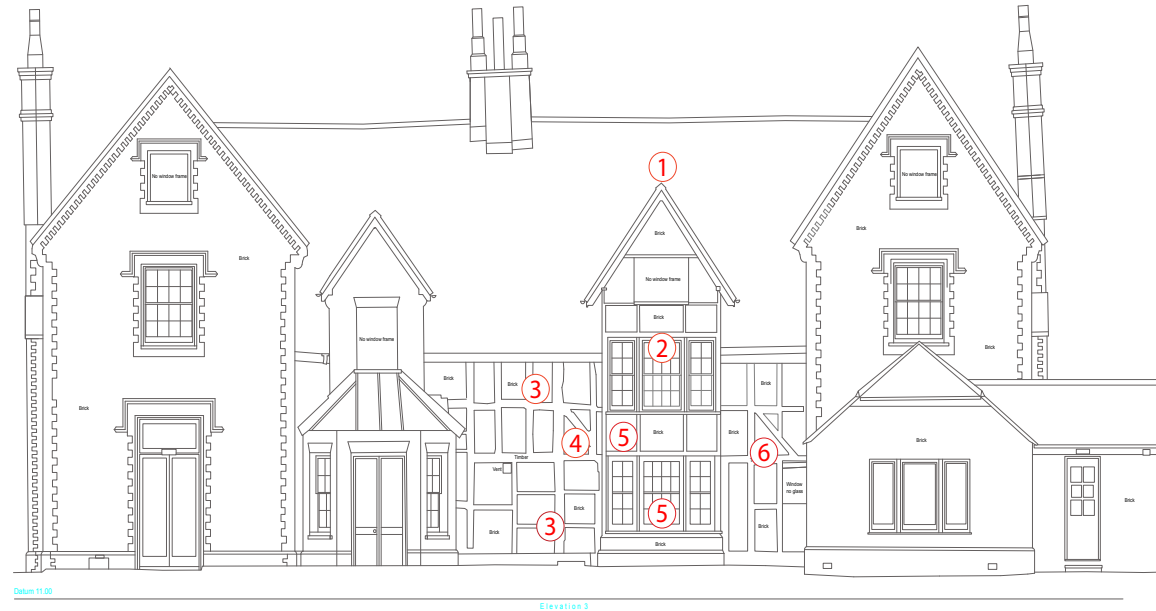
1. General View of Rear Elevation.  
Brick noggins noted as painted with non-breathable paint. Timbers painted with black - also not breathable.  
Evidence of decay to box frame and timbers to projecting bay.
