## Joinery Details

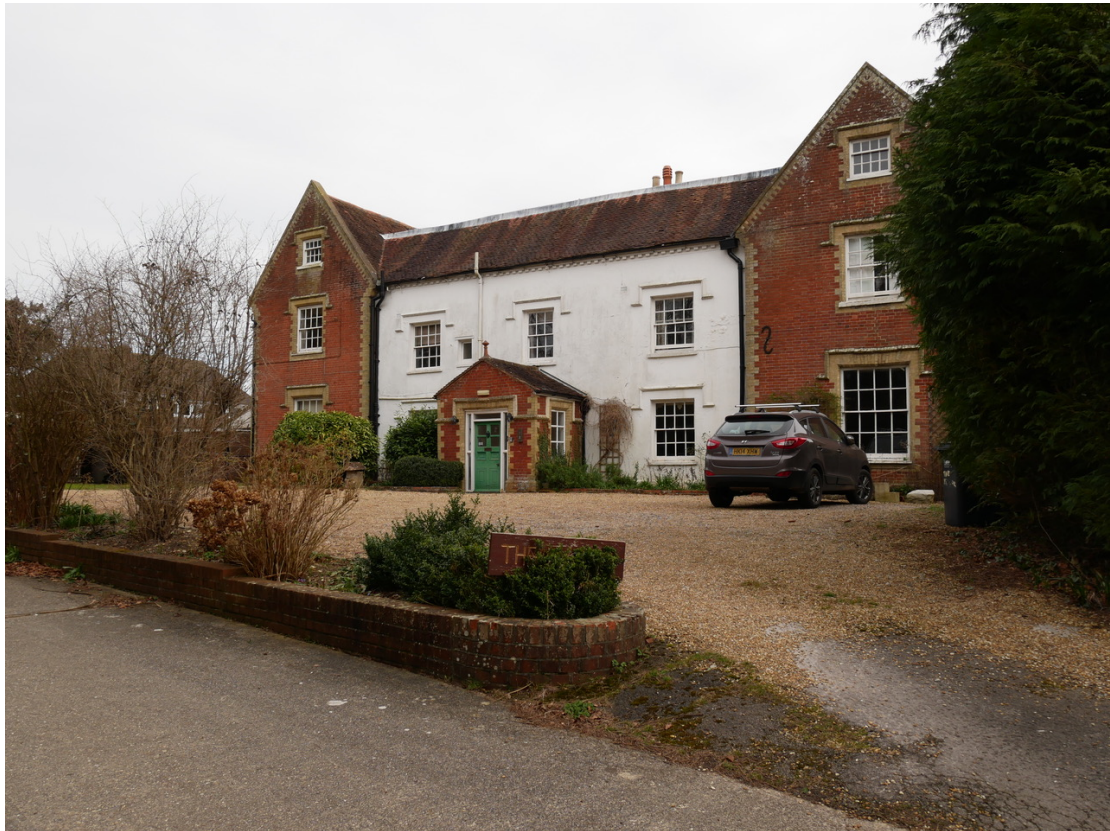
Front elevation

No horns to any windows

Multi paned no opening lights

Centre to staircase - no horns

No horns to any windows.

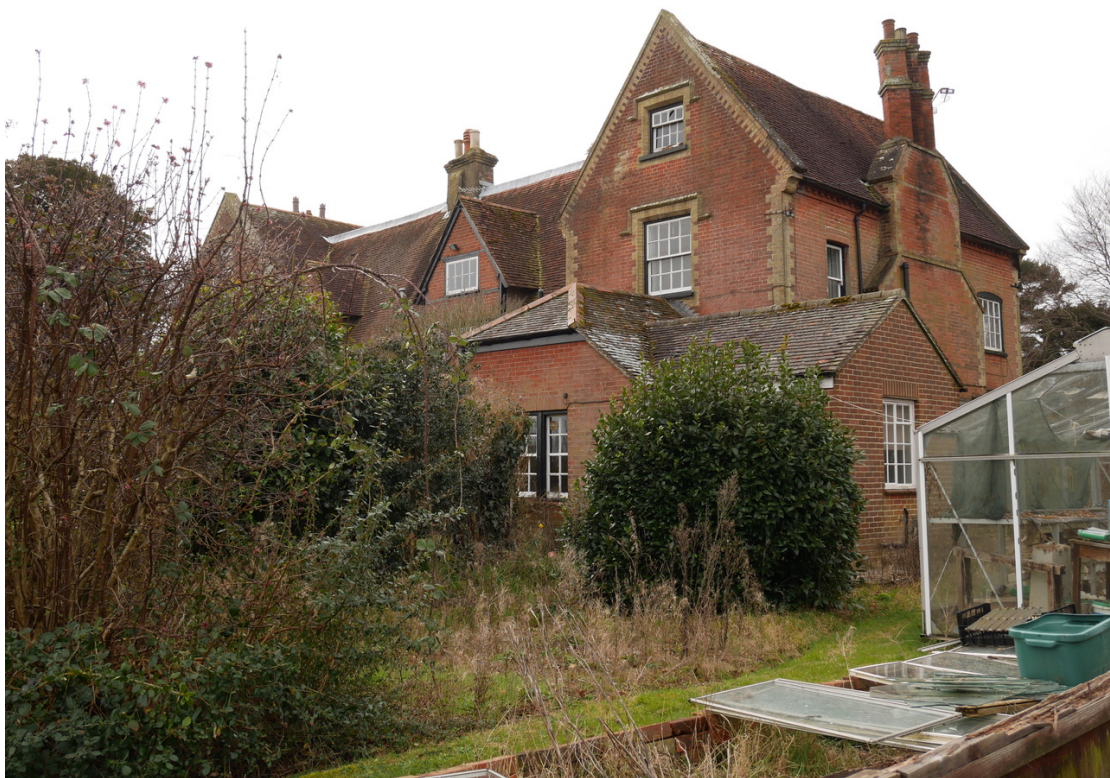
Part Rear (East) Part Side (North)

Ground floor - to east of stack, mutli paned, not a sash. Does not need replacing.

First Floor - with horns to sash bottom to east of stack. Does not need to be replaced. Needs new cill.

First Floor window to west side of stack only needs repairing. It is not a sash. Has one opening light

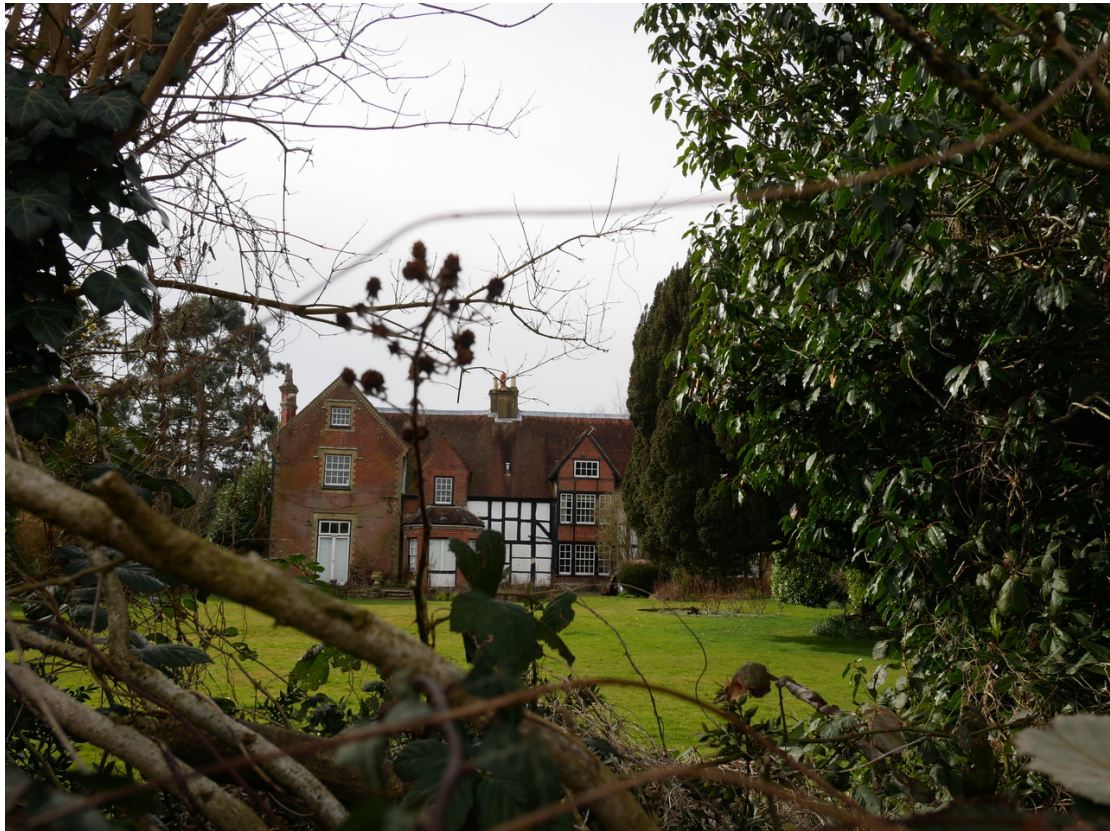
Rear (East)

Rising Bay - with horns to top and bottom tripartite sash.

Single Storey Bay - no horns

Gabled wings - no horns

Rising Bay - No horns - flush window!

No horns to other windows.
