SHEET 17  
Photographic Record / Inventory:  
First Floor: FF15 & FF16

January 2020

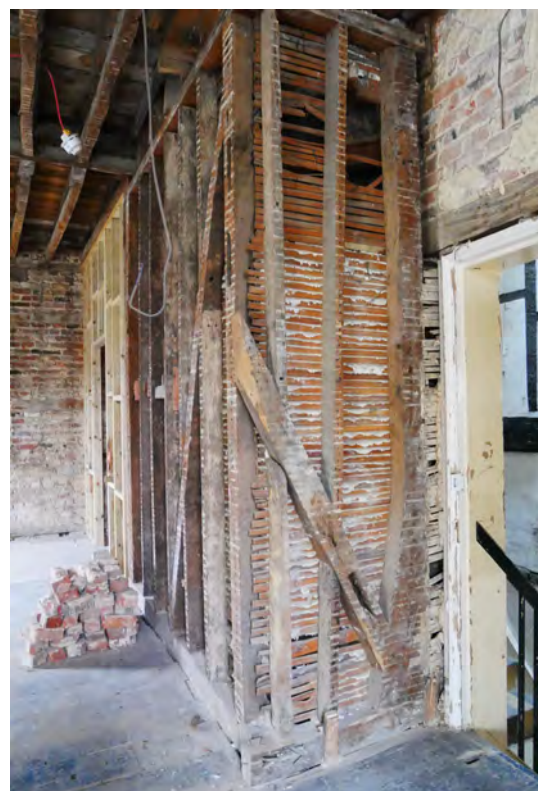
91. Stairs from FF14 to FF15 with later partition to accommodate landing. Note upturned 'swell' jowl to corner and reused rake. Softwood to east, more recent.

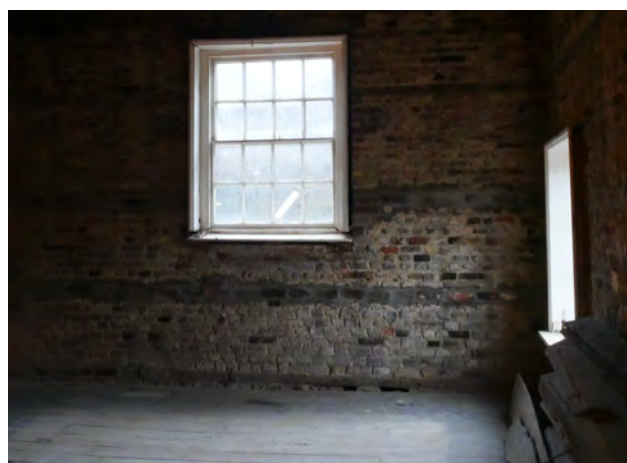
92. FF15 - former staff sitting room with dual aspect and windows in place.

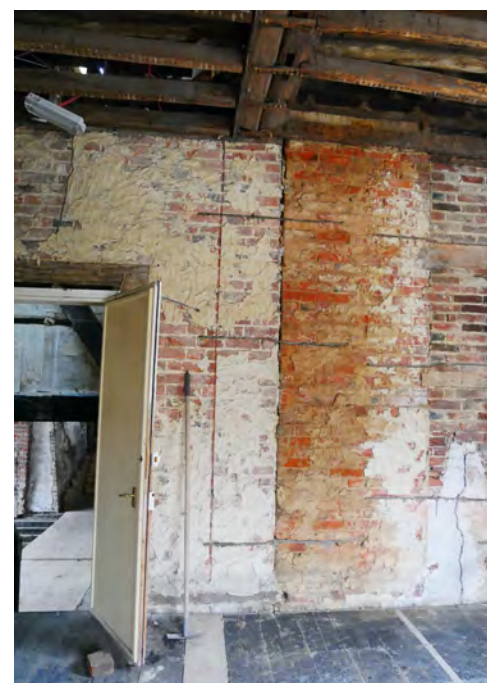
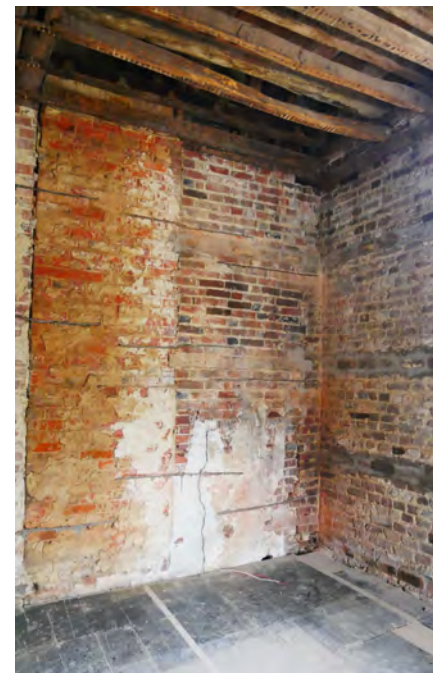
93a/b. South wall of FF15 with evidence of flue for FF13. Also potential evidence of a two stage build at first floor level. Note there is a partition line to the west of the door, not aligned with the paired beam above (reused).

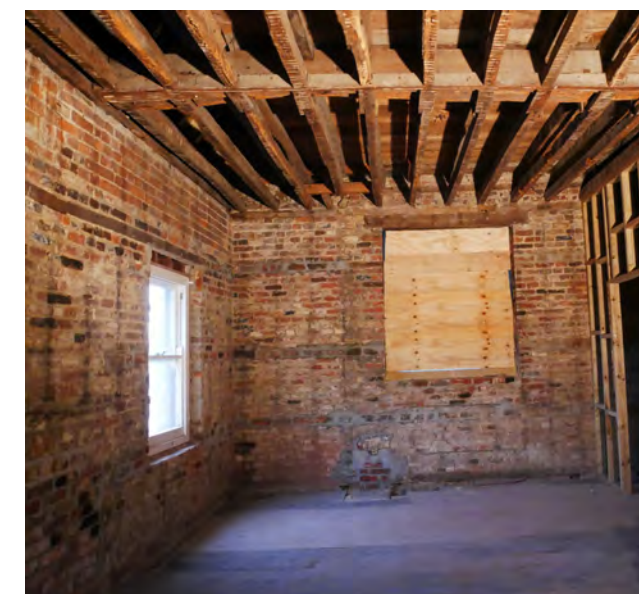
94. East and north walls of FF16 with dual aspect. Room division came off corner of internal partition shown in photo 91.

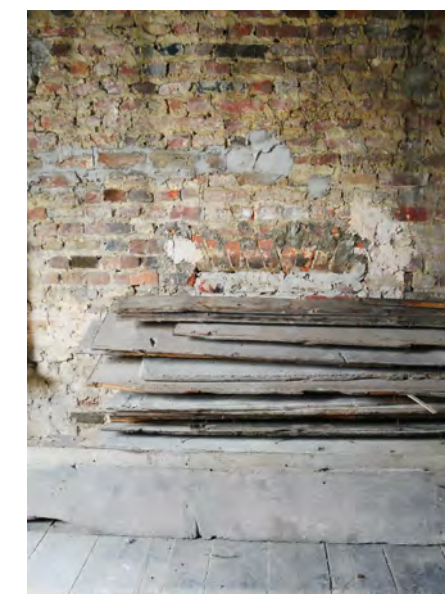
95. Fireplace to FF15 blocked up. Past planning application indicates this had a modern surround.

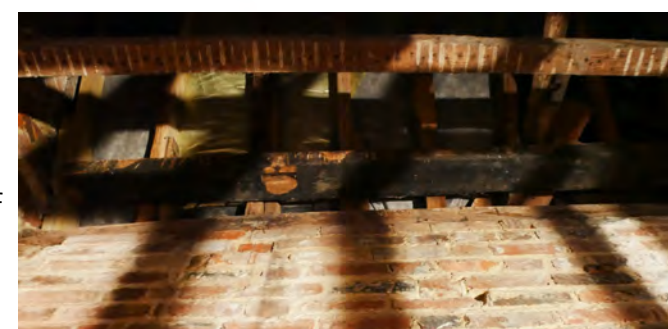
97. Fire damage to timbers that have been reused above to FF16 and FF17.

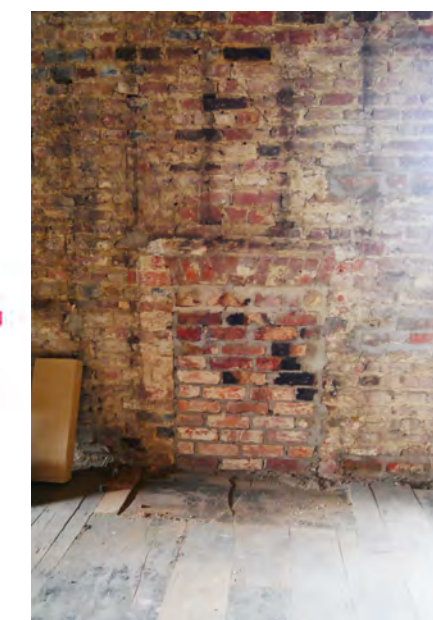
96. Fireplace to FF16 blocked up. Hearth slab cracked.
