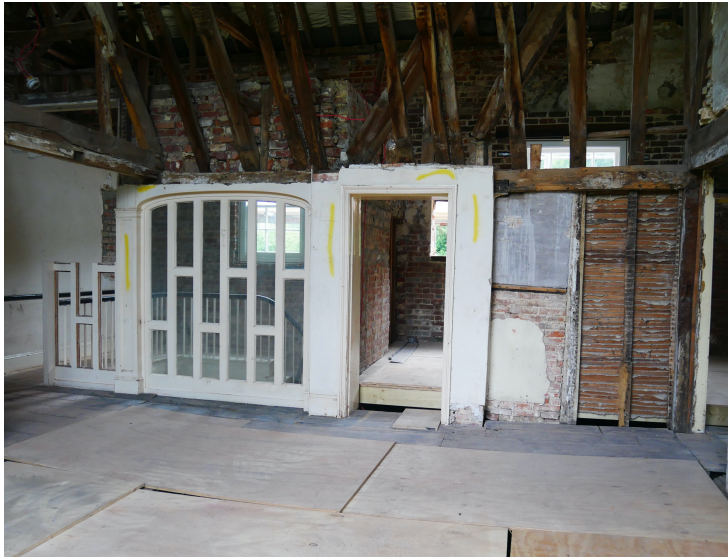
76. FF2/3 and Door to FF12. Doorway inserted below the wall-plate to the former external west wall. Door to FF13 is off the landing for FF14 (and ghost bay). Possible window particularly obscured. Staged works with mixture of lath and plaster and brick noggins with plaster over.

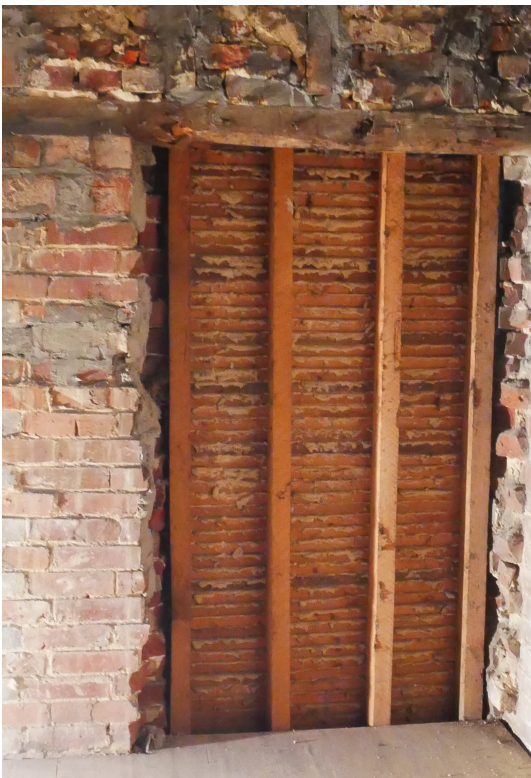
77. Door to FF1. Above the wall plate, joists can be seen but do not equate with the actual ceiling joists nor are these visible to FF1.

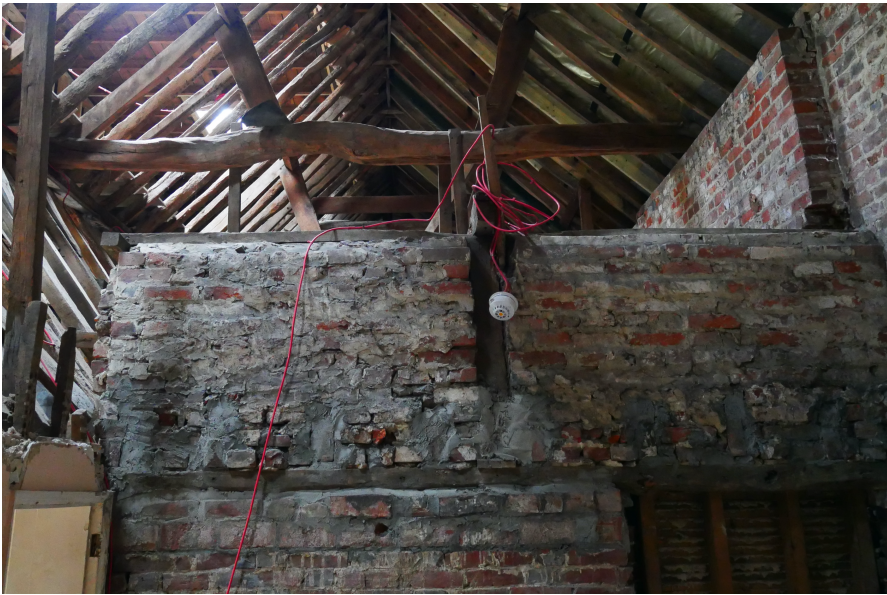
78. South wall to FF12 shows evidence of intruded stair bay. The roof struture is basic in this position, unlike the roof over FF5.

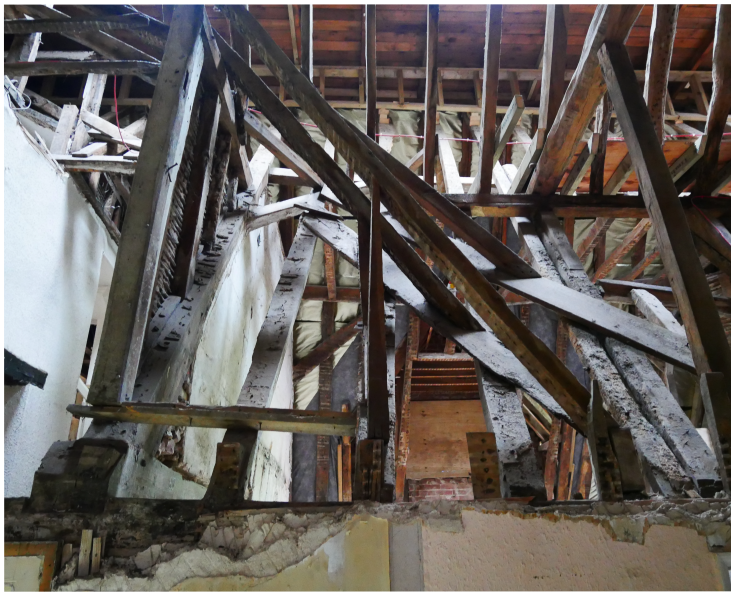
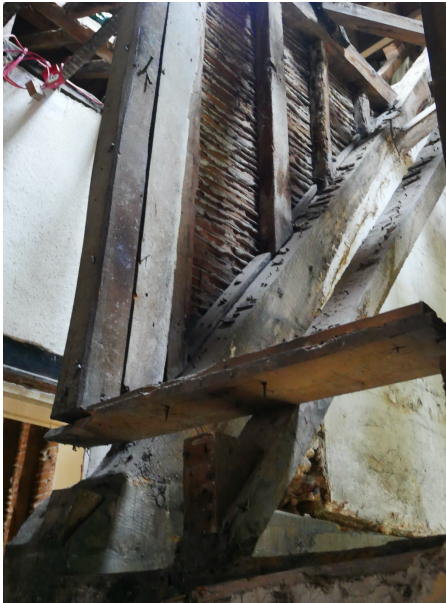
79a & b. East wall plate height with view of roof over middle bay. Shows evidence of fire damage, reuse added rafters along withraking shores. Rafters are also added to increase the height over the main range. Ashlars indicate ceiling height to FF12/13 raised. The principle post and rafter can be seen as the divide for the original north bay. Studs added to create FF14 partition. Roof over main chamber - rafters are bridle jointed at apex. Marked II and II.

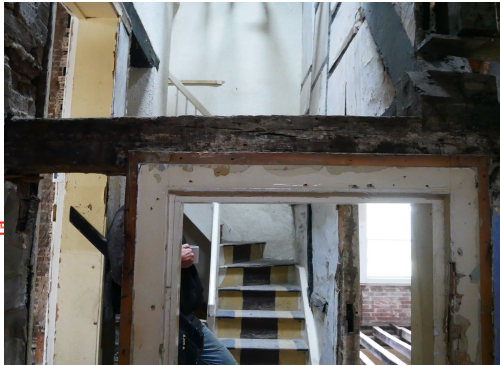
80. West wallplate to 'ghost' north bay and FF14. Note that box frame is visible to the stairway.

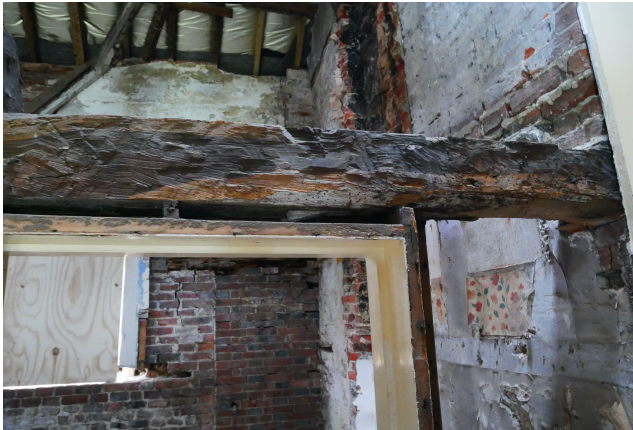
81. West wallplate 'interior' face, at pt where the 3rd nrth bay existed. Note evidence of bay window. Former fireplace & flue removed in past.
