SHEET 3  
Photographic Record / Inventory:  
Ground Floor: G4

December 2019

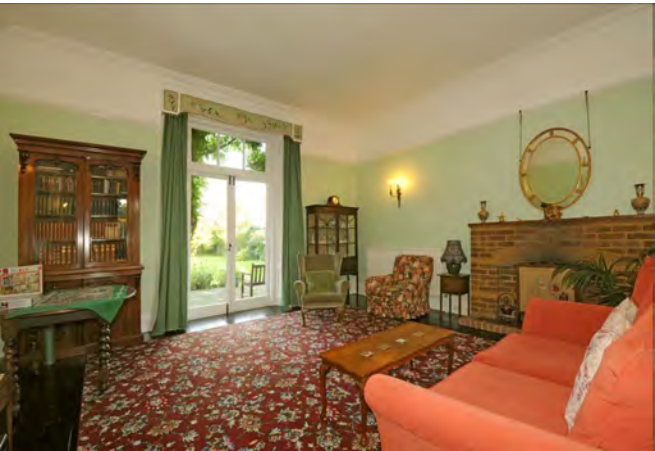
French doors and fanlight to G4 (replacement approved). Brick fireplace, skirting boards, picture rail and coving visible (Source: Zoopla).

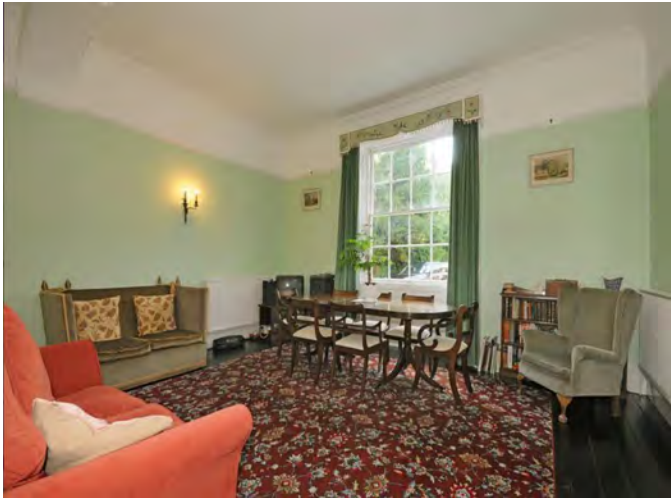
View to west showing carpentry covering spine beam, sash window, stained softwood floorboards, skirting, picture rail, coving (Source: Zoopla).

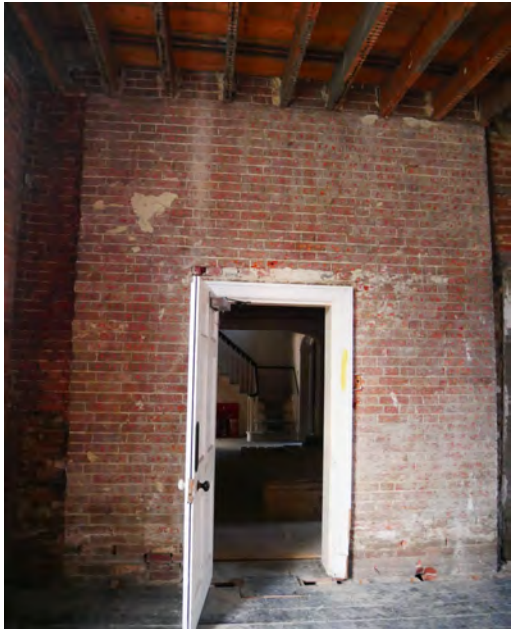
10. Exposed brickwork to NW corner. This shows the point where the Late Victorian south cross-wing range was added.

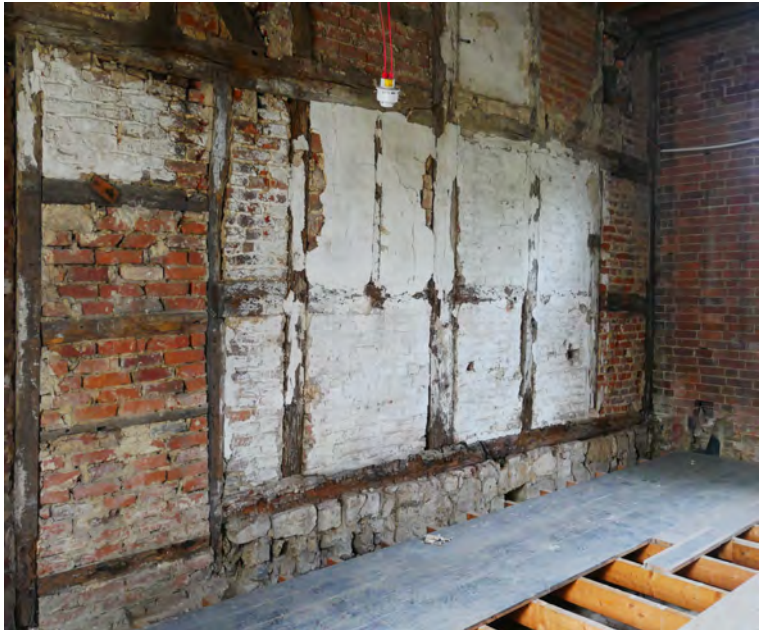
11. Timber-box frame to C16th 'end' bay with evidence of former door and window. Masonry plinth below cill plate. Evidence of cement mortar used for repairs and repointing.

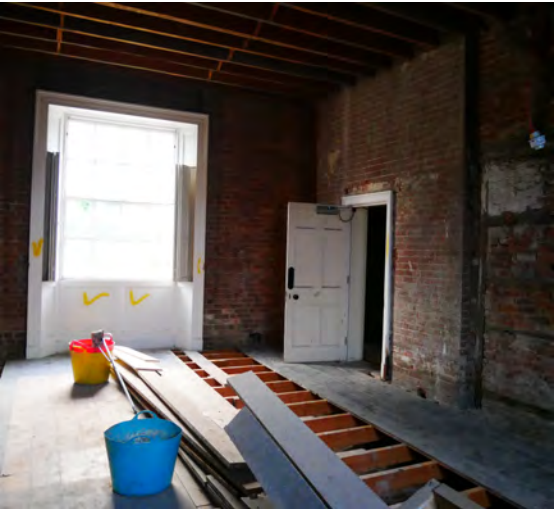
8. View to west showing two stages of change as well as an increase in ceiling height. Floor joists have been replaced - modern softwood.

Notes: There is evidence to suggest that this room was subdivided as there are two former fireplaces evident. With changing demands the two spaces were amalgamated and a boxed arch introduced to concealed the spine beam. No evidence to floor of division suggesting that the room was refloored. Ceiling joists have cross bracing. Evidence of modern gypsum plasterboard with modern nails found in debris between floor joists.

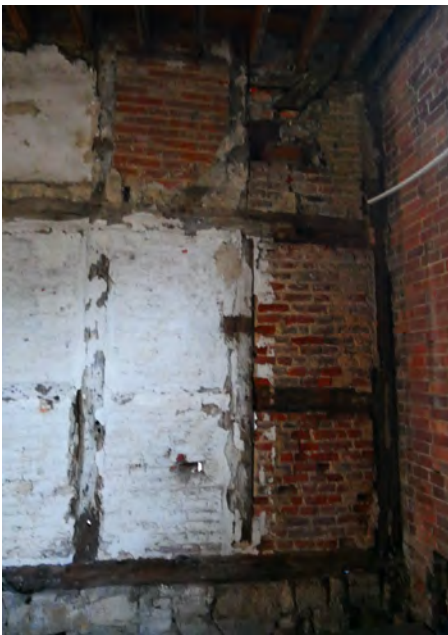
12. NE Corner of room. Diagonal brace has partly deteriorated. Lime wash to former external wall.

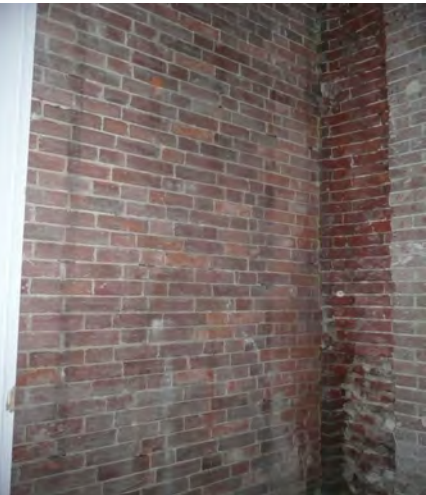
9. Exposed brickwork to NW corner. This shows the point where the Late Victorian south cross-wing range was added.

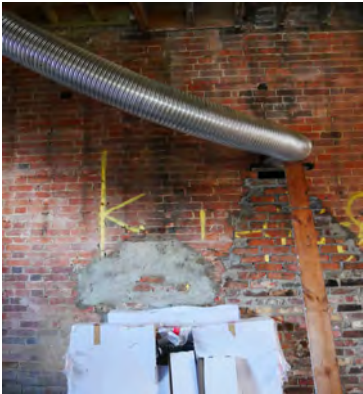
13. Position of former fire place. To be replaced.
